# **Summary Building Condition Survey Report**

**Portknockie Primary School**  
**King Edward Terrace, Portknockie AB56 4NX**

**3<sup>rd</sup> & 4<sup>th</sup> October 2022**

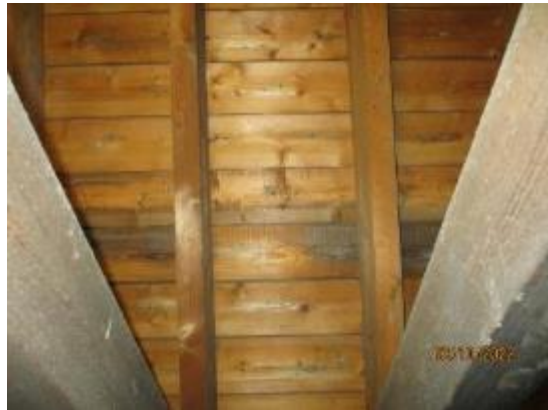
4. Timber sarking boards

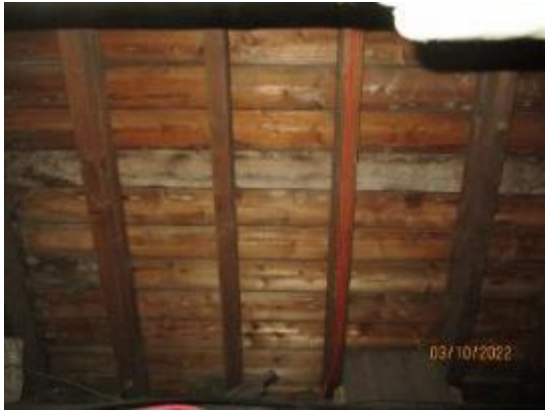
7. Timber sarking boards

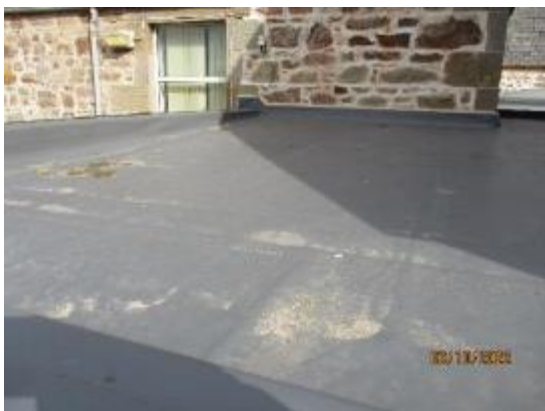
11. Single ply membrane

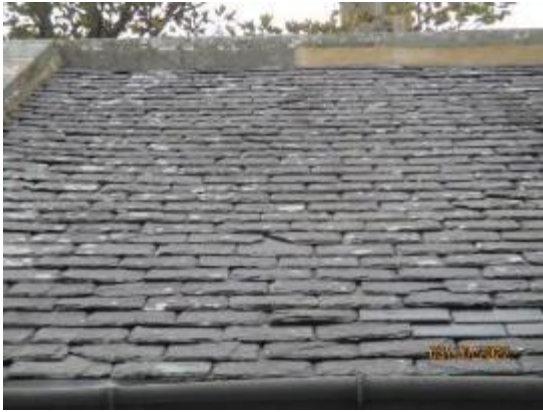
13. Slates to external store

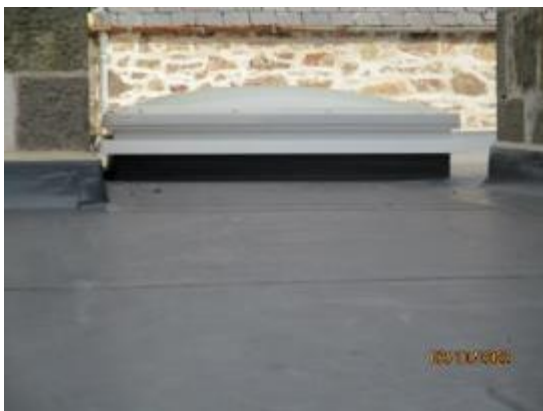
17. Rooflights to school

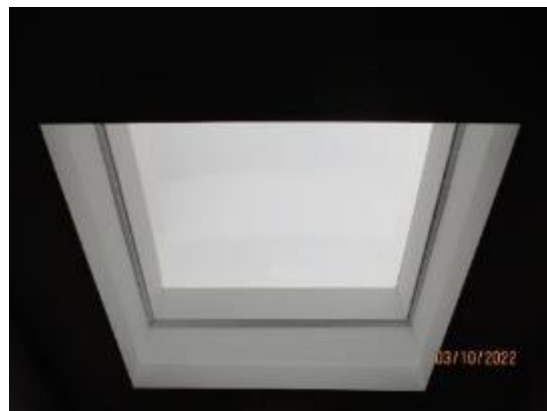
18. Rooflight internal linings

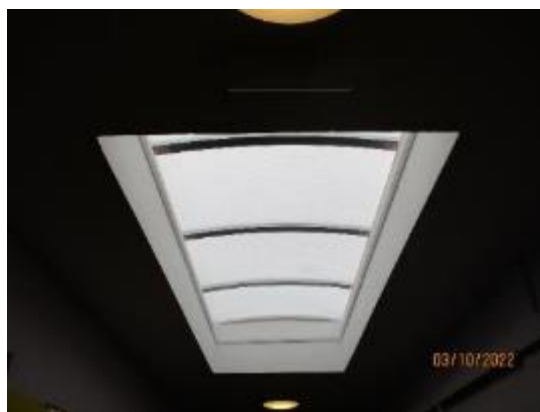
20. Large rectangular rooflight

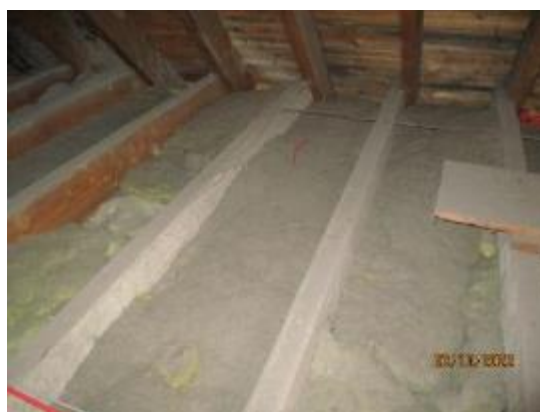
22. Thin mineral fibre insulation

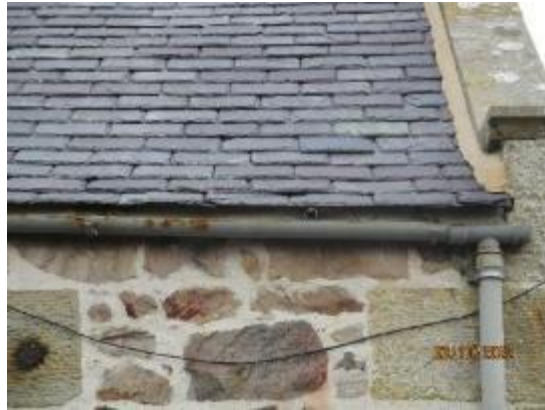
- Cast iron rainwater goods have surface corrosion.
- Cast iron gutters to the west elevation are not aligned with the roof surface.
- External ground level is above floor level in the west elevation.
- Lath and plaster ceilings are cracked in many locations.
- Lath and plaster walls are cracked and watermarked in several locations.
- Timber window sills, and surrounds are swollen and watermarked.
- Carpets are worn and soiled.
- Internal timber doors are worn and damaged and have exceeded their useful life.
- Kitchen units and worktops have exceeded their useful life.

26. Cast iron miss-aligned gutters to Nursery

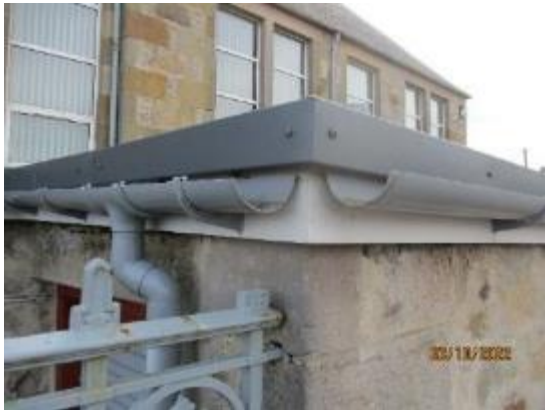
27. UPVC gutters to Boiler House

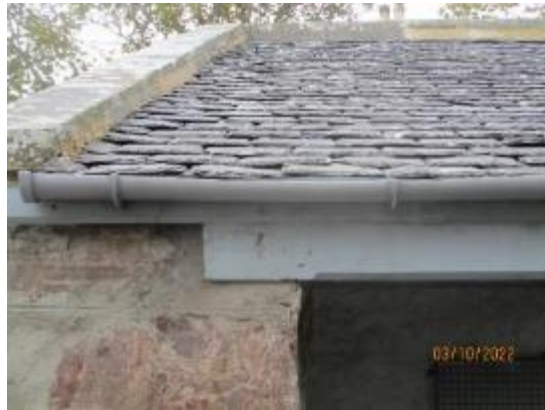
28. UPVC gutters to external store

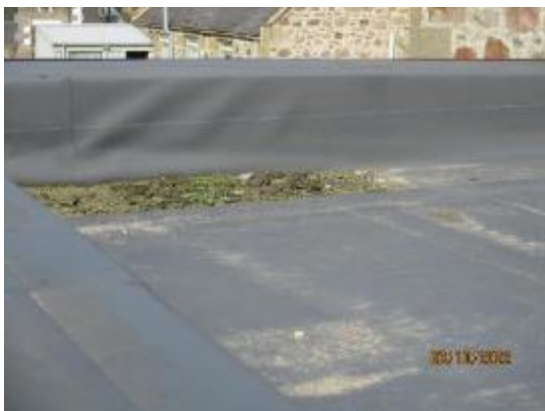
29. Vegetation to box gutters

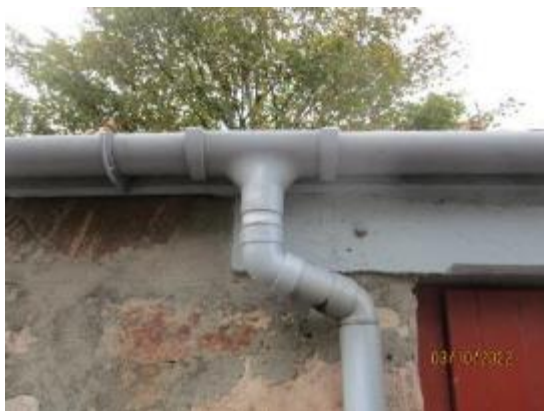
35. UPVC downpipes

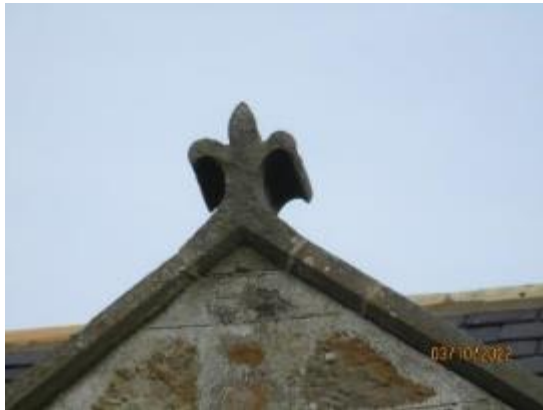
46. Stone finial – fair condition

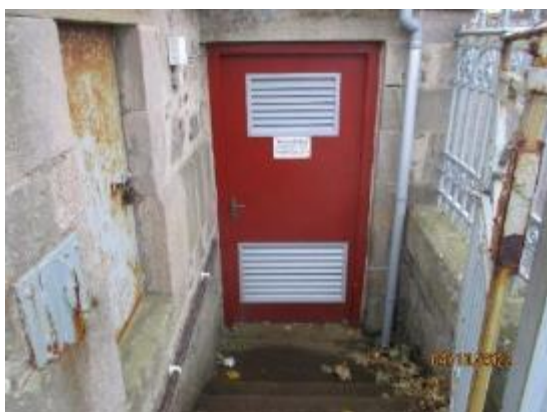
55. Timber Boiler House door

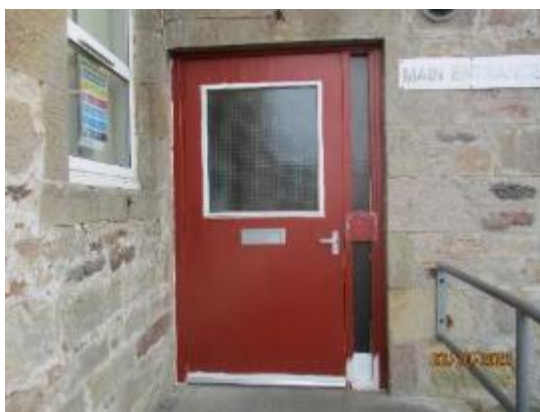
56. Timber front entrance door to school

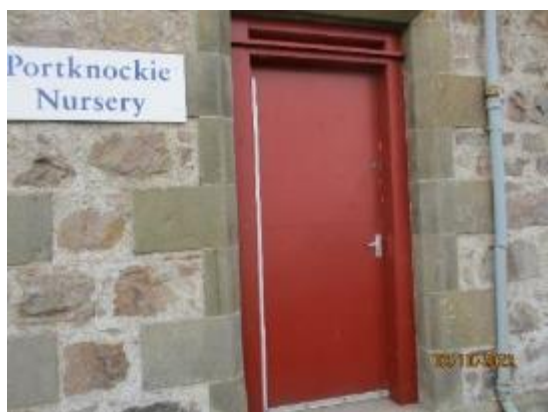
57. Timber entrance door to Nursery

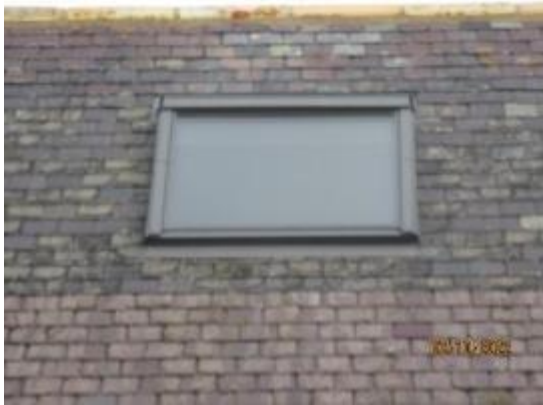
61. Velux windows to school

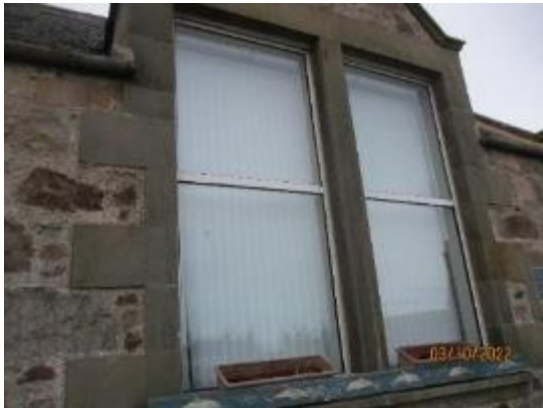
63. UPVC windows to Nursery

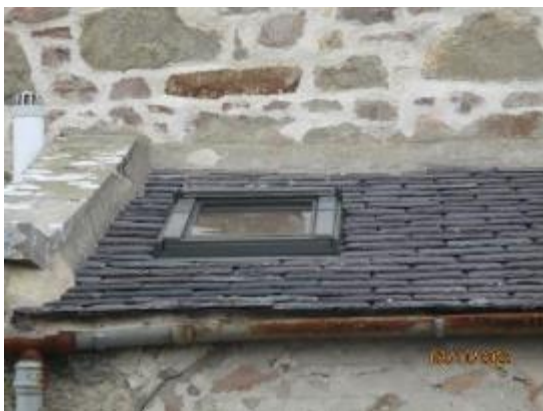
65. Velux to Nursery toilets

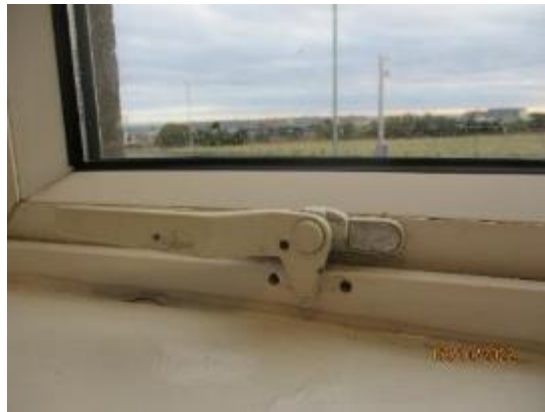
68. Lever handles to school windows

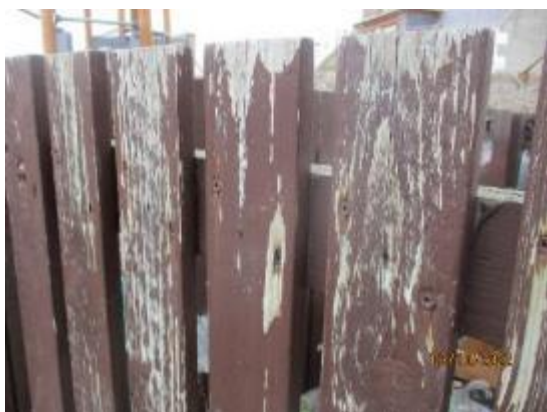
72. Timber fencing

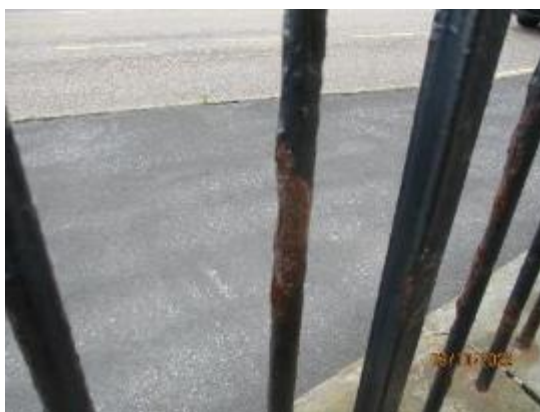
- Natural stone walls require repointing.
- Metal railings have considerable surface corrosion.
- Boiler House gate – corroded with sharp edges.
- Surface water drainage to the west playground is poor.

73. Metal railings

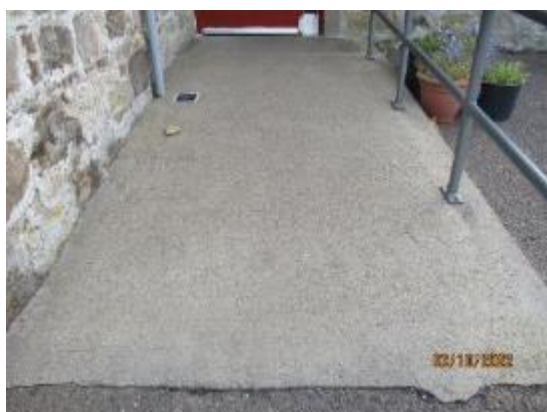
74. Concrete entrance ramp

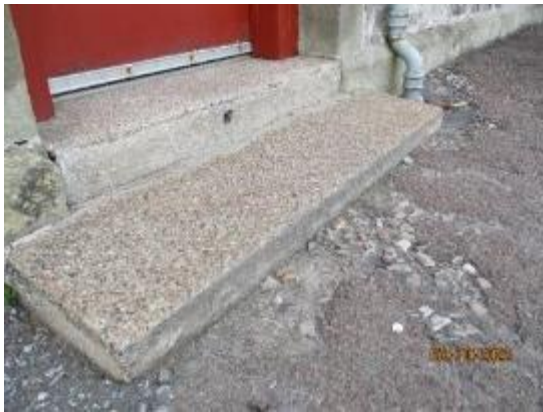
78. Concrete step to Nursery entrance

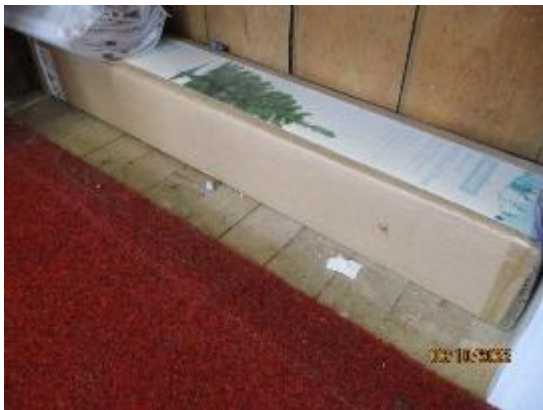
80. Timber suspended floors

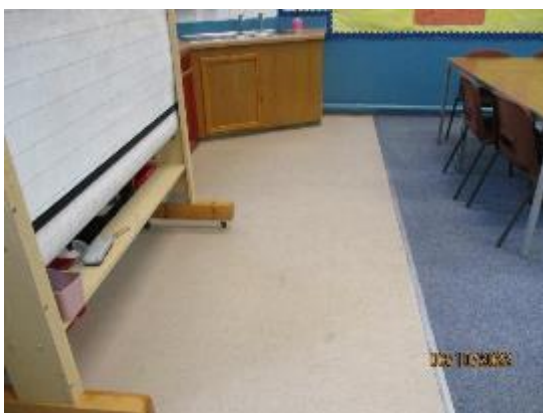
82. Vinyl floors in the school

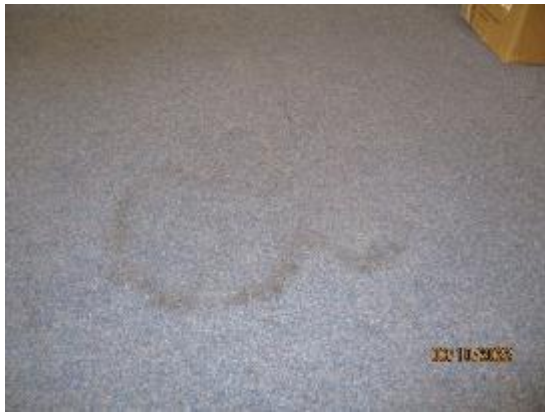
84. Carpets are soiled

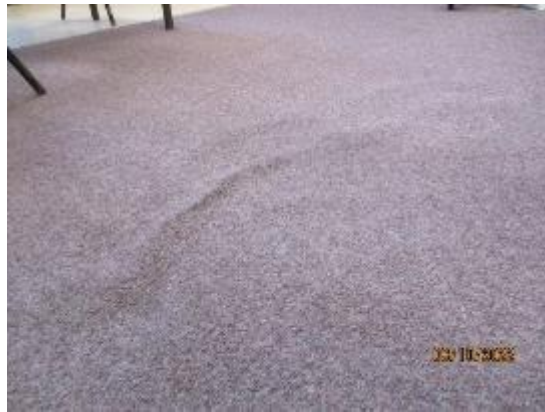
85. Carpets are stretched and wrinkled

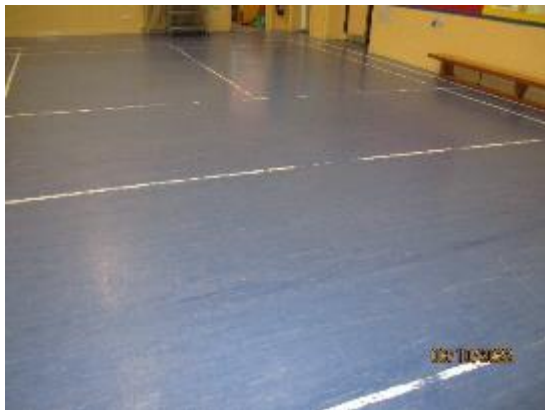
86. Vinyl sports floor

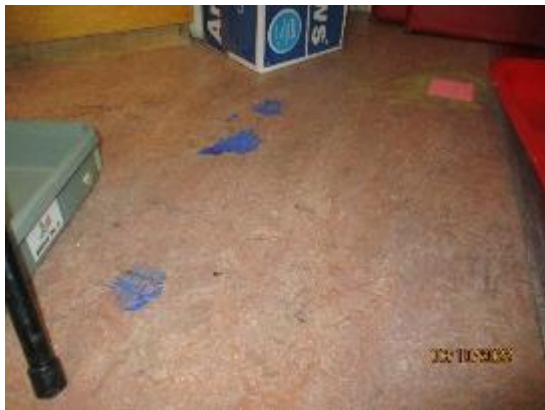
87. Linoleum flooring

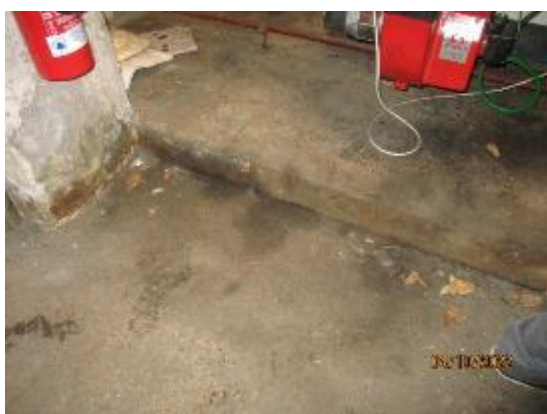
90. Concrete floors

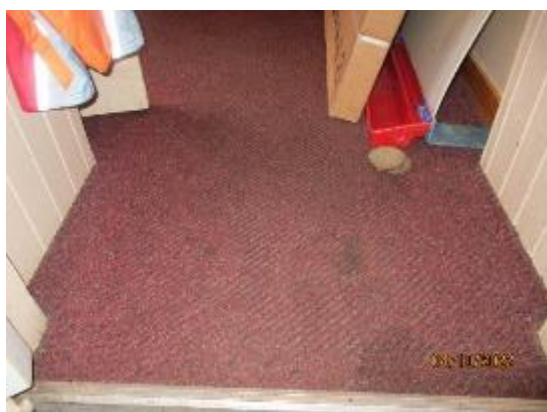
92. Carpets are worn and soiled

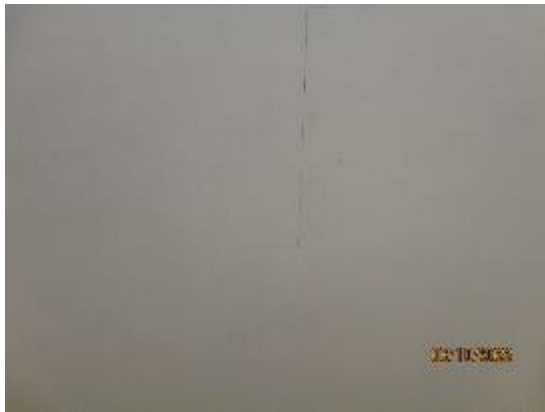
96. Plasterboard ceilings

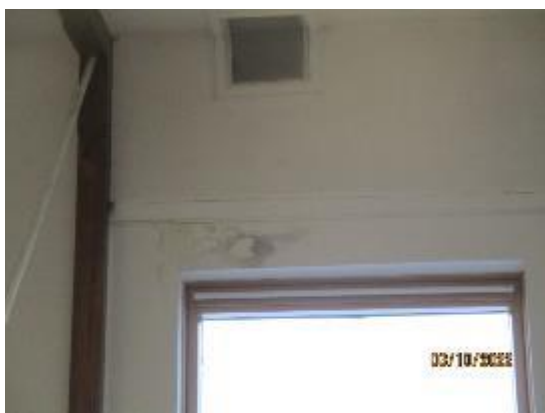
101. Watermarks around Velux windows

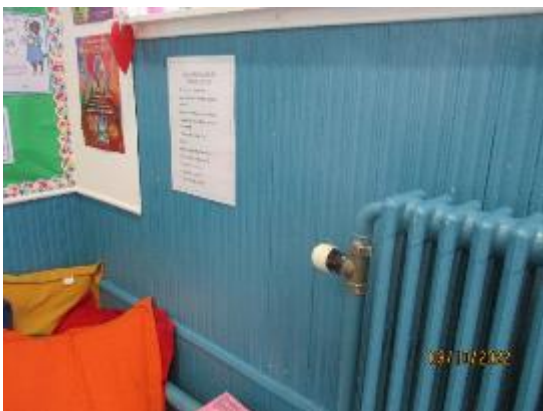
111. Timber linings

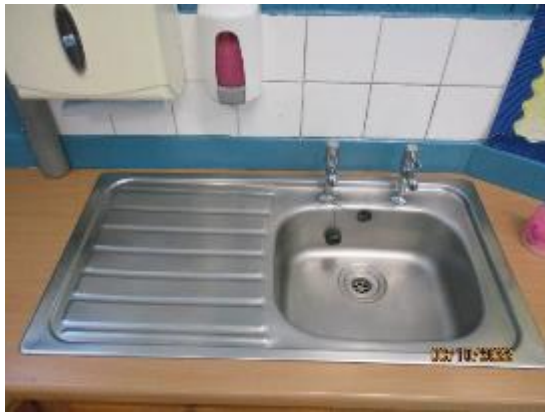
113. Ceramic tile splashbacks

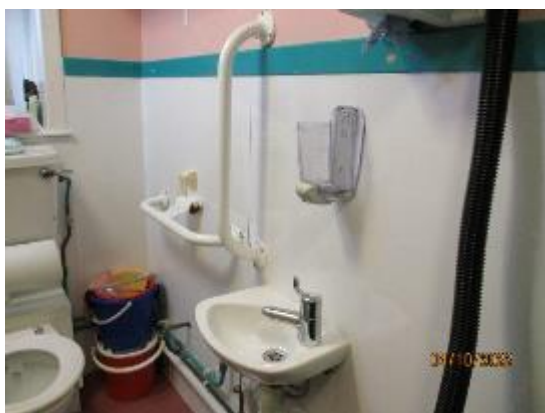
117. Wetwall in the Nursery toilets

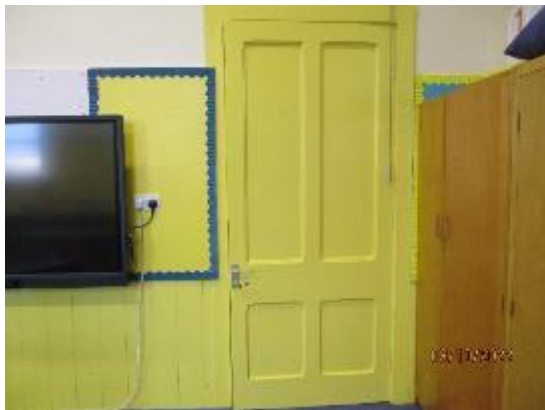
121. Timber panelled doors

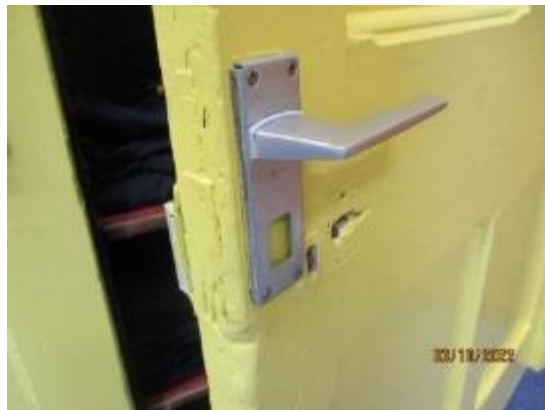
128. Faulty ironmongery

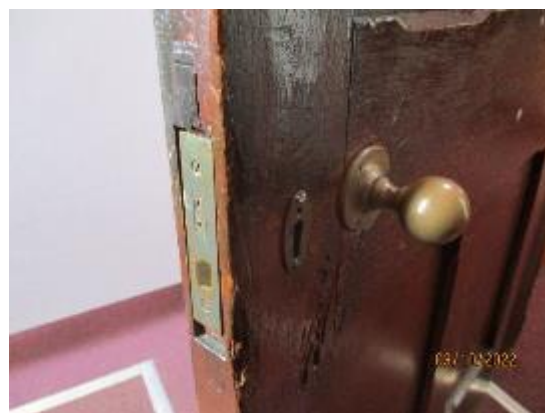
130. Brass knob ironmongery

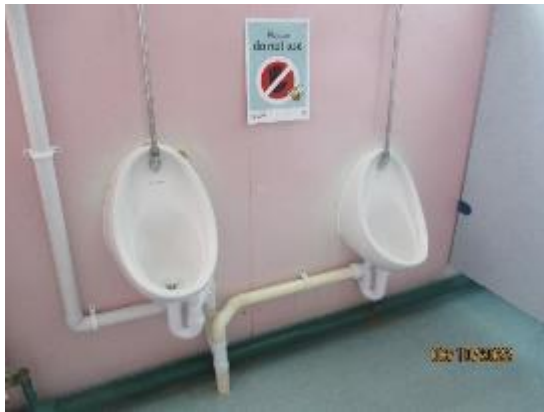
131. Urinals

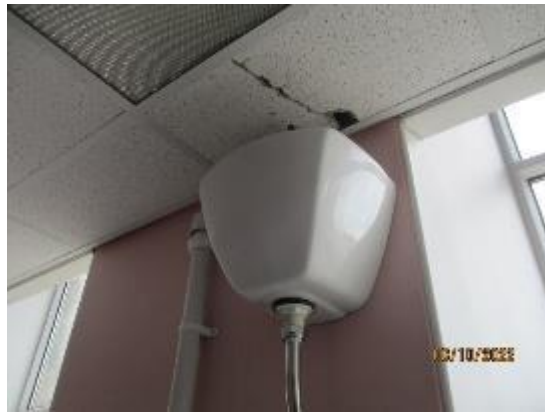
132. Urinal cistern

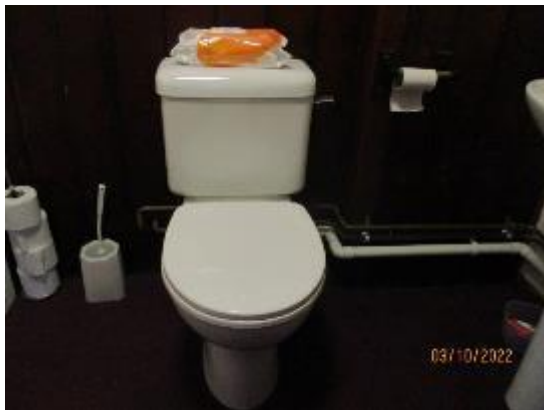
133. Staff WC

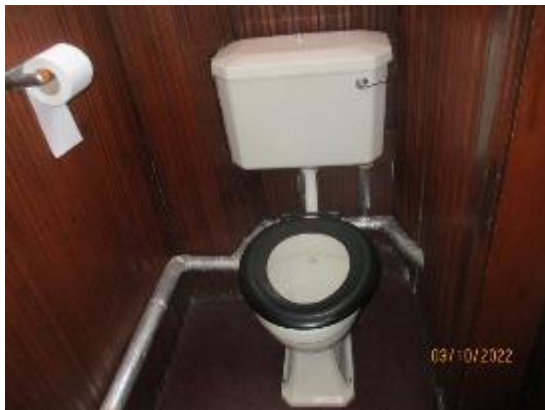
134. Staff vintage WC

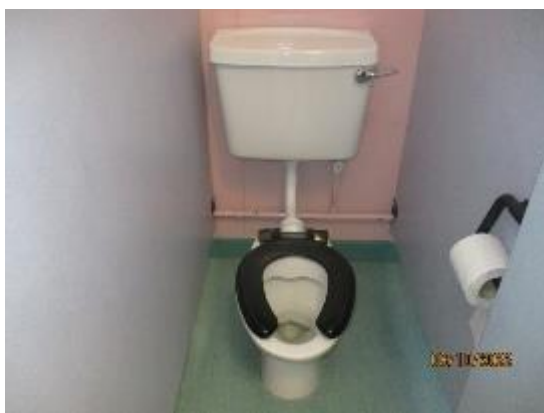
135. Pupil WC

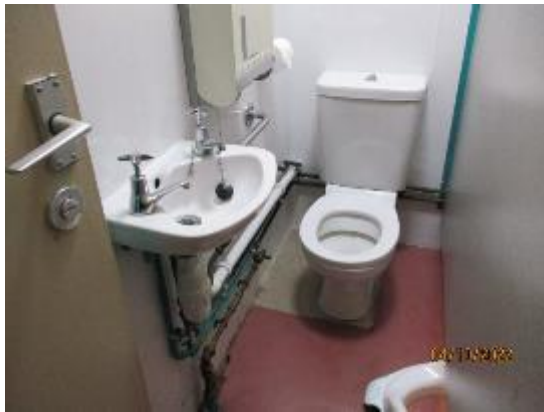
137. Nursery WC

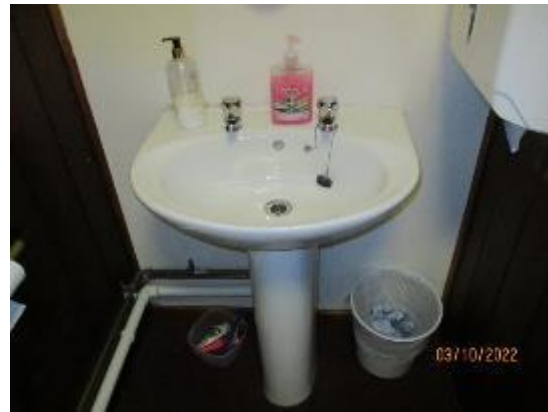
138. Pedestal basin

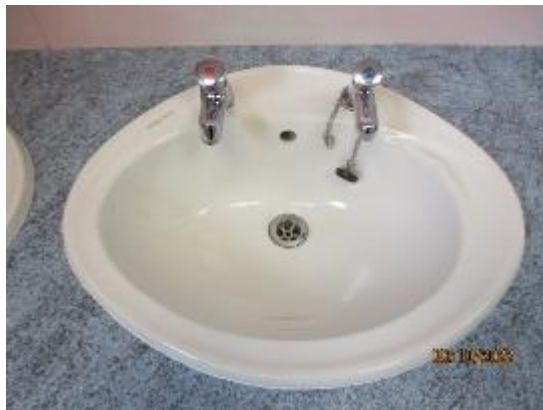
139. Vanity basin

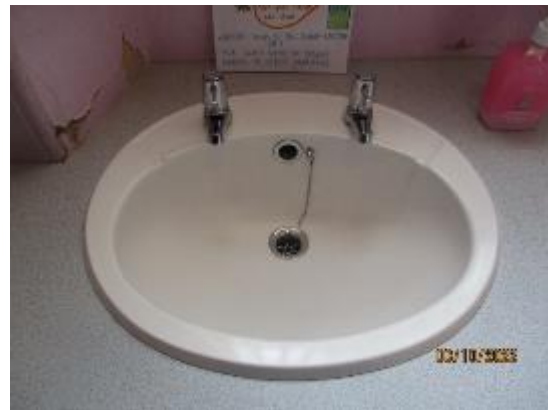
140. Vanity PVC basin

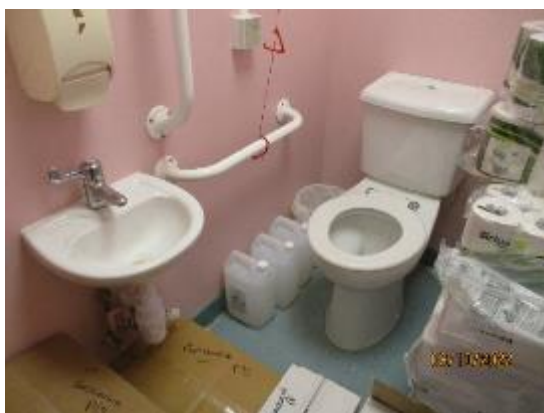
150. Accessible toilet in school

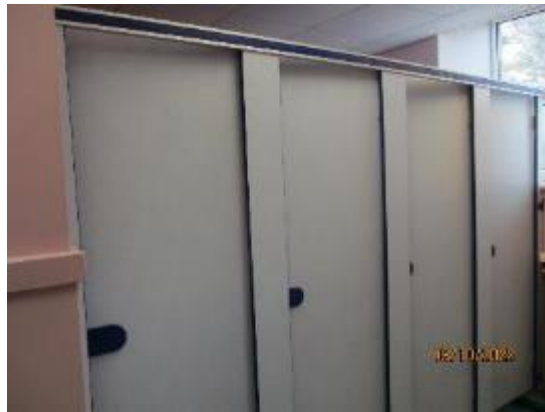
153. Composite cubicle partitions

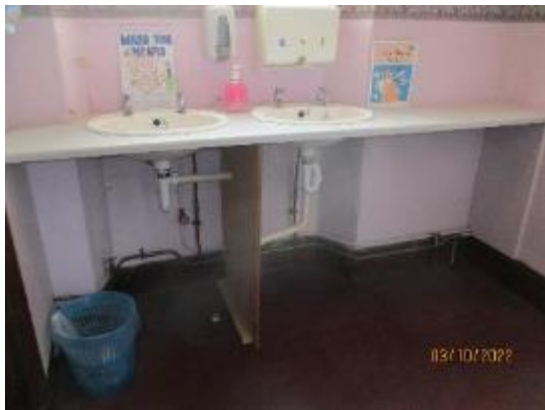
154. Vanity worktops

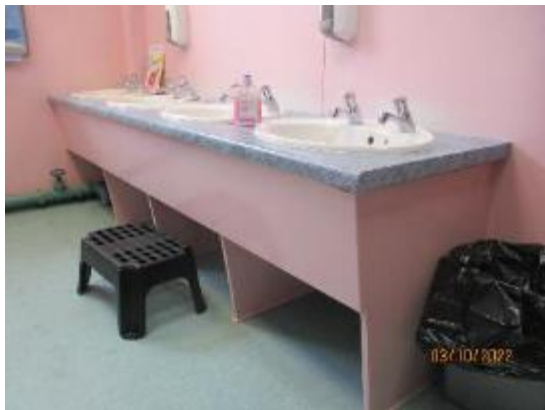
155. Vanity base unit

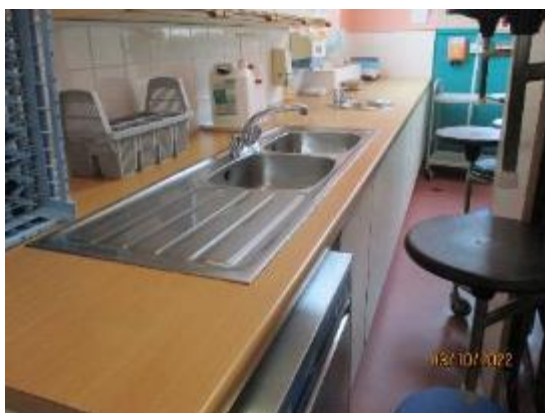
156. Commercial kitchen units

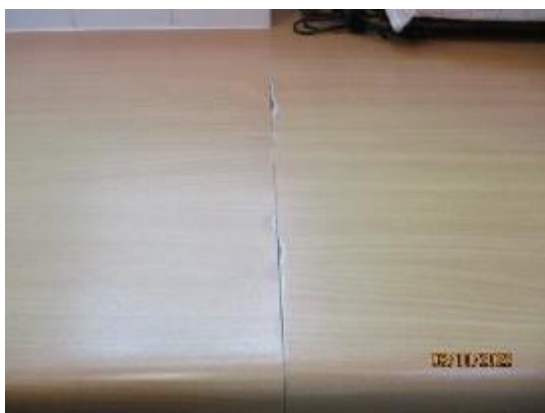
157. Worn worktops

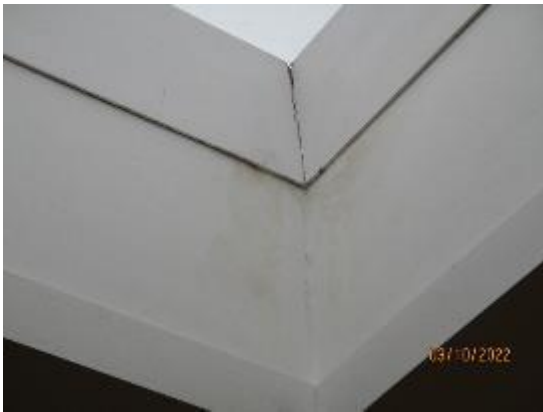
164. Watermarked rooflight linings

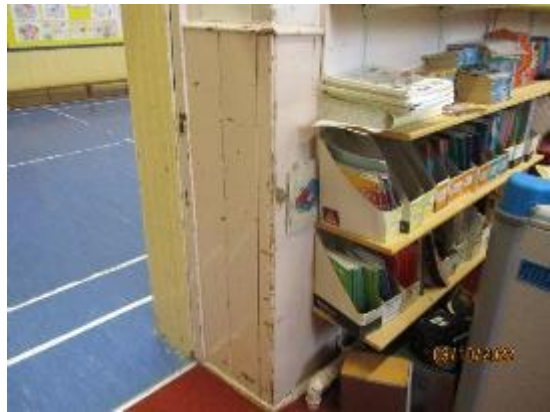
165. Timber linings

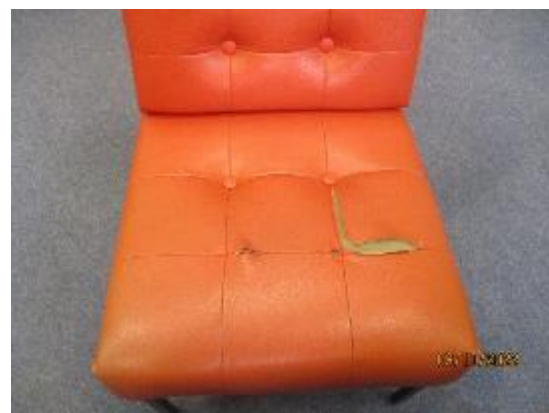
175. Damaged chairs

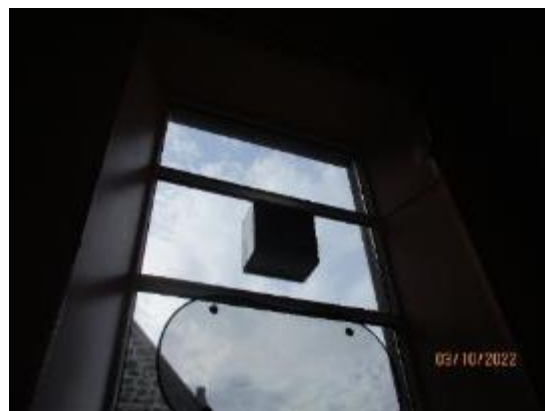
192. Extract fan – boys toilet.

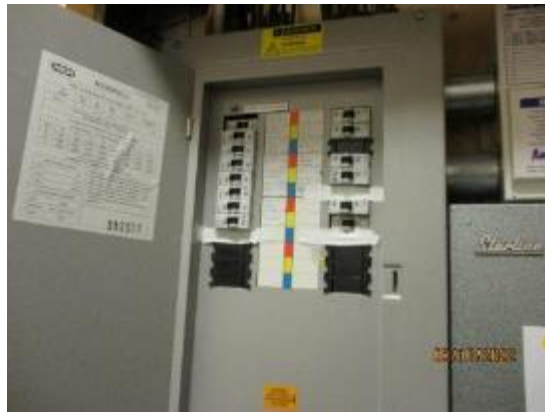
194. DB – West distribution. Janitors room 1/10

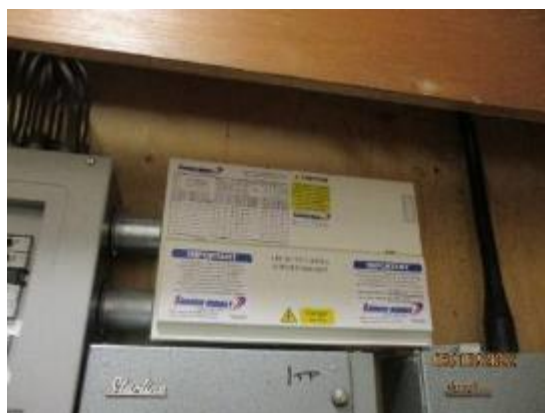
- Main school heating system and boiler are in poor condition and have exceeded their useful life.
- General wiring and accessories have exceeded their useful life.

198. General wiring. Void above staff room.

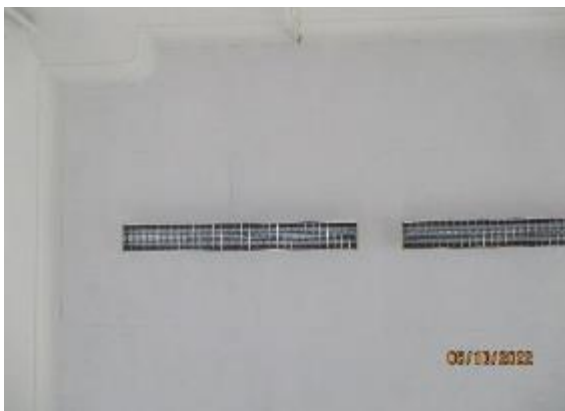
203. General wiring MICC cupboard 1/22

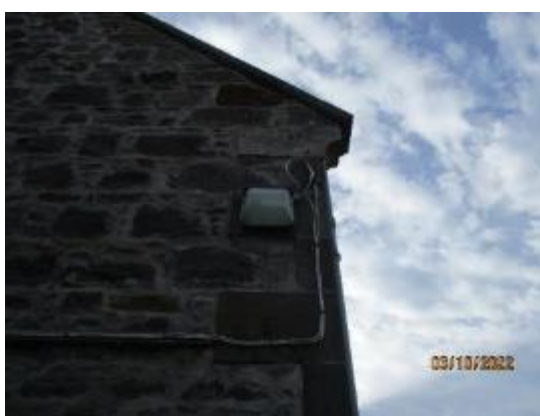
210. External lighting typical.

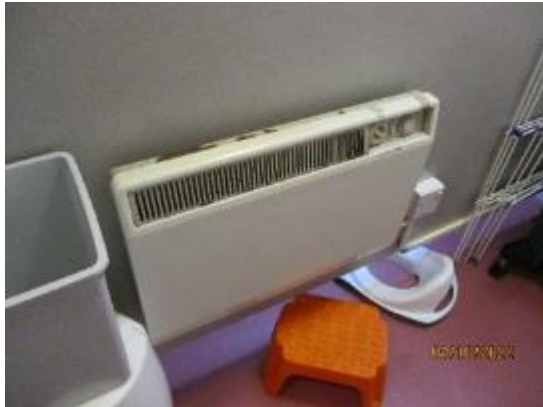
225. Electric convactor heater. Disabled WC.1/B3

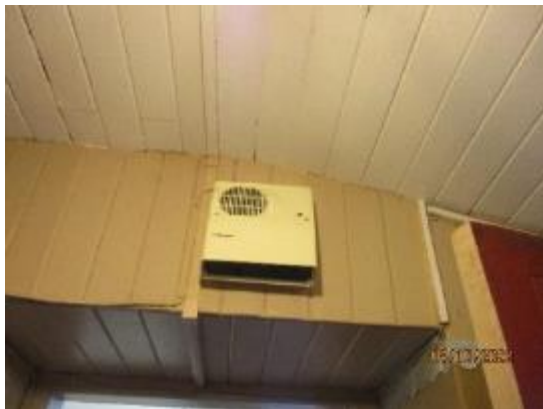
226. Electric fan convector – 1/B4

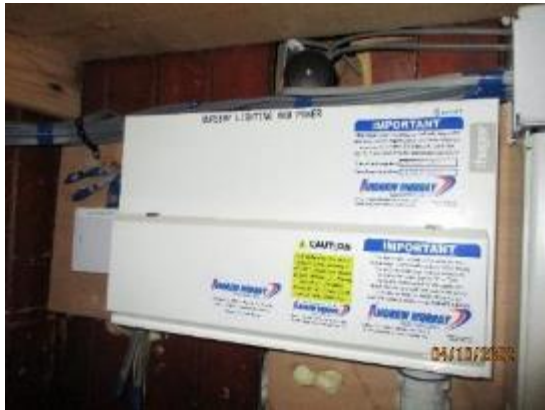
232. DB – Cupboard 1/B4

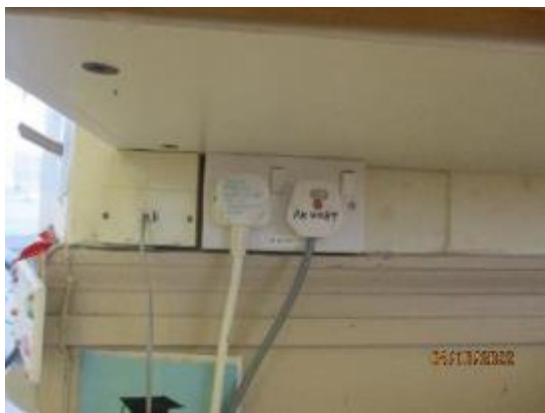
234. General wiring cupboard 1/B4

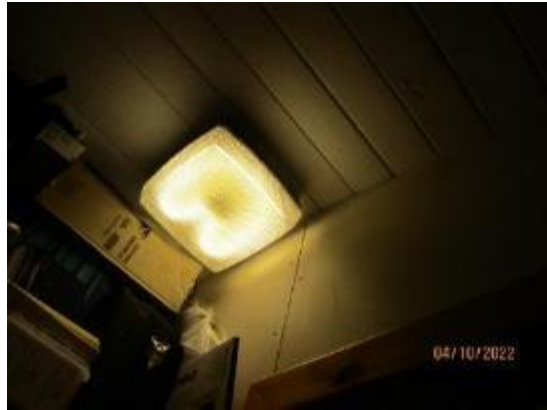
236. Lighting – main open area. Typical.

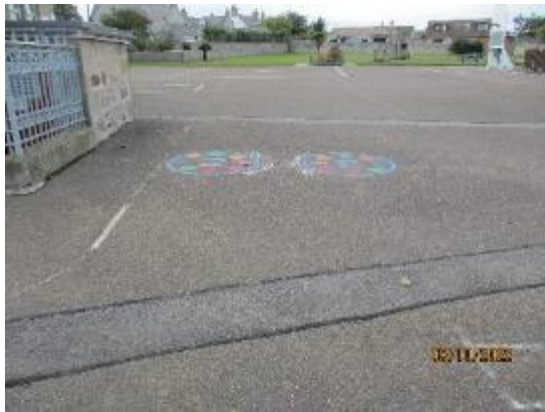
242. Tarmacadam playground

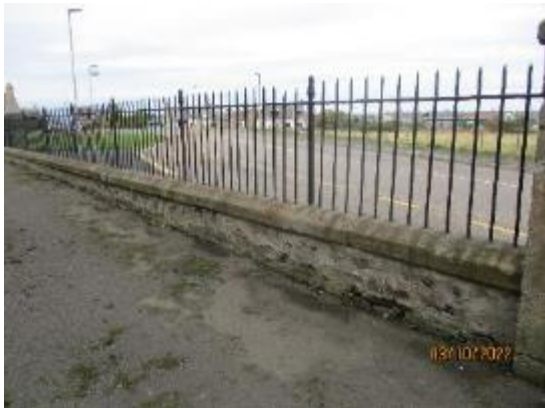
249. Metal railings to east boundary

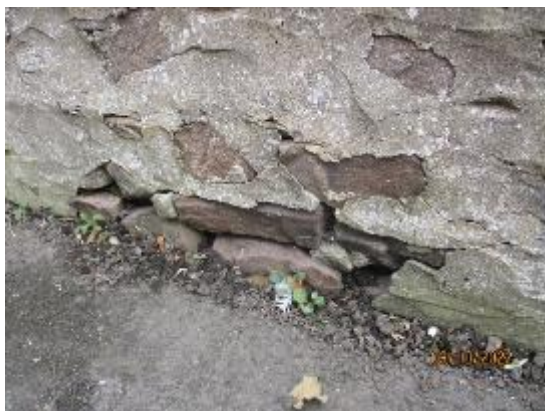
264. Low stone wall to east boundary

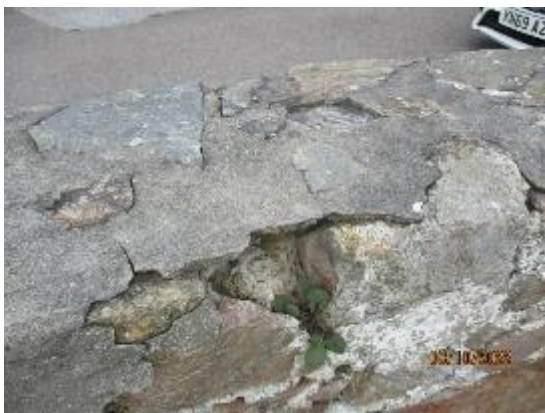
270. Repointing required

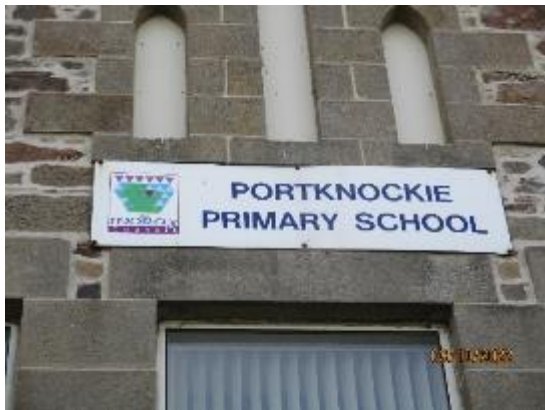
275. School signage

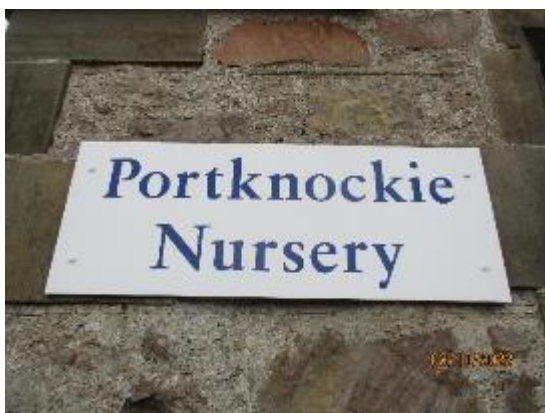
276. Nursery signage

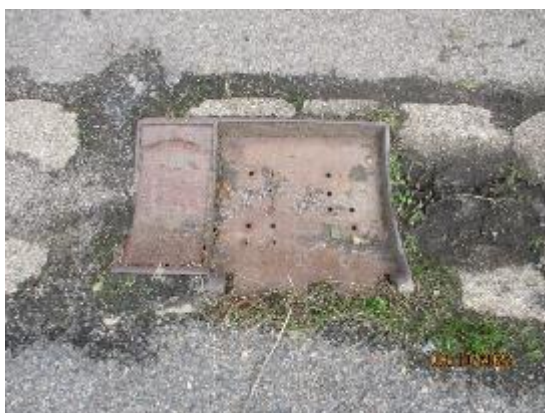
277. Playground drainage

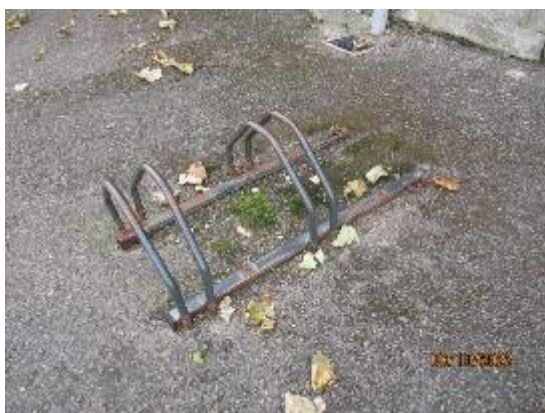
282. Metal hoop cycle rack

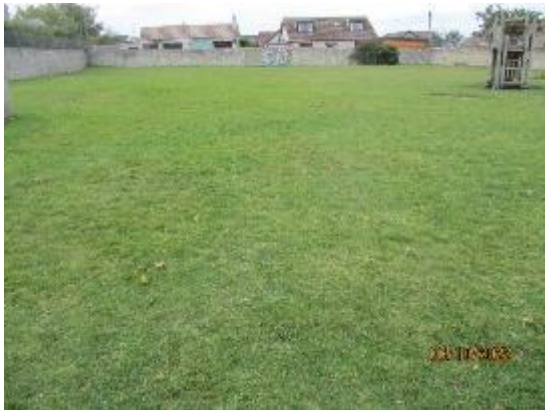
286. Sports field grass

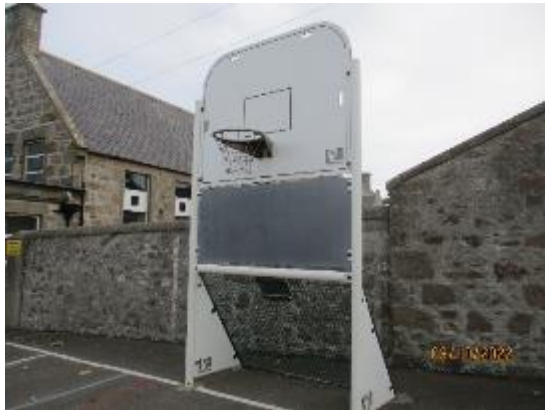
287. Basketball hoop stands
