# **Summary Building Condition Survey Report**

**St Peter's Primary School  
37 St Peter's Terrace, Buckie AB56 1QN**

**13<sup>th</sup> December 2022**

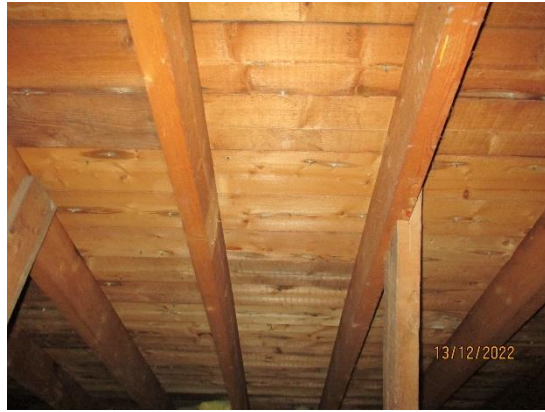
2. Timber sarking boards

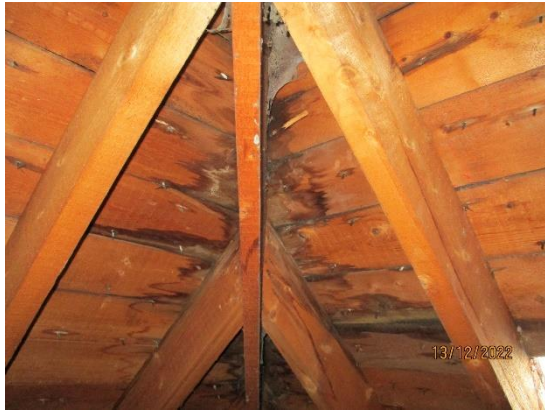
3. Water penetration

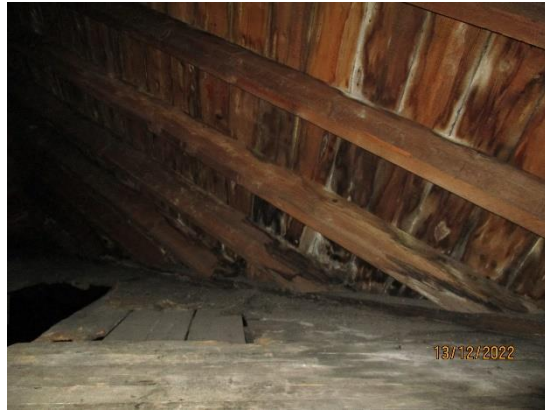
4. Water marked sarking

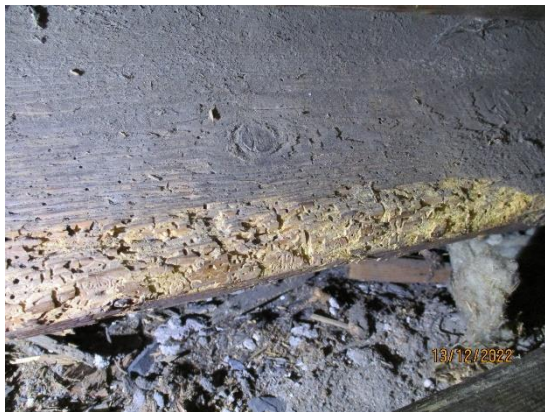
5. Woodworm in sarking

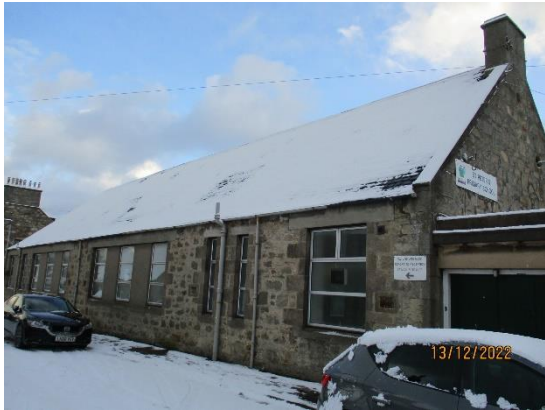
7. Natural slate roofs

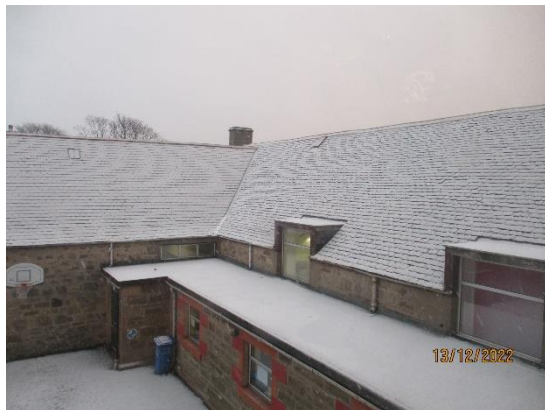
9. Flat roofs south (snow covered)

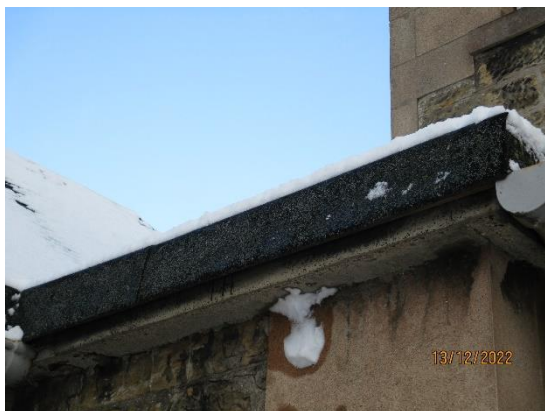
12. Felt covering

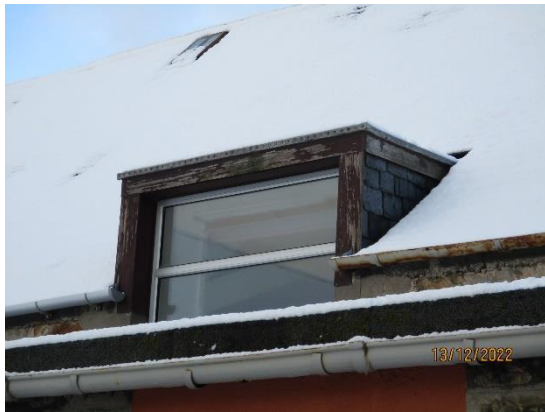
13. Lead dormer coverings

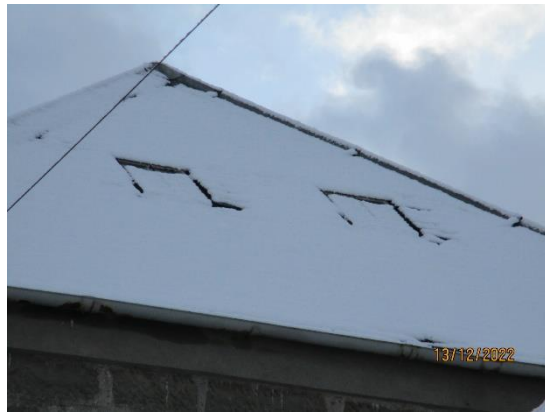
14. Metal skylights

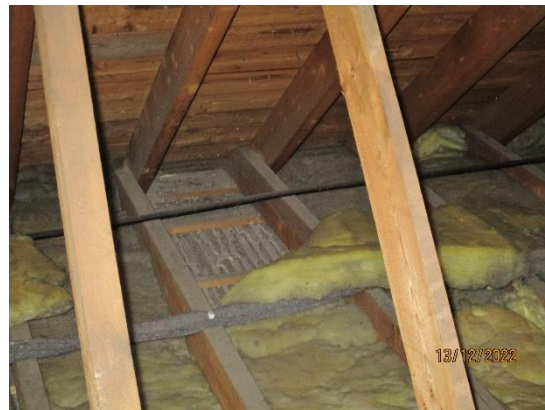
16. Disturbed insulation

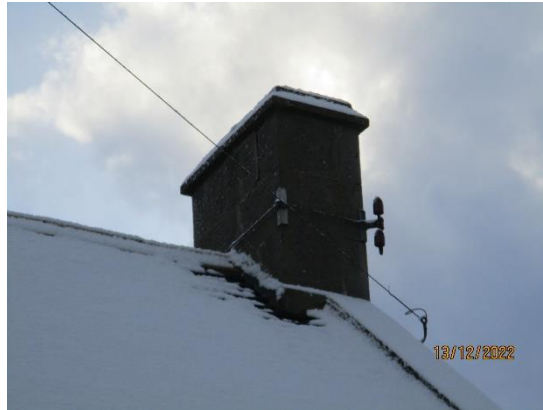
26. Stone chimneys

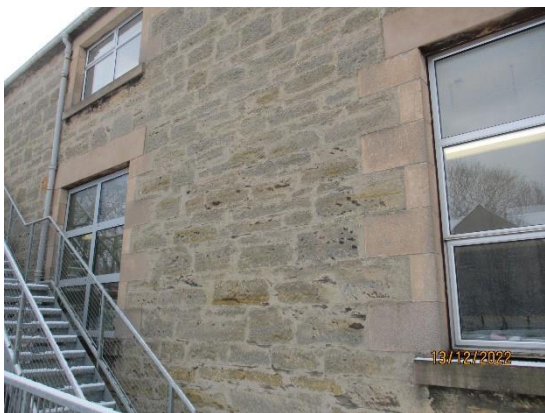
29. Natural stone walls

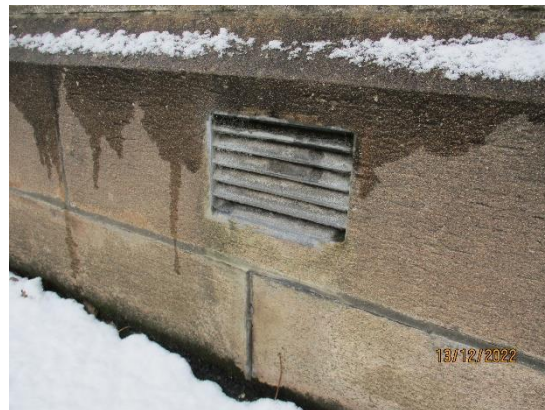
34. Sub-floor ventilation

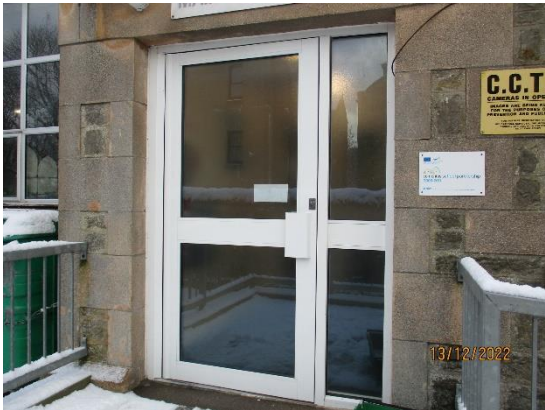
39. Powder coated aluminium doors

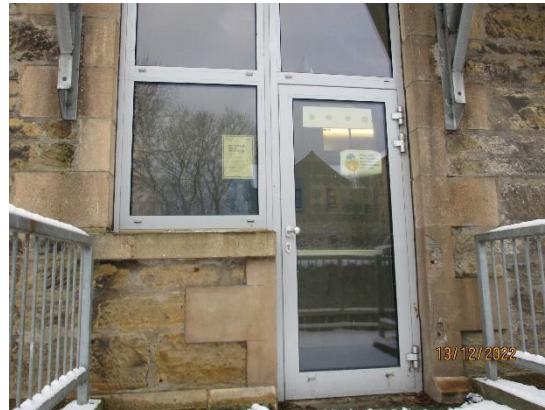
40. Aluminium fire escape doors

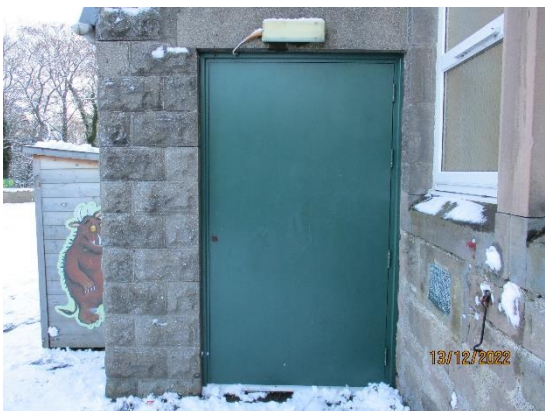
41. Timber solid core fire escape door

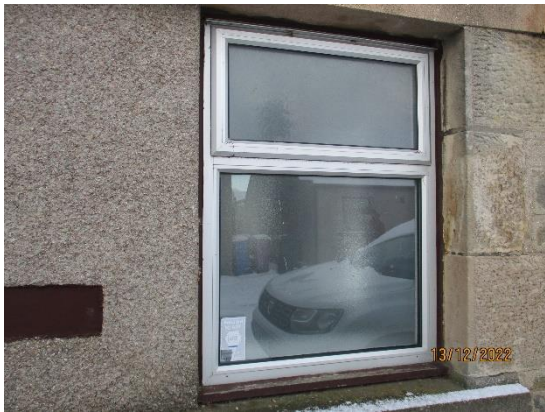
43. Aluminium windows

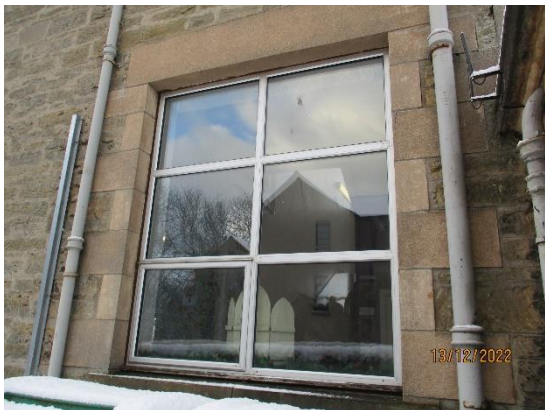
45. Large aluminium windows

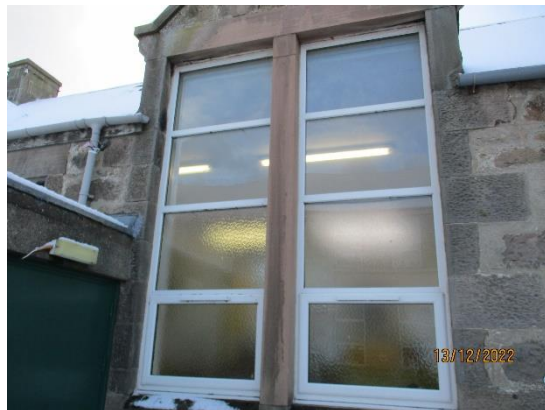
46. Large UPVC windows (Games Hall)

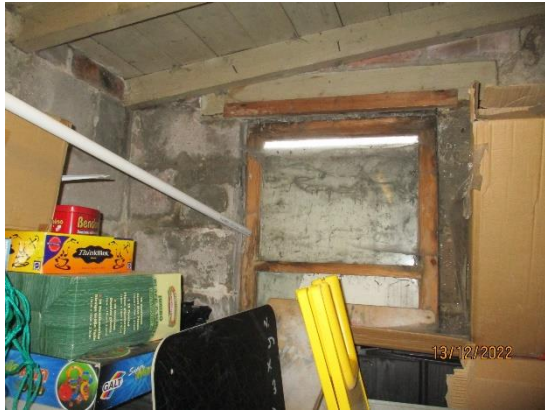
49. Timber window

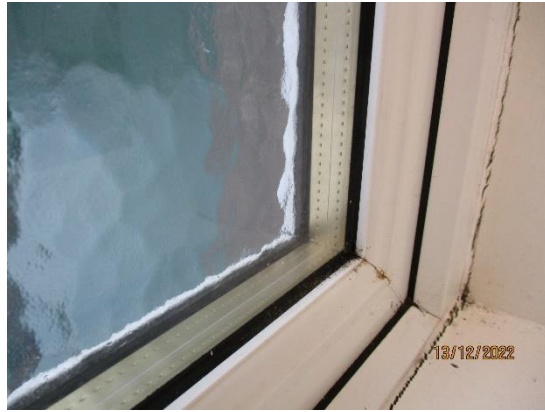
50. Double glazing

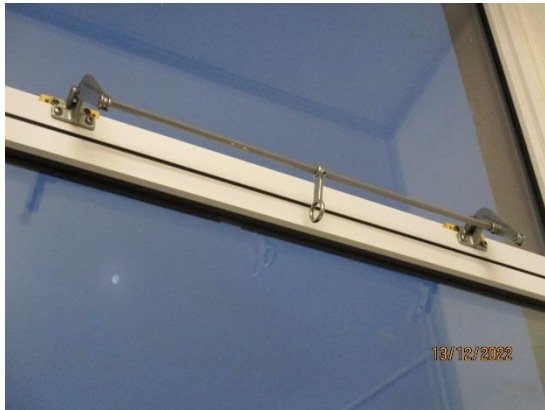
51. Window ironmongery

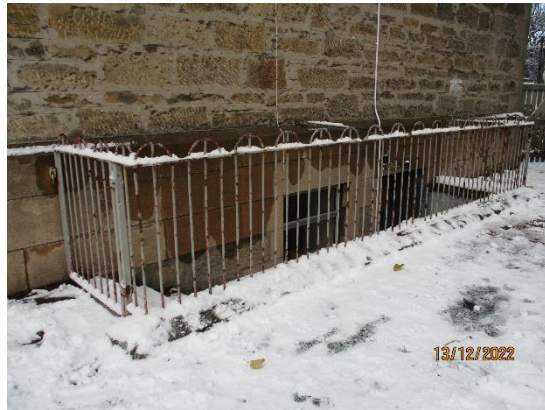
58. Metal railings

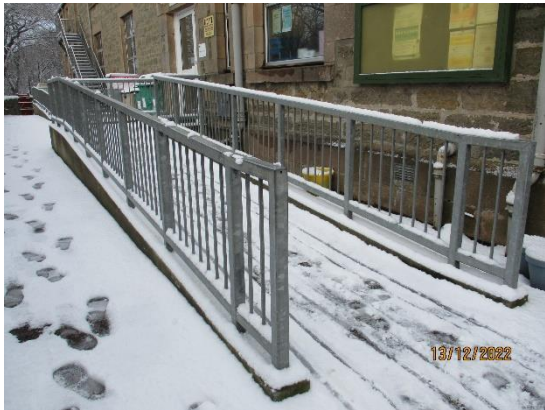
63. Galvanised guardrail

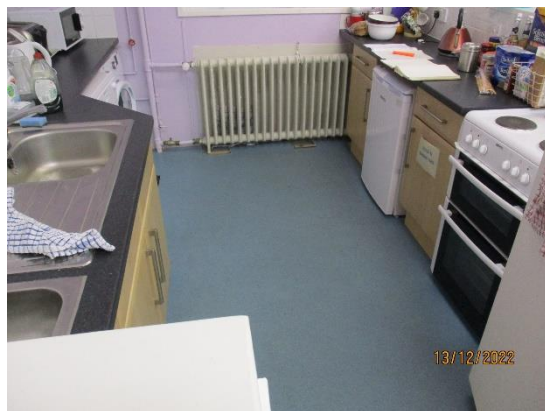
66. Sheet vinyl flooring

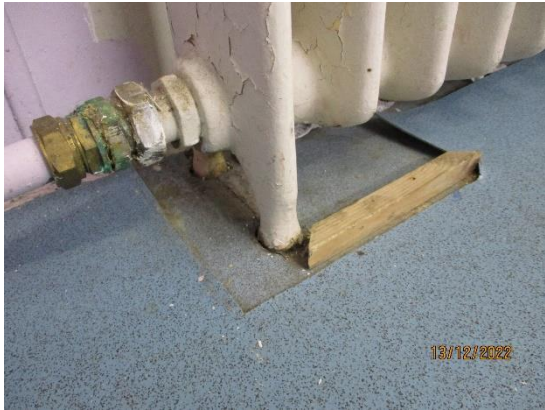
67. Vinyl flooring cut around radiators

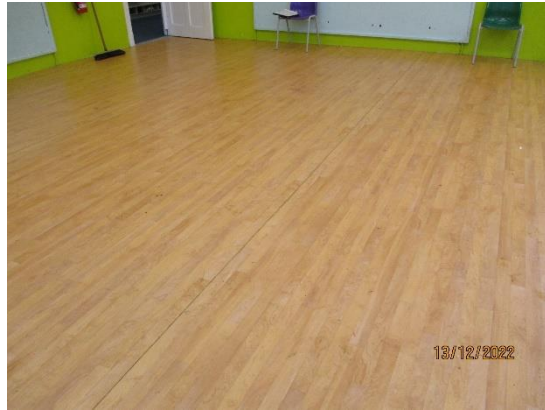
68. Games Hall vinyl flooring

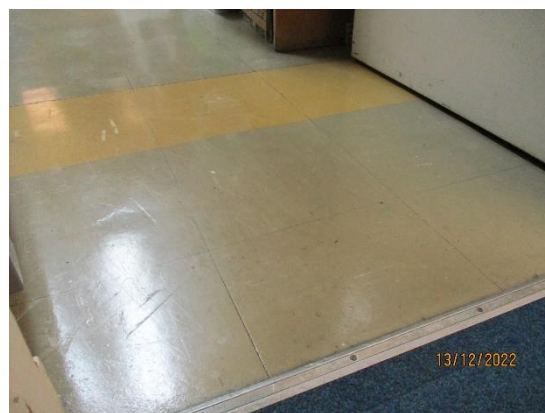
72. Vinyl tiles

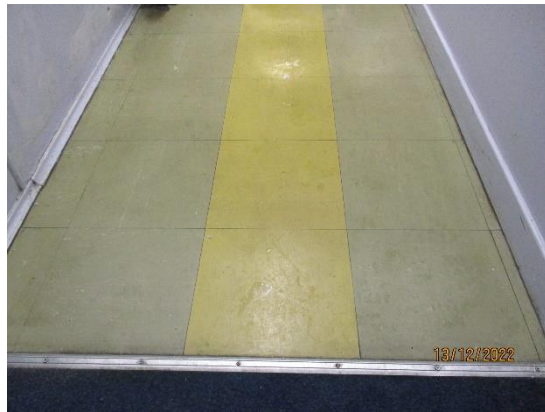
74. Vinyl tiles

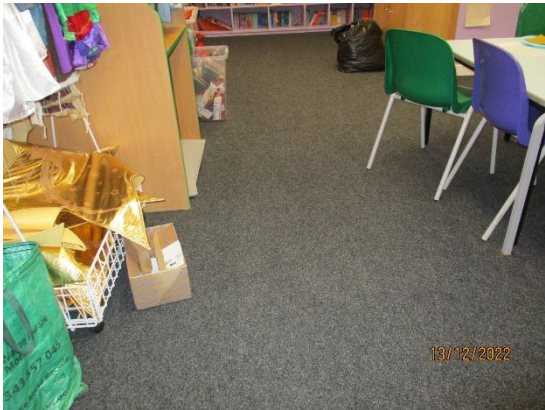
75. Carpet floor finish

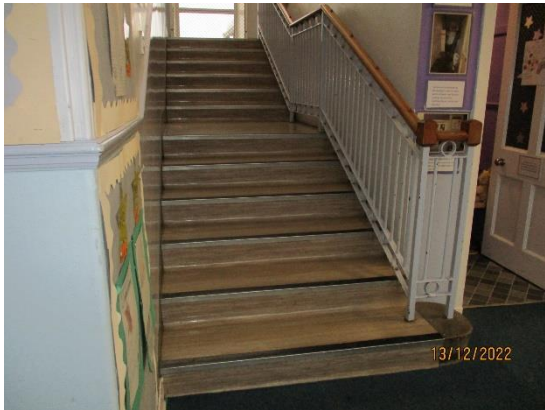
81. Concrete stairs

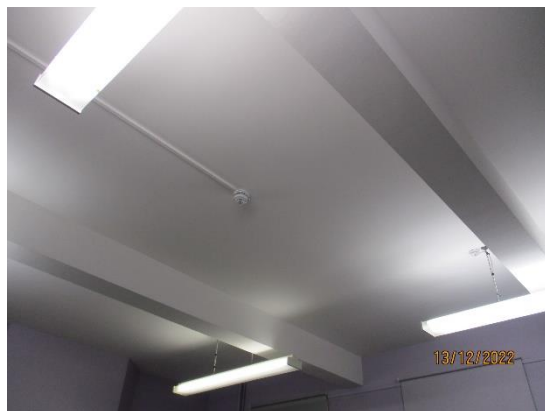
90. Plastered ceilings

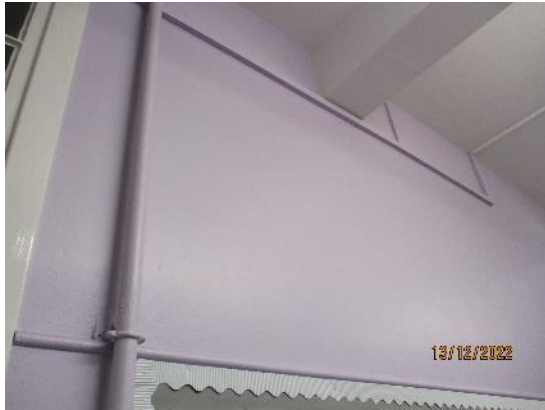
96. Plastered walls

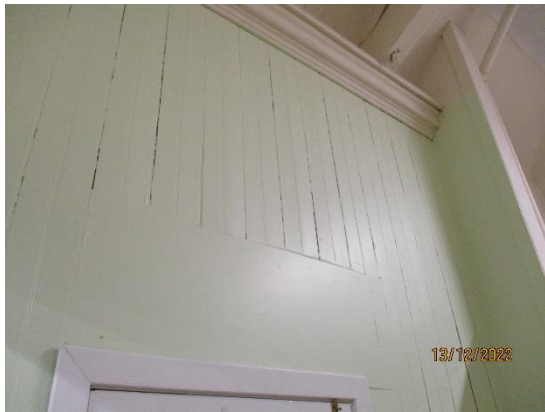
102. Timber linings

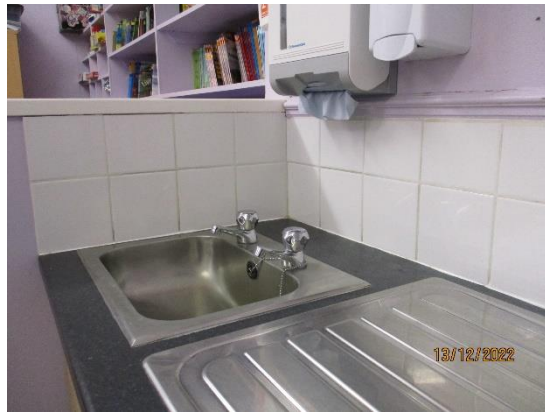
103. Ceramic tiled splashbacks

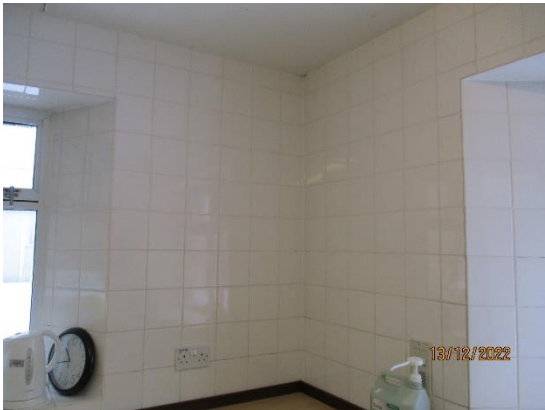
104. Ceramic tiled walls

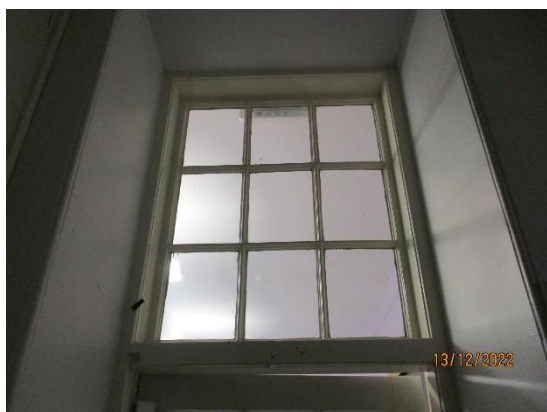
108. Timber framed borrowed lights

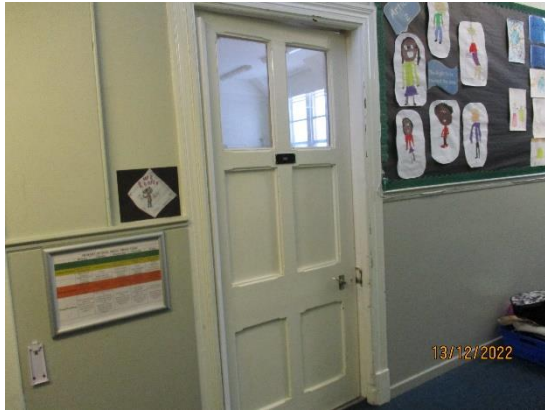
114. Timber panelled doors

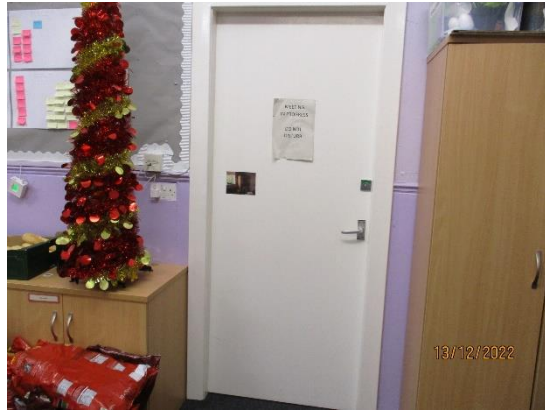
115. Timber flush doors

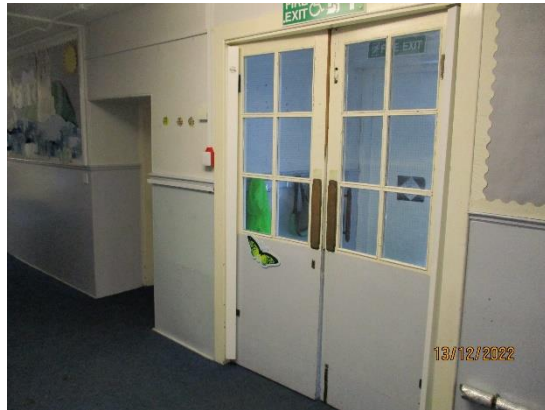
117. Double timber panelled doors

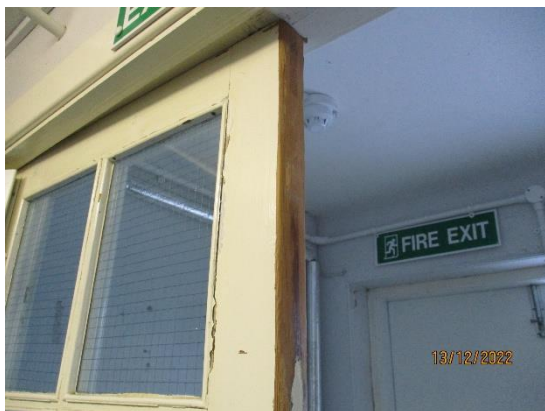
118. Double doors binding

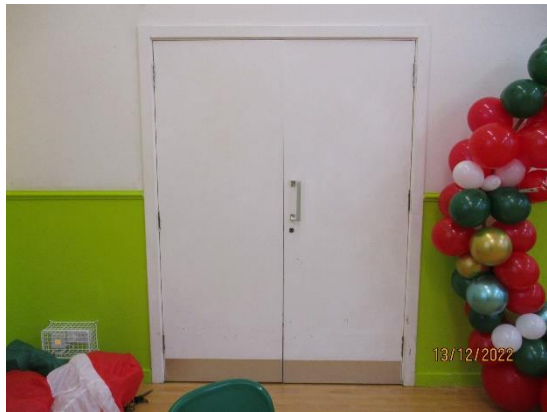
120. Timber flush, double doors

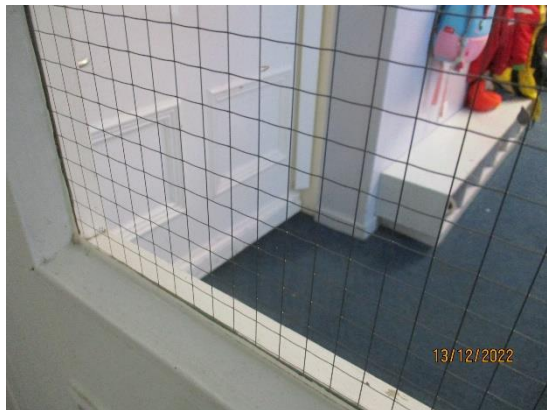
122. Georgian wired clear glazing

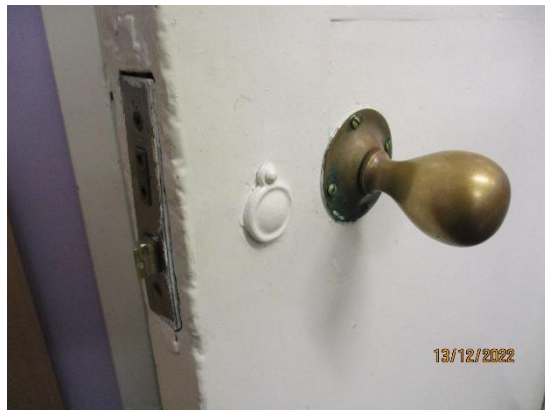
123. Brass ironmongery

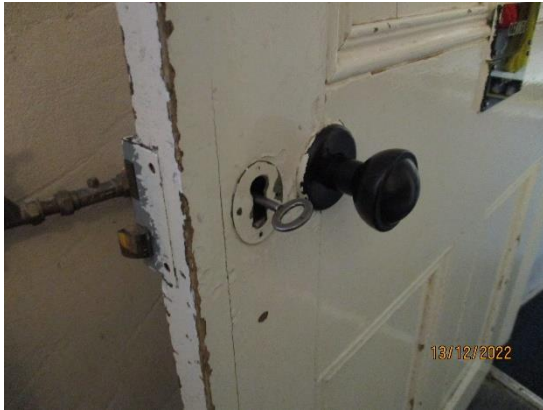
126. Bakelite ironmongery

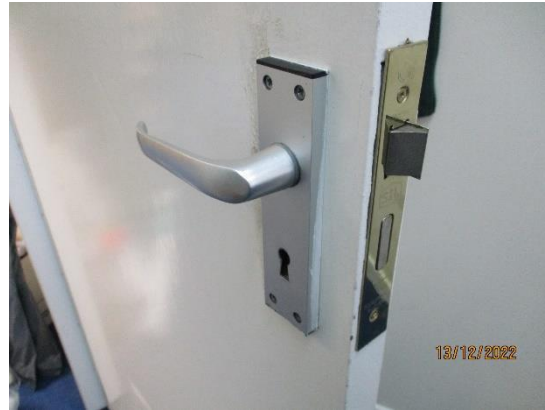
127. Aluminium ironmongery

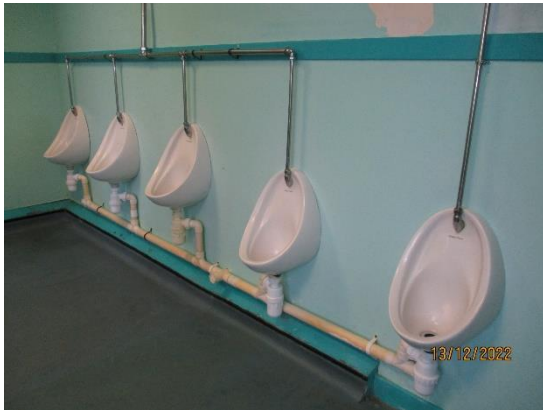
128. Urinals

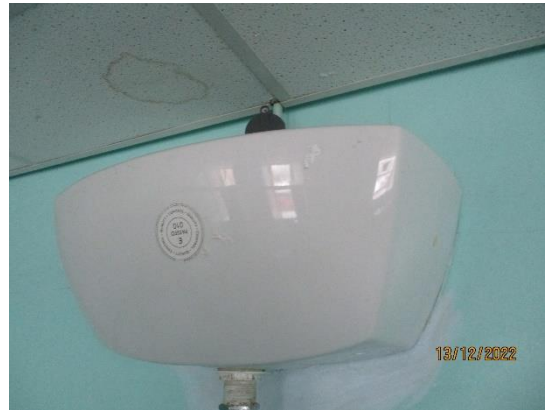
129. Vitreous china cisterns

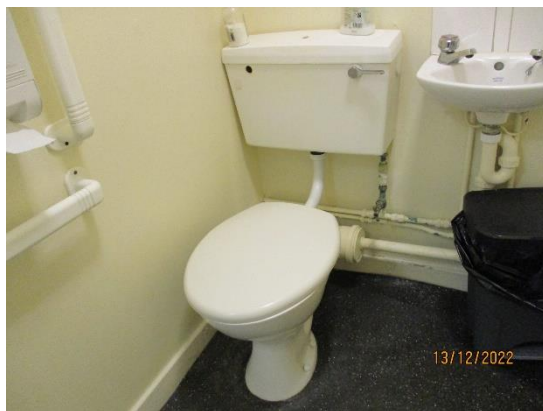
130. Staff WC

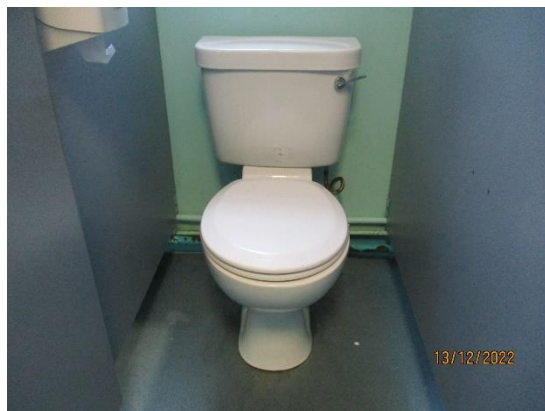
131. Pupil WC's

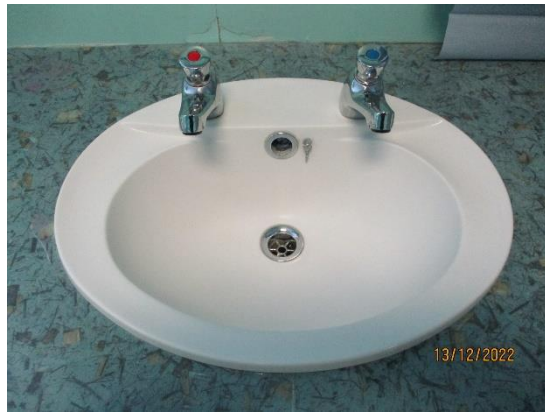
133. Vanity basins

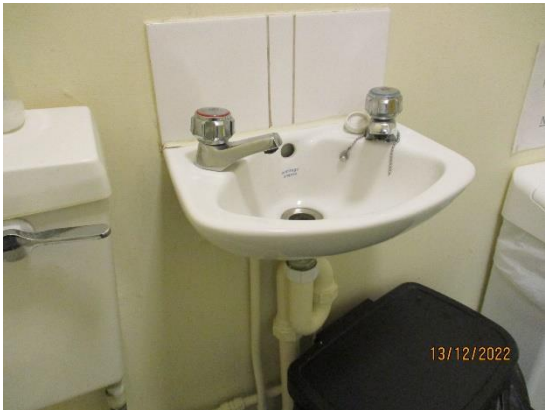
134. Wall hung basins

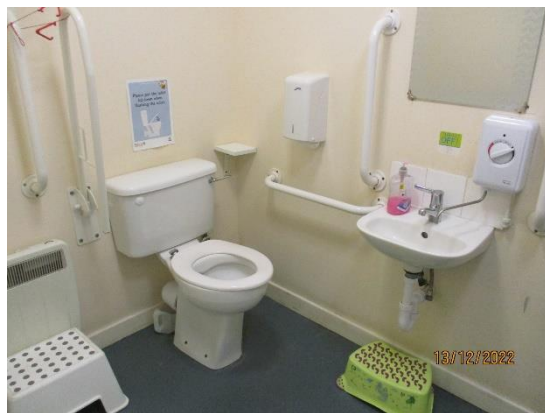
137. Accessible toilet

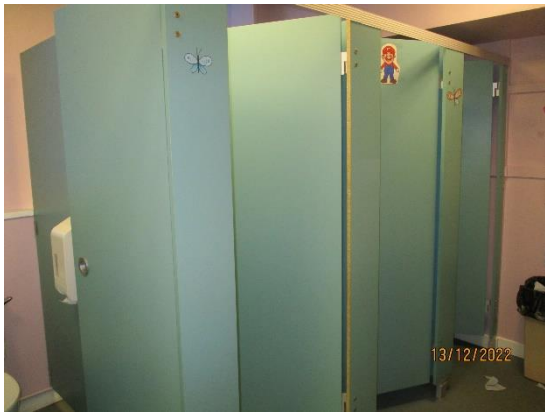
138. Composite panel cubicles

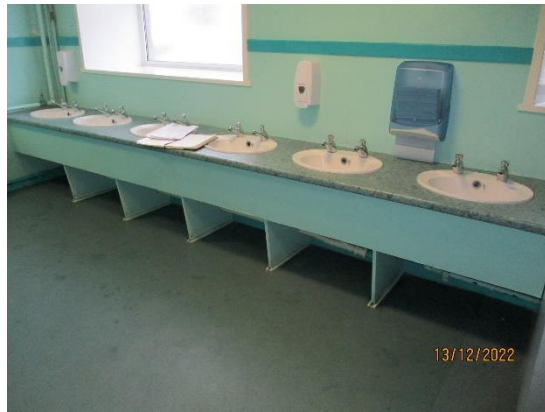
139. Vanity units

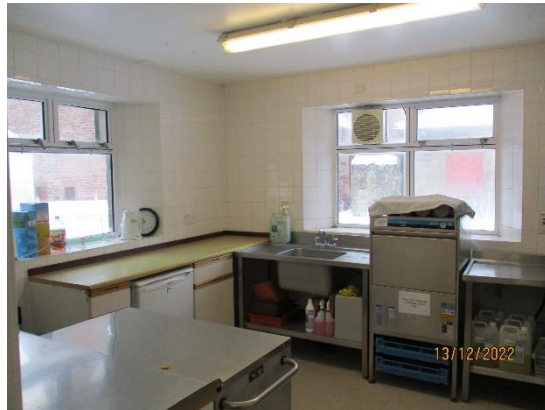
141. Commercial kitchen

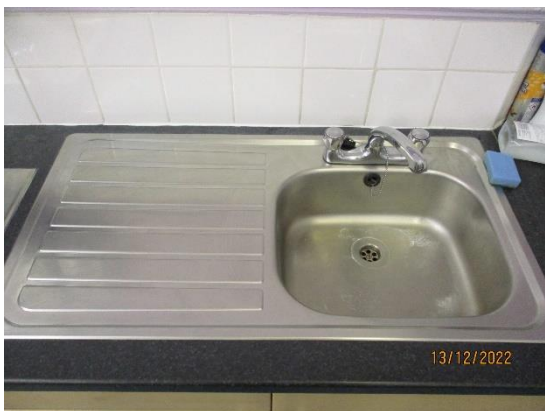
142. Stainless steel sinks

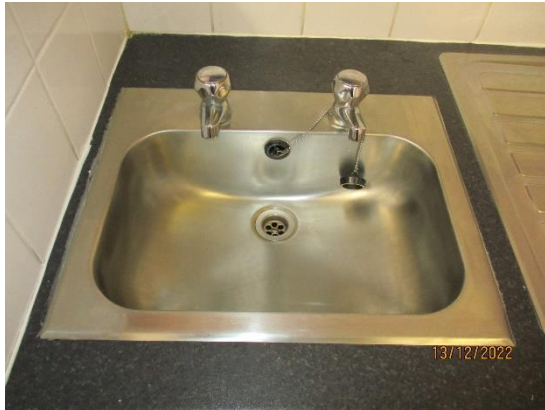
144. Stainless steel inset sinks

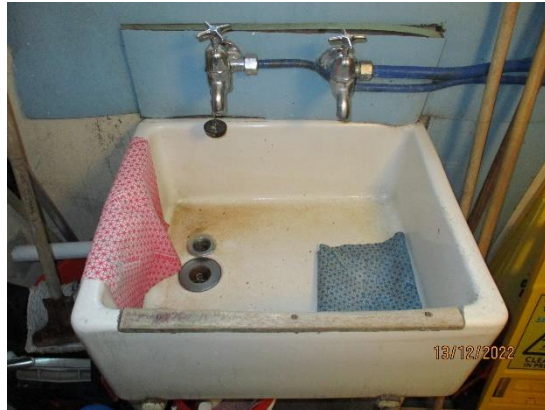
145. Cleaners butler sink

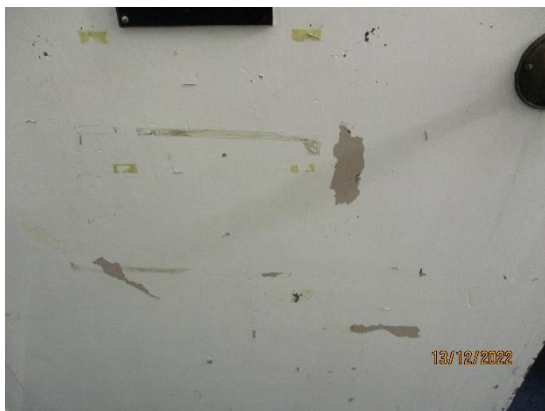
153. Timber doors

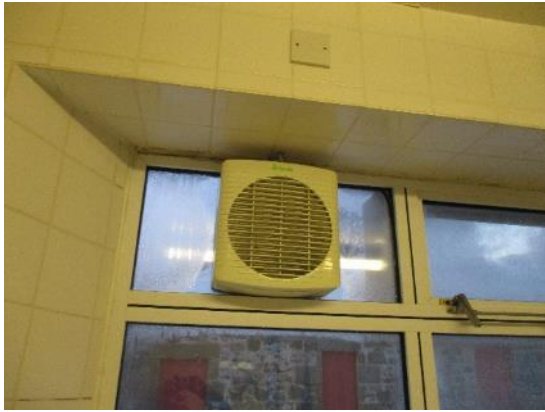
- Cold water distribution pipework is life expired as per CIBSE guide M and in poor condition.
- Mechanical ventilation – extract fans are generally in poor condition and approaching the end of their useful life. Controls for these fans could also be improved to aid energy consumption.

185. Extract fan – kitchen 1/21

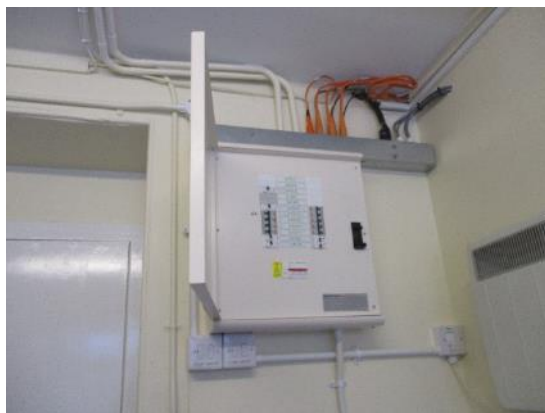
188. DB – Plant room 0/3

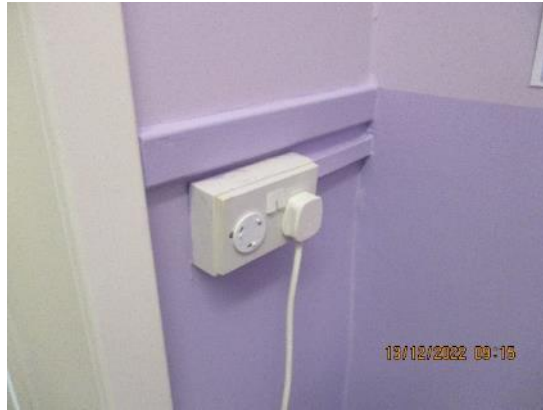
- Electrical distribution power boards and subsequent general wiring is life expired as per CIBSE Guide M.
- Wiring accessories are life expired as per CIBSE Guide M and in poor condition.
- Internal lighting and controls are life expired as per CIBSE Guide M and would benefit from being upgraded to LED fittings with energy saving controls.
- External building lighting is life expired as per CIBSE Guide M and would benefit from being upgraded to LED fittings with energy saving controls.
- Emergency lighting appears to be only intermittent throughout the building and may require to be reviewed for coverage in line with the fire risk assessment and escape strategy.
- The school period bell system is life expired as per CIBSE Guide M and in poor condition.

191. General wiring from DBs 1/14

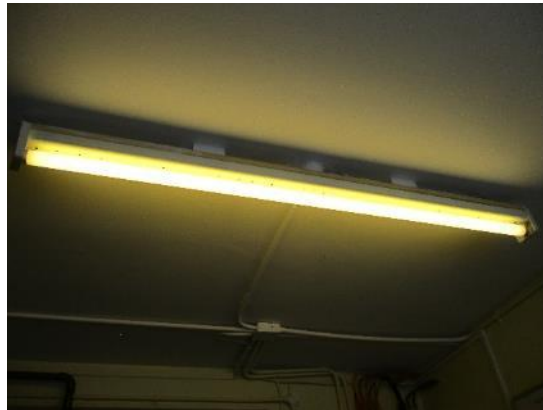
193. Lighting – classroom typical.

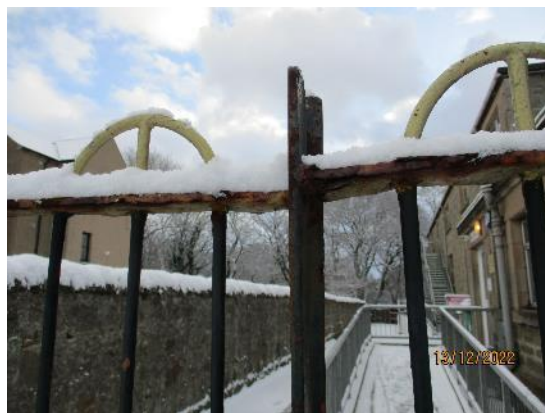
226. Gates don't meet

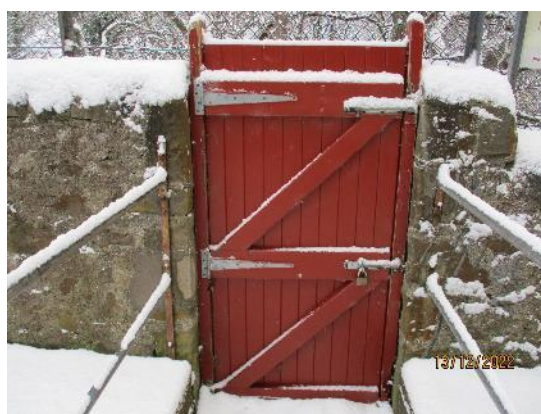
228. Timber gates

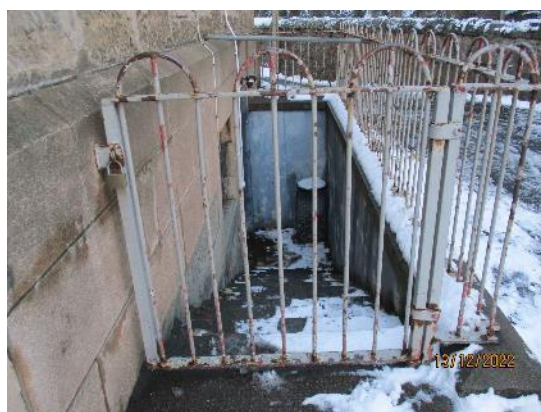
230. Metal bar gate

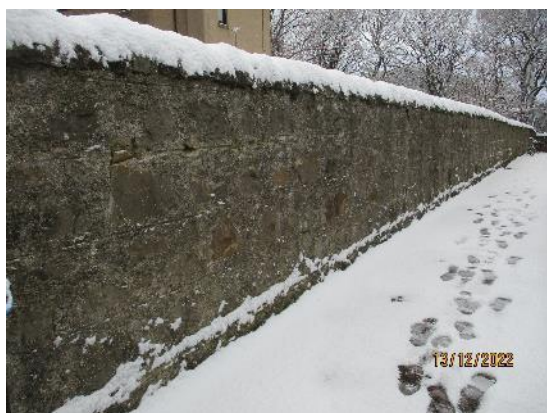
231. High stone wall

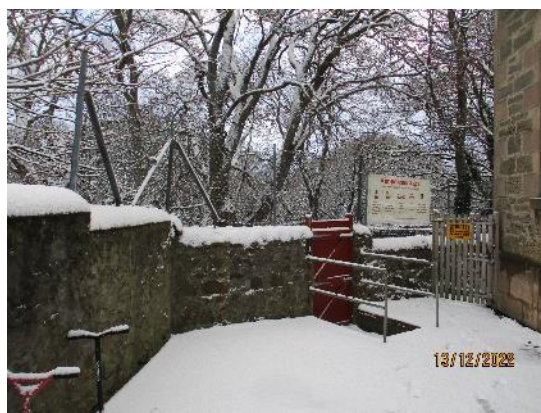
232. Lower stone wall

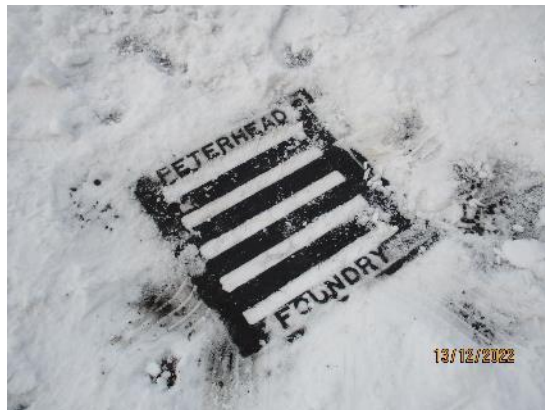
236. Playground drainage

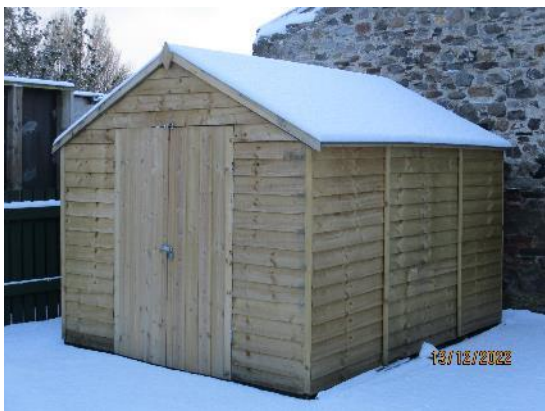
237. Timber sheds

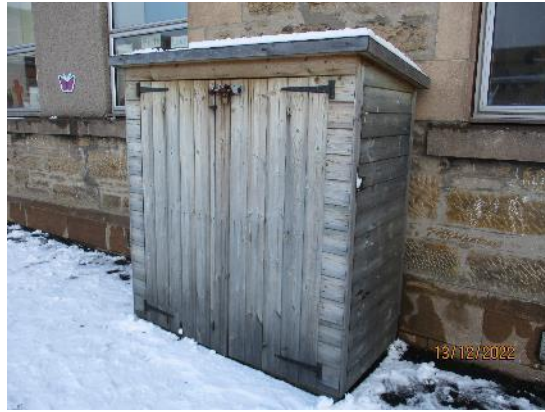
240. Small storage sheds
