# **Summary Building Condition Survey Report**

**Bishopmill Primary School  
Morrison Road, Elgin IV30 4DY**

**8<sup>th</sup> & 10<sup>th</sup> August 2023**

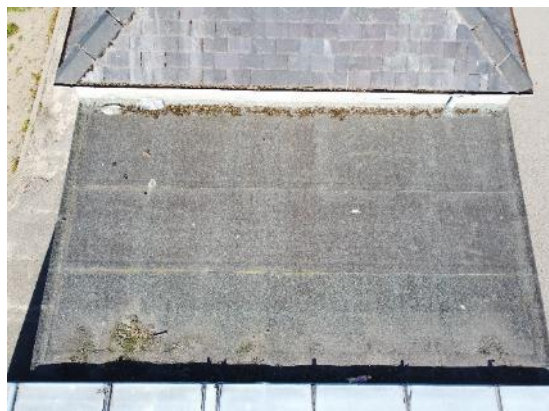
30. Mineral felt flat roof

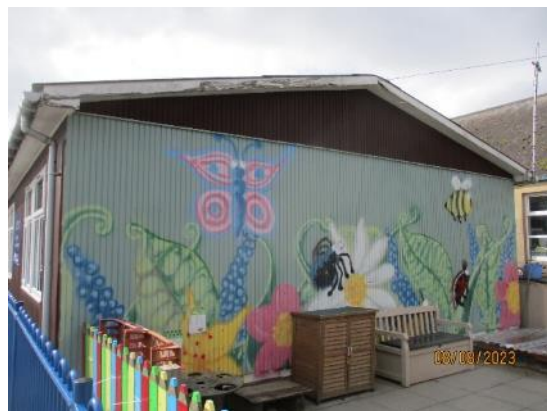
42. Timber fascia and barge boards to Nursery

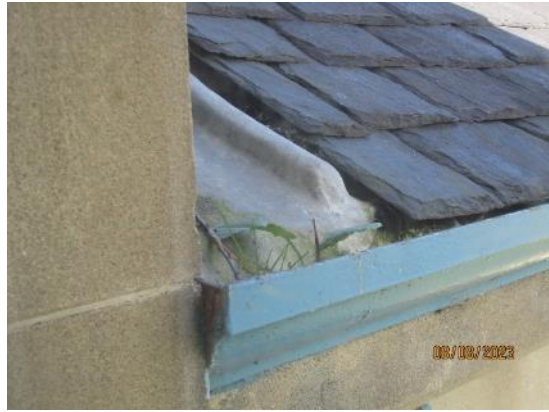
50. Isolated vegetation

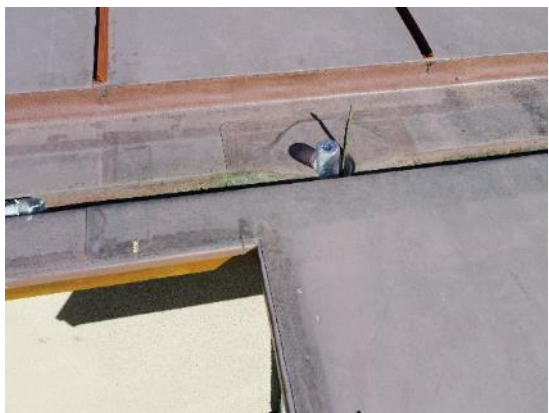
54. Isolated blockages

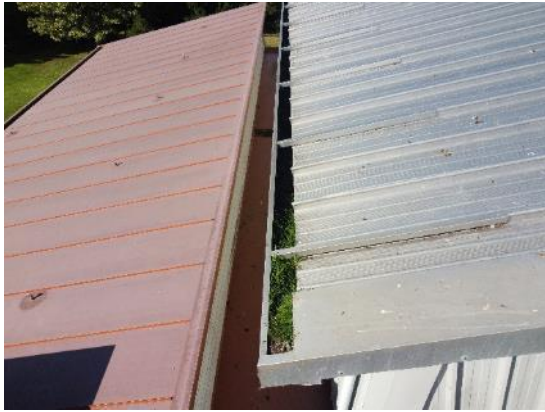
55. Aluminium box gutters

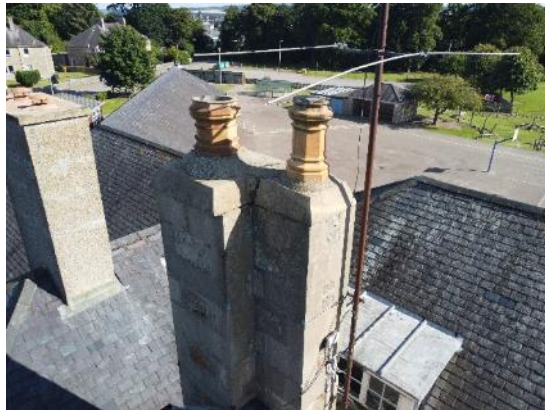
64. Repointing required

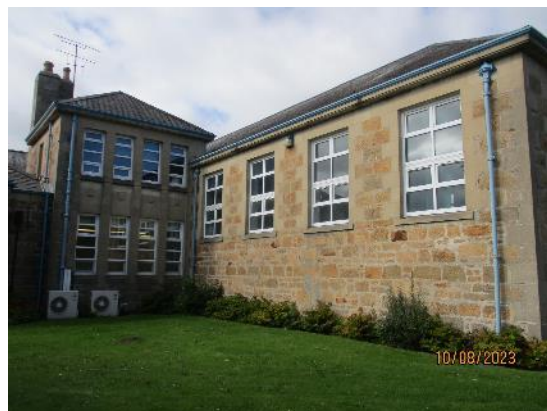
72. Stone external finish

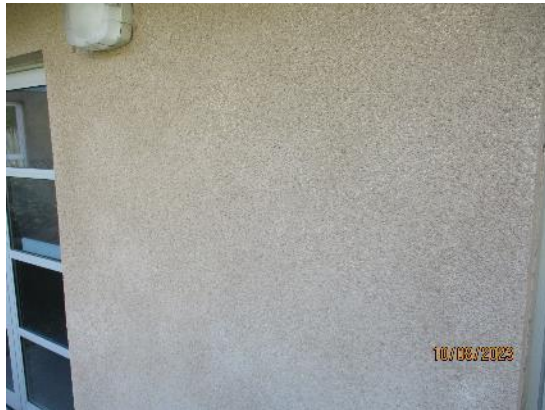
76. Roughcast external finish

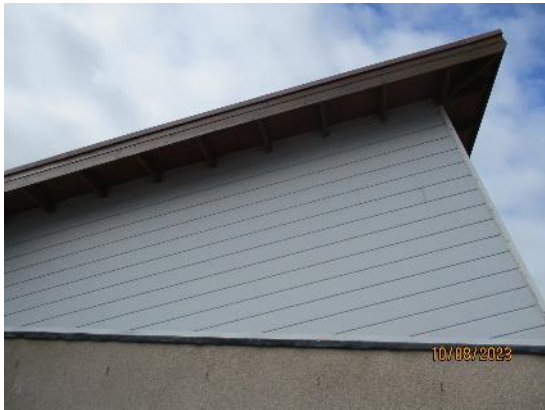
81. Timber cladding to 2007 extension

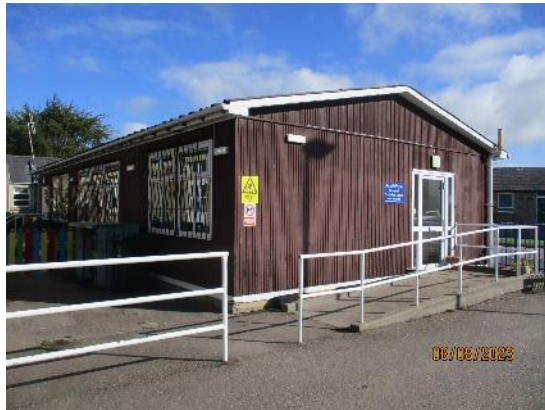
82. Timber cladding to Nursery

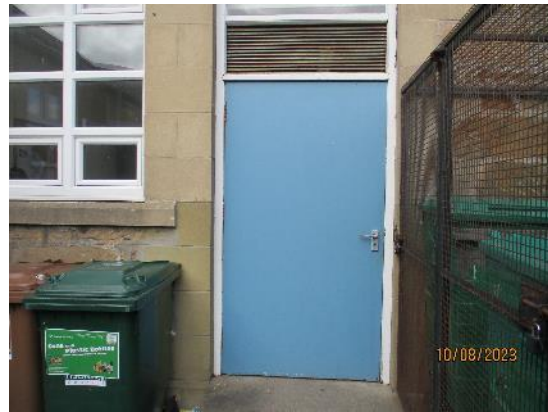
86. Timber solid core single doors

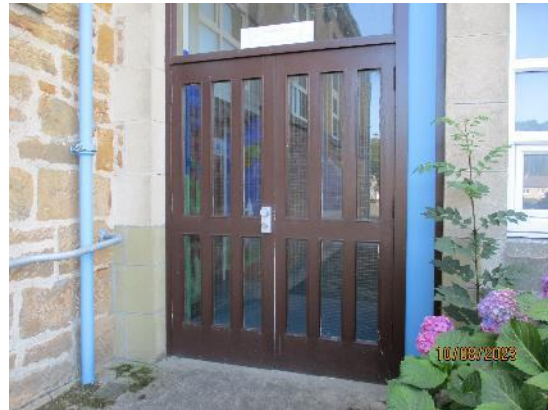
88. Timber part glazed double doors

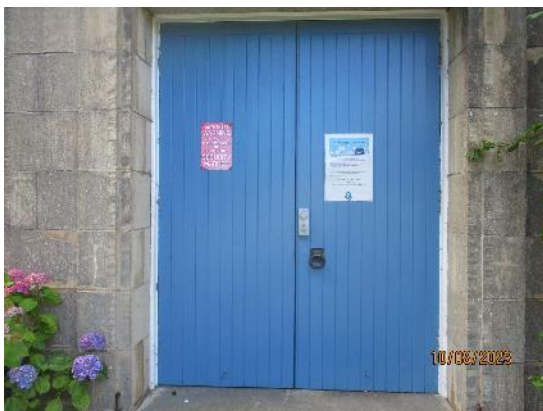
89. Timber tounged & grooved double doors

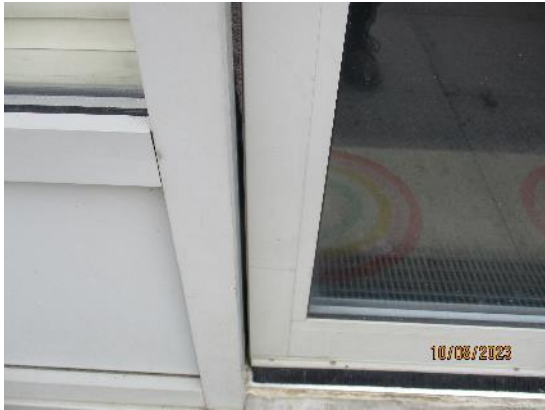
- Brush seals to external doors have failed, resulting in open gaps.
- Plasterboard walls are water damaged at exposed trusses.
- The Games Hall timber floor is lifting and uneven.
- Internal decoration is overdue.

103. Brush seals not meeting frame

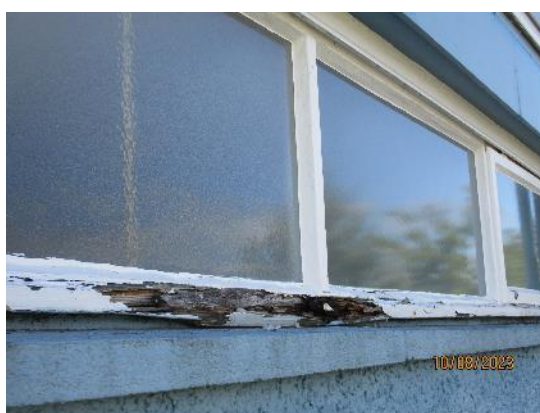
119. Rot in timber window frames

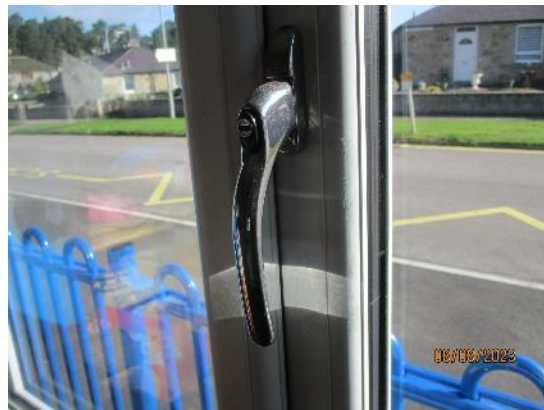
129. Failed double glazing units

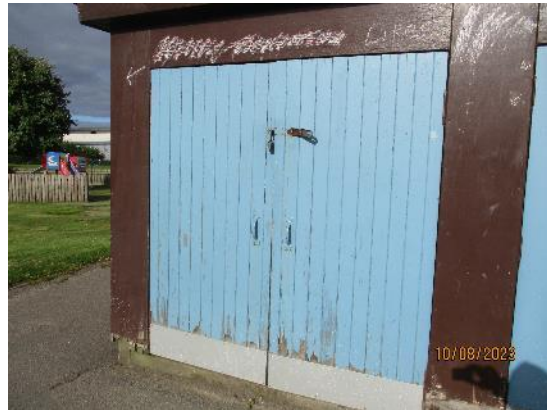
136. Timber doors

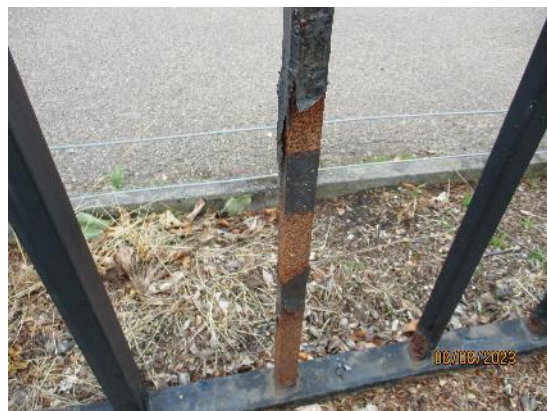
138. Metal fences and gates

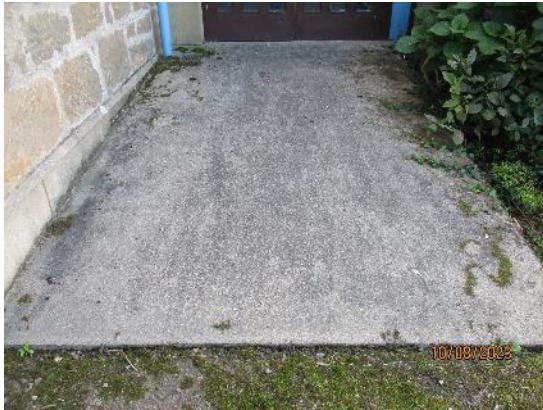
139. Concrete ramps

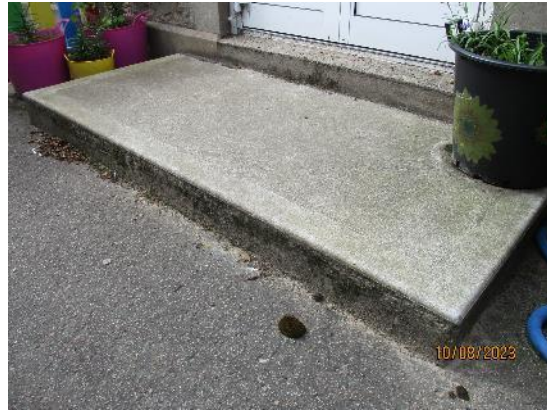
140. Concrete steps

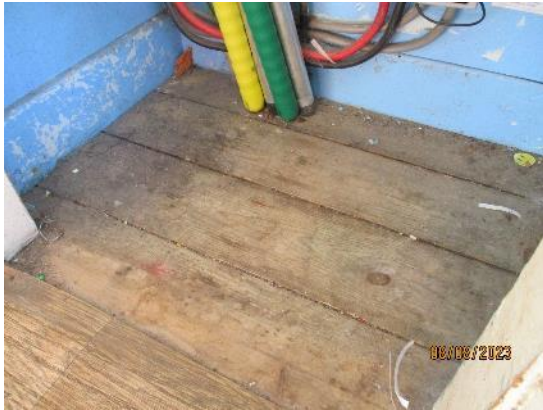
145. Suspended timber floors

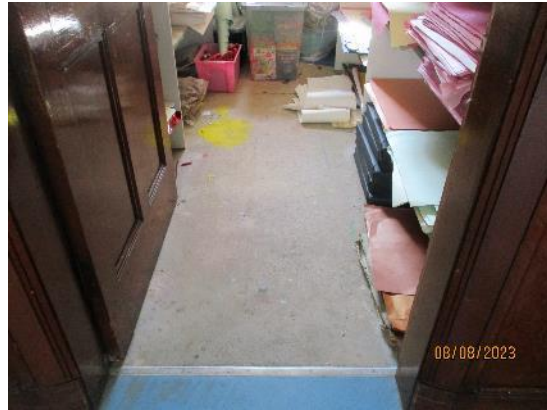
146. Concrete floors

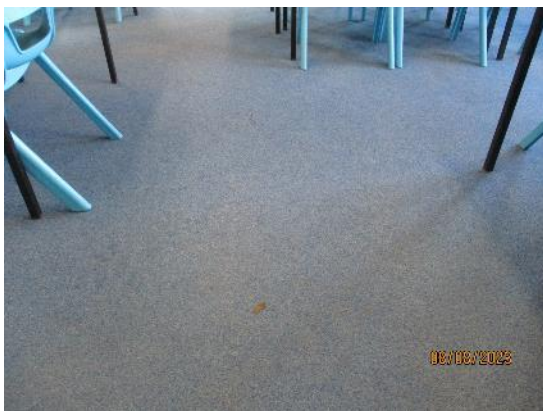
149. Carpet floor finishes

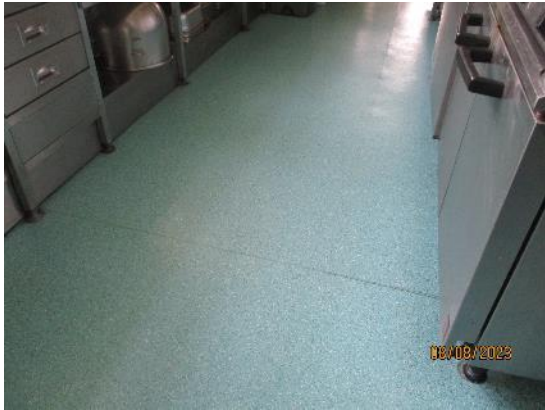
151. Sheet vinyl flooring

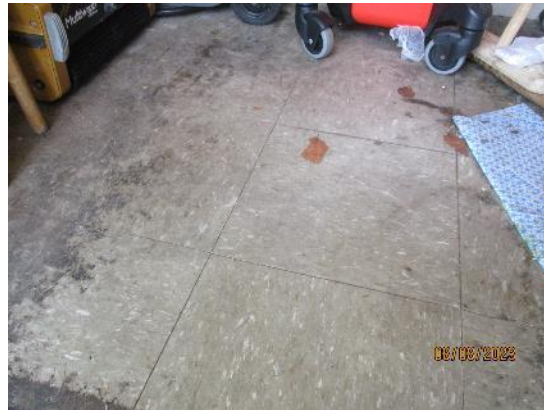
154. Vinyl tiles

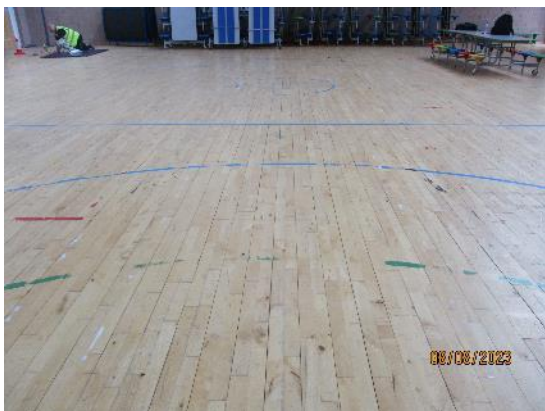
155. Timber sports floor

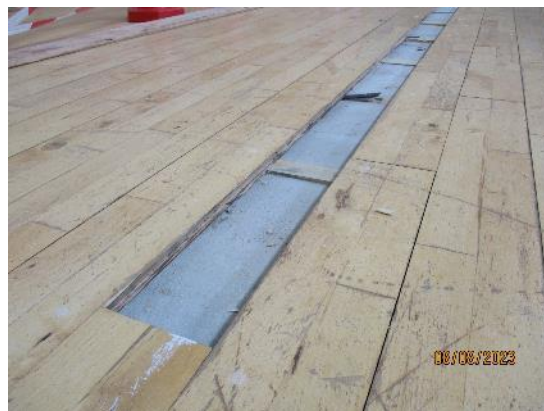
156. Raised timber flooring

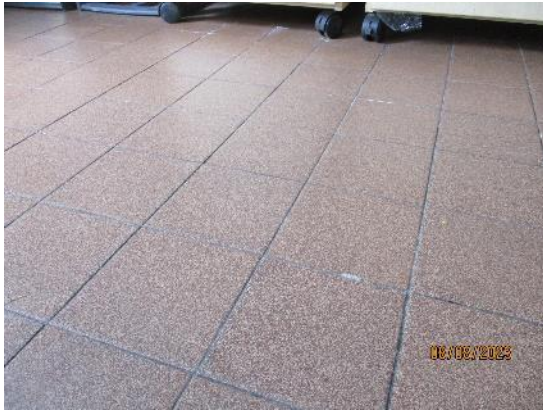
157. Quarry tile to sink areas

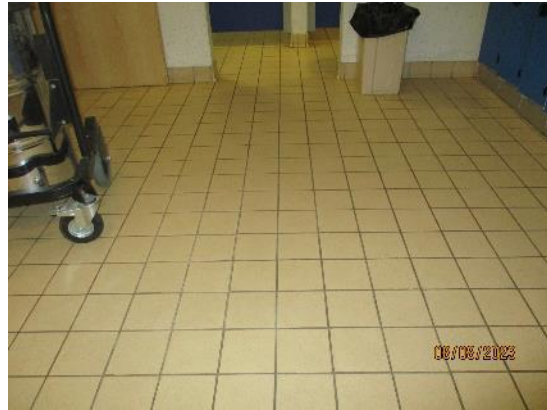
158. Quarry tile to changing rooms

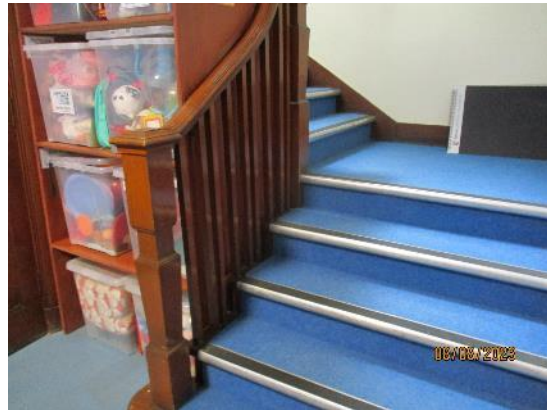
166. Timber balustrades

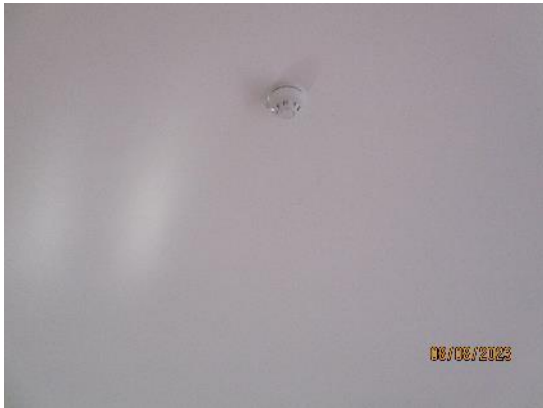
176. Plasterboard ceilings

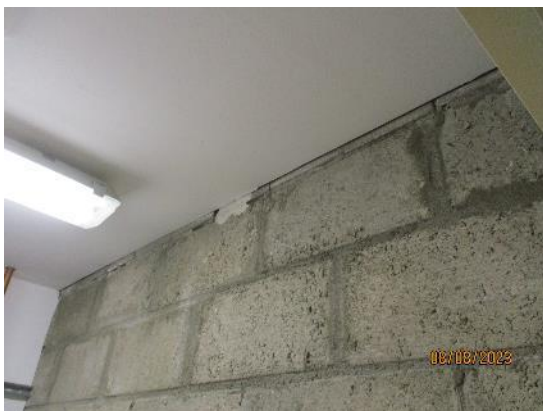
183. Masonry walls

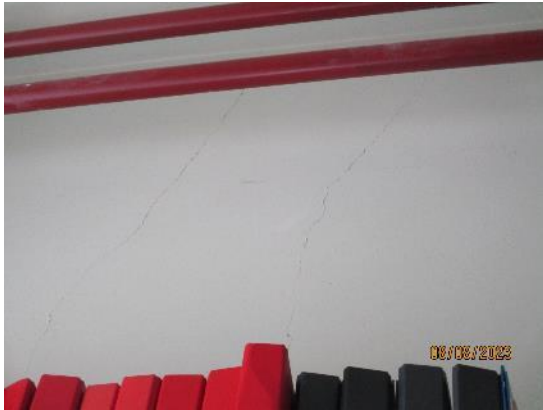
185. Plastered walls

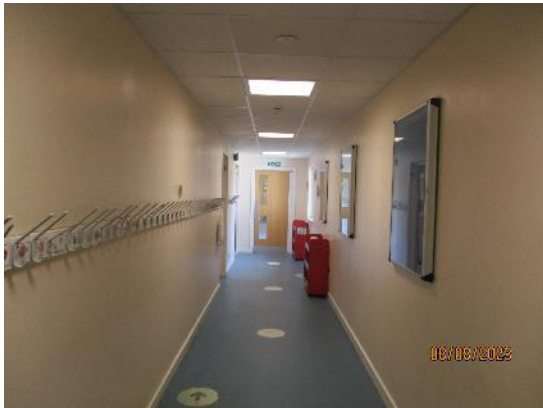
187. Plasterboard walls

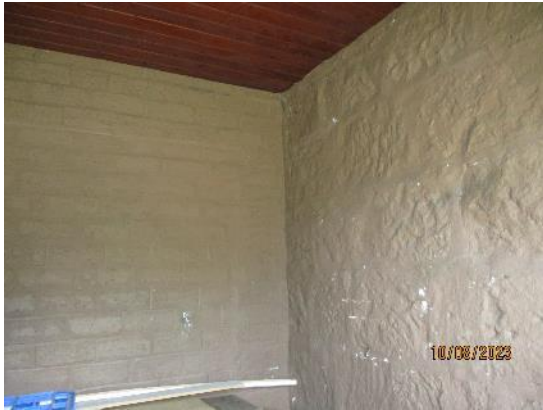
191. Brick and stone to external stores

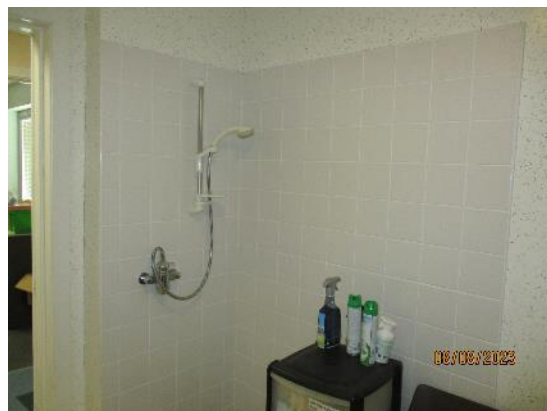
196. Ceramic tiles to shower areas

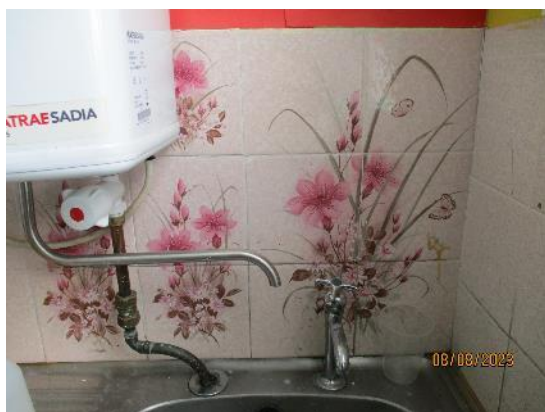
197. Ceramic tiled splashbacks

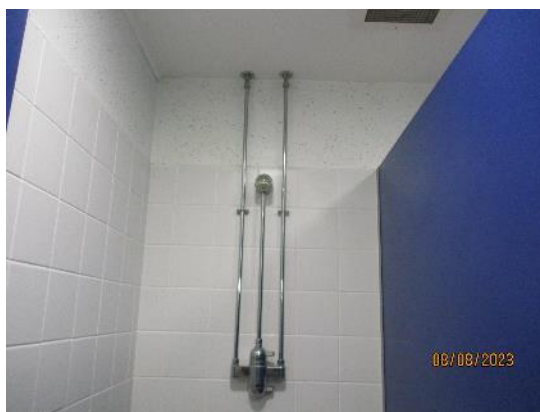
198. Ceramic tiles in changing room showers

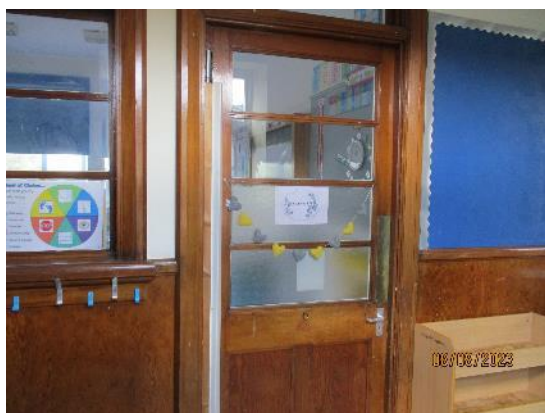
201. Timber panelled doors

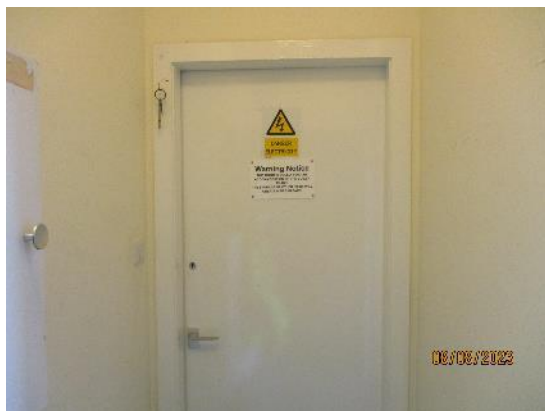
208. Timber hollow core doors

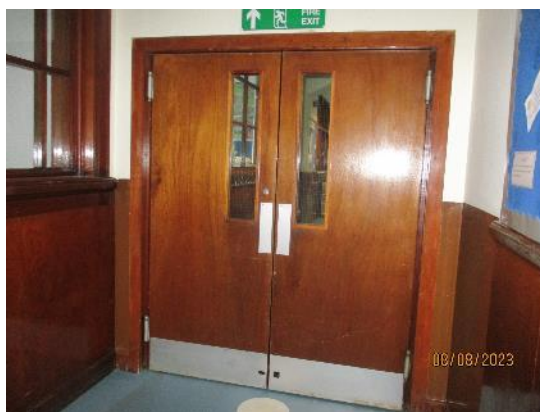
210. Timber solid core doors

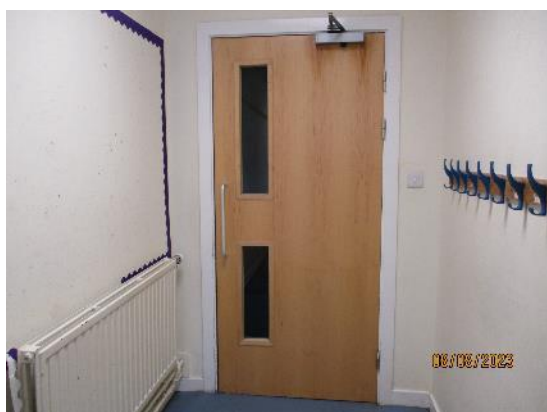
211. Timber single veneered doors

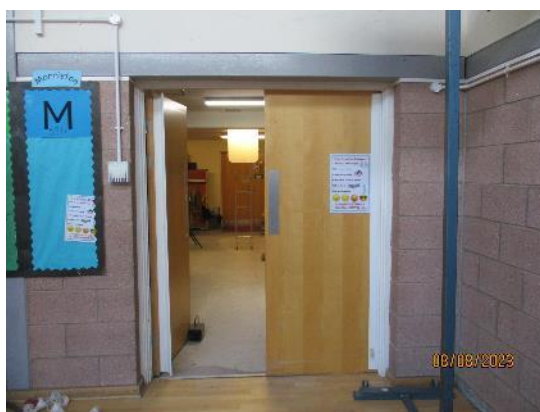
212. Timber double veneered doors

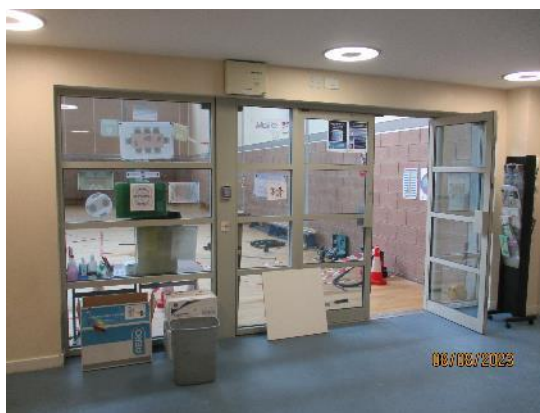
214. Aluminium screen and door to Games Hall

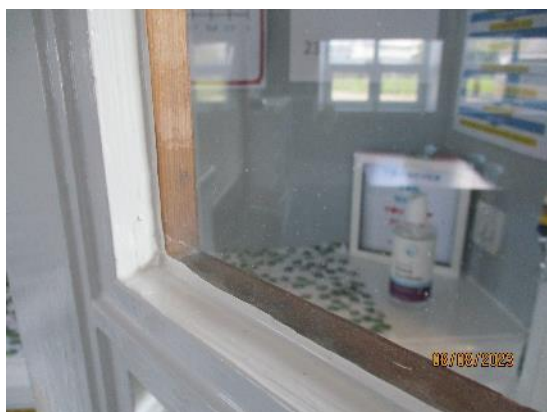
215. Clear glazing to internal doors

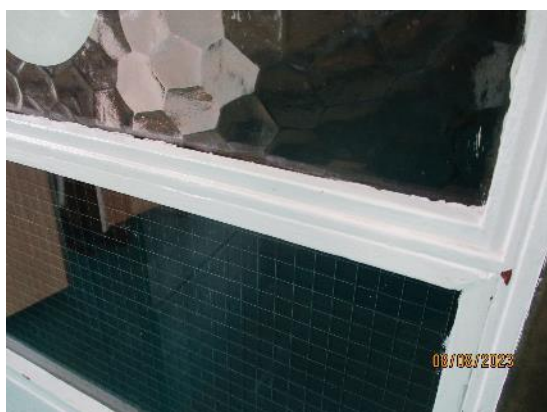
217. Variety of glazing to internal doors

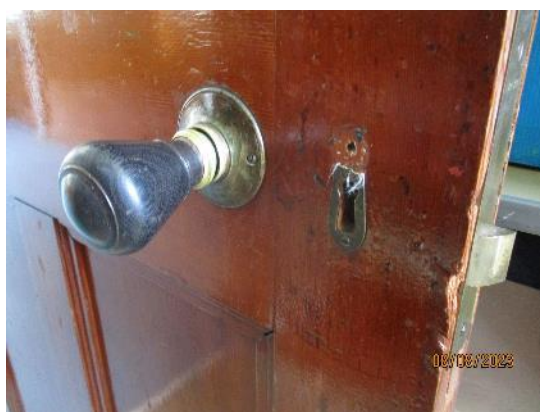
218. Timber door knobs

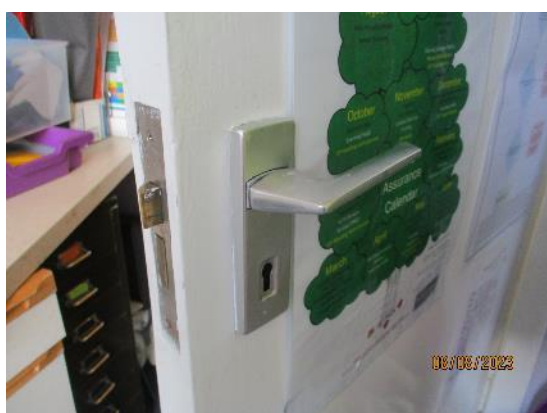
219. Aluminium levers

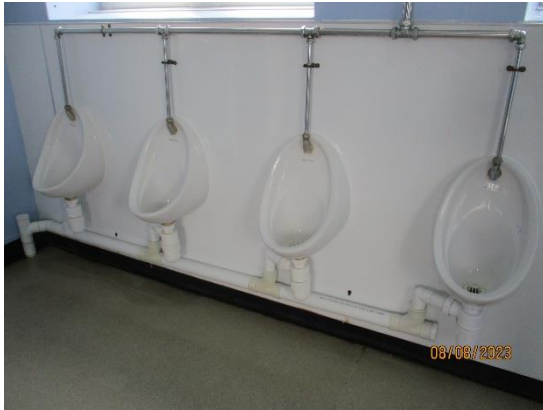
221. China urinals

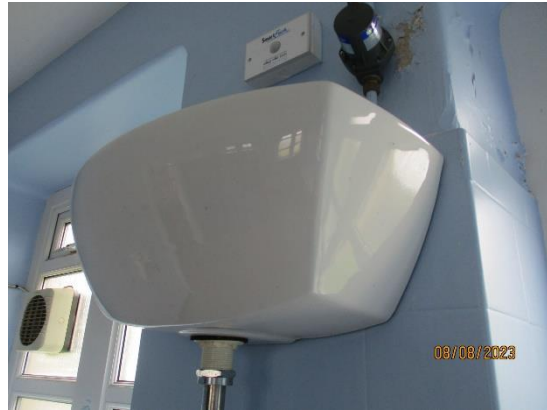
222. China cistern

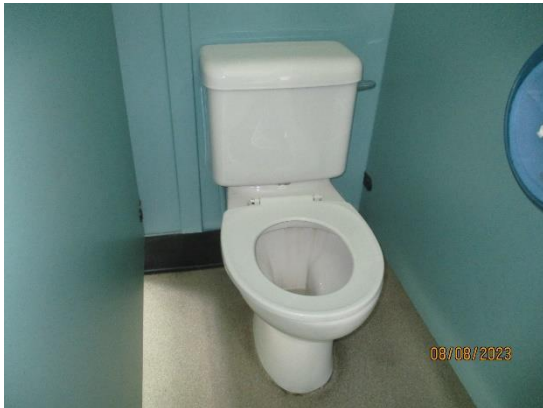
223. Pupil toilets

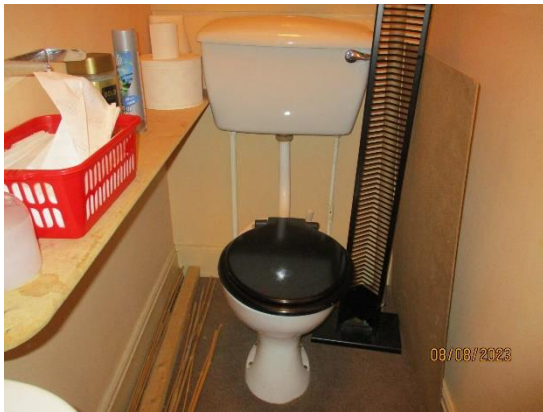
227. Staff toilets

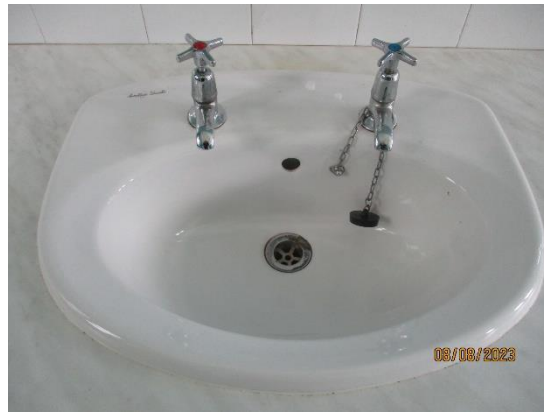
228. China vanity basins

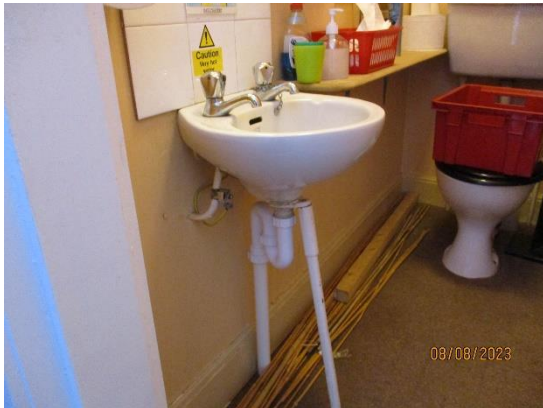
229. Wall hung china basins

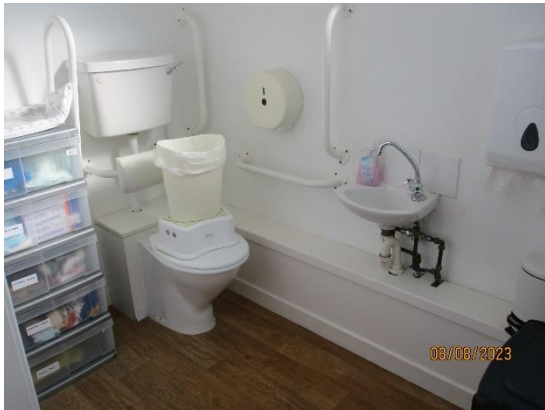
235. Accessible toilets

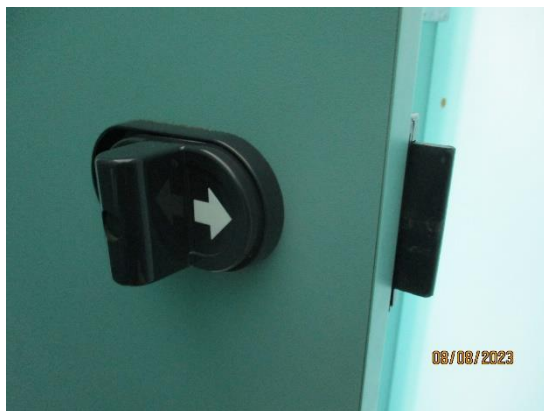
238. Ironmongery

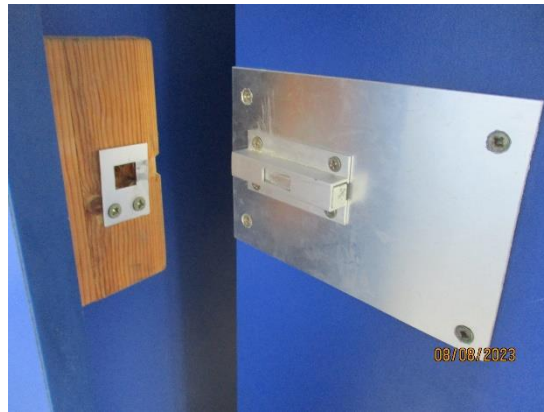
240. Replacement ironmongery

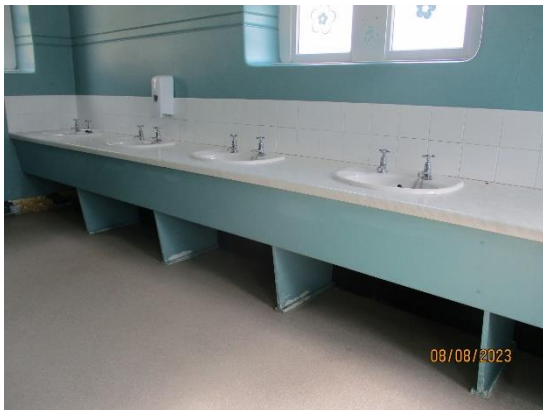
241. Composite vanity base units

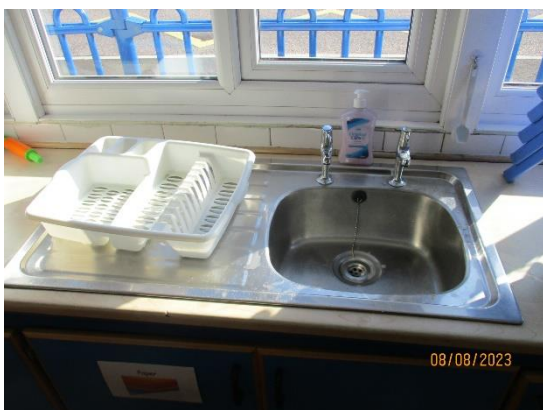
243. Stainless steel sinks

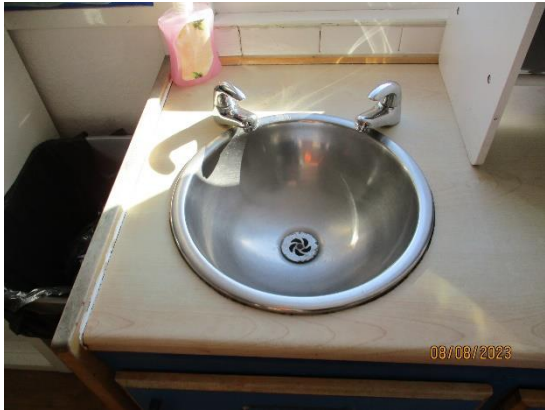
245. Stainless steel inset sinks

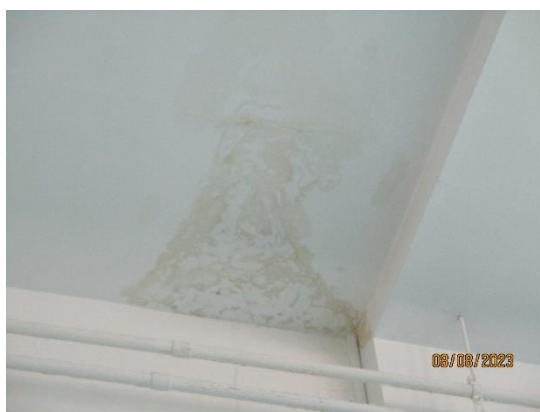
254. Watermarked plaster ceilings

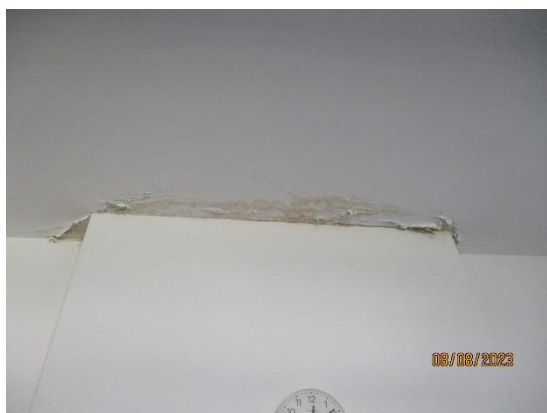
255. Peeling paint

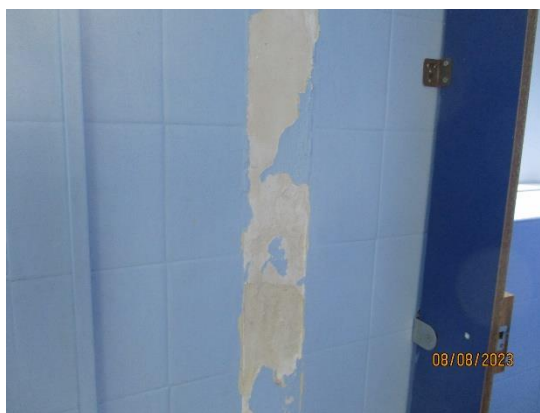
256. Painted ceramic tiles

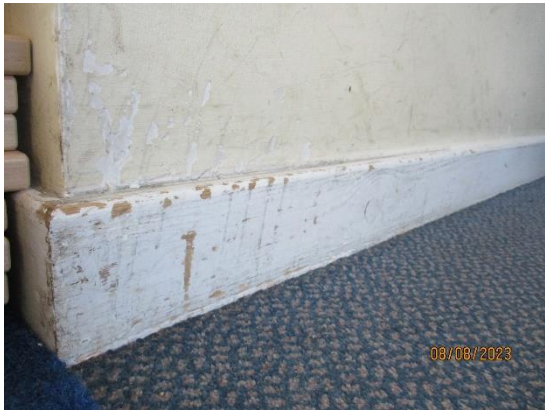
259. Painted joinery items

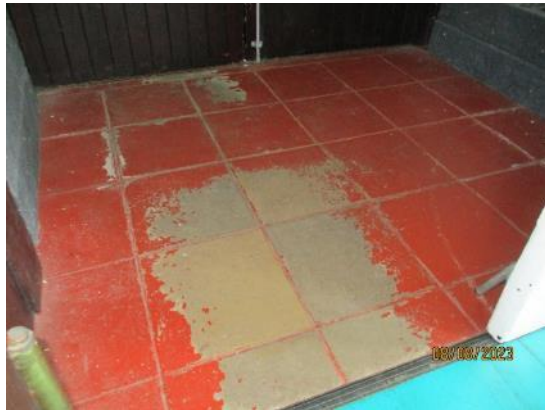
260. Painted quarry tiles

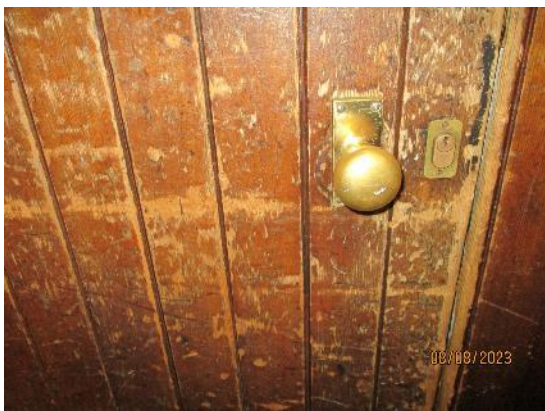
261. Varnished doors

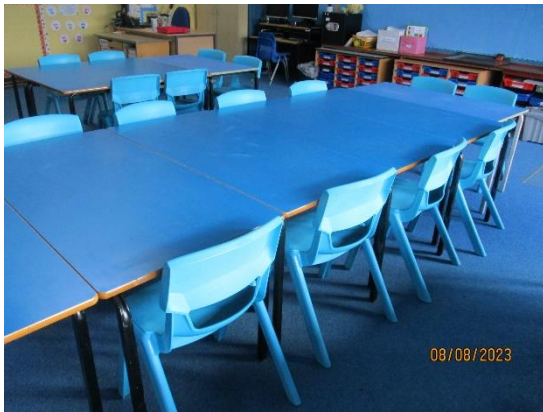
262. Classroom furniture

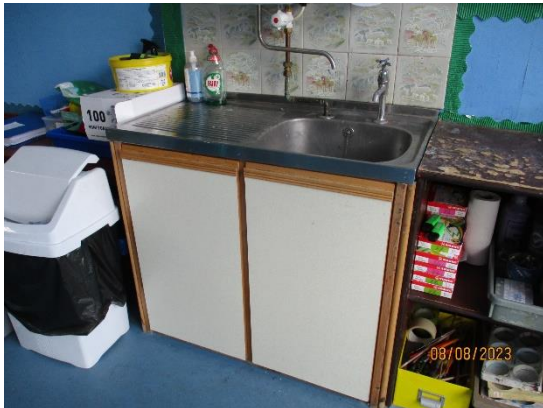
264. Dated sink base units

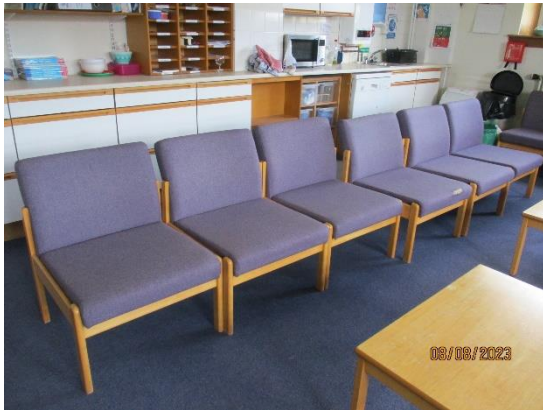
270. Staff room furniture

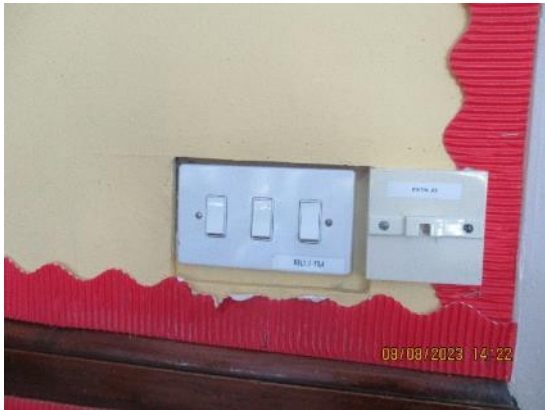
328. Light switch original school building typical.

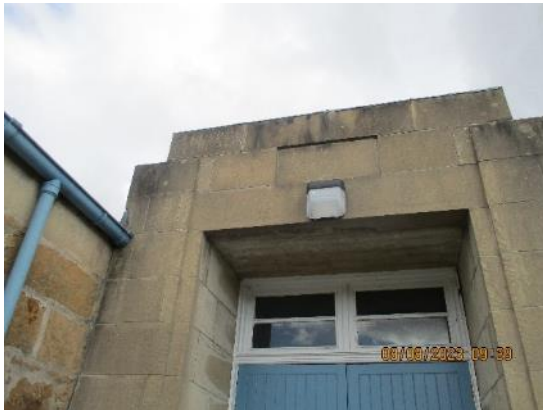
340. External lighting original school.

- Upgrade general lighting to LED types with automatic control.
- Upgrade external building lighting to LED types with lux sensors.
- Appraise cold water systems at replacement date, with intent of reducing number of cold water storage tanks to reduce cyclical maintenance and reduce potential water hygiene issues.

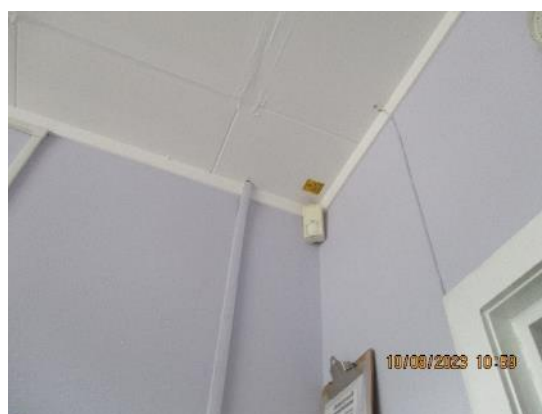
350. Intruder alarm keypad – office 1/3.

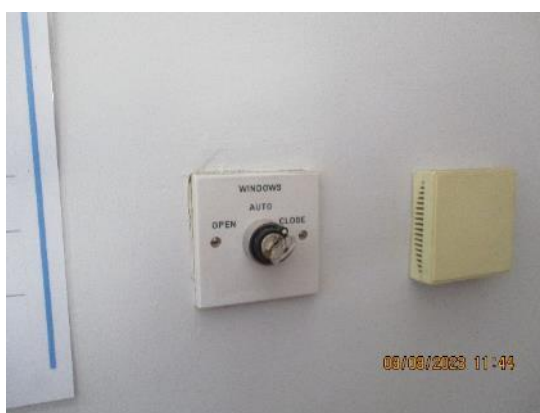
360. Electric windows – 2008 extension classes.

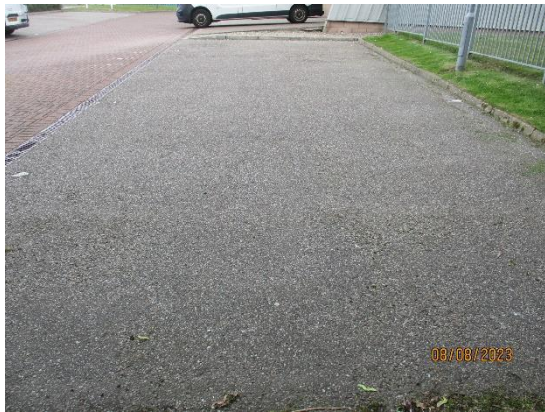
362. Tarmac parking spaces

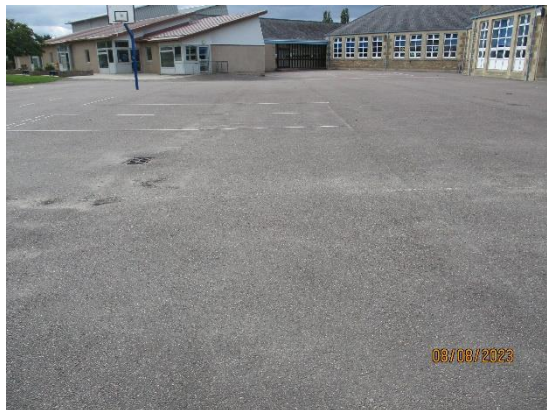
365. Tarmac playground

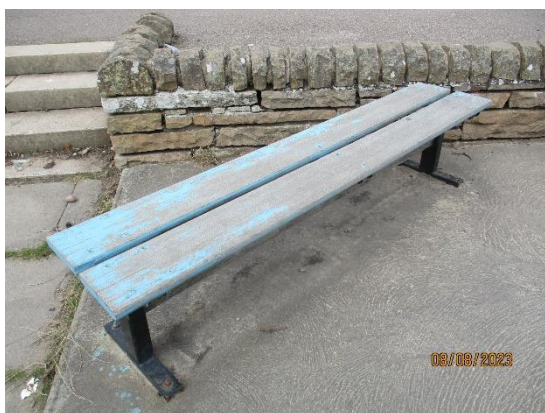
366. Timber benches

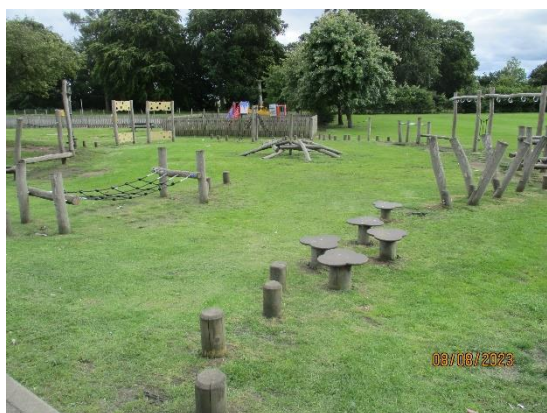
367. Playground equipment

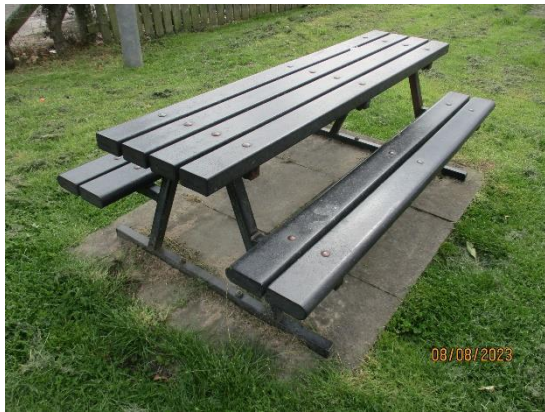
368. Recycled table and benches

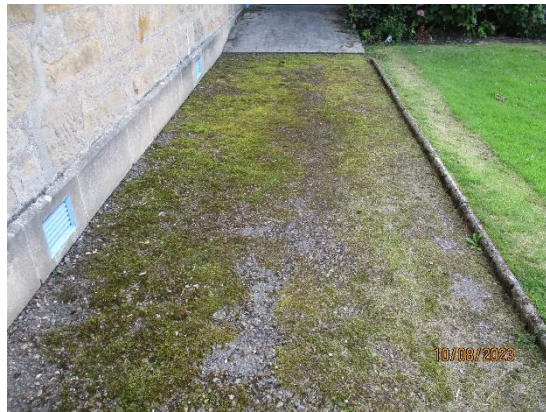
369. Tarmacadam footpaths

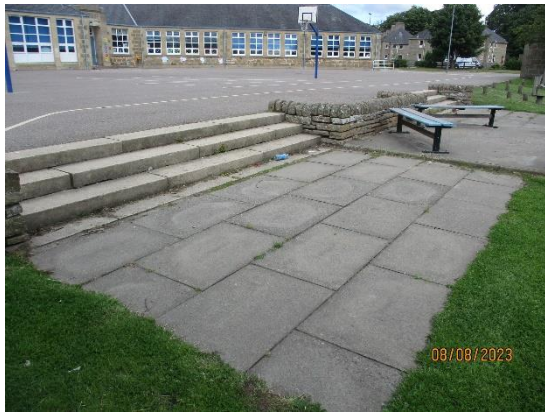
374. Concrete steps

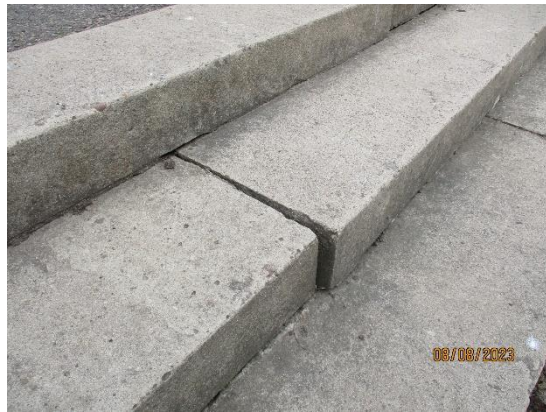
375. Miss-aligned and uneven

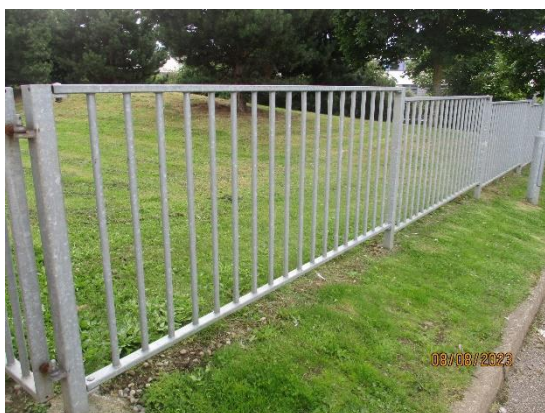
378. Aluminium rail fence

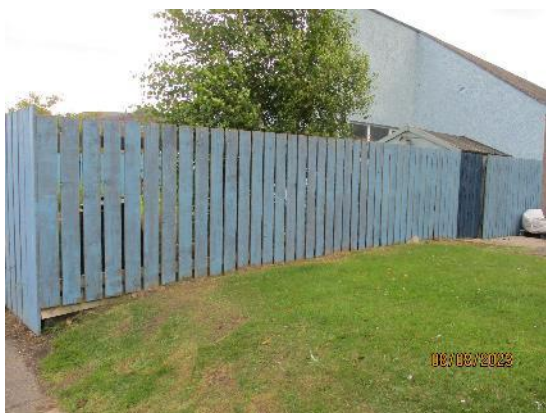
379. Timber boarded fence 1.50m

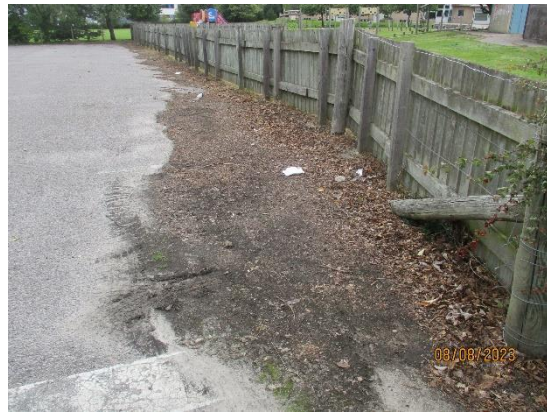
381. Timber boarded fence 0.90m

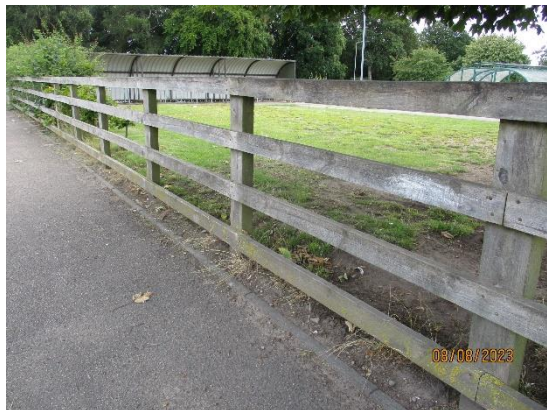
383. Timber horizontal rail fence

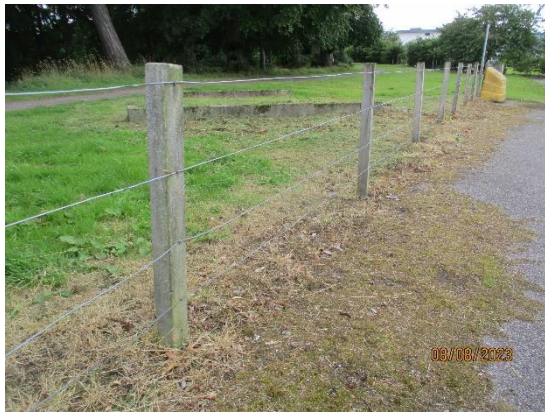
386. Timber post and wire fence

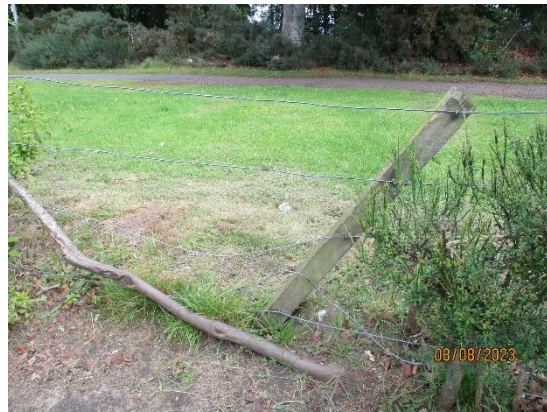
387. Partially collapsed

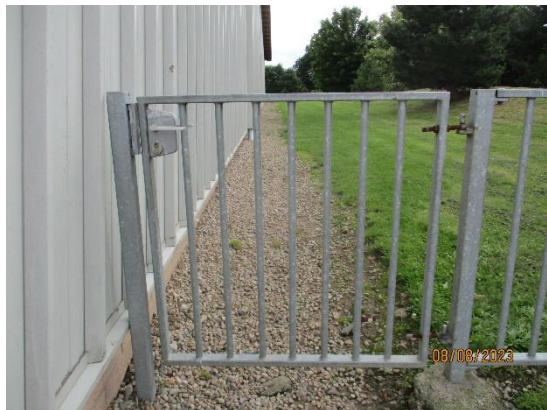
389. Aluminium rail gate

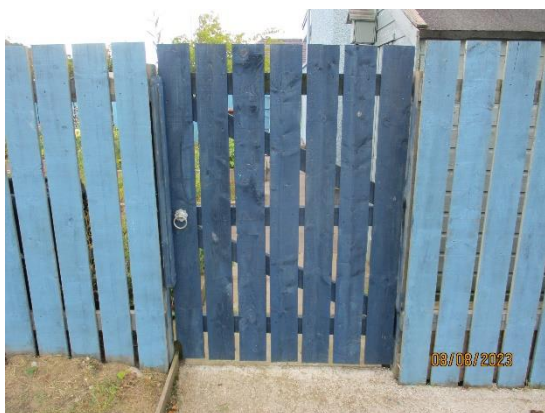
390. Timber boarded gates 1.50m

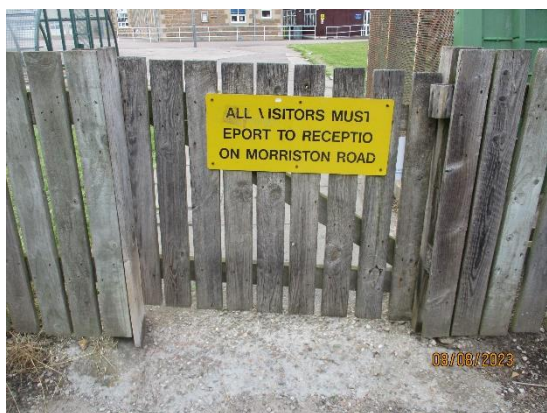
391. Timber boarded gates 0.90m

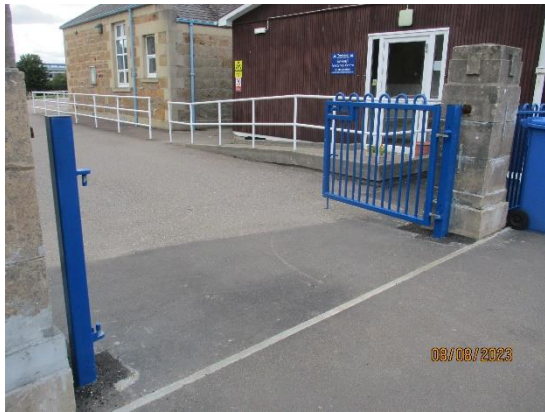
392. Tubular rail vehicle gate

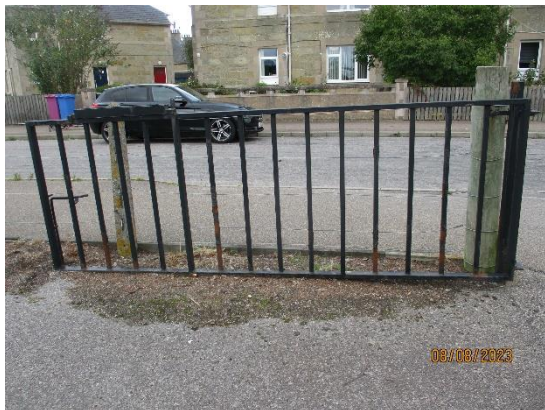
394. Metal bar vehicle gate

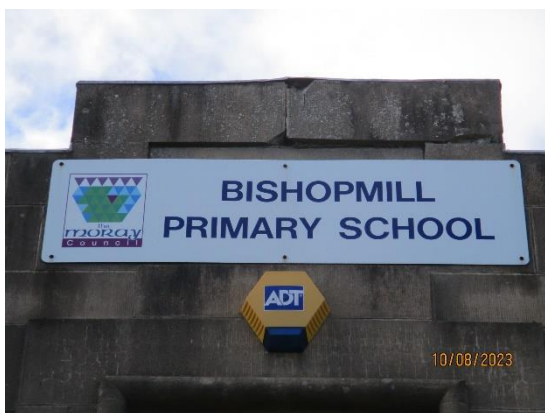
396. School signage

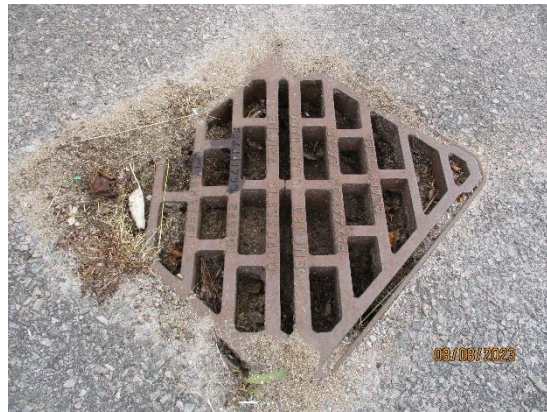
399. Car park road gully blocked

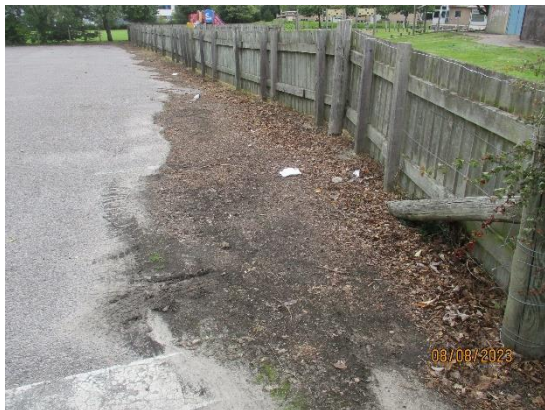
400. Debris from flooding of staff car park

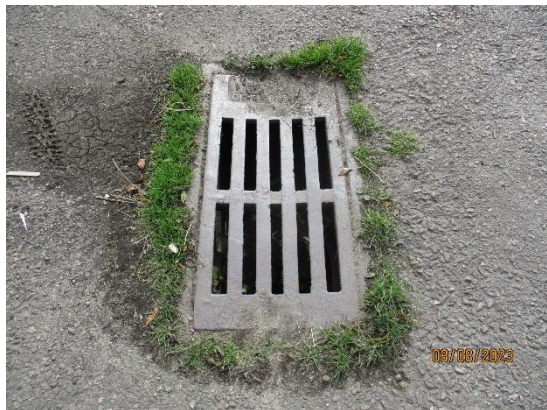
401. Playground road gully partially blocked

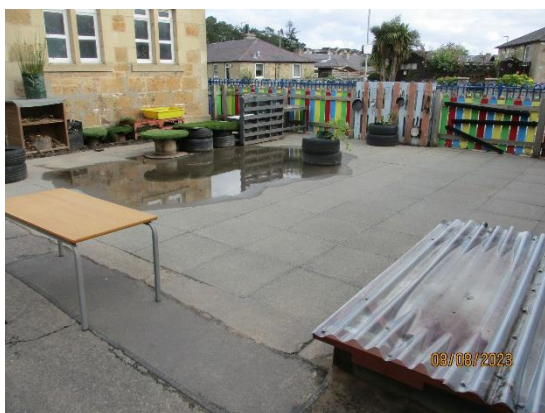
402. Nursery playground flooding

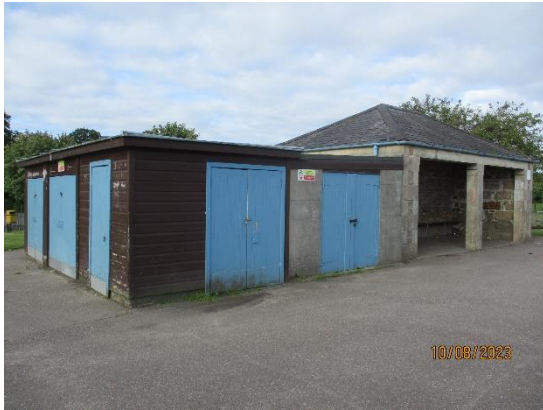
404. External stores and shelter

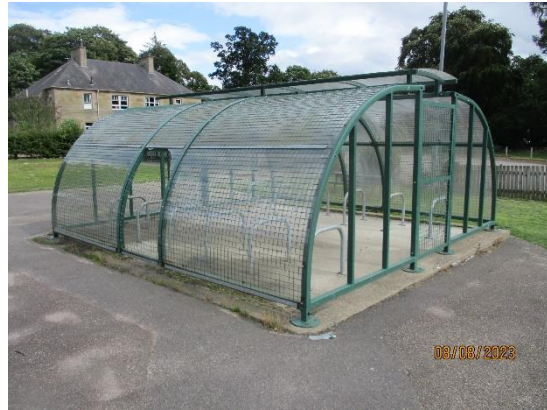
405. Cycle shelter 1
