# **Summary Building Condition Survey Report**

**Bishopmill Primary School  
Morrison Road, Elgin IV30 4DY**

**8<sup>th</sup> & 10<sup>th</sup> August 2023**

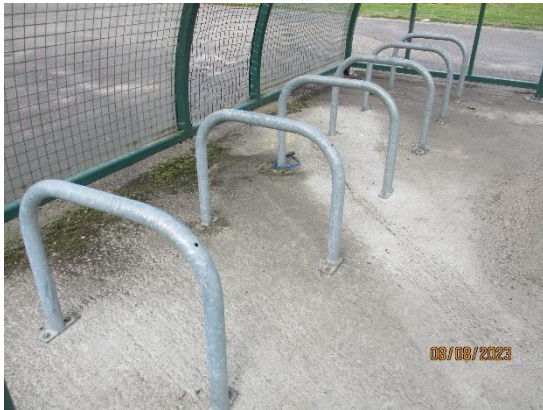
406. Cycle hoops

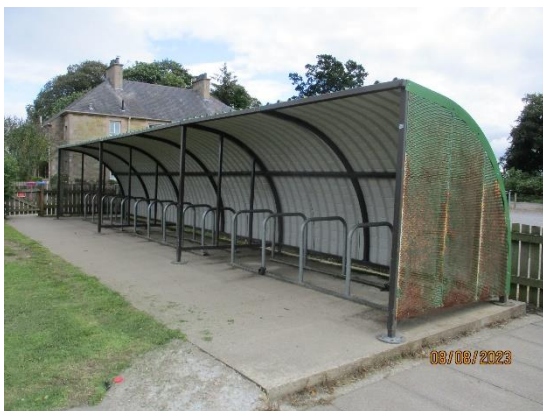
408. Cycle shelter 2

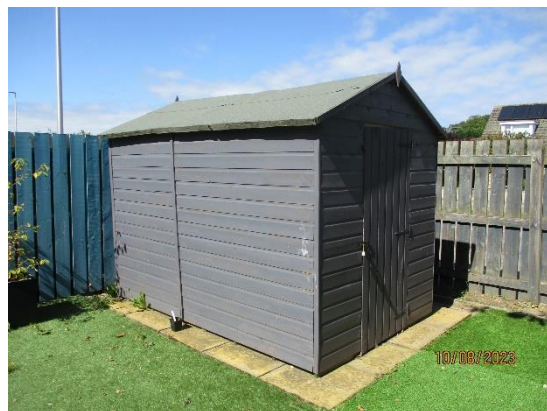
409. Timber sheds

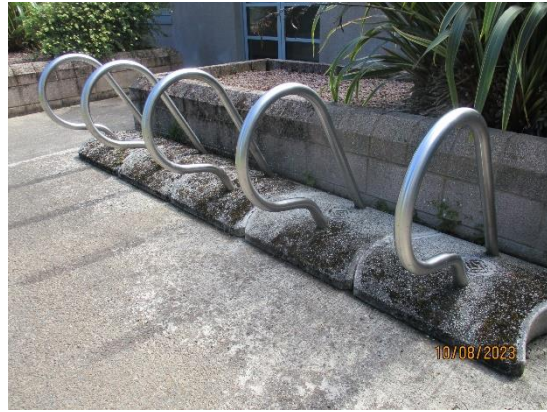
411. Cycle hoops at main entrance

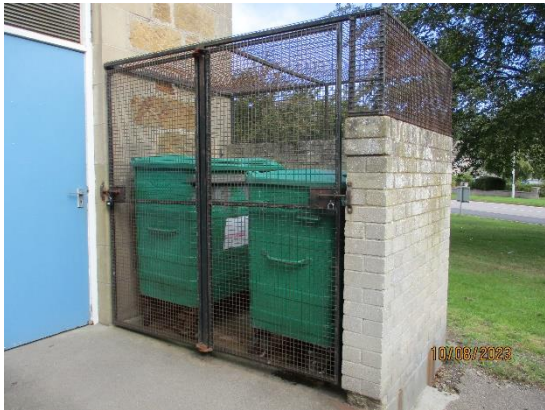
412. Bin enclosure

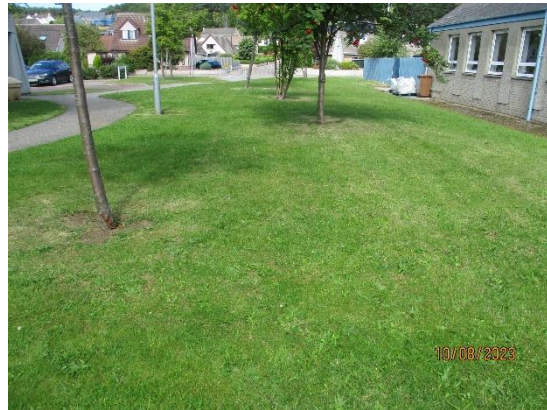
413. Landscaping trees and grass

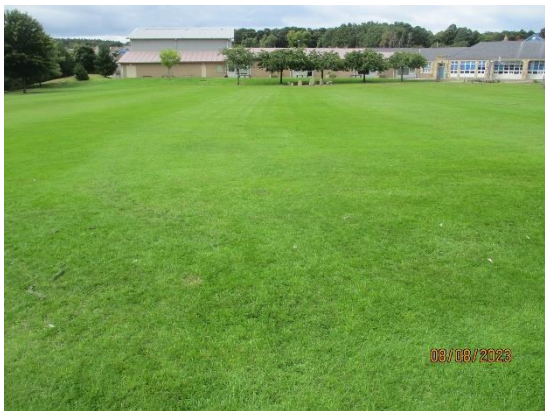
414. Grass sports field

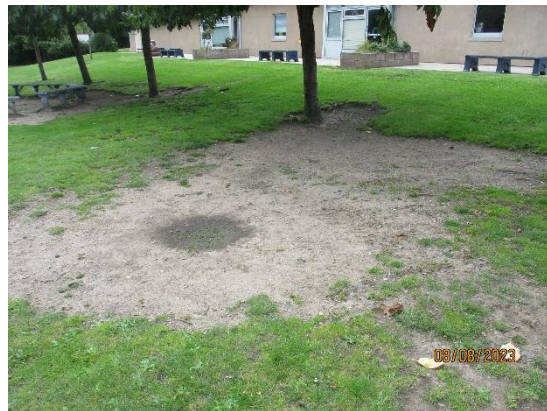
415. Bald patches

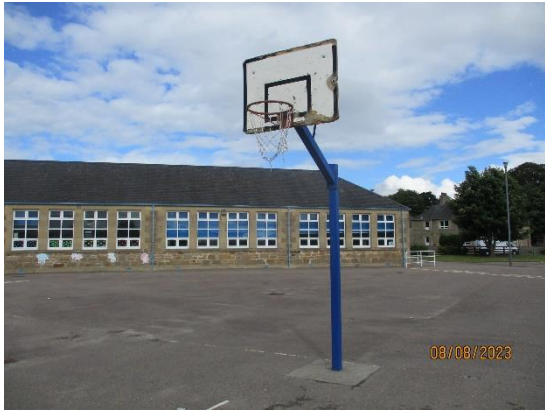
416. Basketball hoop stands
