# **Summary Building Condition Survey Report**

**East End Primary School  
Institution Road, Elgin IV30 1PR**

**10<sup>th</sup> & 11<sup>th</sup> April 2023**

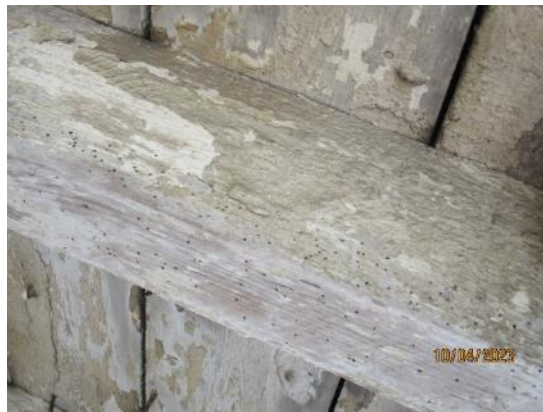
4. External shelter - Woodworm

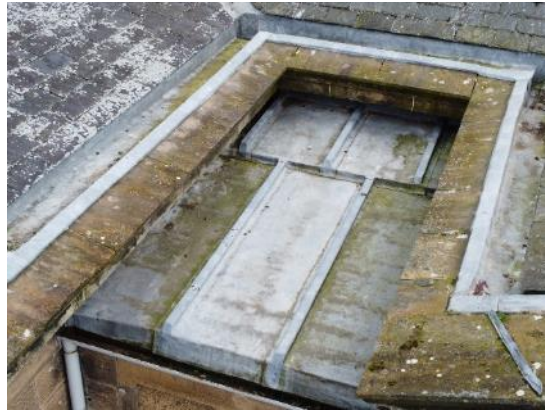
8. Lead roofs

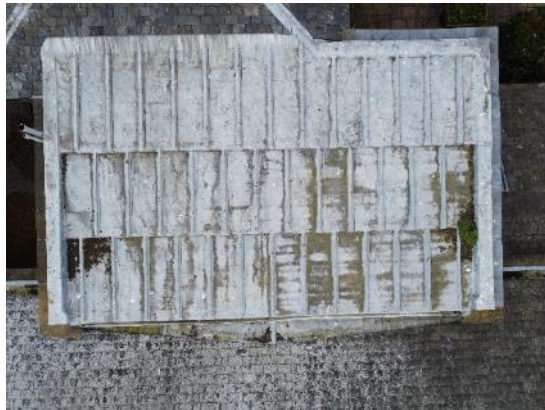
9. Lead roof

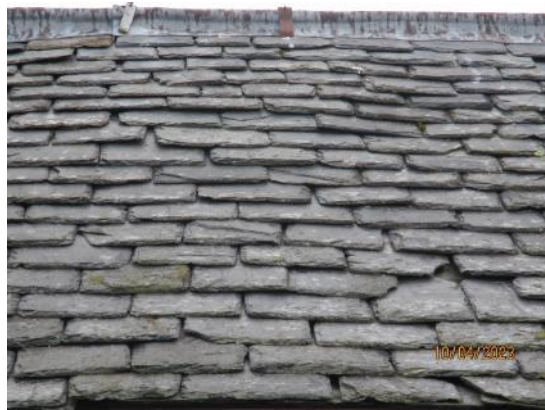
14. External shelter

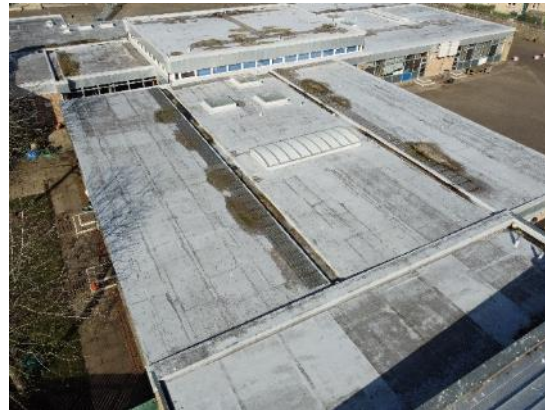
16. Single ply membrane

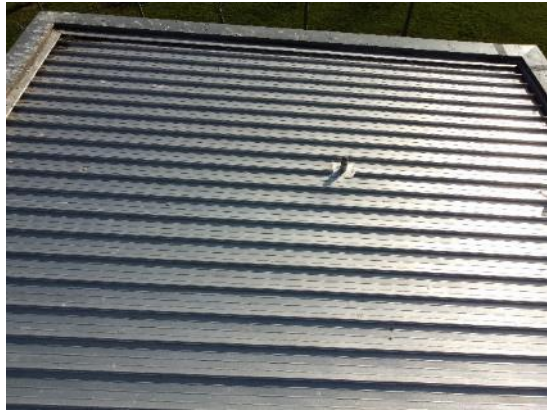
20. Nursery standing seam

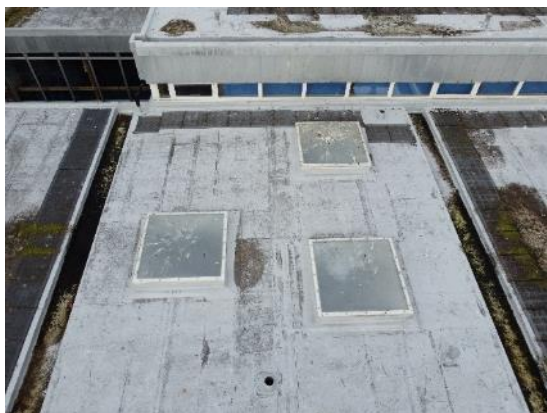
23. Block 2 - Rooflights

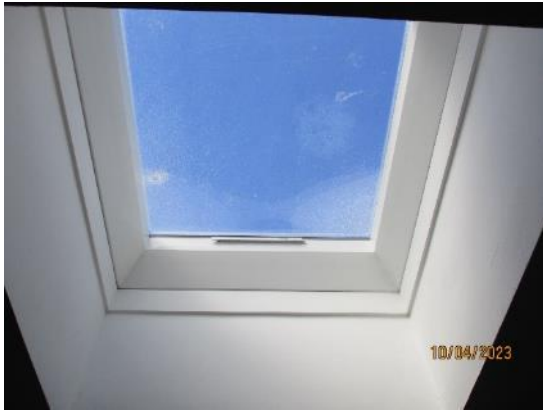
25. Rooflights internally

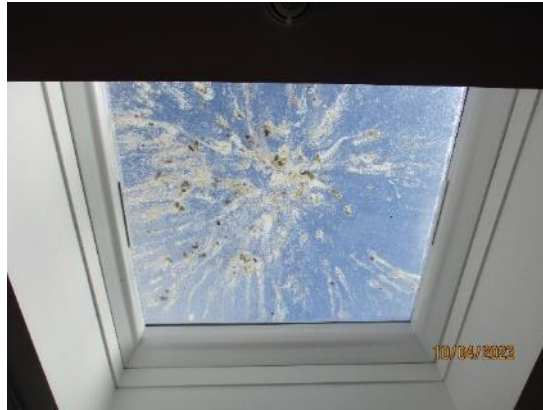
26. Rooflights soiled

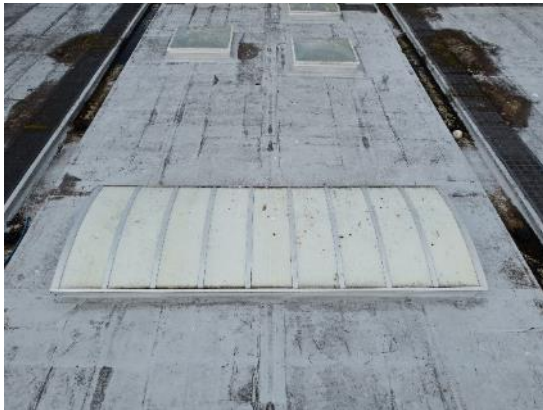
27. Barrel vault rooflights

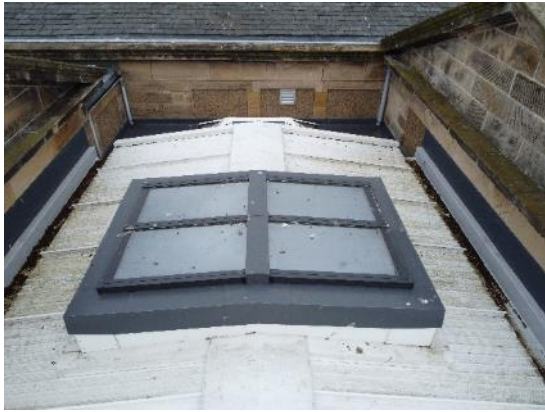
31. Block 1 skylights

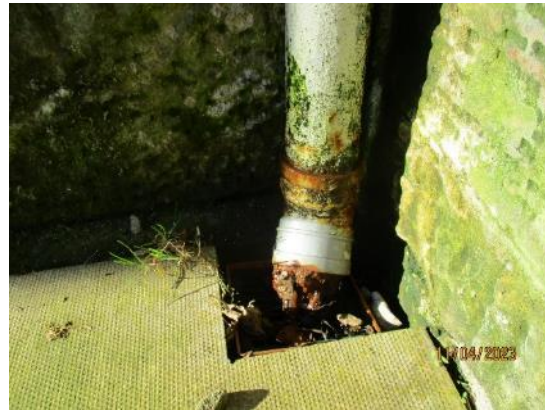
40. Blocked downpipes

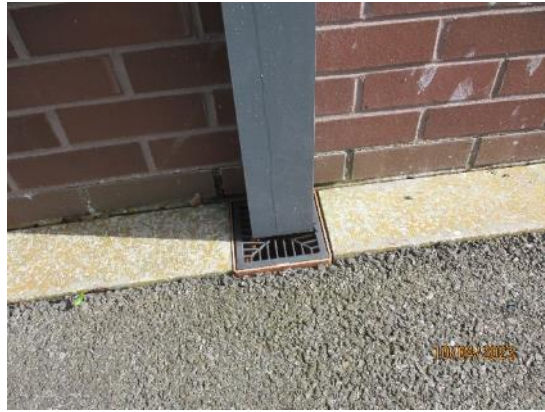
44. Metal downpipes

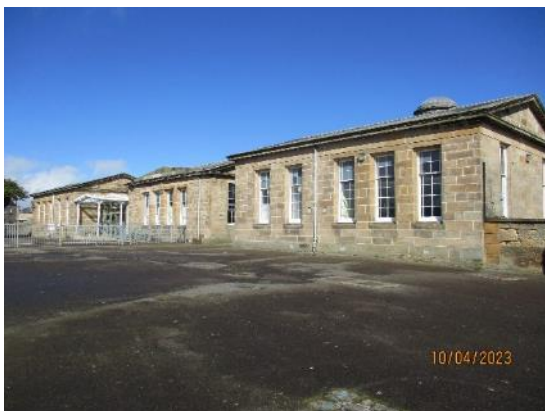
47. Block 1 – Natural stone walls

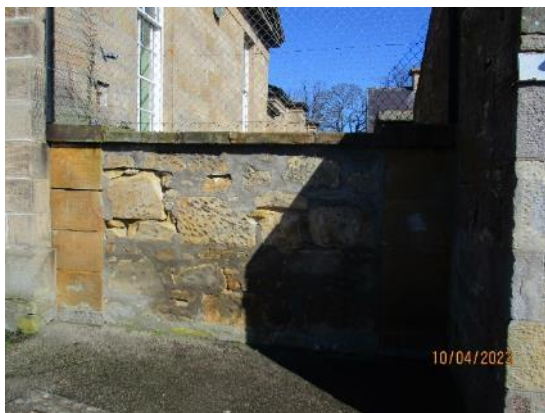
54. Surface erosion

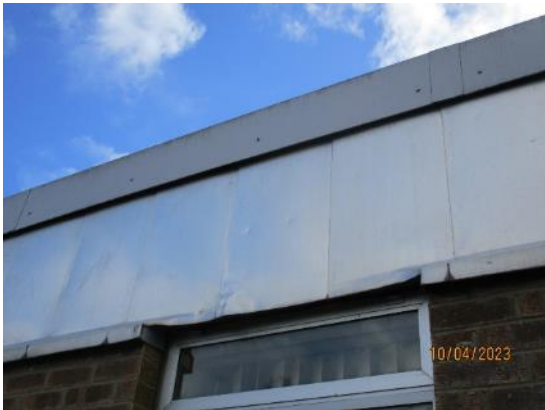
58. Aluminium cladding

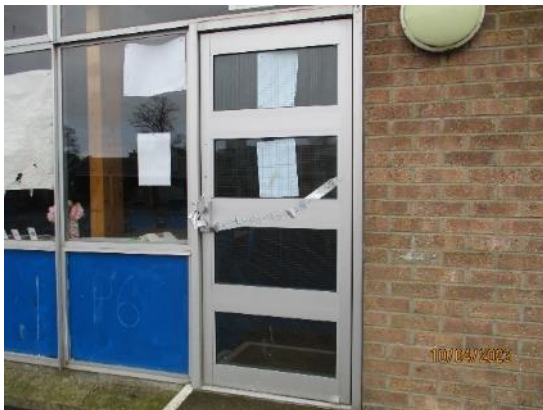
- Roof covering missing from Games Store.
- Aluminium windows and doors are life expired and single glazed.
- Concrete steps to west playground are broken.
- Internal doors and ironmongery are reaching the end of their useful life.
- Sanitary ware is functional although dated and life expired.

64. Aluminium single doors

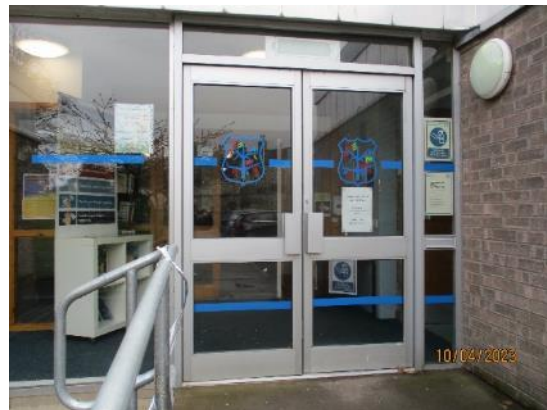
65. Aluminium double doors

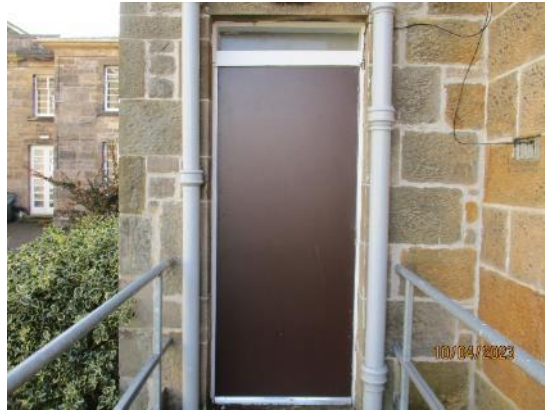
- Cast iron gutters and downpipes are damaged and partially blocked.
- Evidence of rainwater penetration to be investigated.
- Timber suspended floors to first floor have sagged and slope, investigate condition.
- Timber panelled doors are life expired.

69. Timber single doors

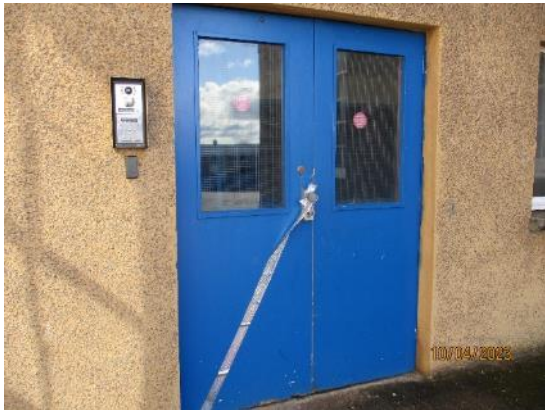
70. Timber double doors

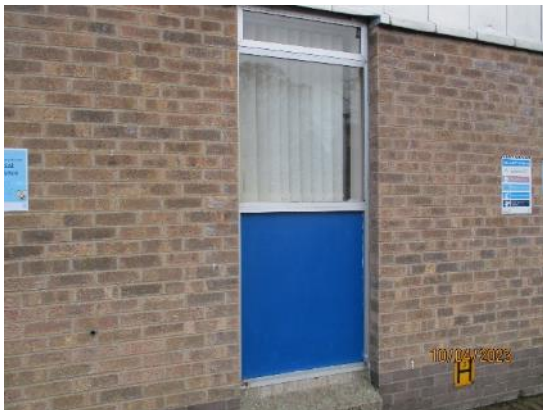
76. Block 2 – Aluminium windows

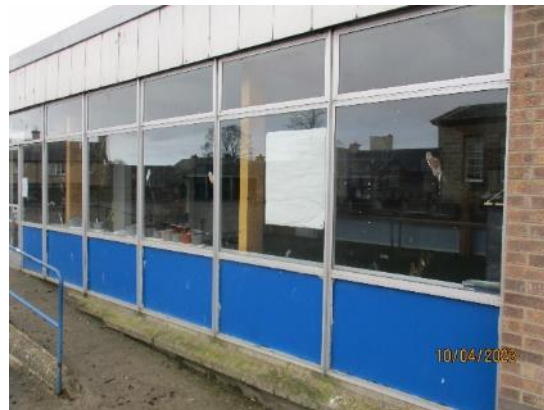
77. Block 2 – Aluminium screens

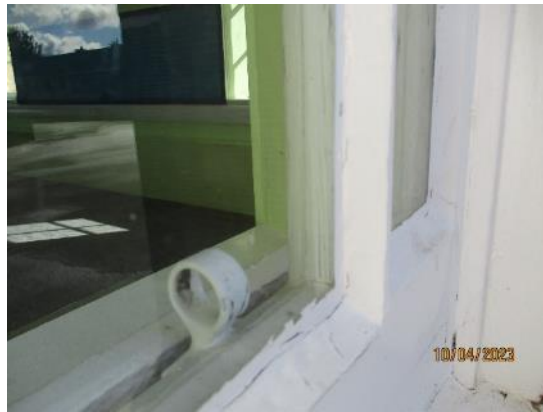
81. Block 1 – single glazing

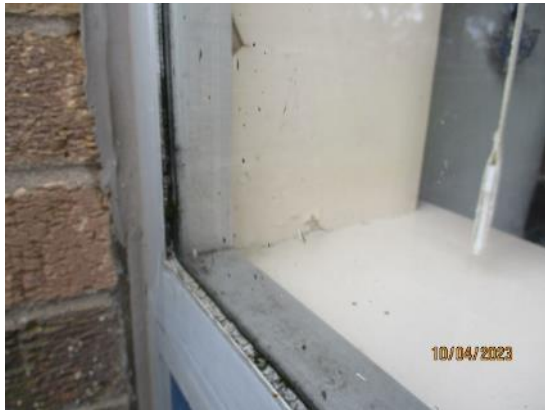
82. Block 2 – single glazing

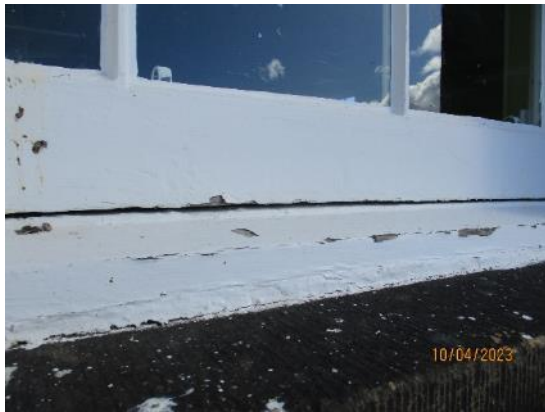
91. Windows and cills

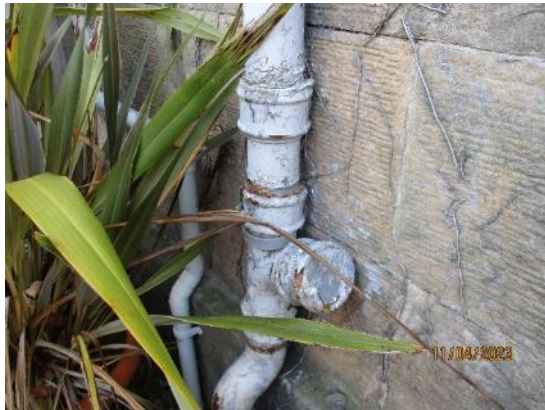
93. Rainwater goods

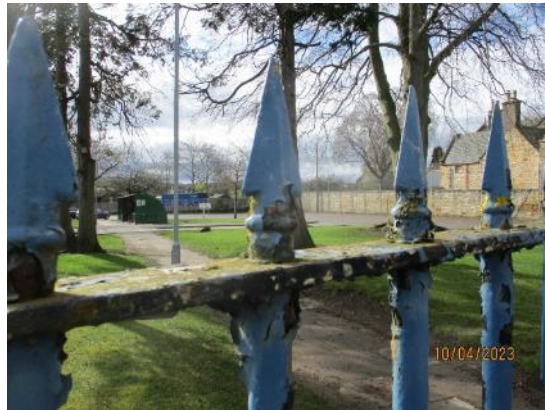
94. Metal railings

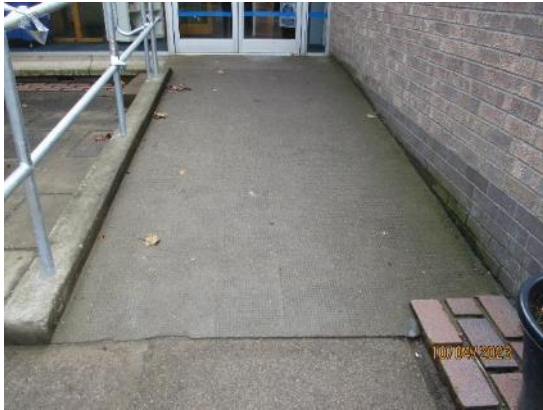
96. Concrete ramps

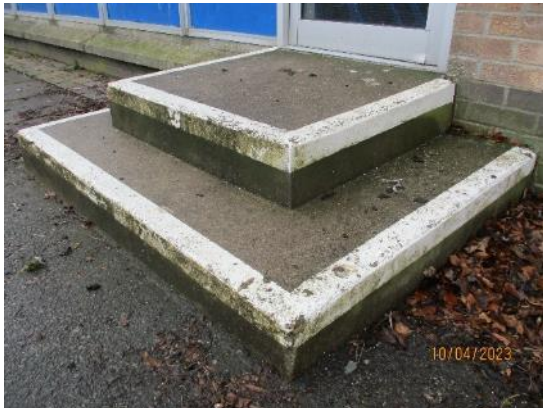
98. Concrete steps

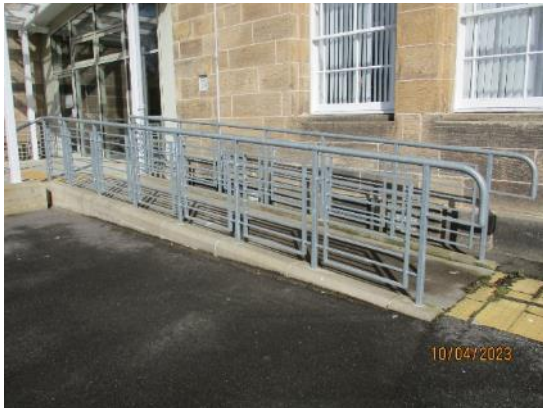
104. Galvanised metal guard rail

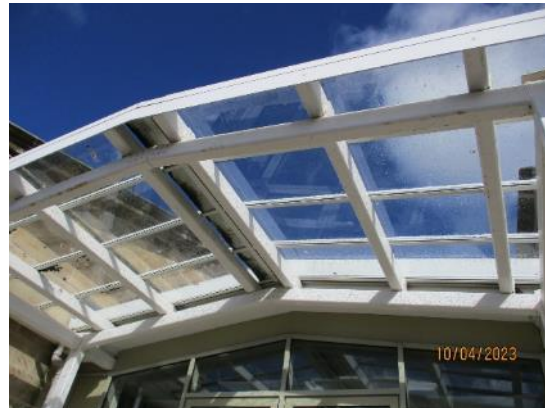
105. Block 1 – Glazed canopy

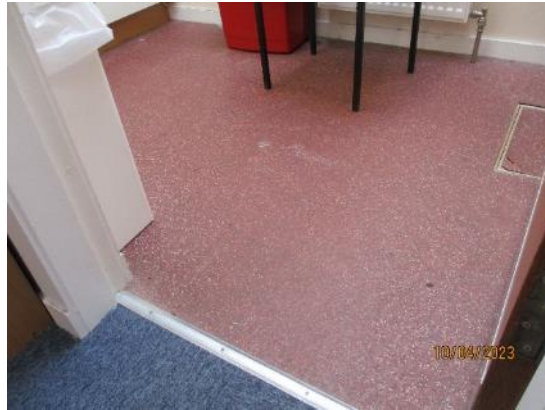
109. Sheet vinyl

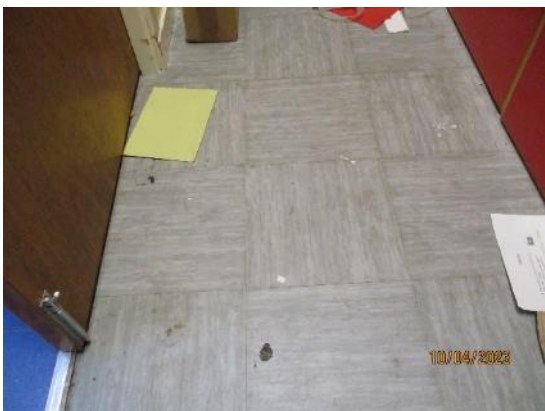
112. Vinyl tiles

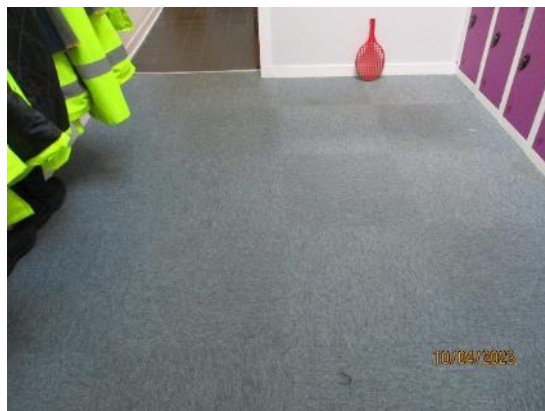
113. Carpet tiles

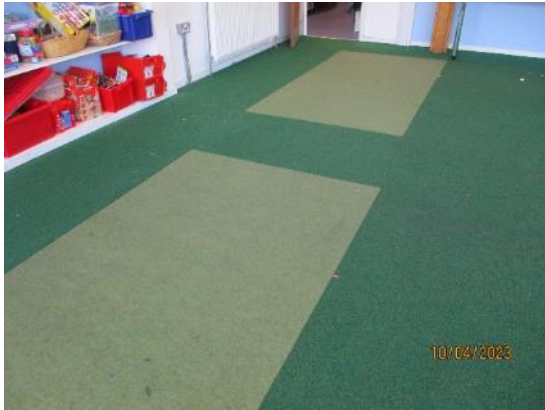
114. Carpet

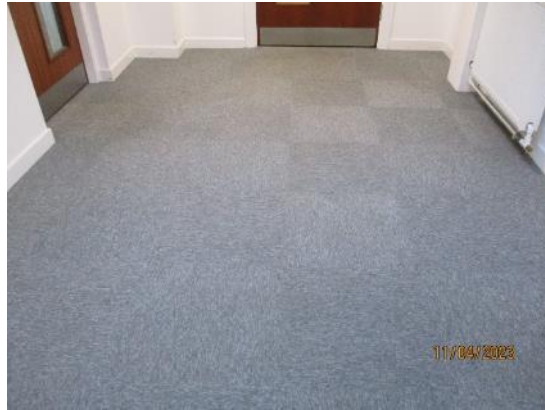
115. Carpet tiles

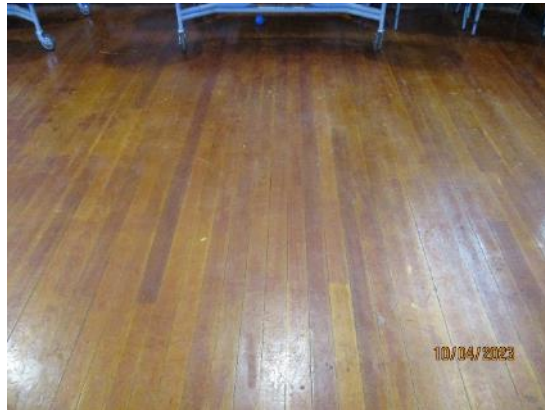
117. Timber sports floor

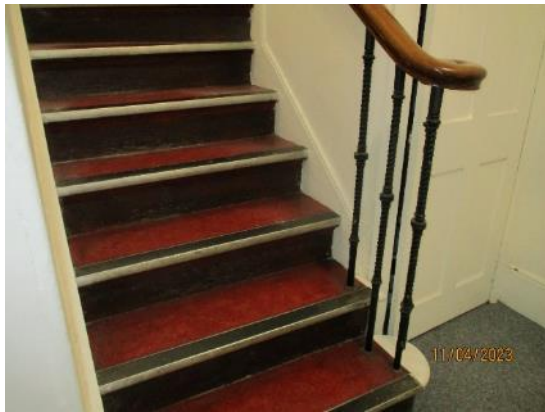
126. Vinyl treads and risers

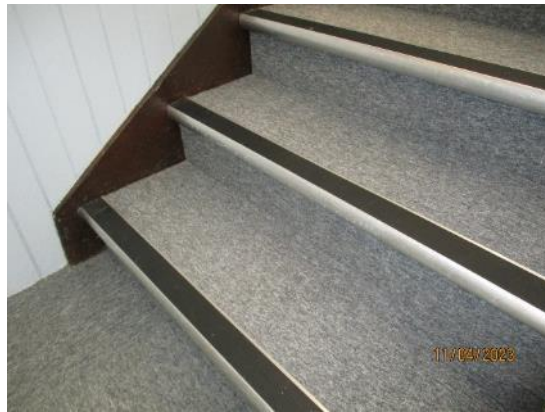
127. Carpet treads and risers

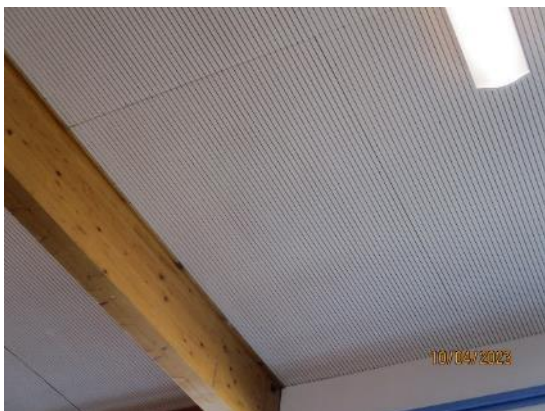
135. Ribbed fibre tiles (Games Hall)

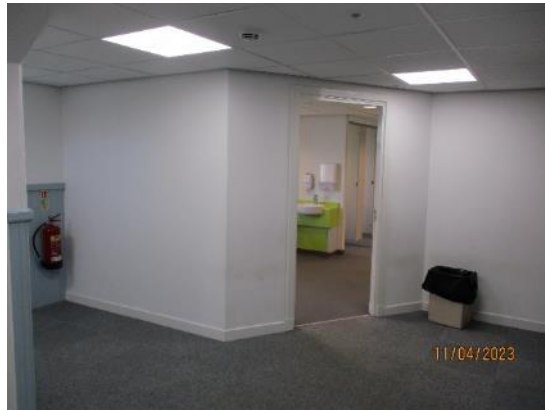
146. Plasterboard walls

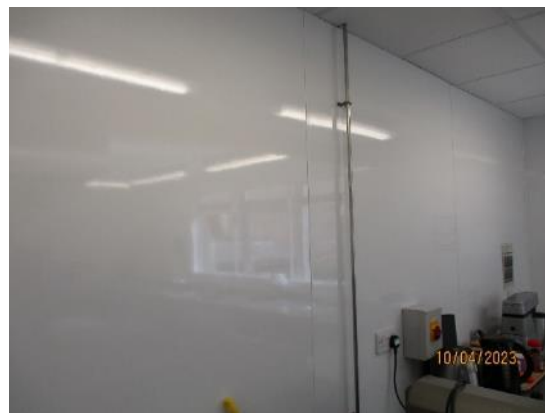
148. Wetwall

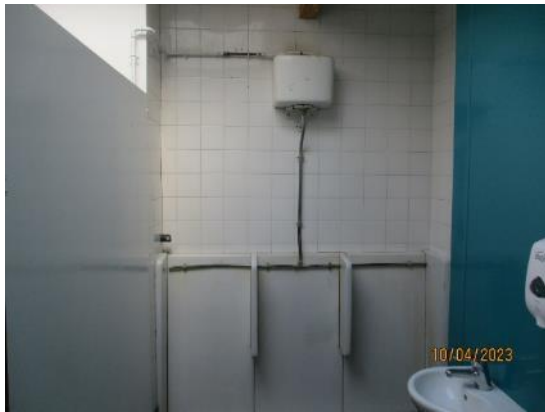
149. Ceramic tiled walls

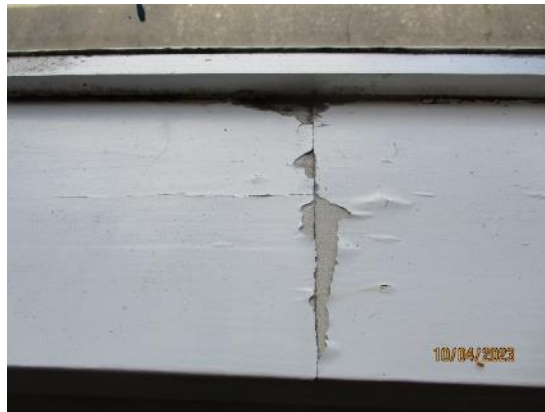
150. Timber window cills

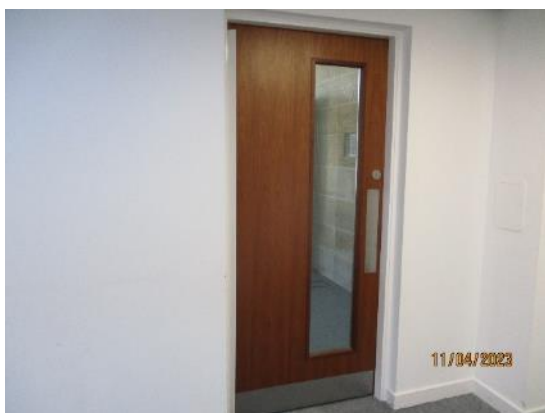
153. Timber veneered doors

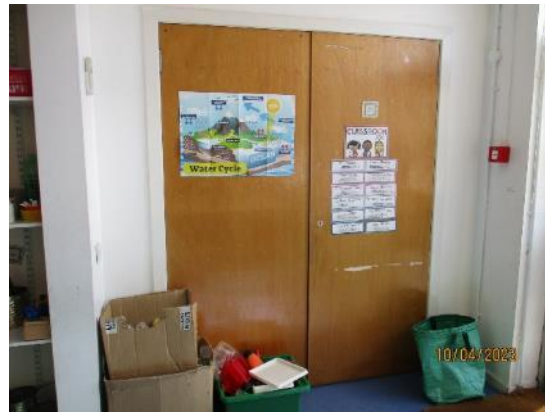
156. Cupboard doors

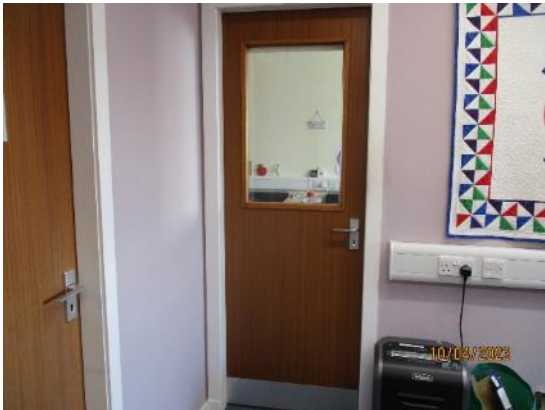
157. Block 2 – Veneered doors

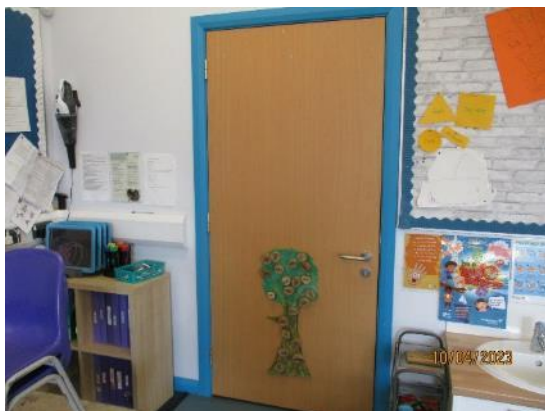
159. Nursery veneered doors

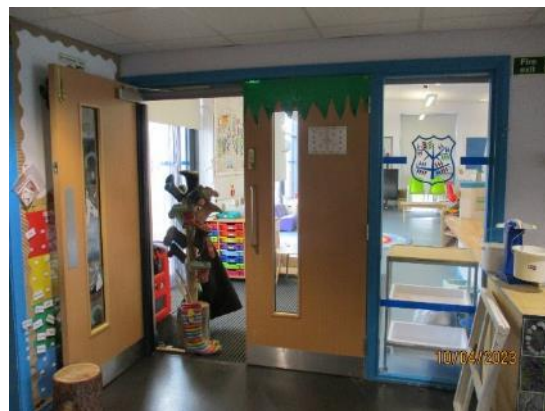
160. Nursery veneered double doors

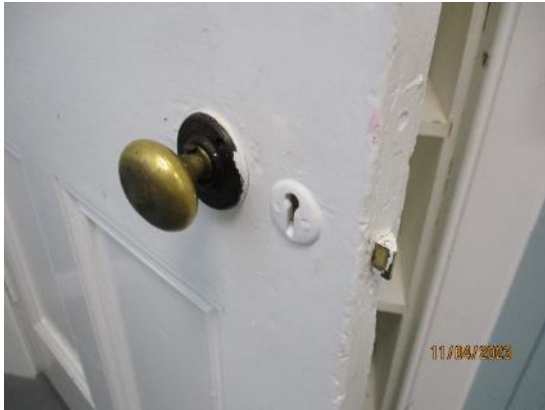
161. Brass ironmongery

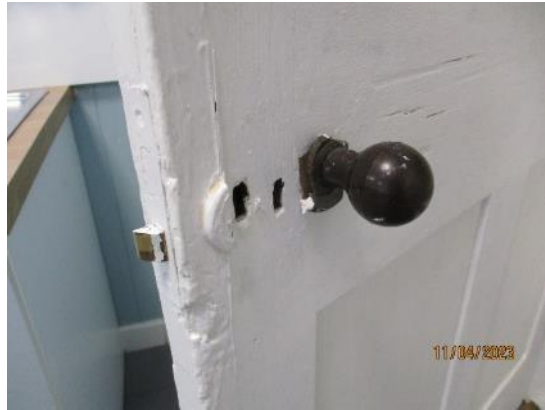
162. Bakelite ironmongery

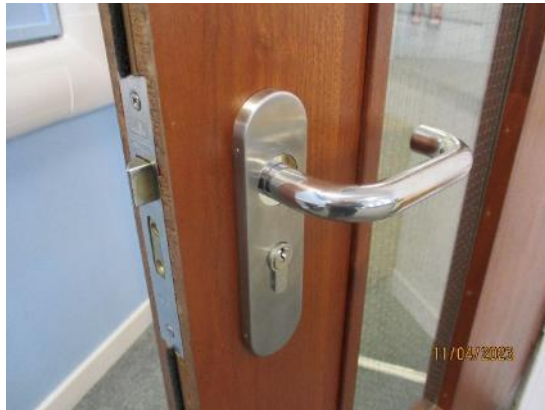
163. Chrome ironmongery

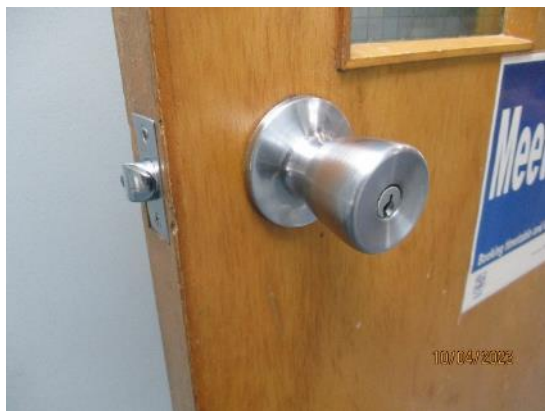
165. Aluminium ironmongery

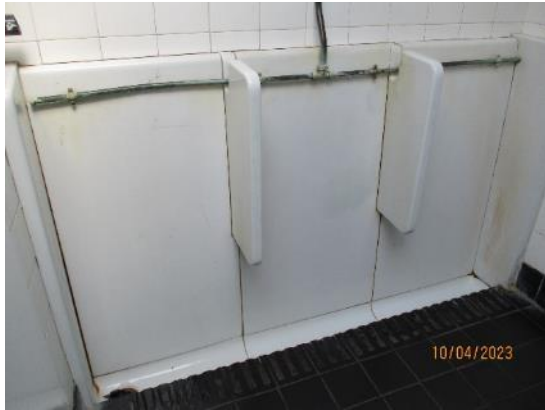
167. Floor standing urinals

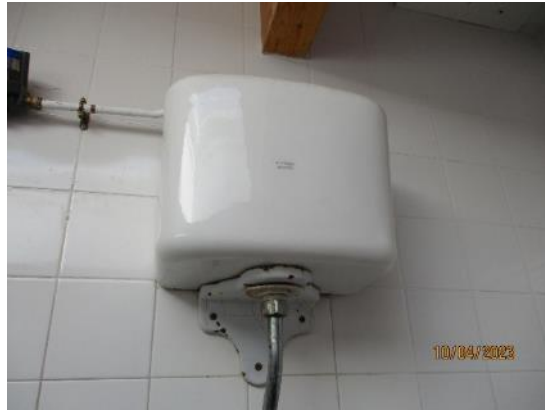
168. China cisterns

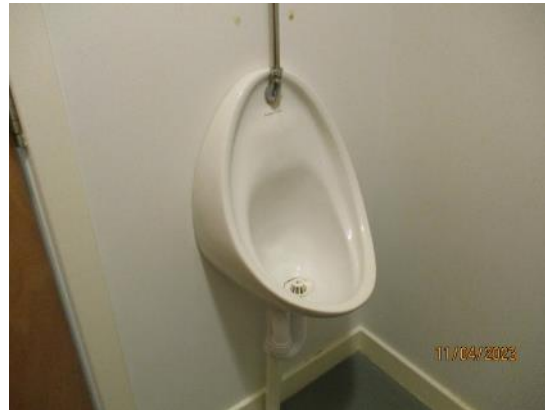
170. Wall hung urinals

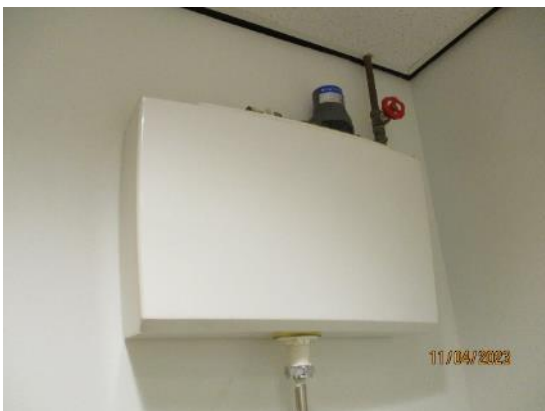
171. Plastic cisterns

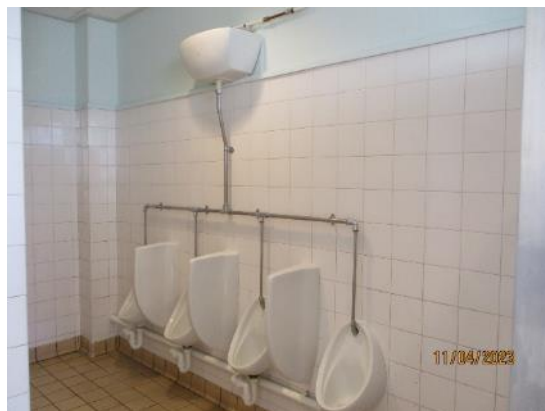
172. Wall hung urinals

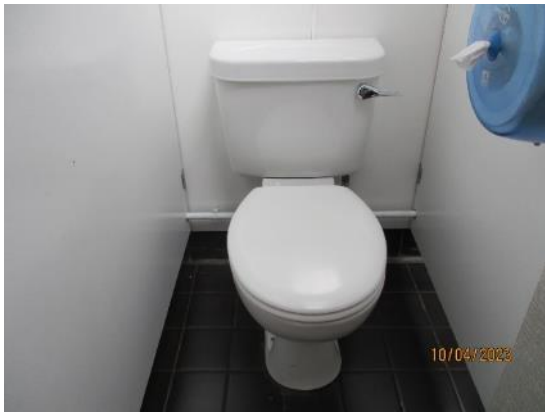
173. Various W.C.'s

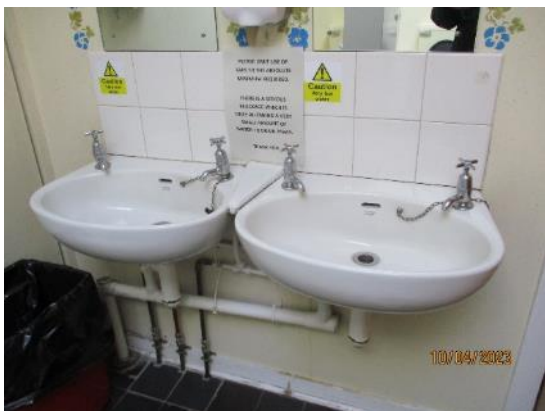
177. Wall hung wash hand basins

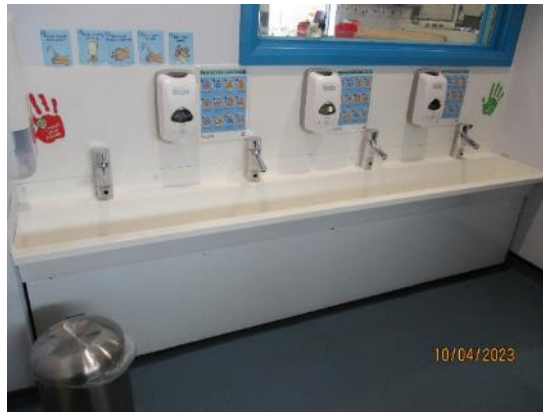
180. Composite trough basins (Nursery)

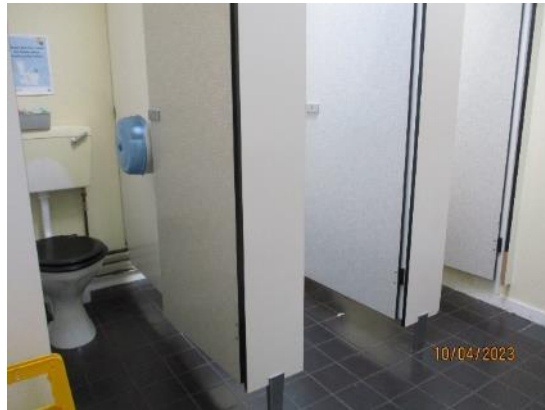
188. Composite cubicle partitions

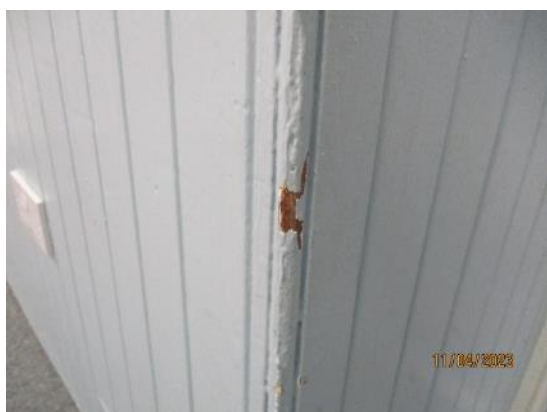
199. Chipped paint

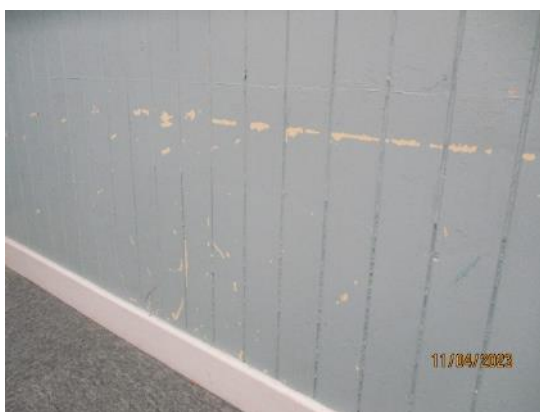
200. Scuffed paint

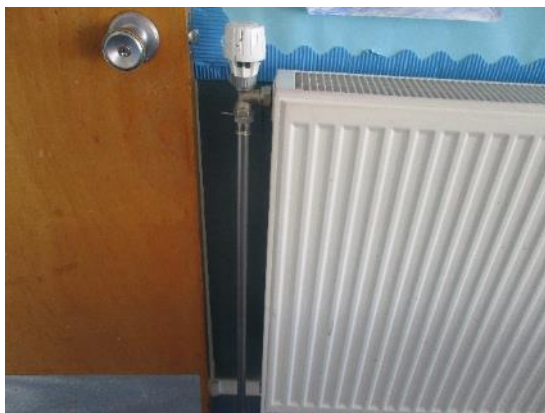
212. Heating pipework class typical block 2.

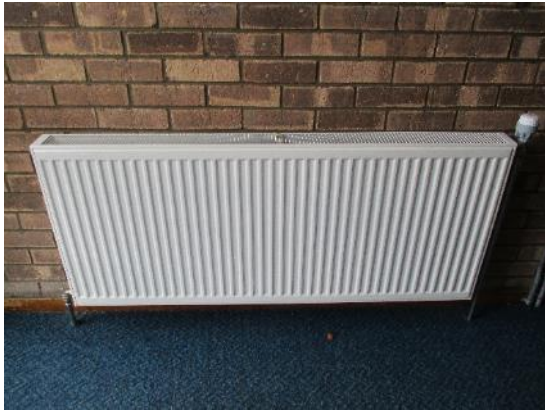
214. Radiator 1/1 corridor block 2.

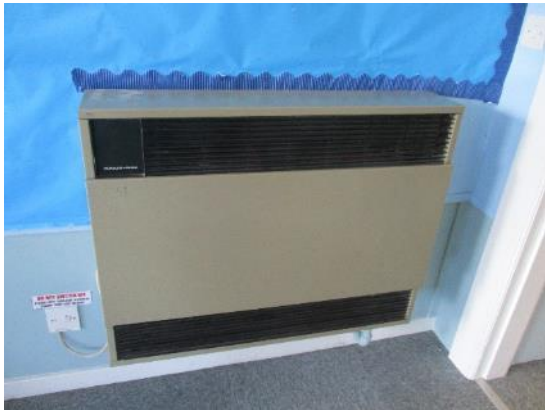
- Heat emitters in block 1 excluding a small number of replacements are in poor condition and life expired.
- Hot and cold water pipework throughout block 1 annexe is only insulated in parts and existing insulation is life expired.

216. Convector heater block 1 annexe typical.

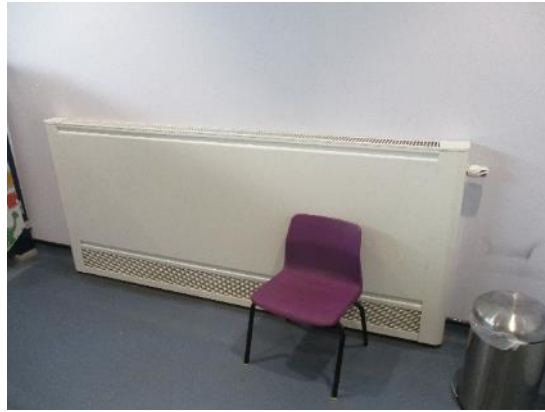
221. Radiator – LST nursery typical.

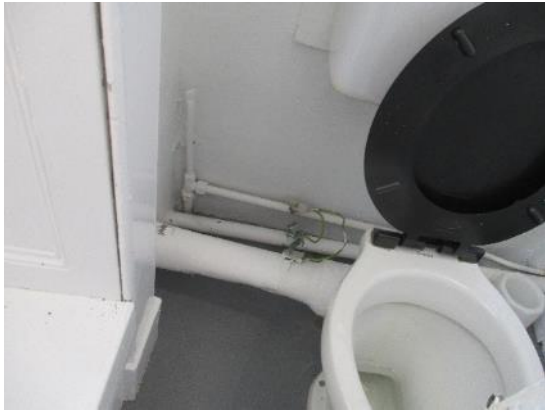
232. Cold water pipework – block 1 annexe typical.

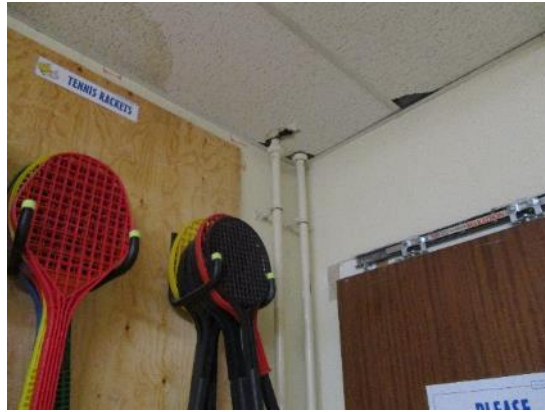
233. Cold water pipework – block 1 annexe typical.

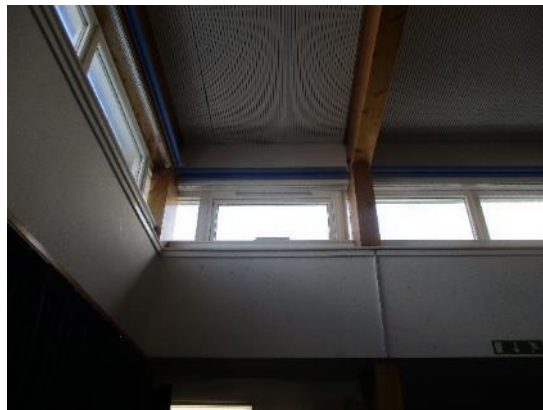
241. Electric windows 1/5 block 2.

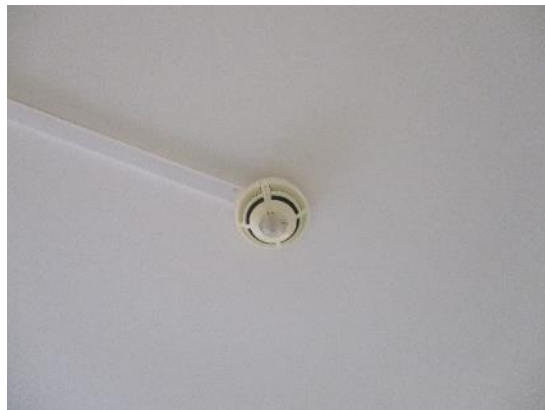
- The air conditioning systems in rooms kitchen 1/3, classes 1/13 and 1/15 are in poor condition and approaching the end of their useful life.
- Smoke and heat detectors in block 2 are assumed to be greater than 10 years old and therefore life expired as per CIBSE Guide M.

271. Smoke detector block 2 typical.

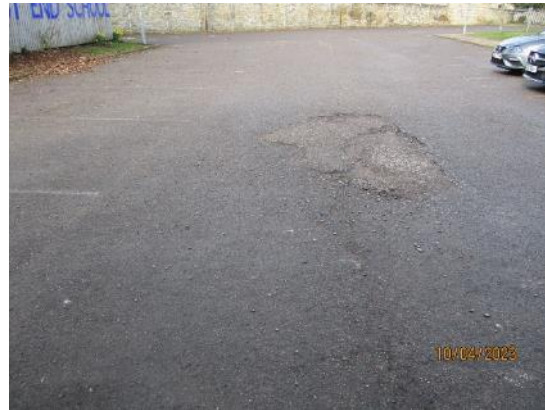
- Tarmacadam access road and car park, sunken and potholed.
- Tarmacadam playground cracked and uneven.
- Timber benches have timber rot and sections missing.
- Precast slab footpaths are broken and uneven.
- Fencing above stone walls is damaged.
- All pedestrian and vehicle entrance gates are seized.
- Stone perimeter walls are cracked, eroded and damaged.
- All surface water drainage to the car park and playground are blocked.
- The roof of the playground shelter is in poor condition, woodworm, slipped slates, water ingress etc.

301. Tarmacadam car park

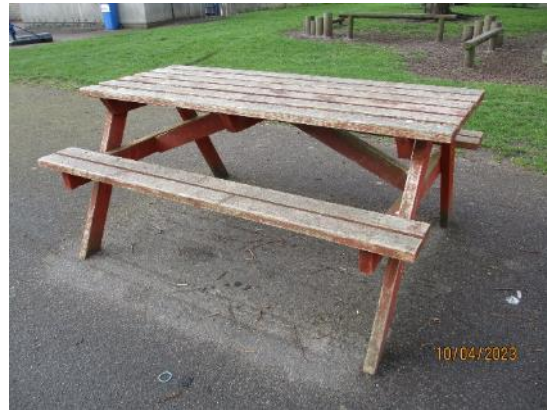
307. Timber benches and tables

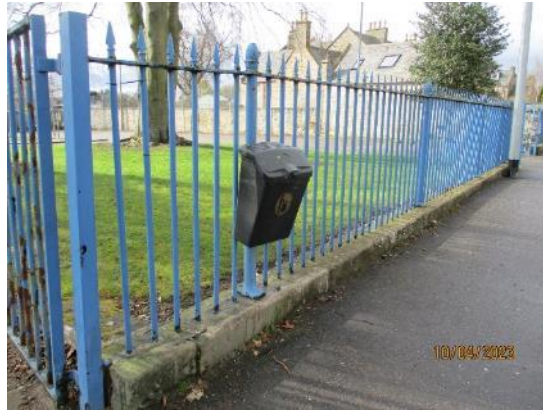
311. Metal railings

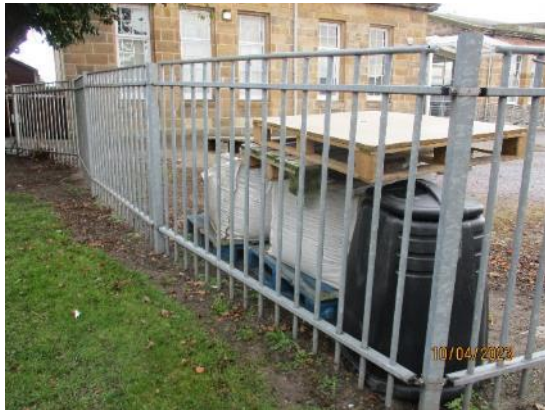
312. Galvanised bar fencing

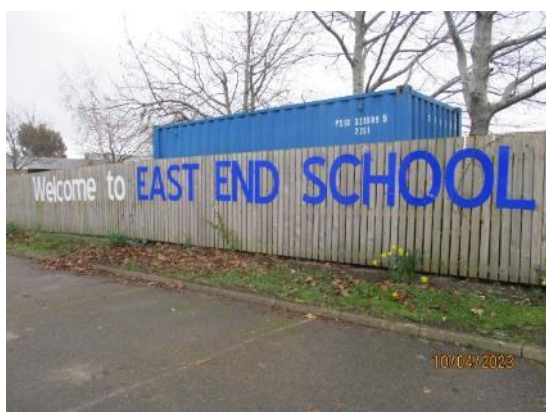
316. High timber board fencing

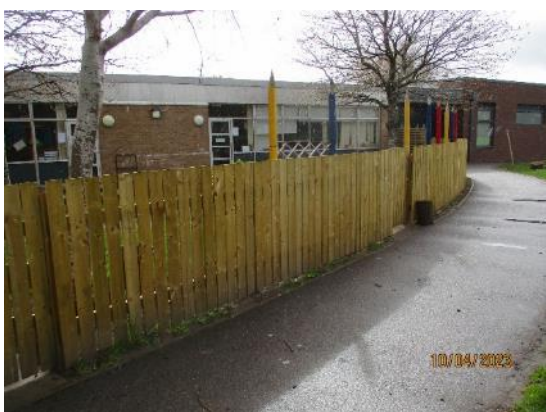
318. Low timber board fencing

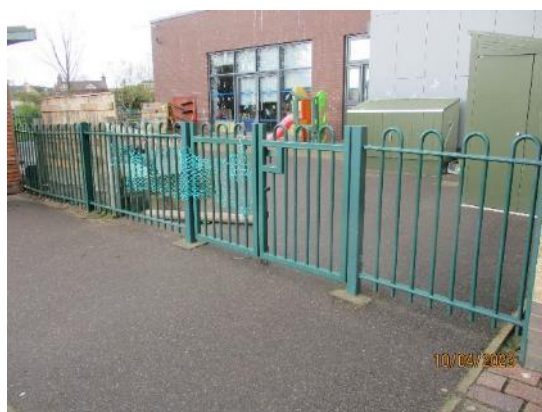
319. Tubular railings

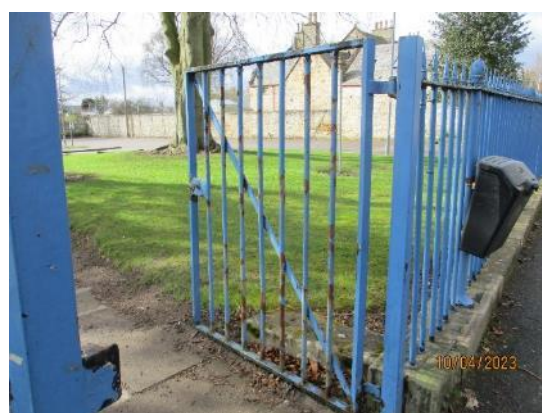
321. Personnel gates (seized)

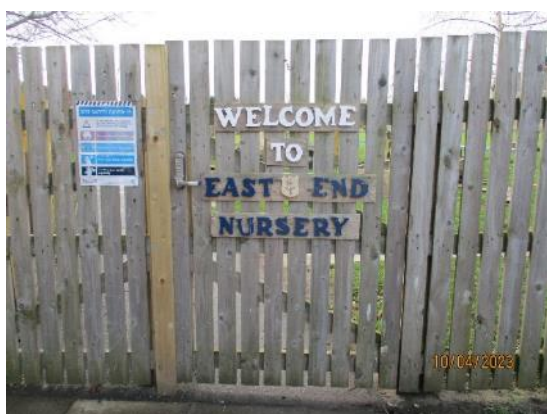
322. Timber boarding gates

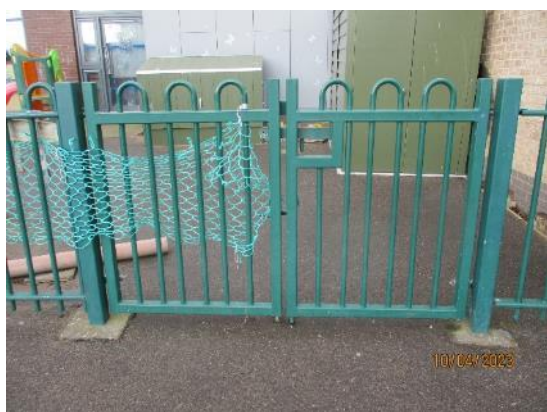
324. Tubular railing gates

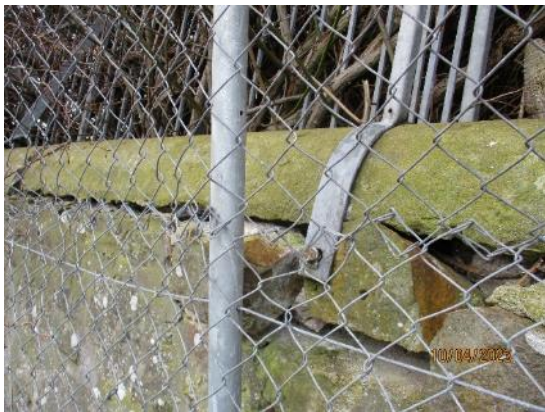
330. Insecure masonry

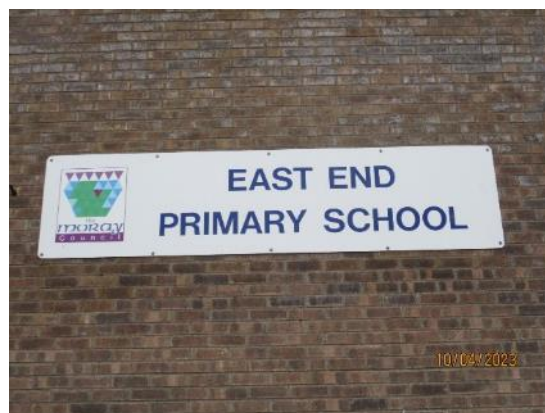
333. School signage

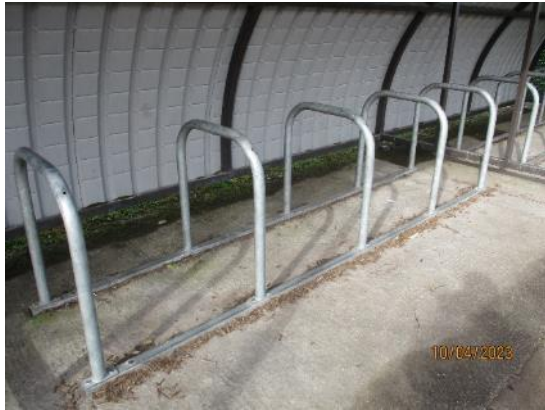
340. Cycle hoops within bike shelter

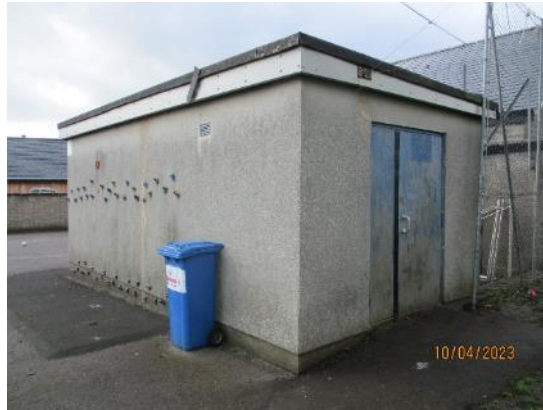
341. Games store

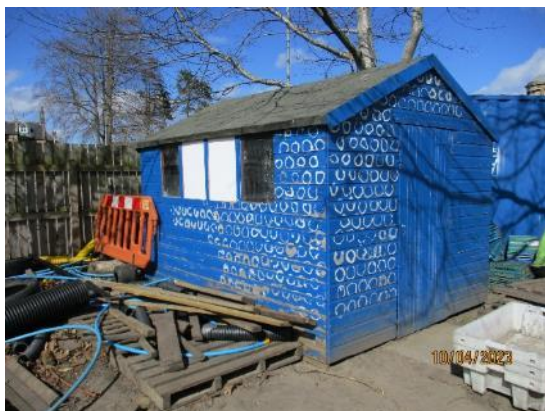
344. Nursery timber sheds

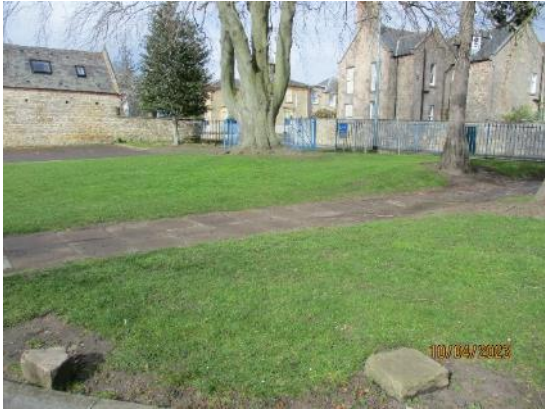
348. Trees and grass landscaping

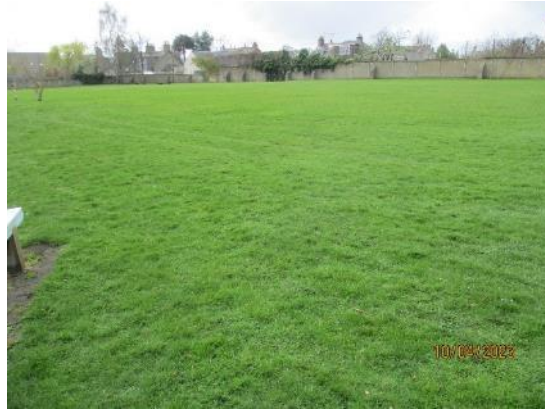
349. Grass sports field
