# **Summary Building Condition Survey Report**

**Seafield Primary School  
Deanshaugh Terrace, Elgin IV30 4ES**

**24<sup>th</sup> to 26<sup>th</sup> May 2023**

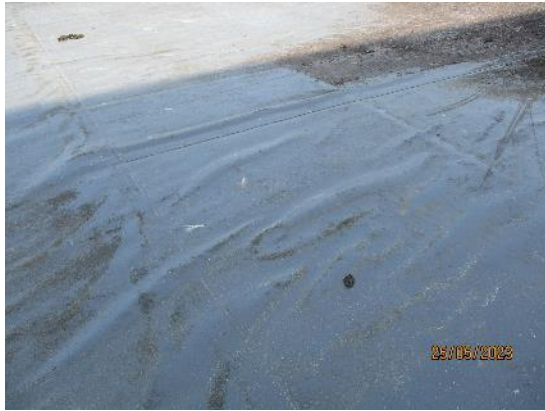
3. Single ply wrinkled in places

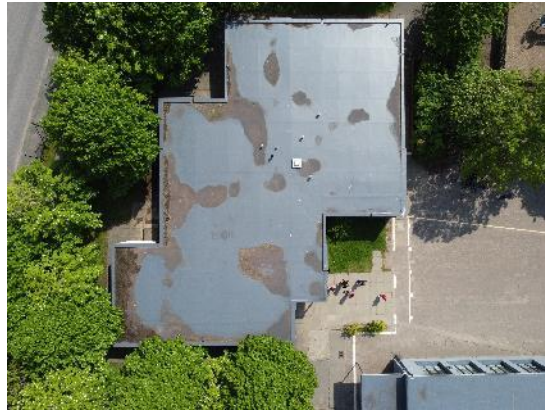
4. The Hub overview, dark patches are silt

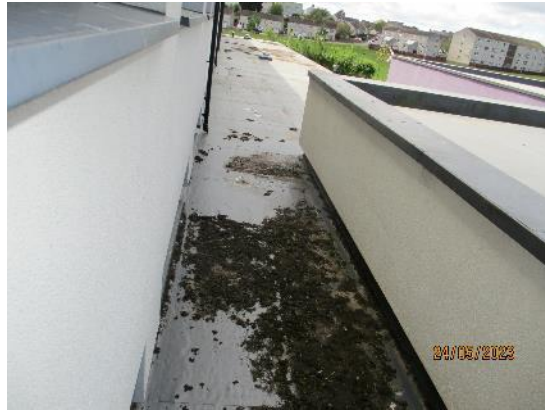
14. Moss and vegetation

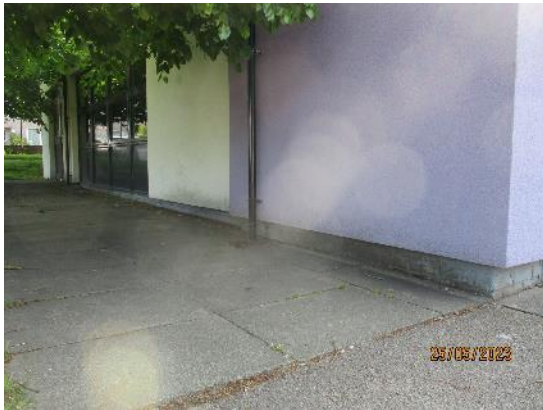
45. The Hub – ground levels

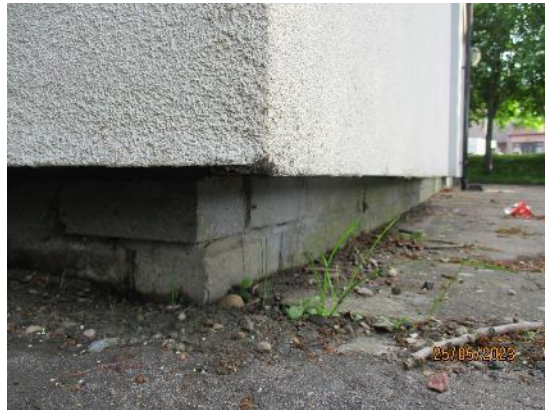
46. Projecting external insulation

- Protection of the external insulation is recommended in the car park area.
- Consider additional bird deterrents, 4 gull nests found on roofs.
- Confirm operational condition of bird scarer on nursery roof.

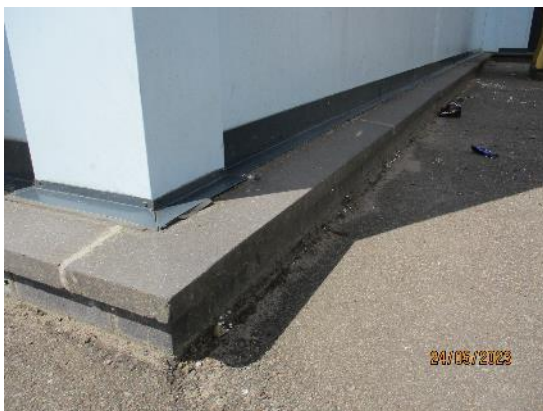
47. The Nursery platt and ground levels

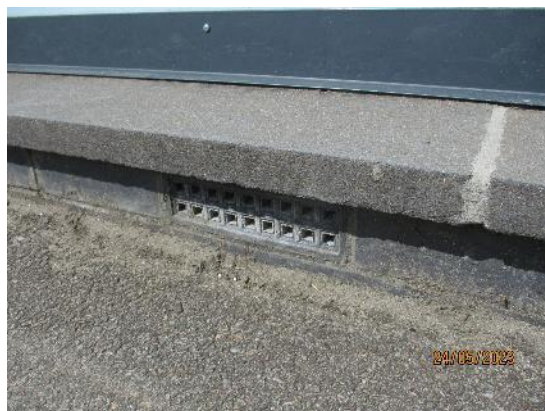
48. Underfloor/frame ventilation

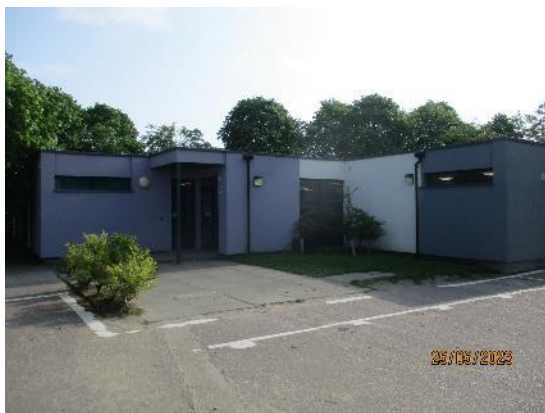
53. External insulation to The Hub

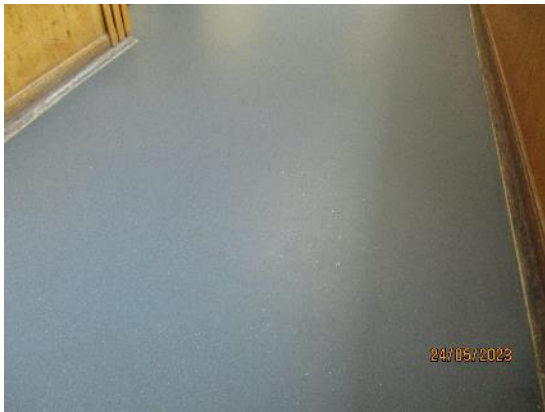
85. Sheet vinyl in school

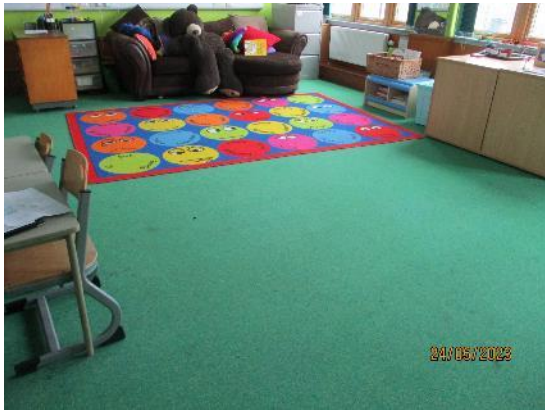
87. Carpets in school

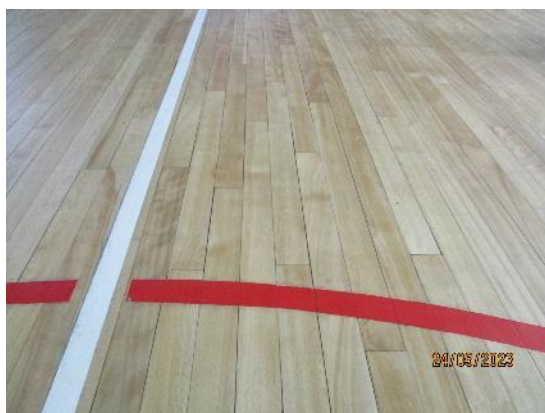
89. Timber boarded sports floor

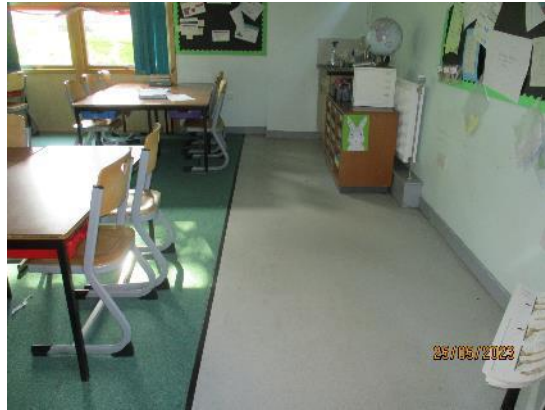
92. Sheet vinyl flooring in The Hub

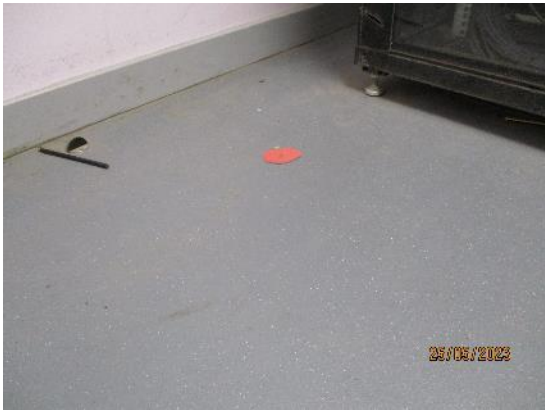
93. Surface scuffs

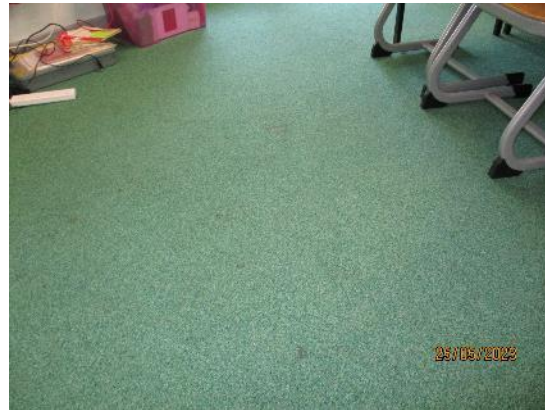
94. Carpet flooring in The Hub

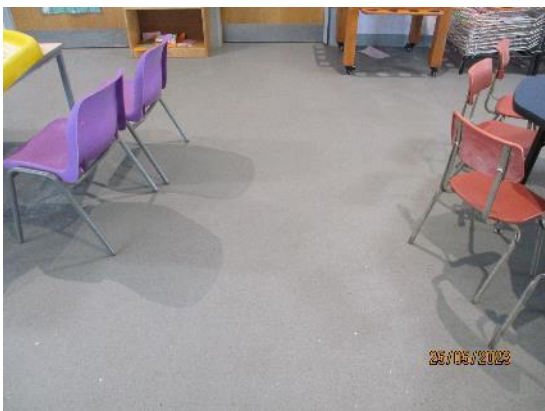
95. Sheet vinyl in Nursery

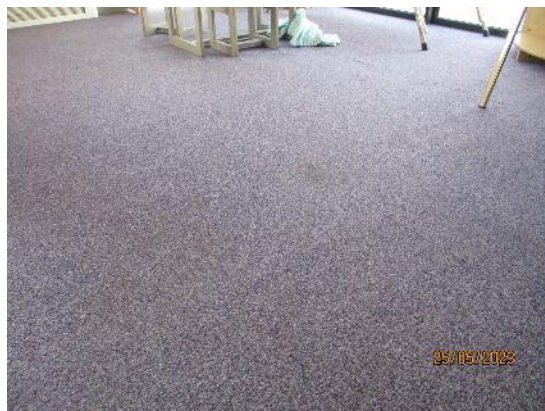
96. Carpet flooring in the Nursery

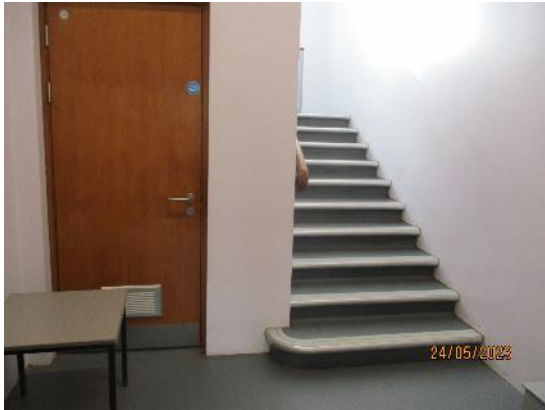
97. Concrete staircases

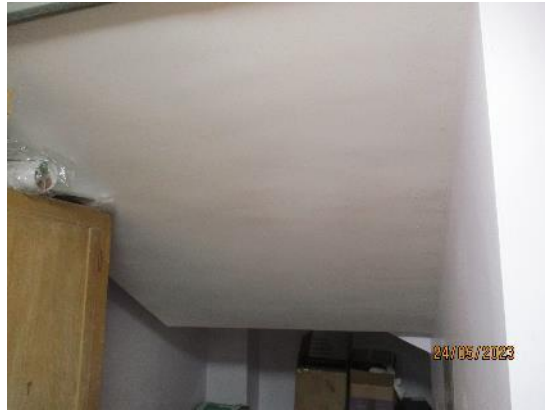
98. Plastered soffits

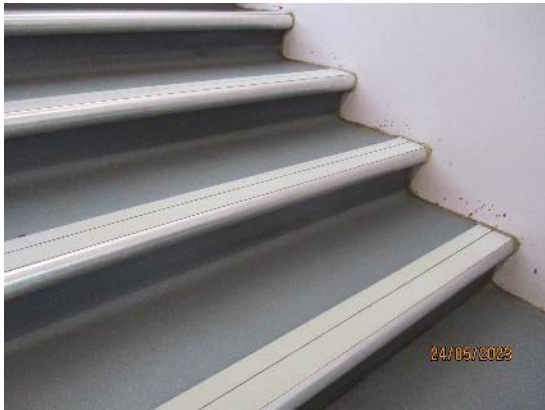
99. Sheet vinyl treads and risers

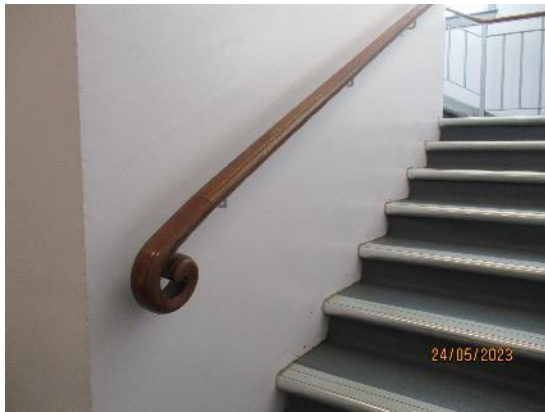
103. Timber handrails

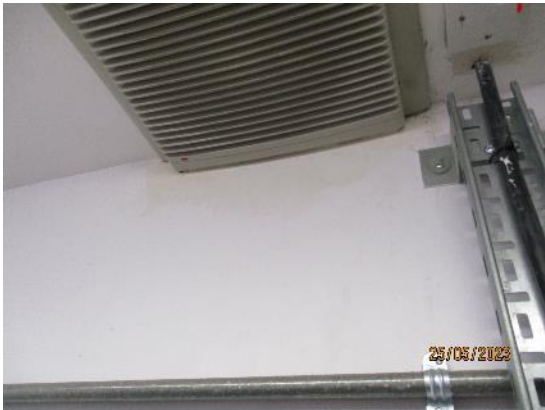
110. Plasterboard walls

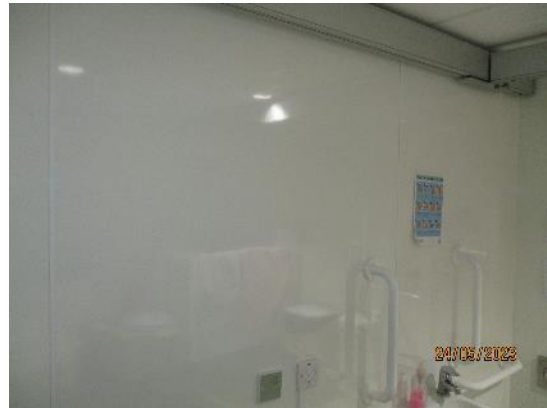
117. Wetwall in some toilet areas

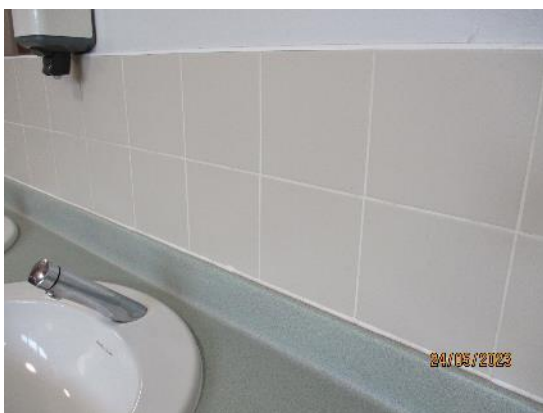
118. Ceramic tile splashbacks

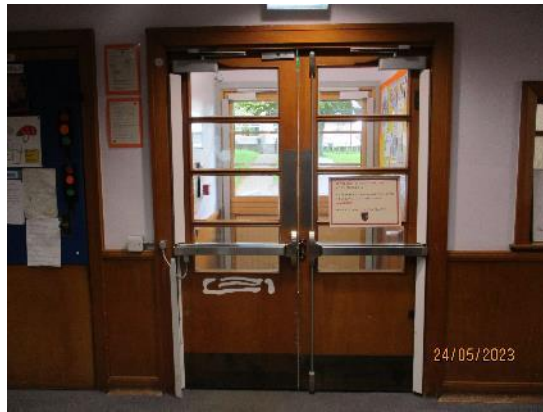
- The original timber internal doors are reaching the end of their useful life.
- Steel structure below the stage has considerable surface corrosion.
- Several carpets are soiled and stained.

127. Older timber double doors

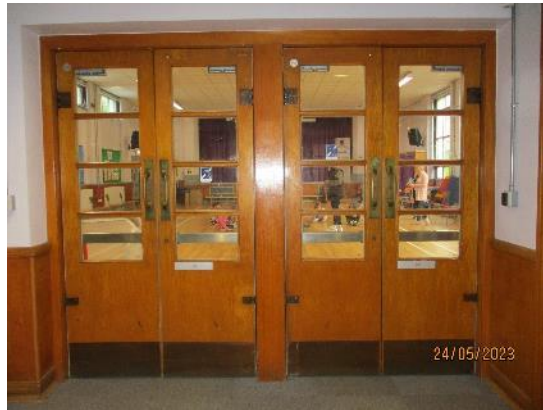
129. Traditional double swing doors

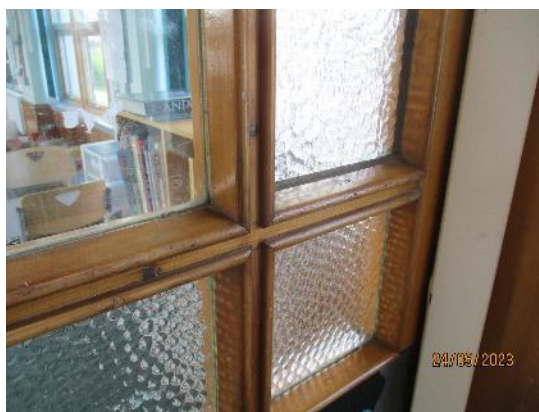
133. Various glazing panels

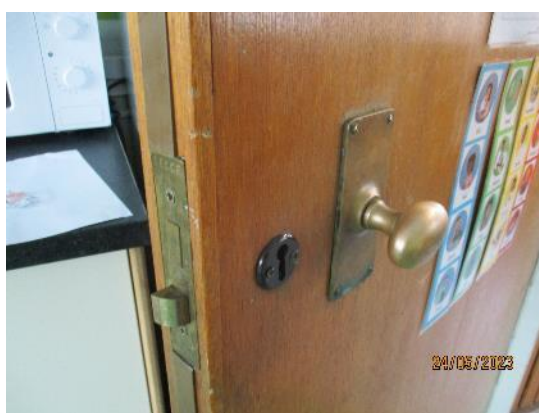
137. Traditional brass ironmongery

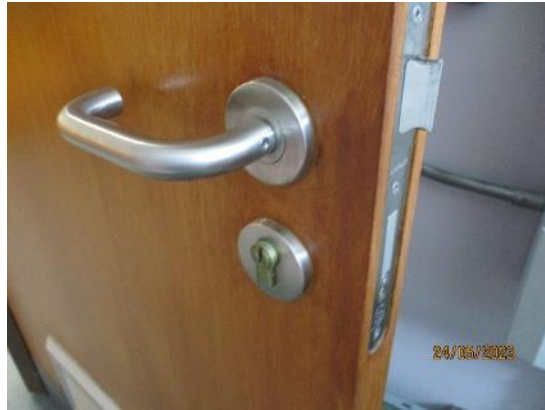
139. Aluminium ironmongery

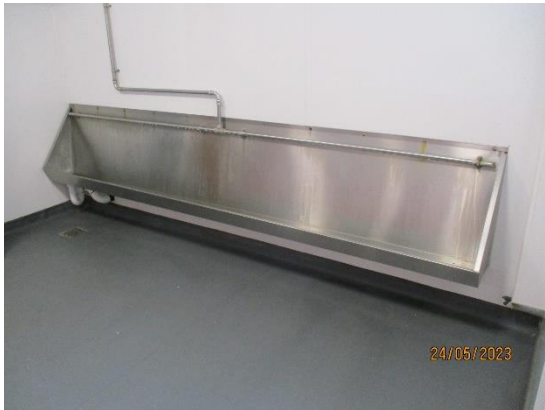
140. Stainless steel trough urinal

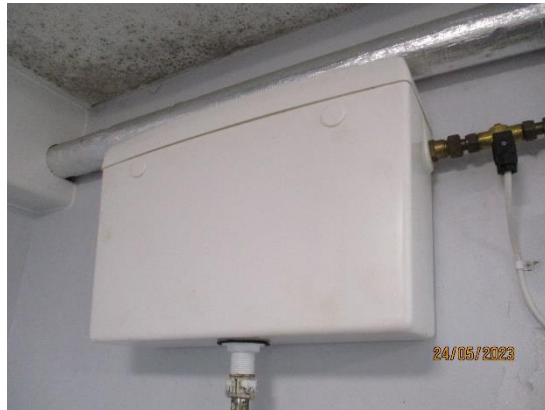
141. PVC cistern

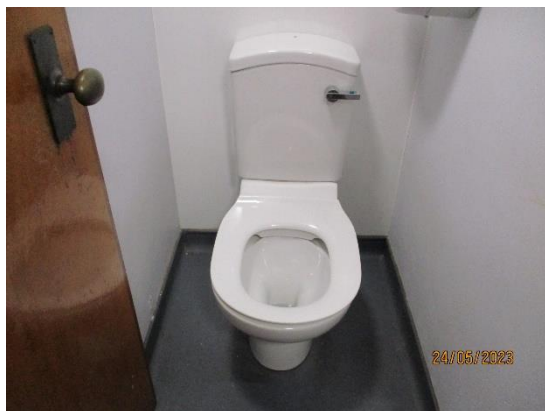
142. School WC

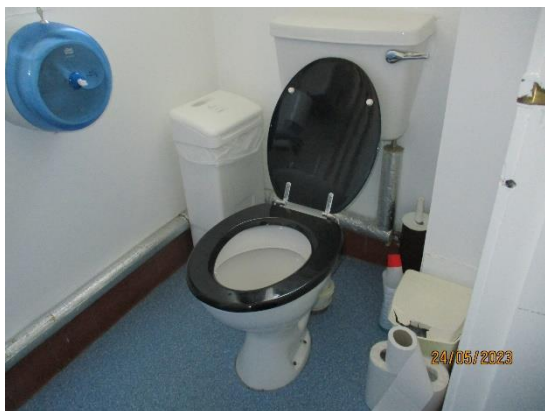
143. Staff WC

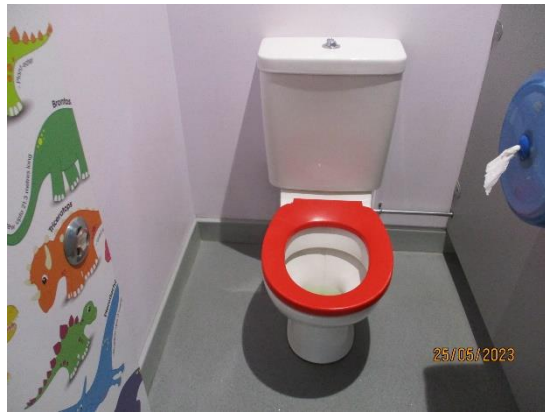
145. Nursery WC

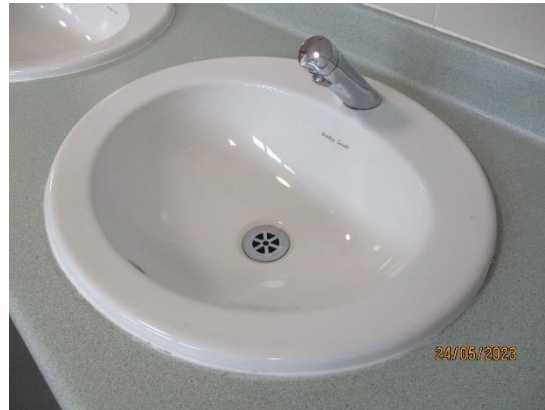
147. China vanity basin

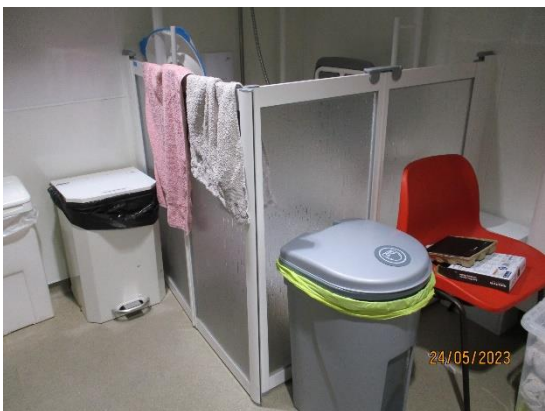
148. Accessible shower enclosures

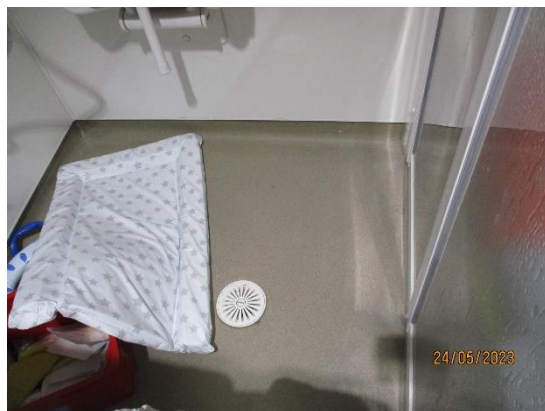
149. Sheet vinyl shower tray

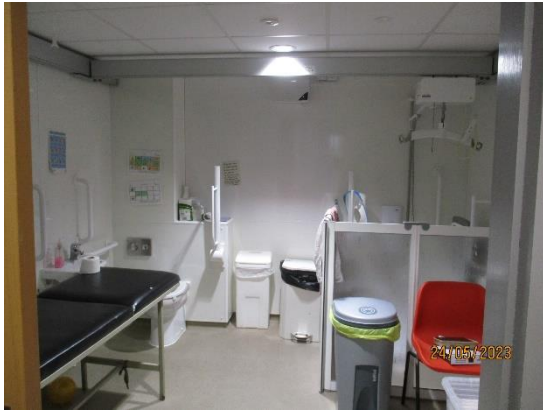
150. Accessible toilets

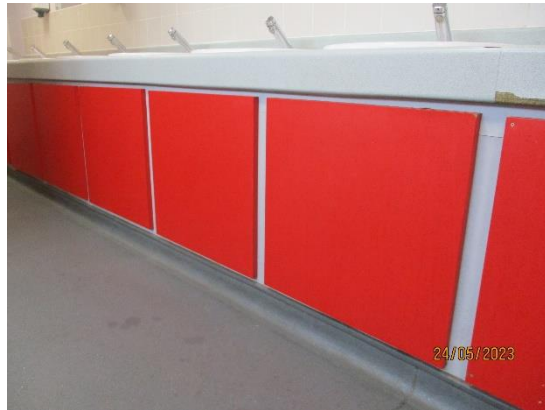
153. Composite vanity units

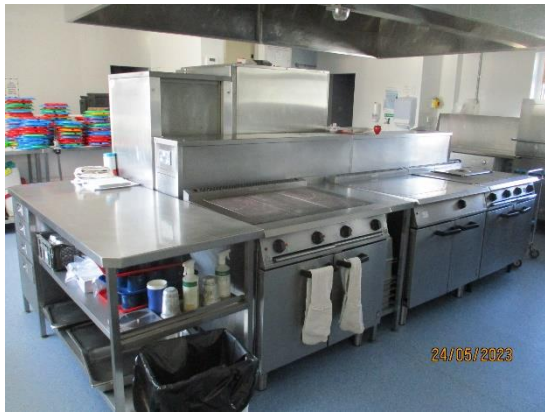
156. Commercial kitchen

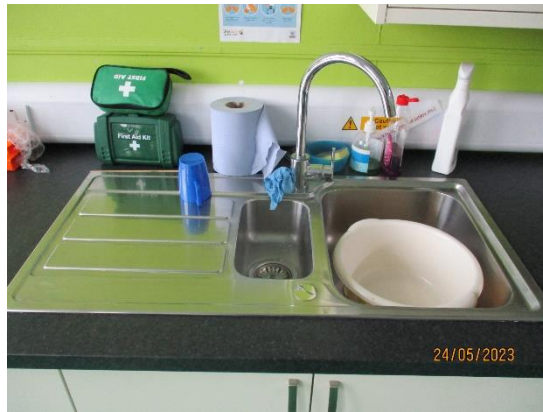
157. Stainless steel kitchen sinks

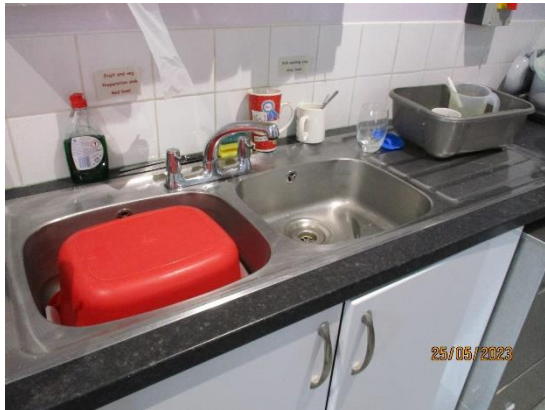
158. Double bowl stainless steel sinks

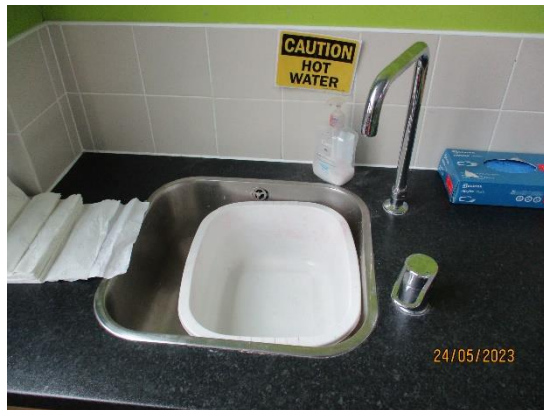
159. Stainless steel inset sinks

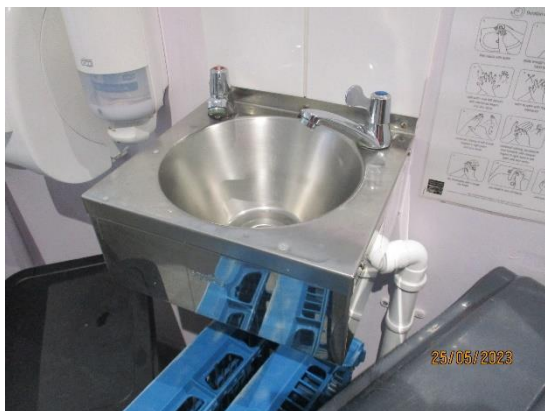
160. Stainless steel wash hand basin

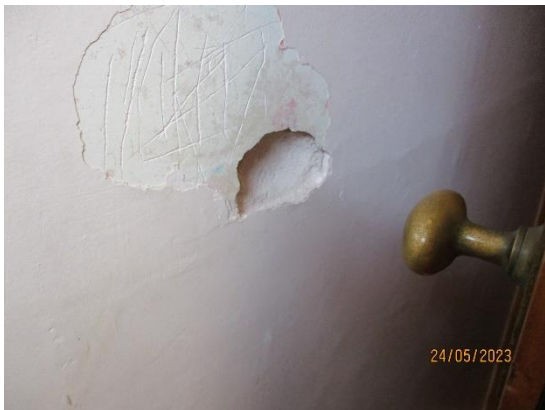
163. Plastered walls

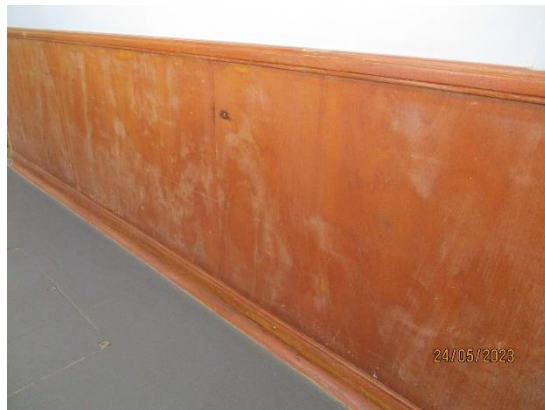
164. Timber panelling

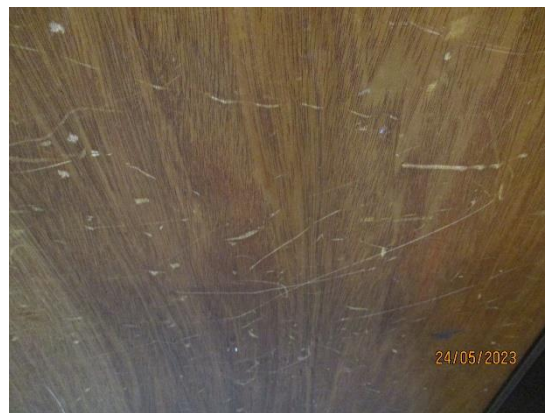
166. Timber doors

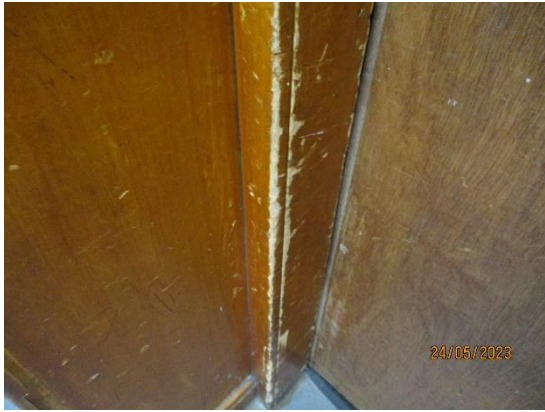
167. Timber joinery items

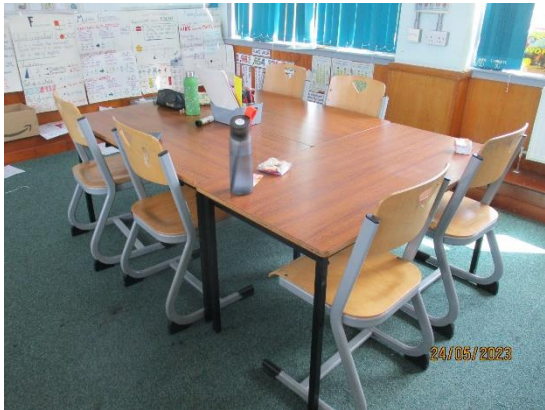
168. Classroom desks and chairs

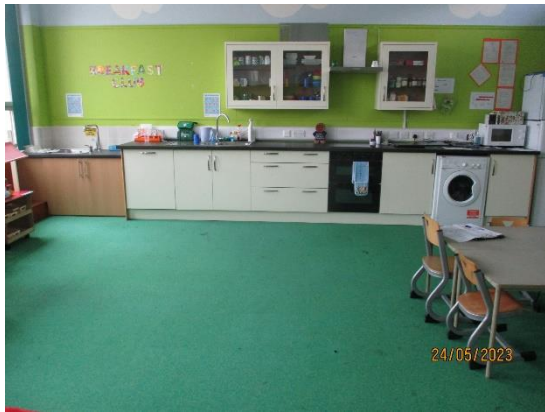
172. Kitchen units

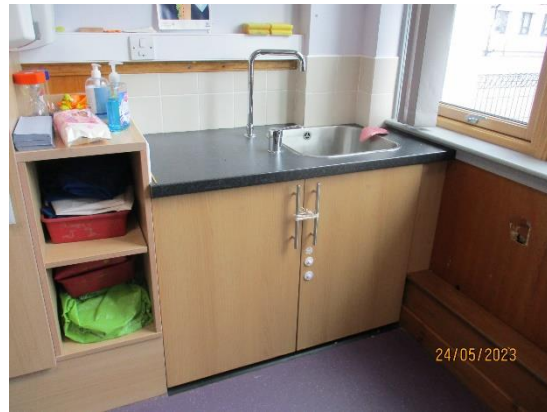
173. Sink base units

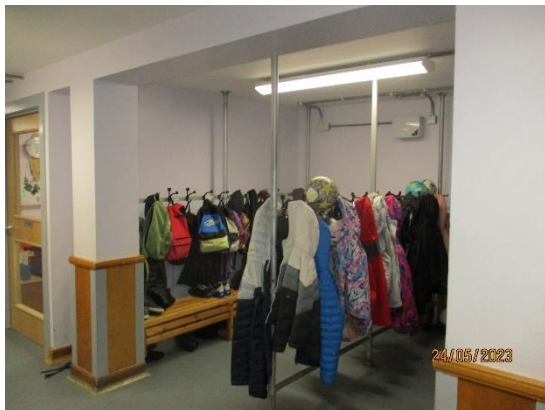
174. Cloakrooms

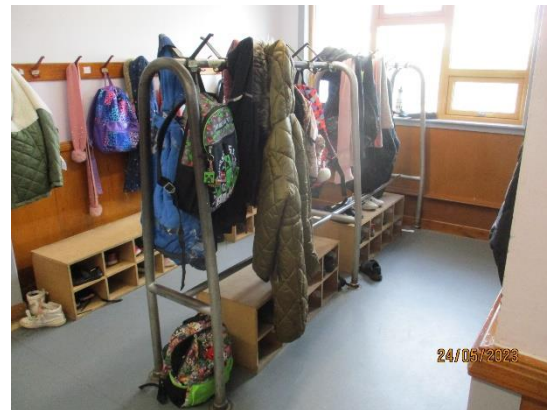
175. Coat hook rails

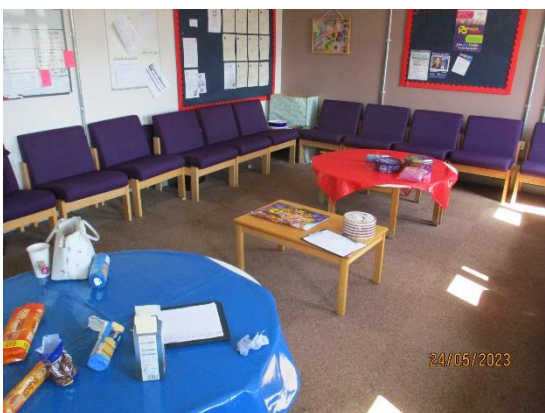
176. Staff room furniture

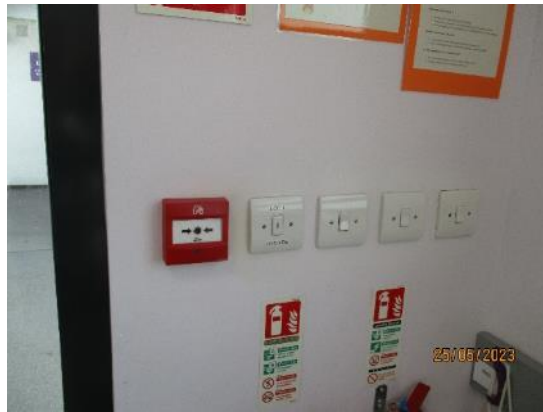
208. Wiring accessories – main school.

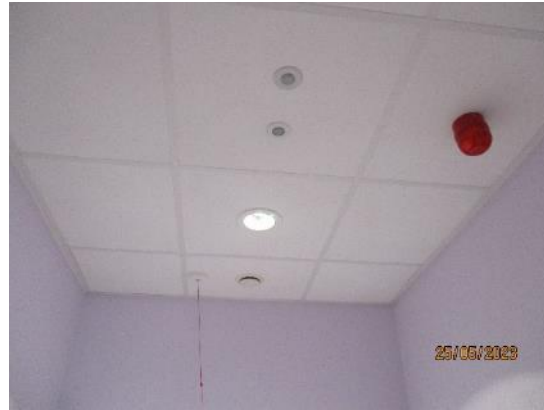
221. Lighting – modular nursery toilet typical.

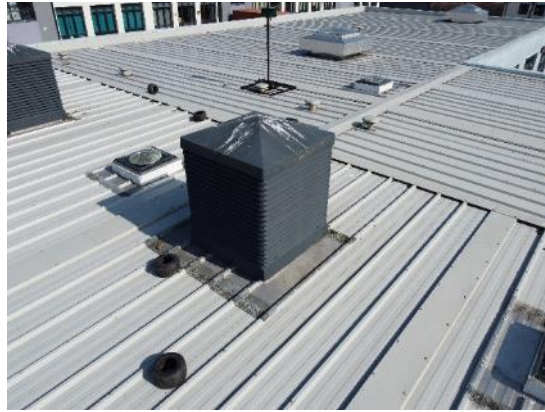
233. Passive windcatcher units – modular nursery.

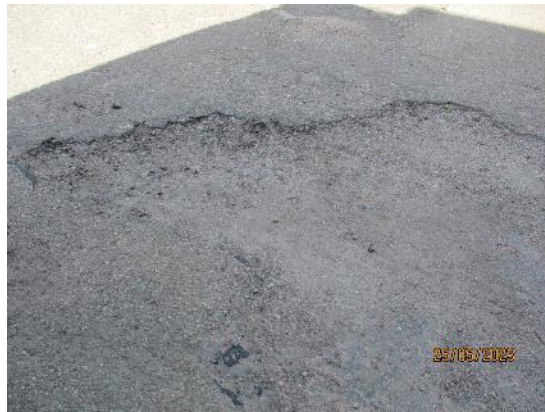
239. Tarmacadam potholed

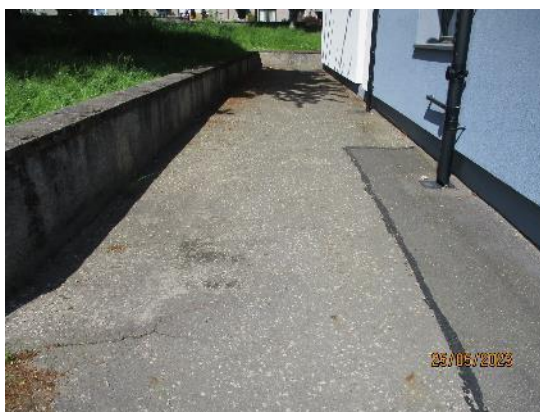
245. Tarmacadam footpaths

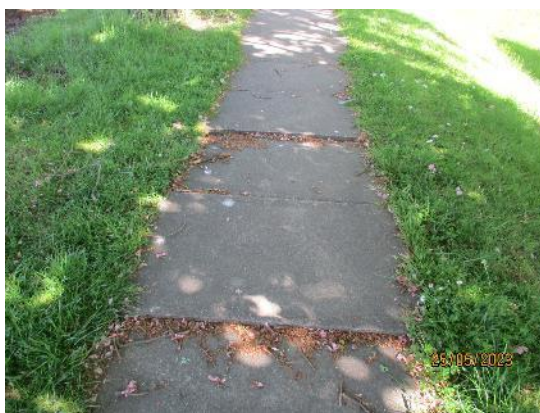
249. Uneven slabs

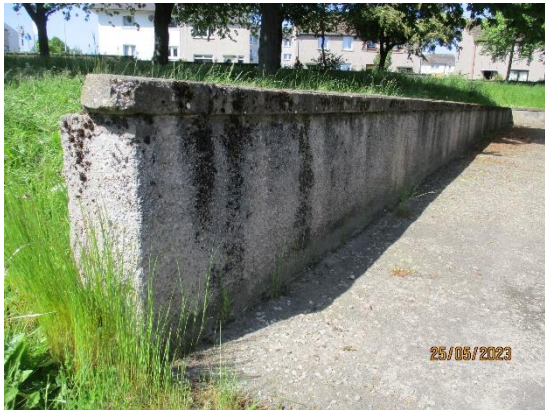
270. Brick and roughcast walls

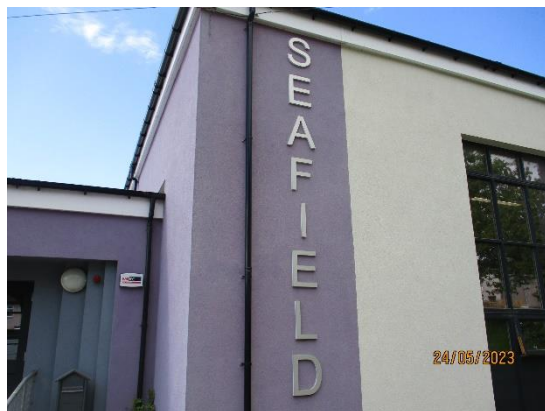
273. School signage

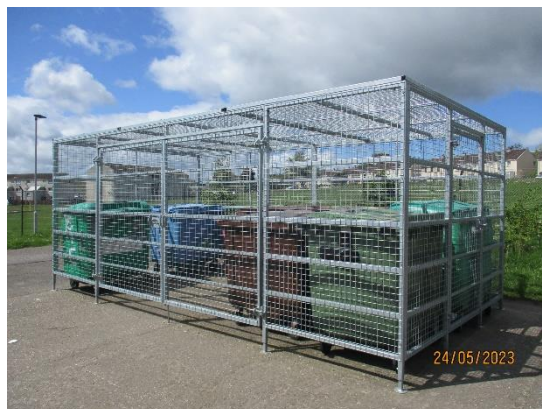
277. Caged bin enclosure

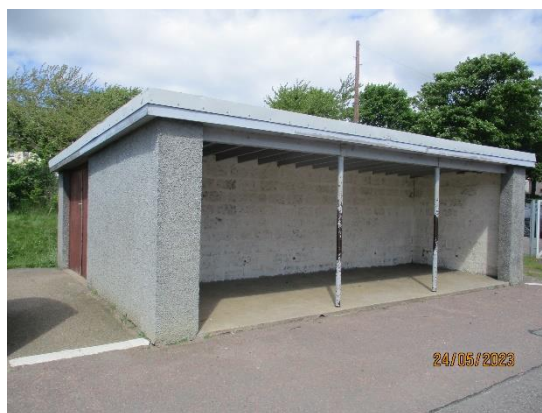
279. Playground shelter and garage

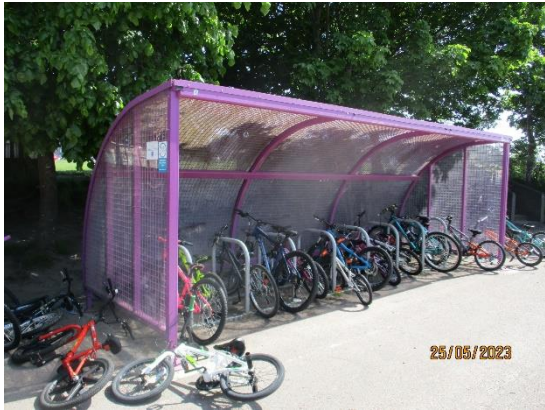
280. Bike shelter

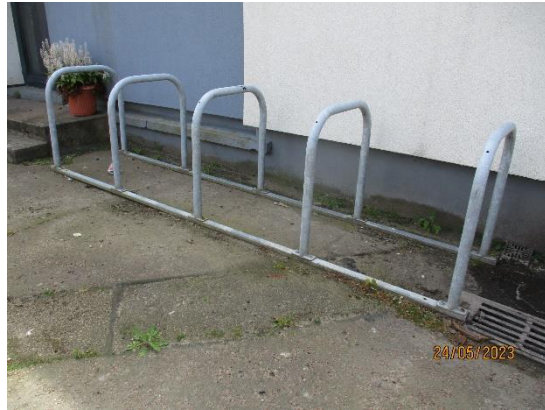
281. Cycle hoops

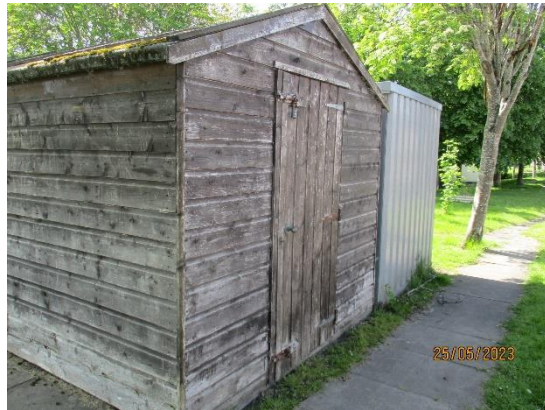
283. Timber sheds

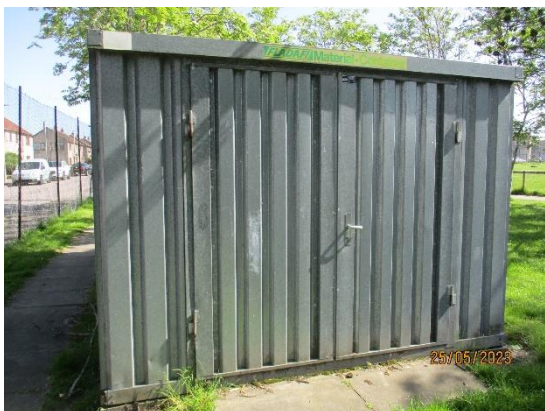
284. Steel sheds

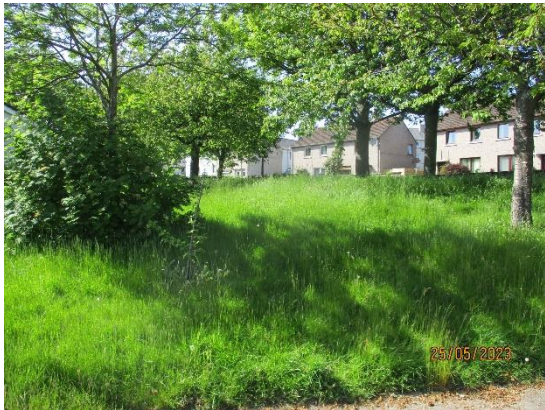
288. General landscaping
