# **Summary Building Condition Survey Report**

**St Sylvesters Primary School  
Abbey Street, Elgin IV30 1DA**

**26<sup>th</sup> & 27<sup>th</sup> June 2023**

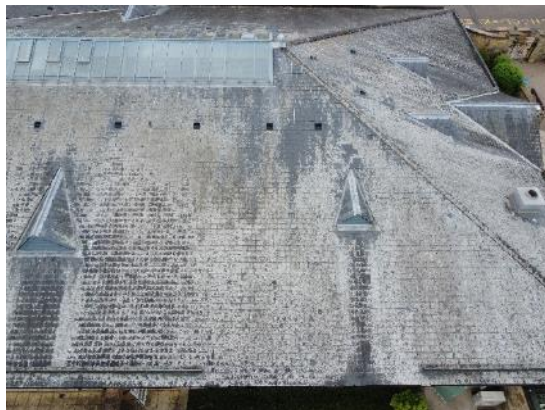
9. Lichen on the surface of slates

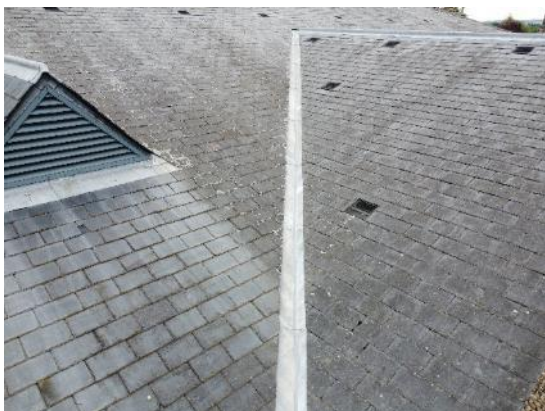
11. Lead valley gutters

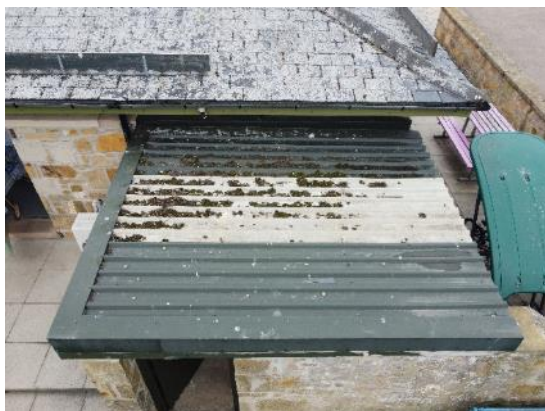
12. Metal profile flat roof (external store)

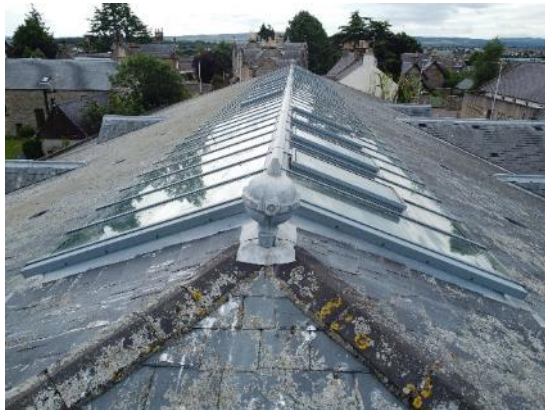
15. Lead ball finials

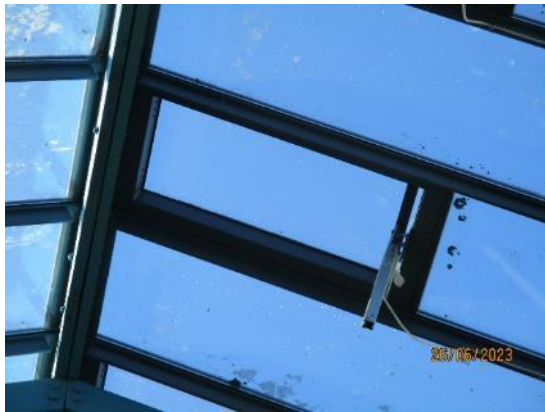
19. Electrically operated skylights

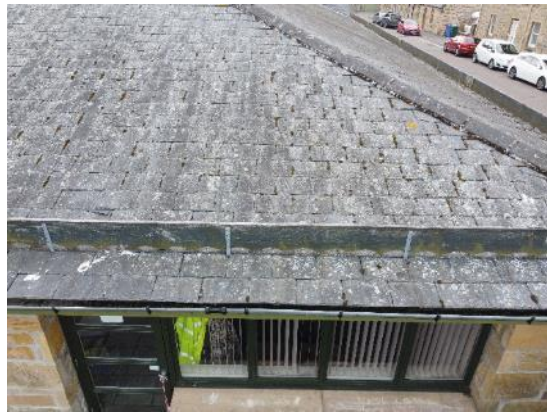
20. Timber snowboards

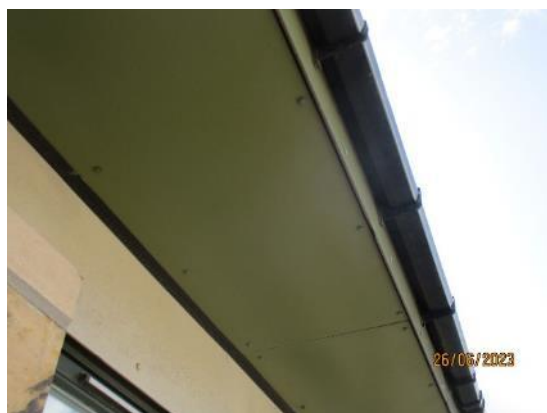
24. Composite fascia & soffit boards

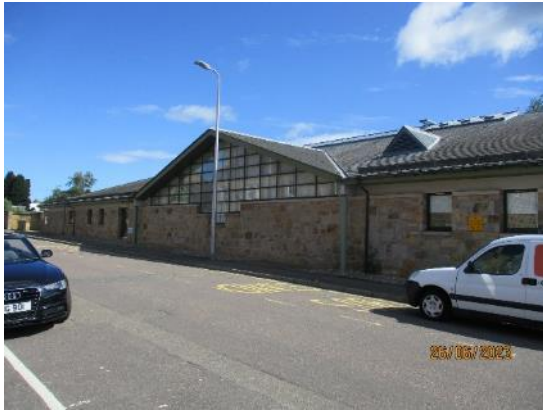
31. Natural stone external walls

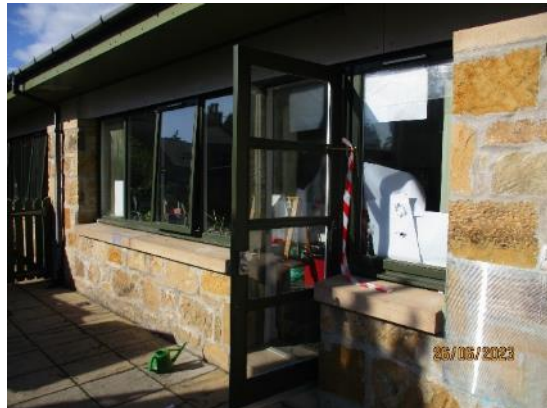
34. Timber glazed fire escape doors

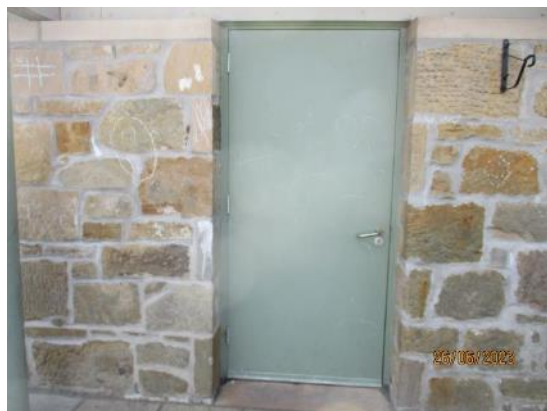
36. Solid core timber doors

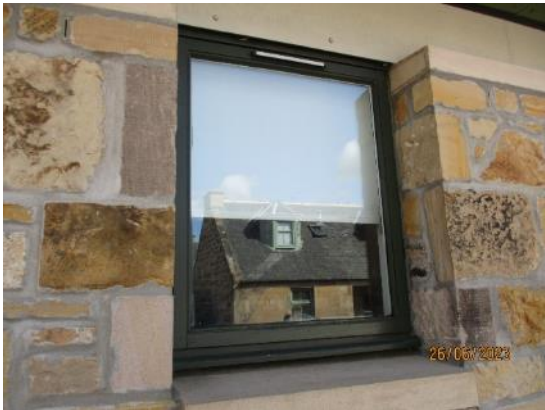
39. Top hung timber windows

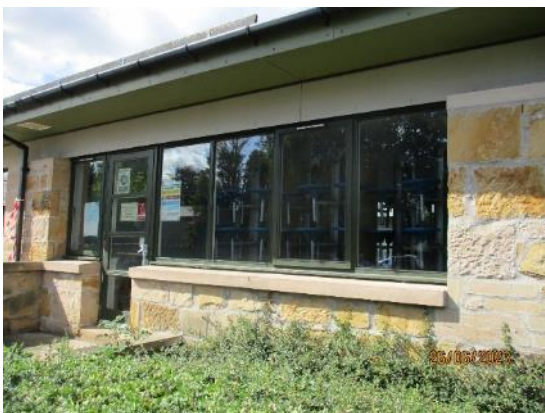
41. Typical series of windows

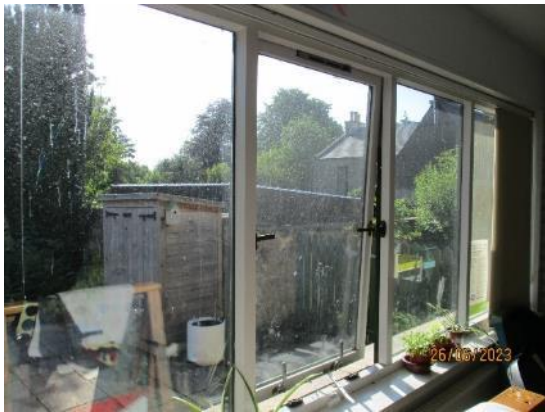
43. Windows internally

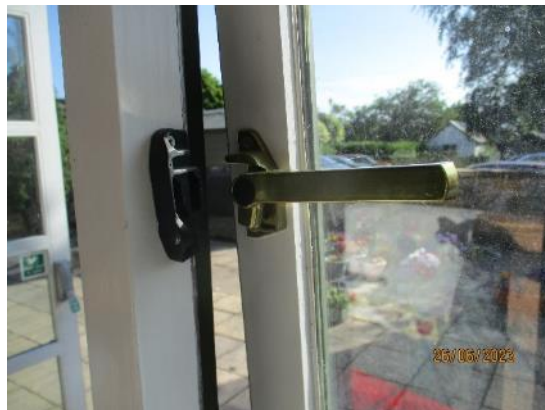
46. Aluminium lever handles

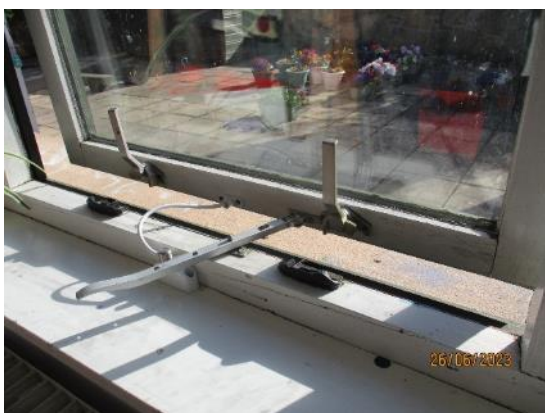
47. Additional window stays

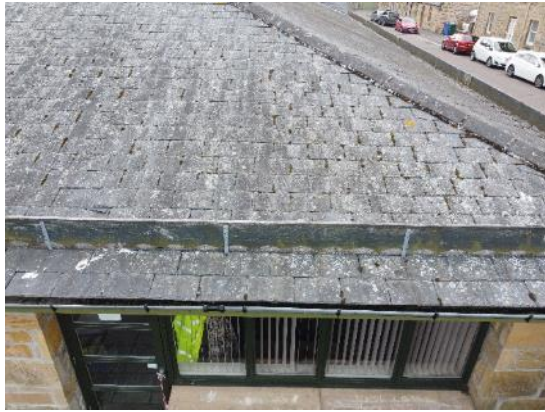
48. Snow boards

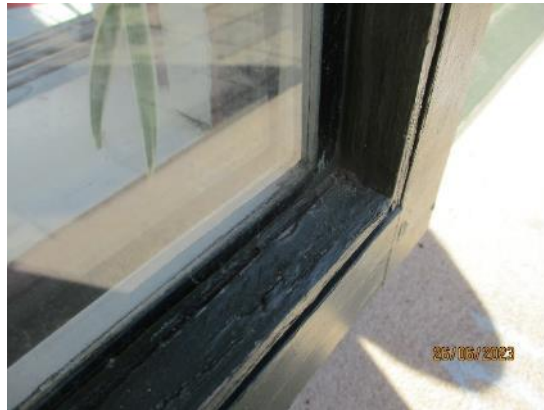
51. Timber windows

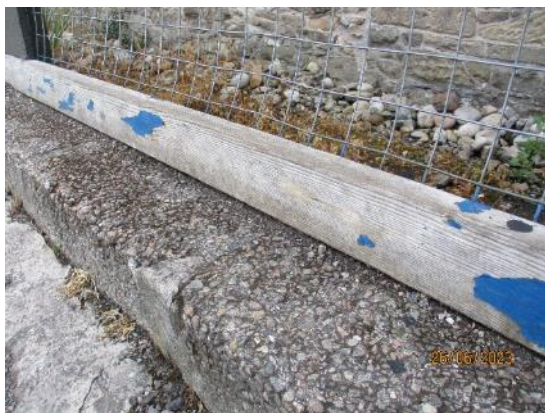
52. Timber fencing

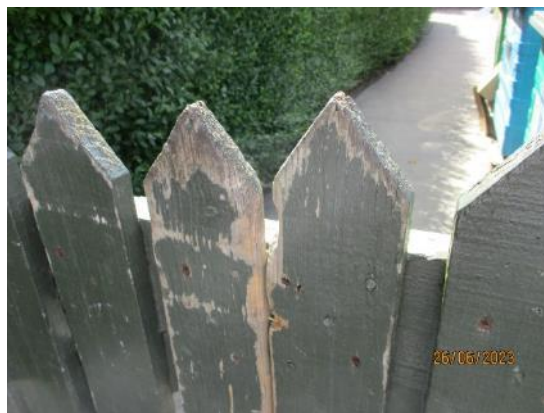
53. Timber gates

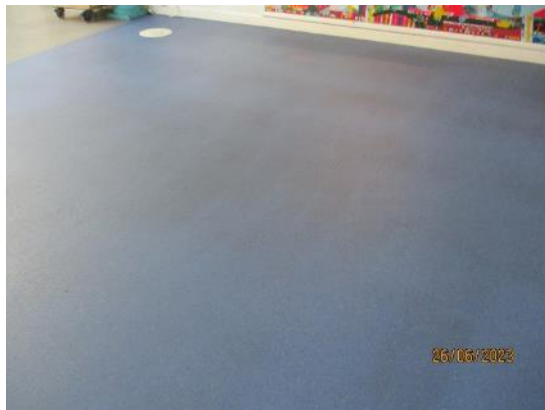
56. Sheet vinyl - soiled

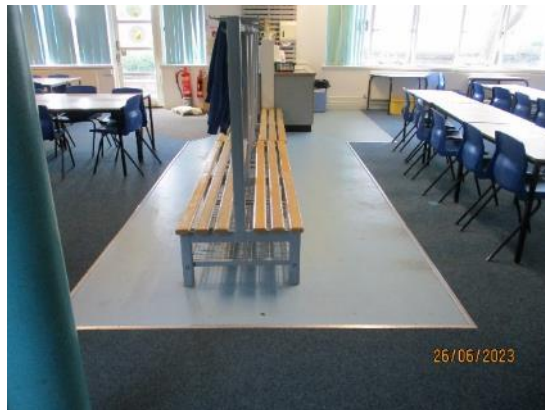
57. Sheet vinyl to wet areas

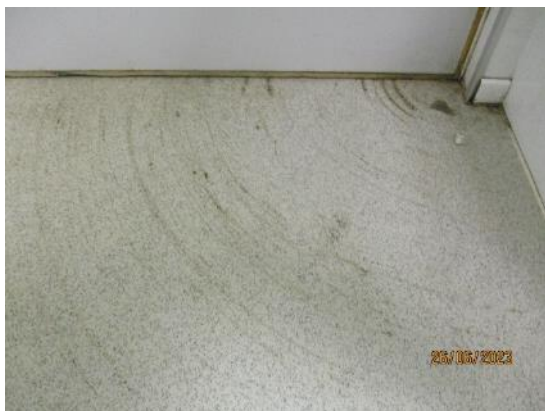
58. Scuffed sheet vinyl

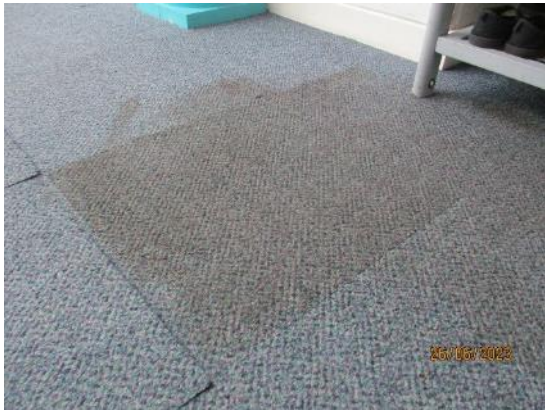
62. Carpet tiles soiled

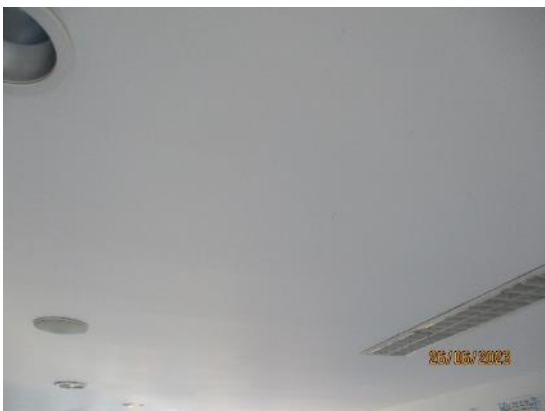
69. Plasterboard ceilings

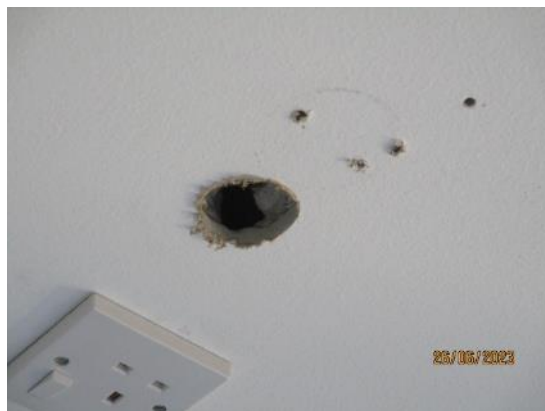
70. Previous fixings removed

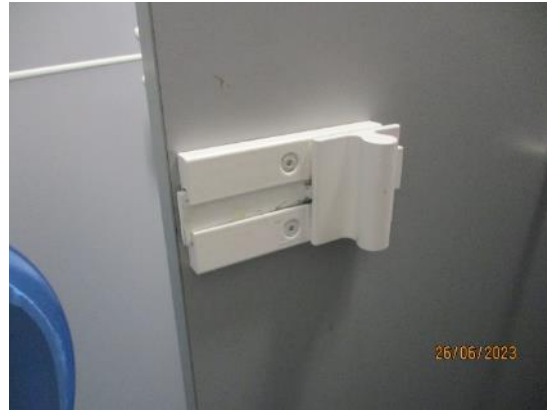
112. Edging coming loose

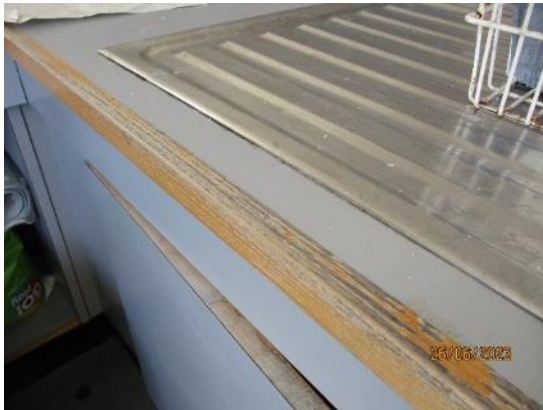
129. Worn worktops

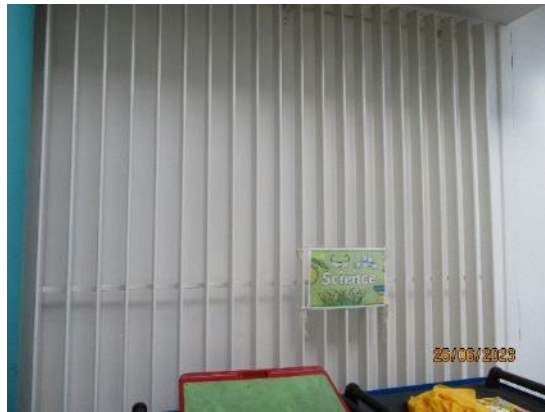
141. Radiator heating system typical 1/11

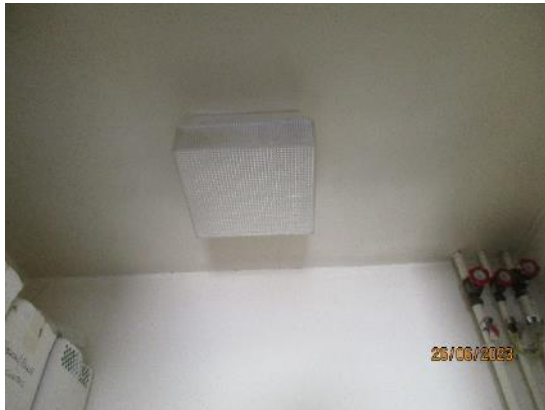
148. Gas pipework – kitchen supply attic space.

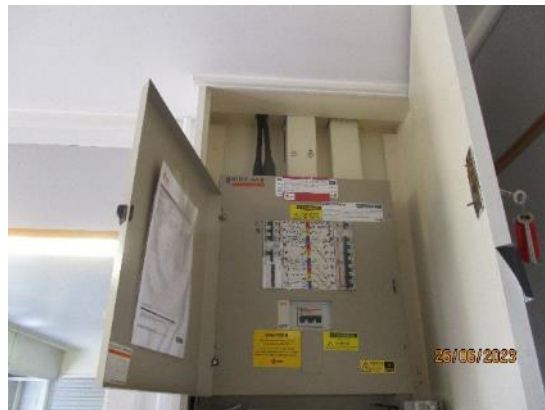
160. DB – emergency lighting 1-11a

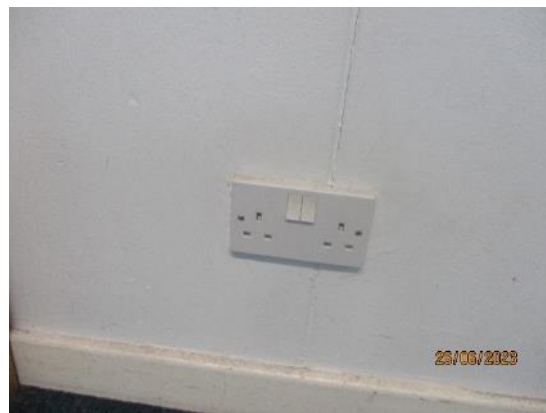
163. Floor socket compartment boxes 1-11

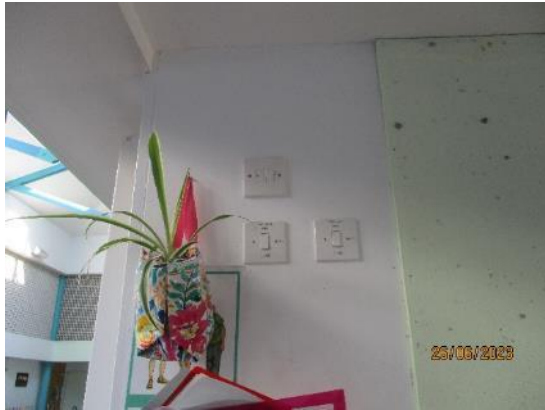
164. Wall mounted flush socket typical.

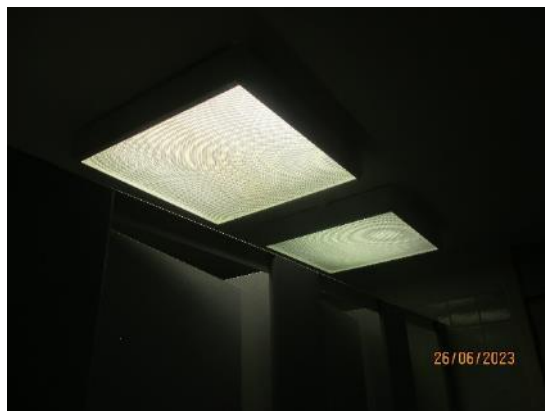
169. Lighting – stores typical.

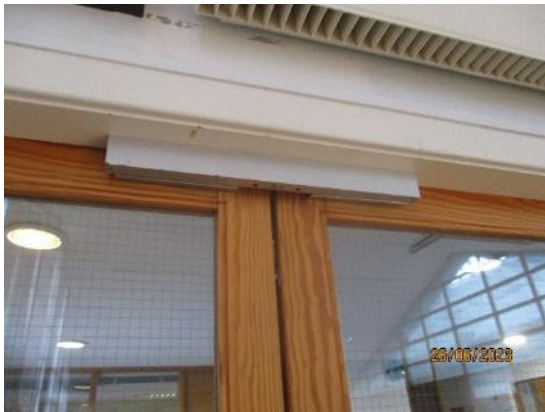
183. Security door electro magnet unit typical.

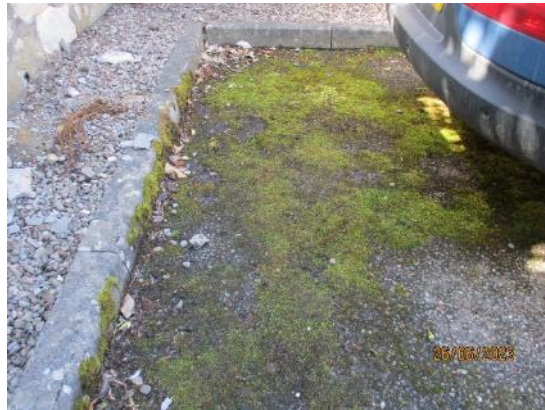
192. Surface moss and vegetation
