# **Summary Building Condition Survey Report**

**West End Primary School  
Mayne Road, Elgin IV30 1PA**

**12<sup>th</sup> & 13<sup>th</sup> July 2023**

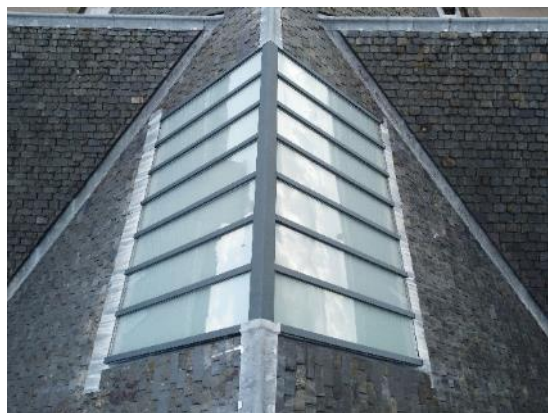
24. Large skylight above Games Hall

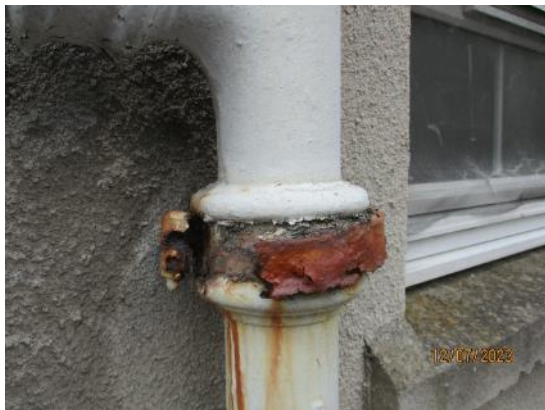
52. Cracked, leaking downpipes

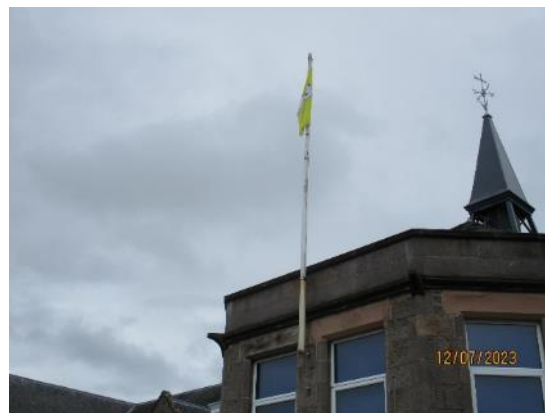
61. Corroded flag pole brackets

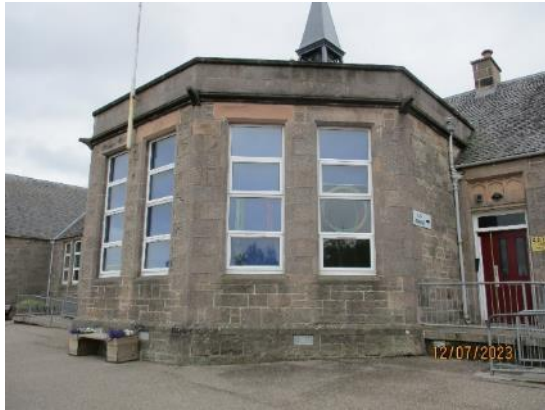
79. Isolated pointing required

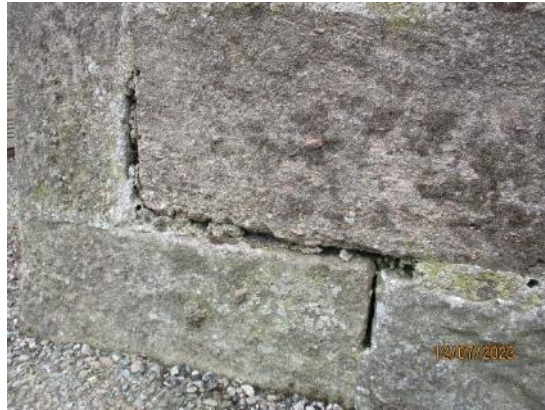
- Clay ridge and hip pieces are cracked and have missing pointing.
- The chimney is not capped which could lead to internal dampness.
- Cast iron gutters and downpipes are cracked and leaking.
- Natural stone walls have surface erosion and some loose pointing.
- The smooth render base course is cracked and spalling.
- Ground level is too high at south corner and breaches the DPC.
- Lath & plaster ceilings have hairline cracking.

80. Surface erosion of stone walls

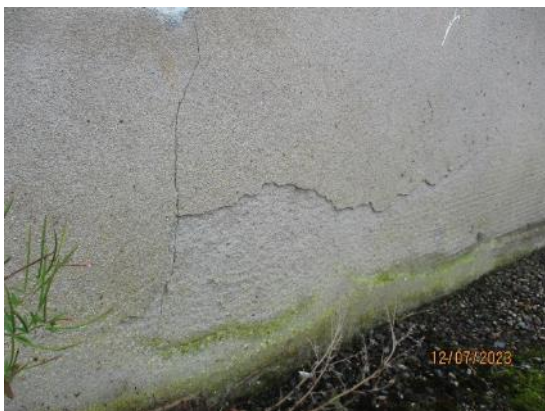
87. Spalling smooth render to Dining Hall

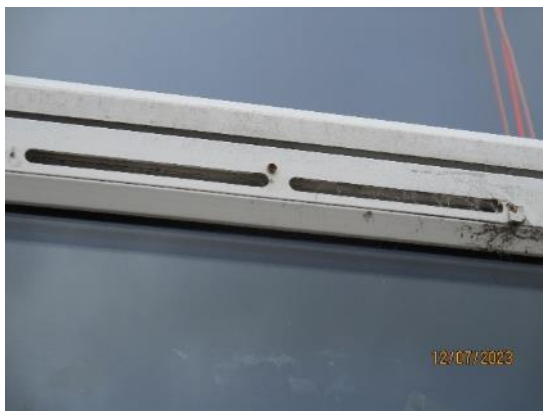
94. Large upvc windows to school

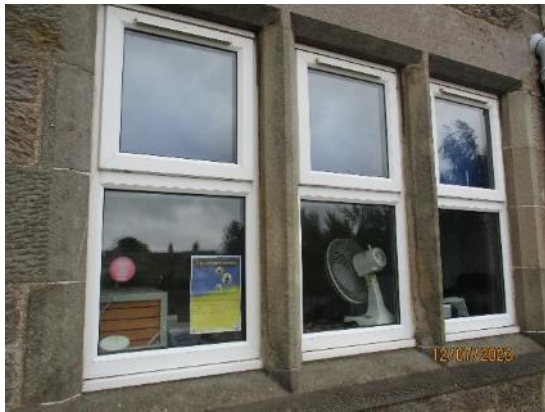
95. Isolated damage

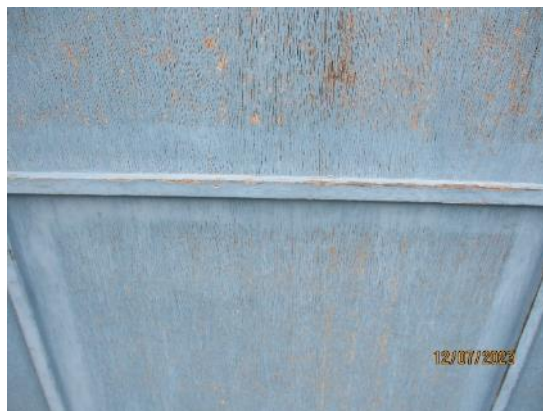
106. Peeling paint to cast iron rainwater goods

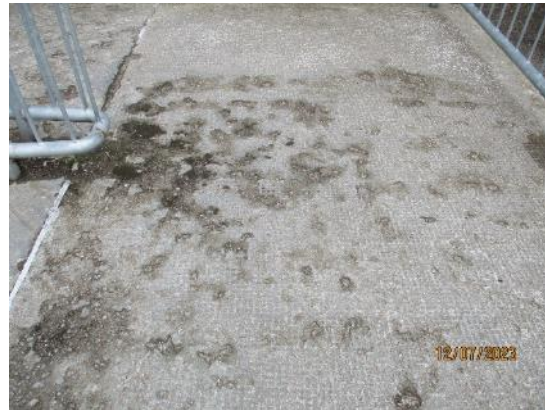
111. Surface erosion

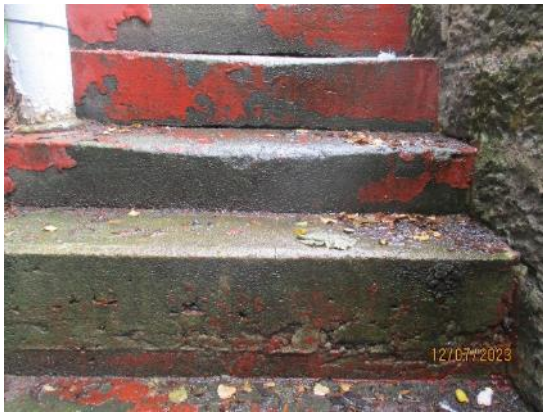
114. Irregular step height

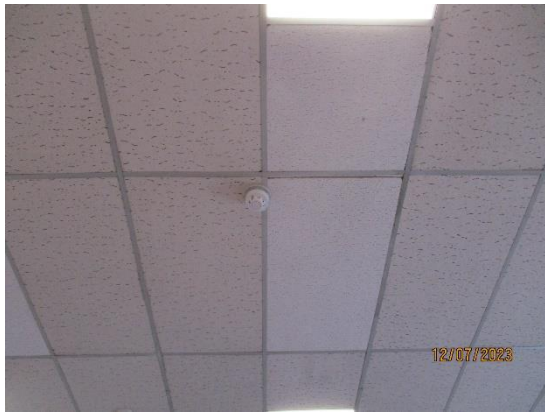
143. Dated suspended ceiling tiles

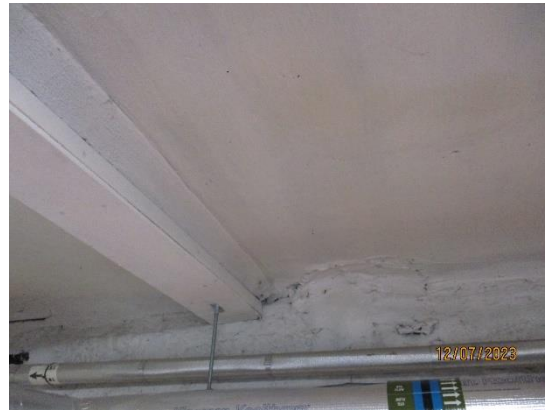
146. Plastered ceilings

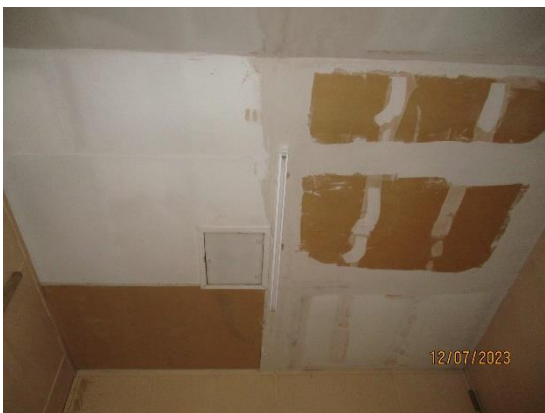
147. Fibreboard ceilings in the Hut

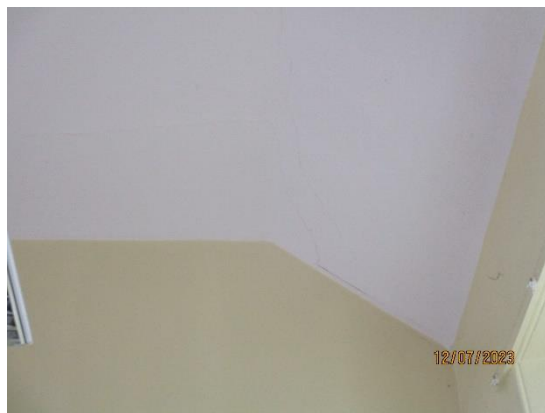
148. Dining Hall - Lath & plaster ceilings

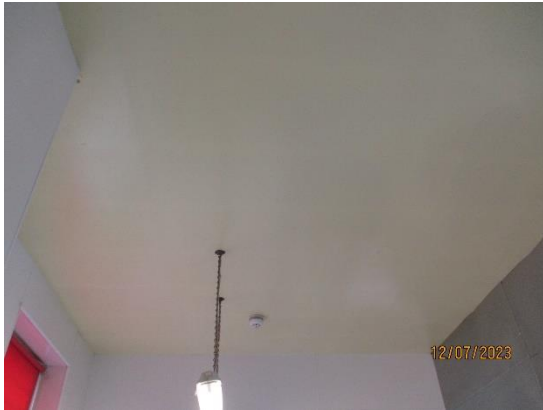
149. Plasterboard ceilings

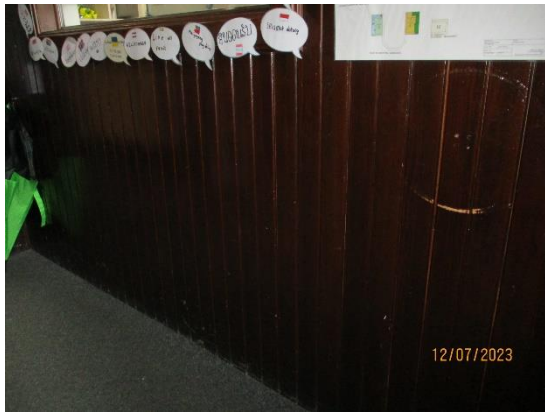
160. Tongued & grooved timber linings

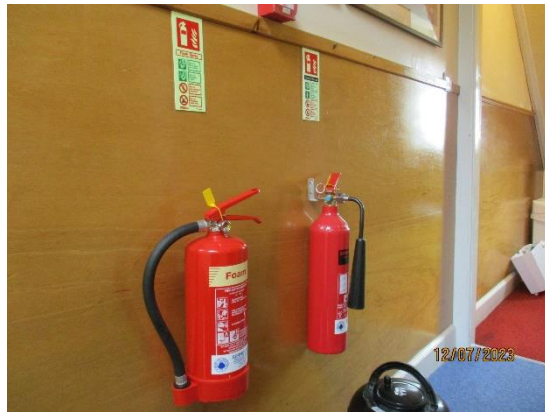
161. Plywood linings

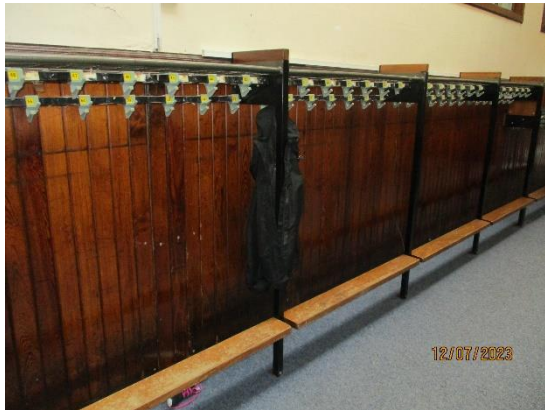
162. Timber linings

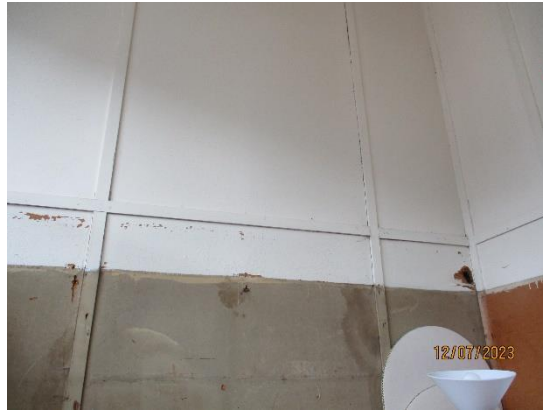
167. Fibreboard and timber straps in the Hut

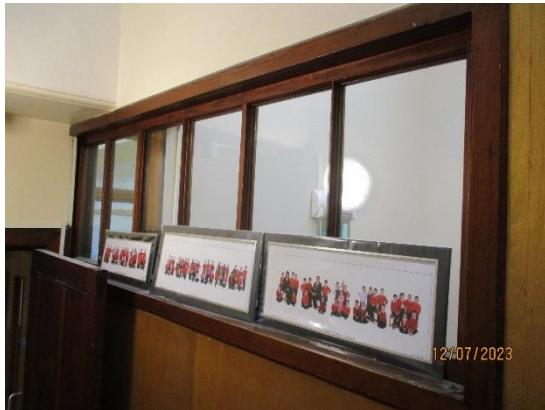
168. Timber borrowed lights in the school

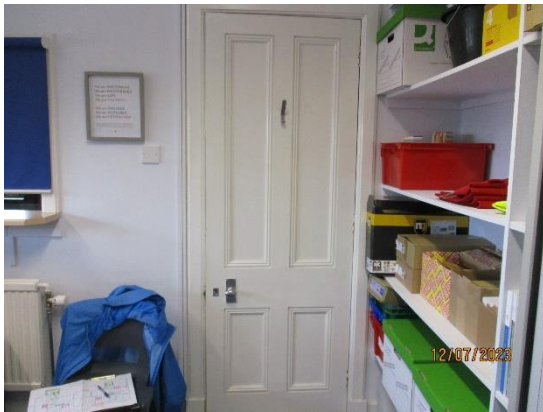
172. Timber panelled doors

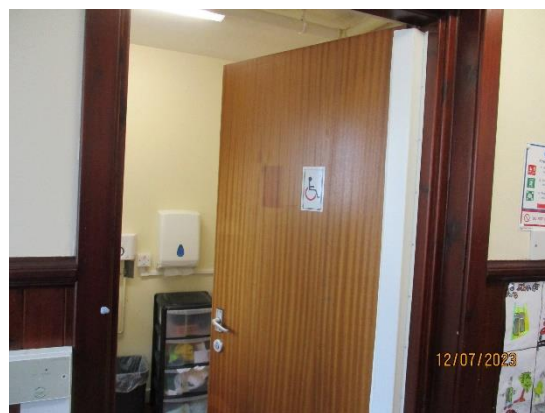
177. Timber veneered doors

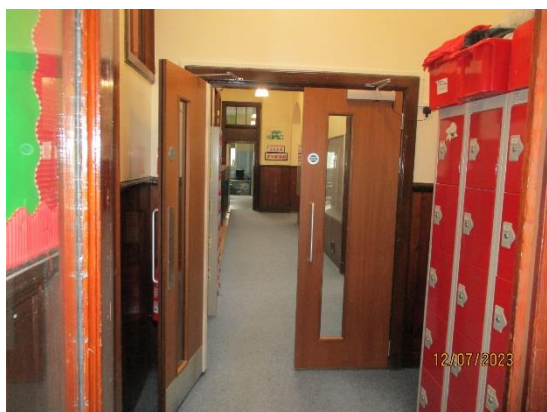
178. Timber veneered double doors

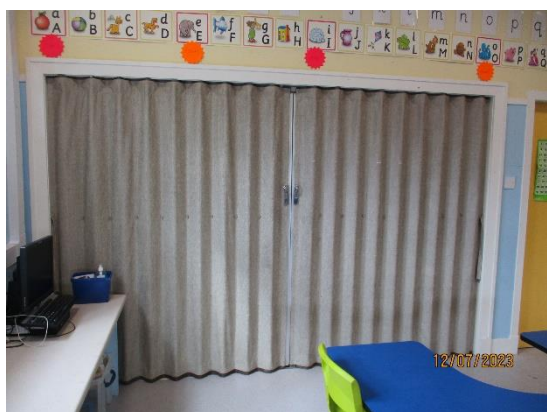
180. Fabric concertina doors

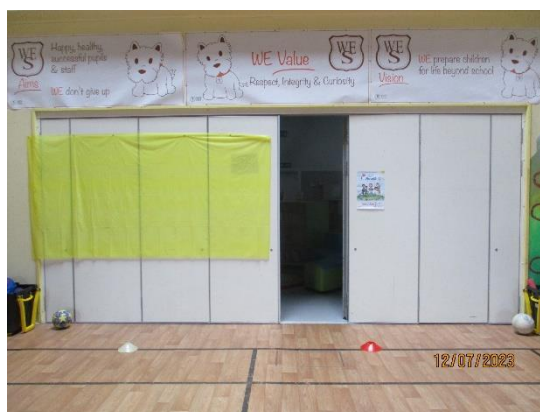
181. Acoustic bi-fold doors

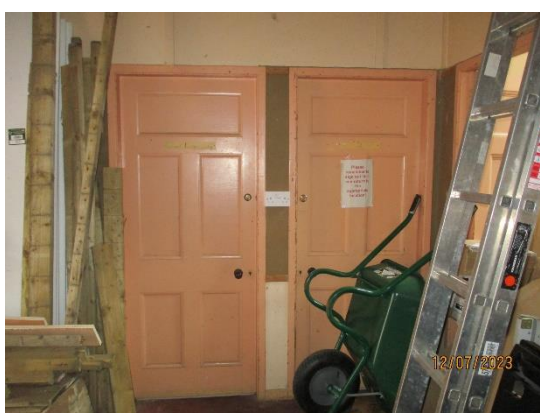
183. Timber panelled doors in the Hut

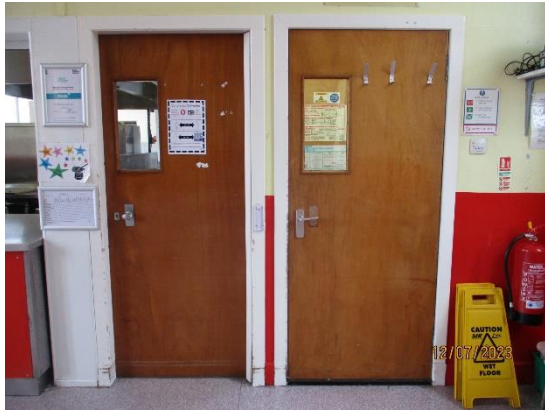
184. Timber hollow core doors in the Dining Hall

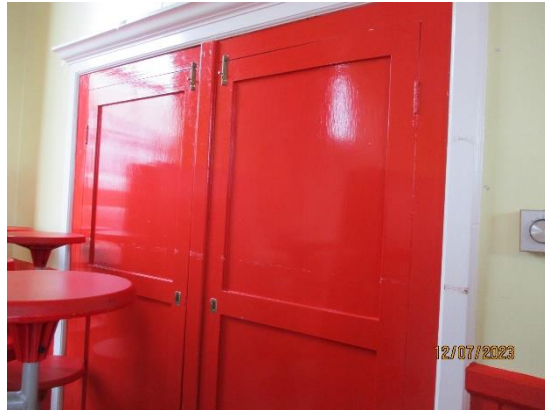
185. Timber panelled doors in the Dining Hall

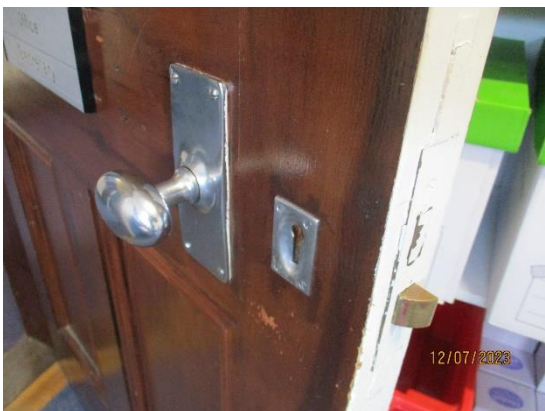
188. Chrome knob ironmongery

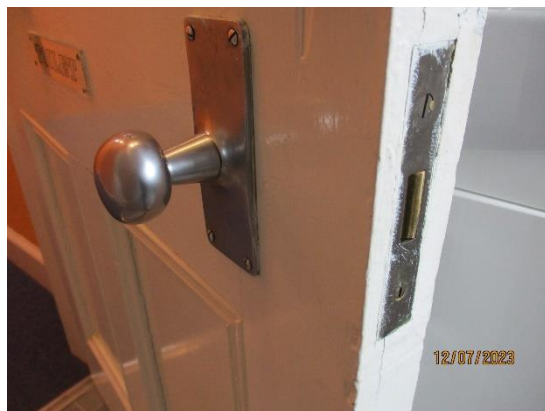
189. Latches struck

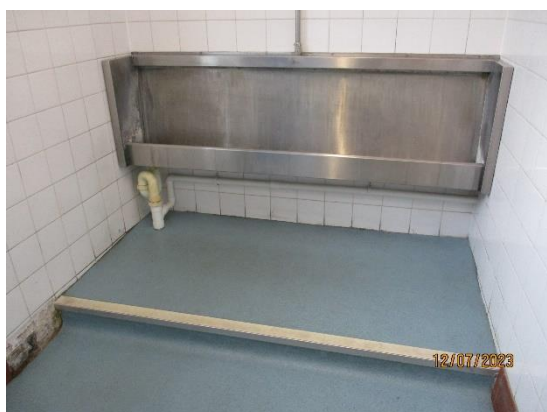
192. Stainless steel trough urinals

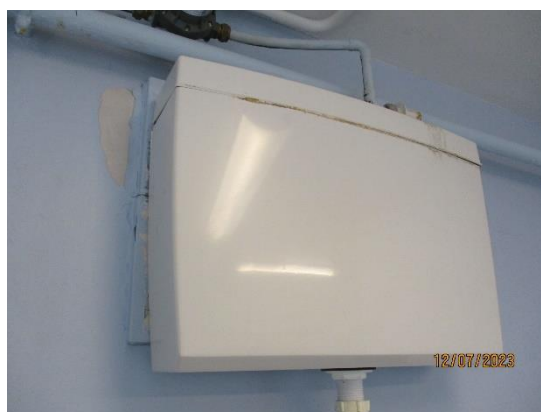
193. Plastic cisterns

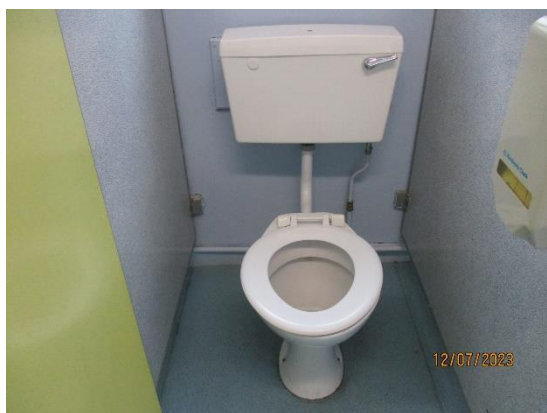
194. Typical WC

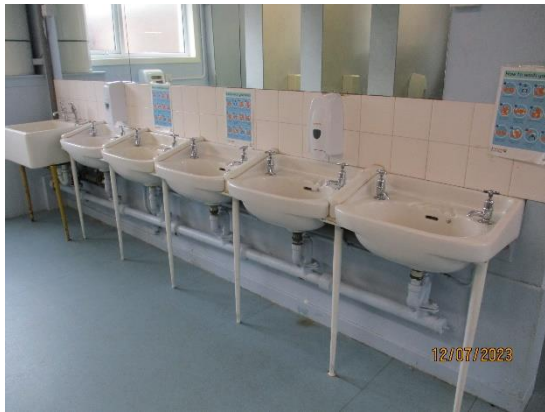
196. Wall hung china basins

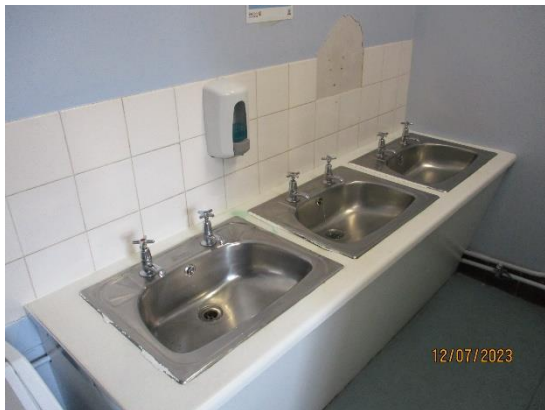
198. Stainless steel vanity basins

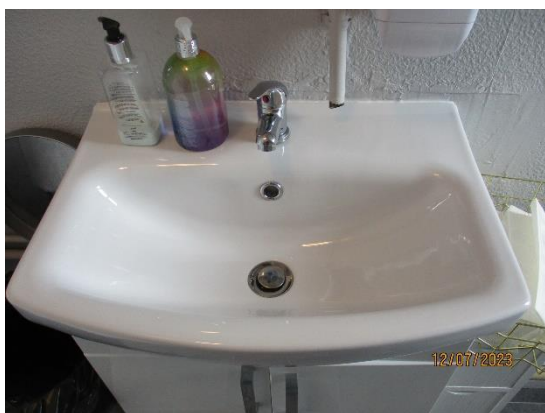
200. Vanity china basin

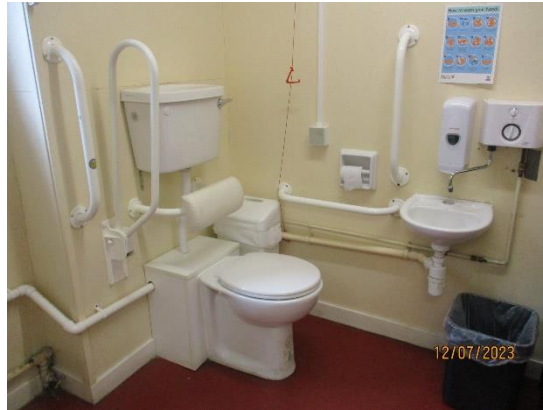
203. Accessible toilet

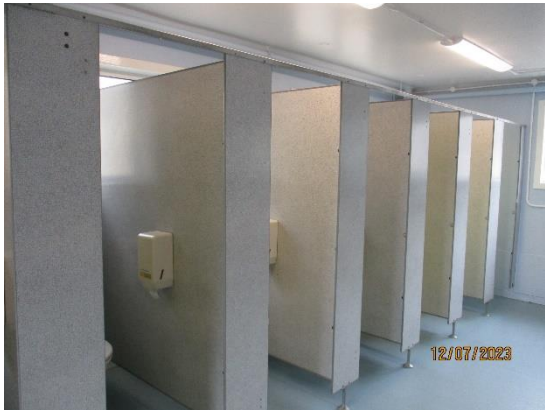
204. Composite panel cubicle partitions

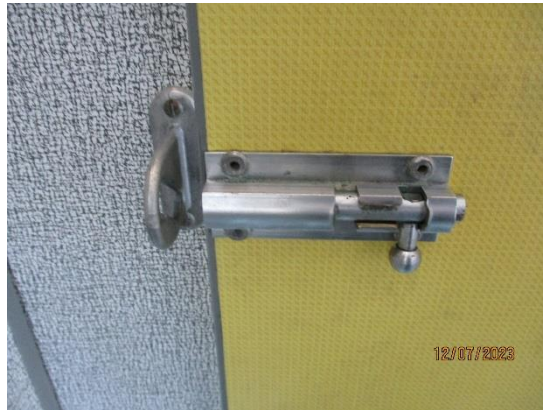
205. Dated cubicles and ironmongery

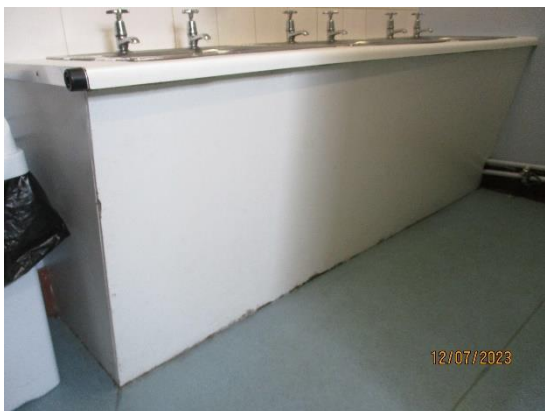
206. Composite panel vanity units

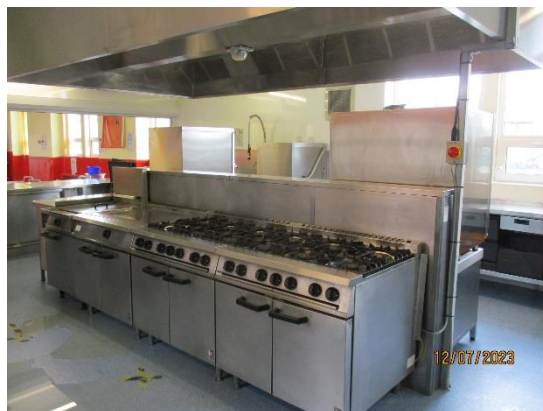
207. Commercial kitchen

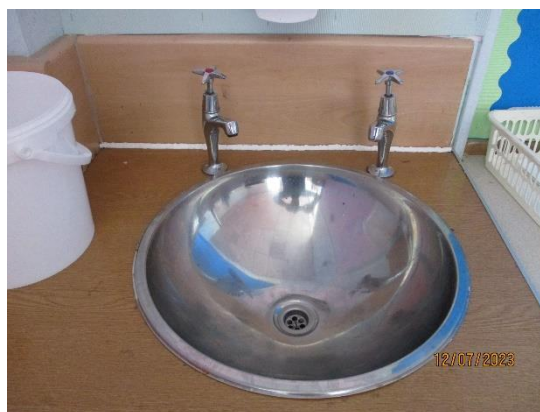
209. Stainless steel inset sinks

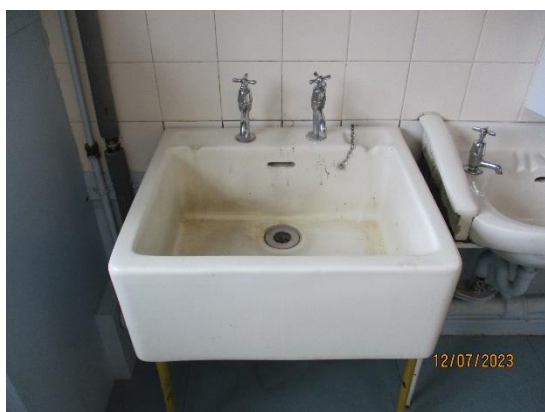
210. Cleaners Butler sink (Girls toilet)

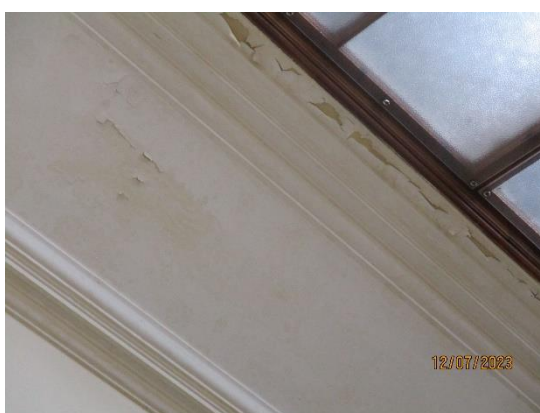
213. Watermarked ceilings

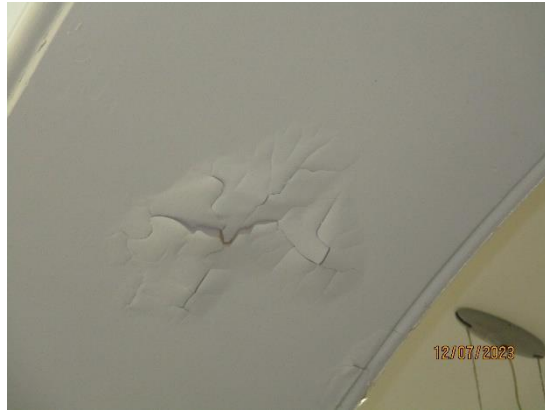
215. Peeling paint

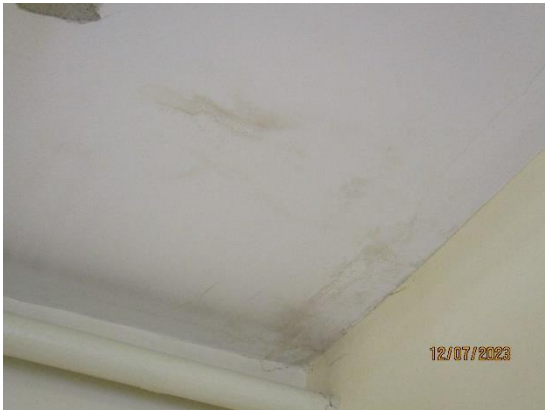
216. Watermarked plaster ceilings

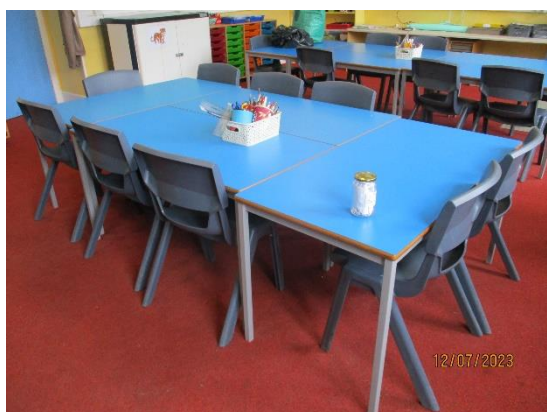
222. Classroom furniture

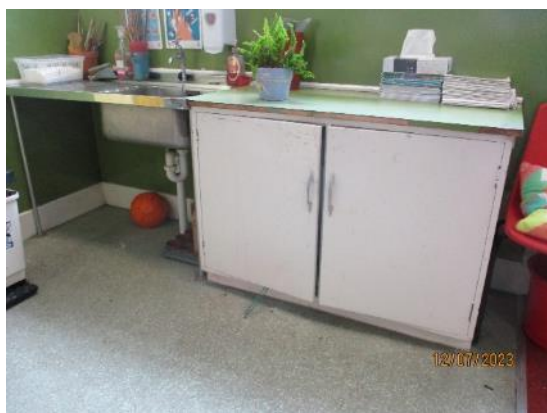
224. Classroom base units

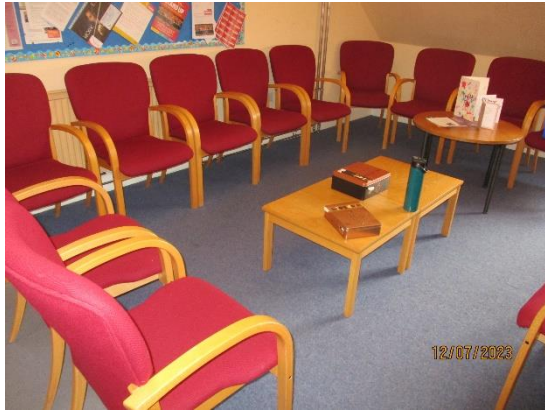
226. Staff room furniture

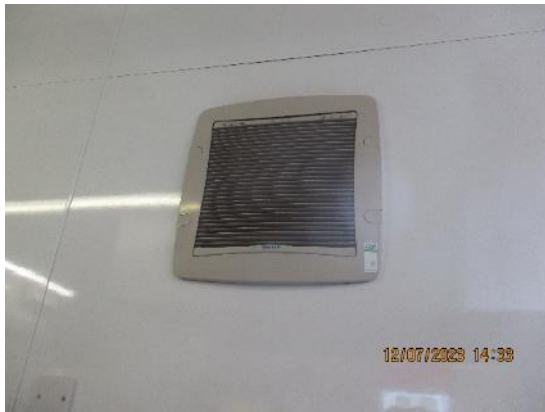
252. Extract fan – kitchen.

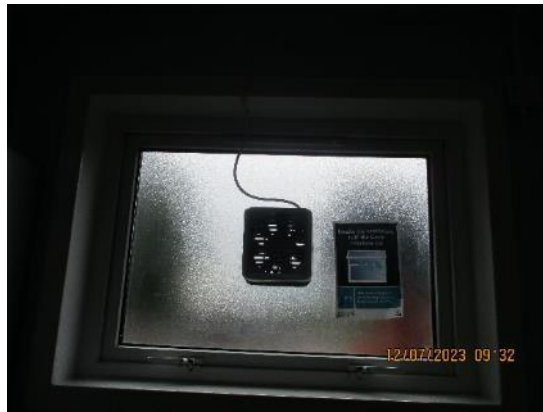
253. Extract fan – girls toilet.

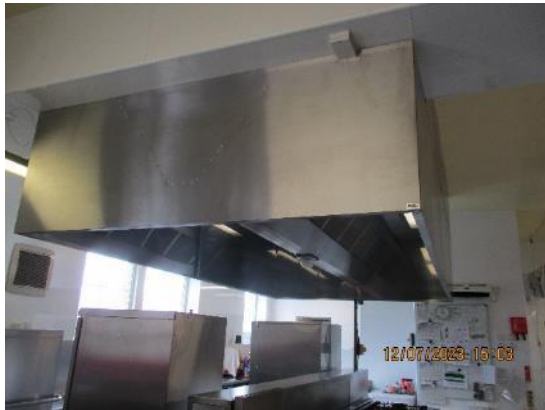
254. Extract canopy – kitchen.

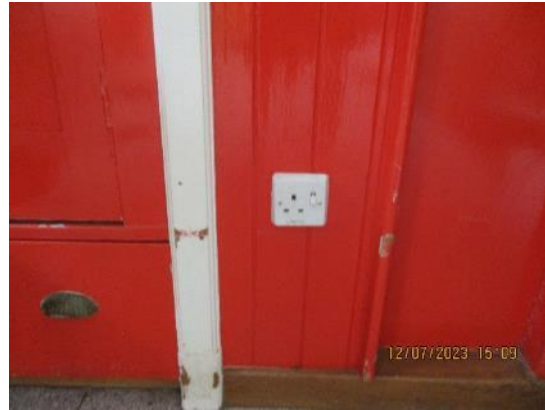
265. Socket – dining room.

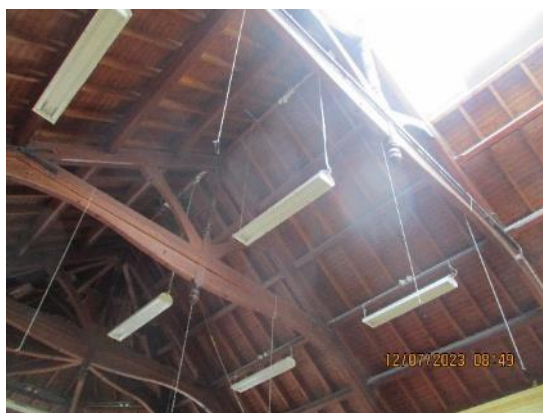
268. Lighting – main hall main school.

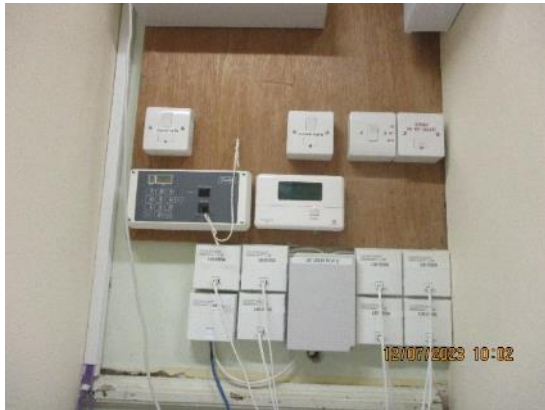
284. Period bell programmer 1/10.

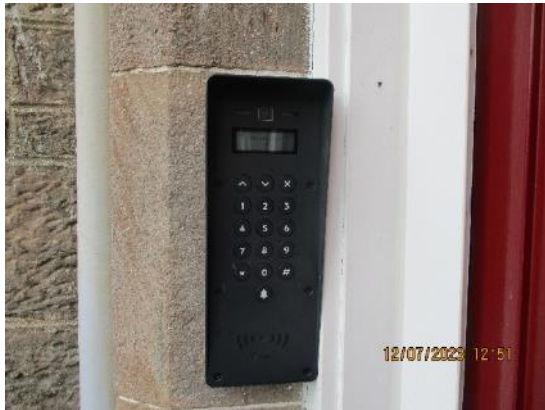
290. Paxton main entrance security door user video/audio unit.

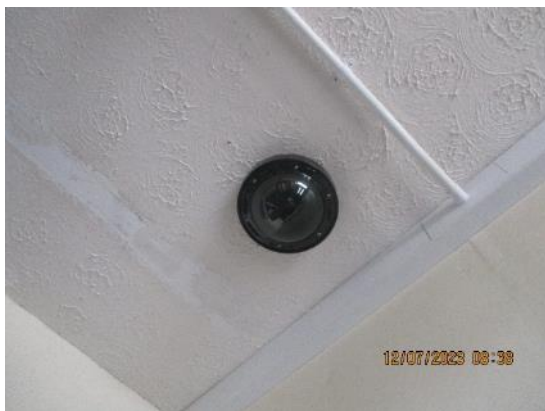
292. CCTV camera main entrance lobby.

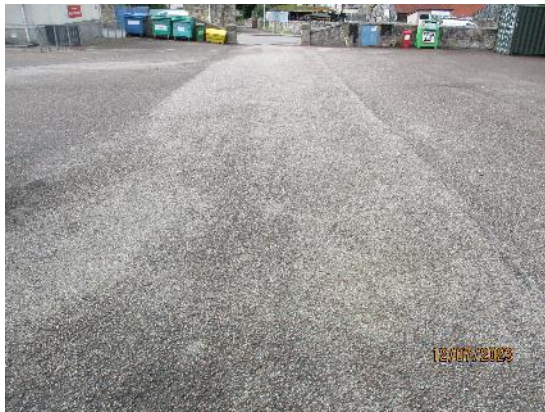
- The tarmacadam car park has surface damage and potholes.
- The tarmacadam playgrounds are cracked and raised by tree roots.
- The car park and playground surface water drainage is blocked.
- The chain link fence to the sports field is corroded and has damage to the north.
- The chain link fence on top of the stone walls is corroded.
- The stone retaining wall to the south east boundary is cracked, has dislodged stones and a considerable lean towards Forteath Avenue.
- The blockwork retaining wall with 4 Young Street is cracked horizontally.
- Concrete ramps are eroded with surface damage.
- Concrete steps to the north playground are cracked and damaged.
- Brick planters and tree surrounds are cracked and damaged by tree roots.

294. Tarmacadam car park

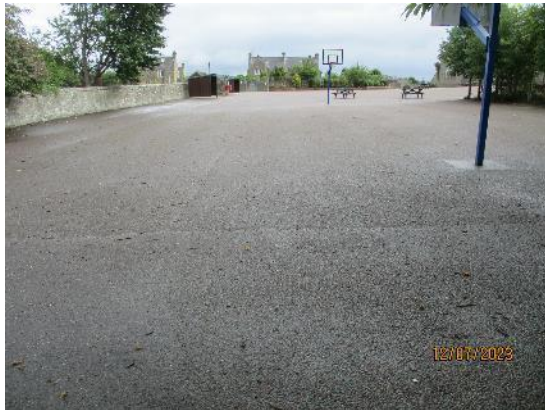
296. Tarmacadam playground (East)

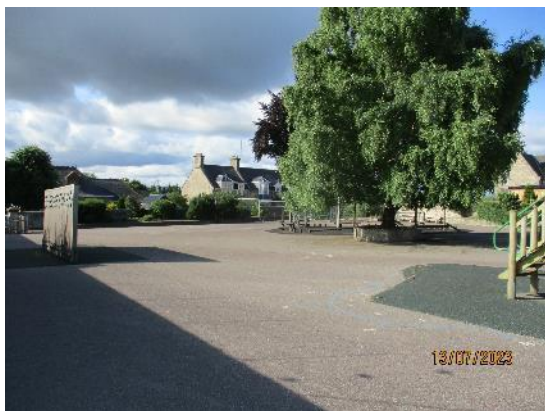
298. Tarmacadam playground (South)

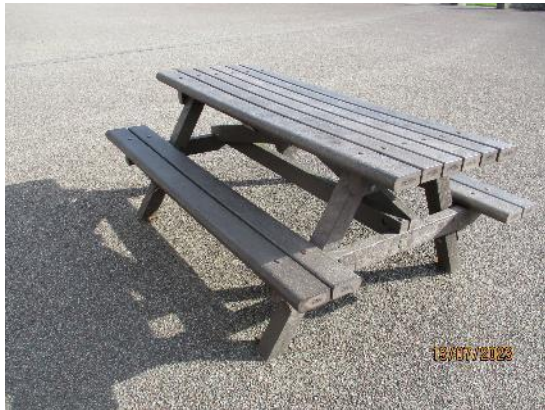
302. Tables and benches

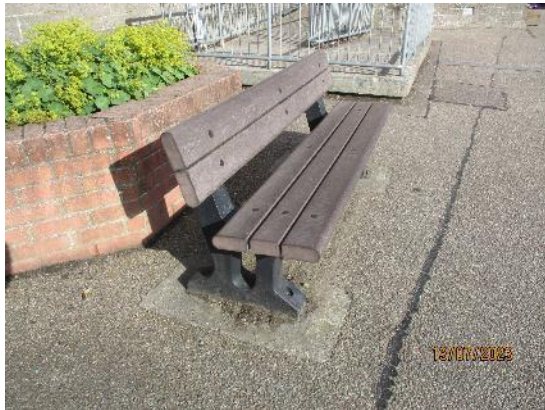
303. Playground benches

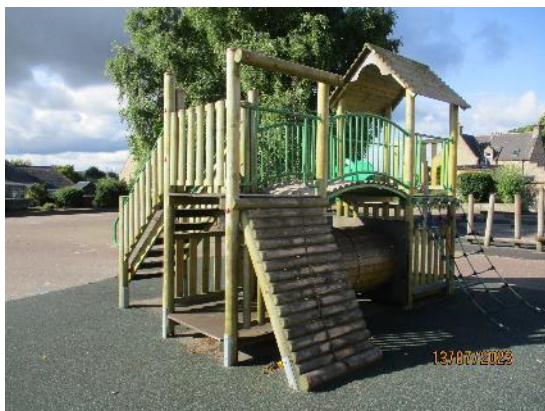
304. Playground equipment

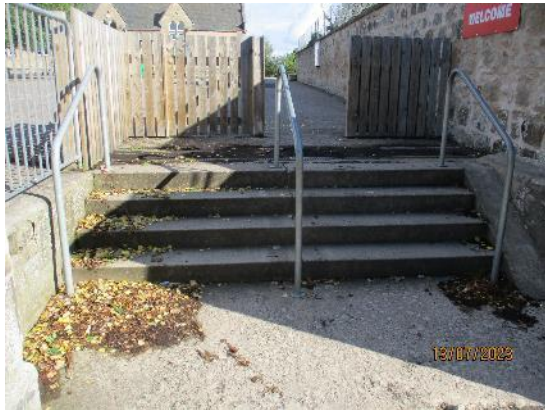
308. Concrete steps (South entrance)

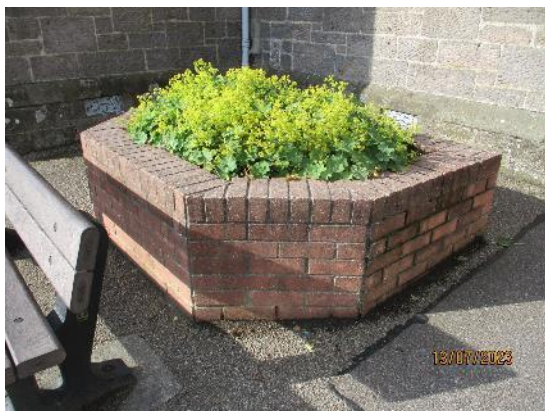
310. Brick planters

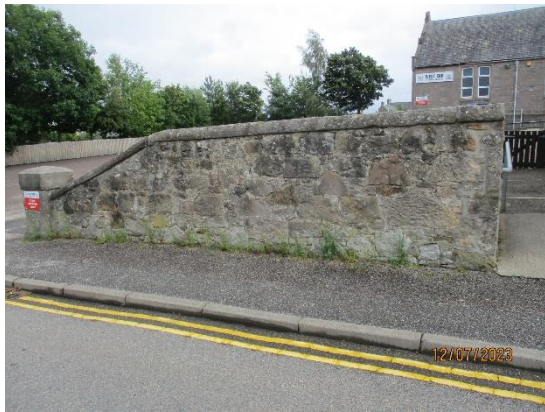
329. Surface erosion

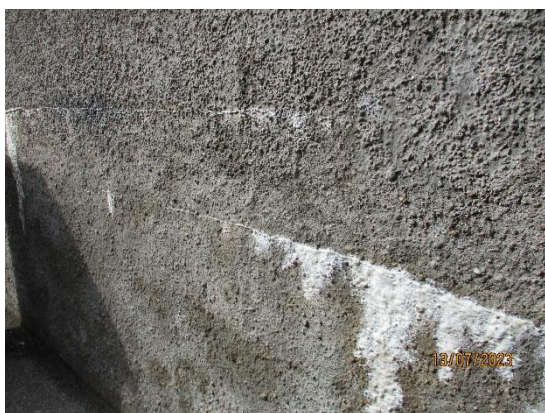
333. Horizontal cracking

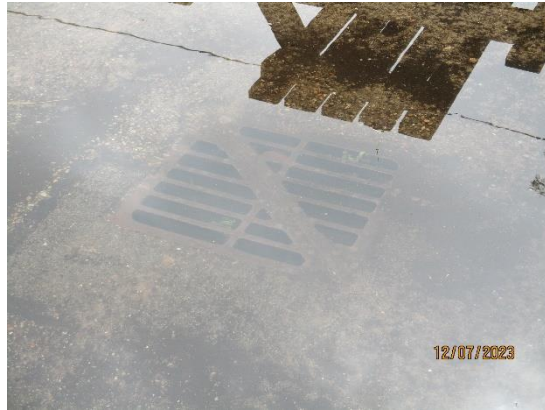
336. Surface water flooding (West playground)

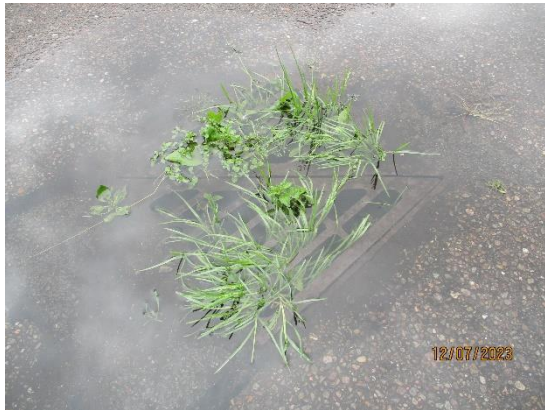
337. Blocked drainage

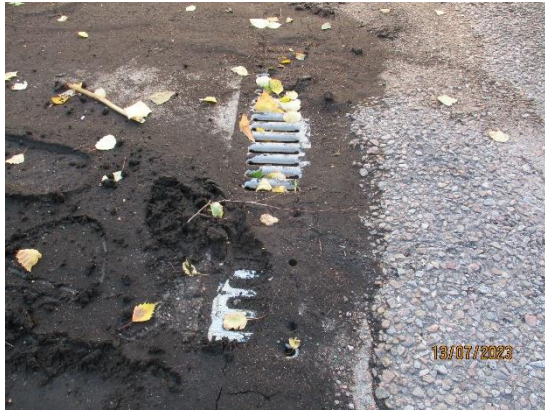
341. Silt blocking drainage

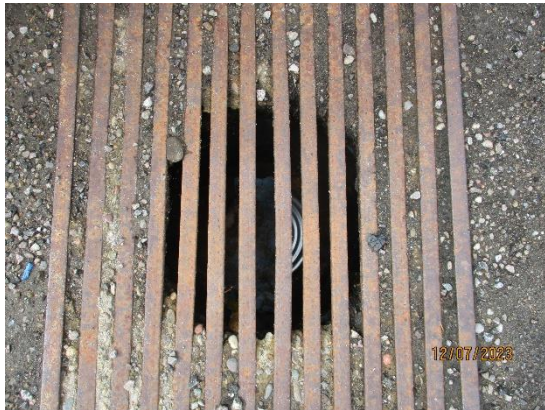
343. Silt blocking gullies
