# **Summary Building Condition Survey Report**

**New Elgin Primary School  
Bezack Street, Elgin IV30 6DP**

**18<sup>th</sup> & 19<sup>th</sup> January 2023**

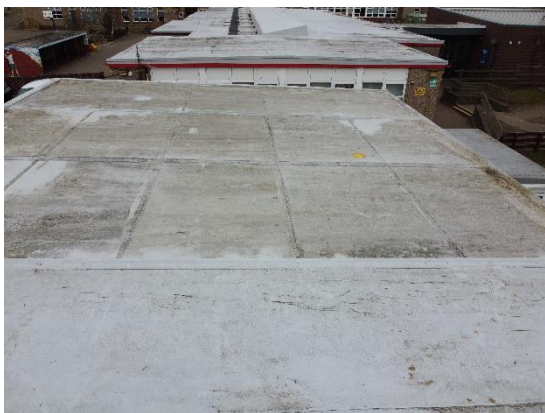
11. Single ply membrane

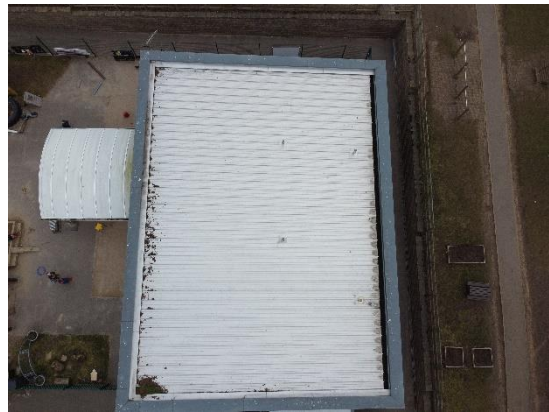
14. Standing seam to New Nursery

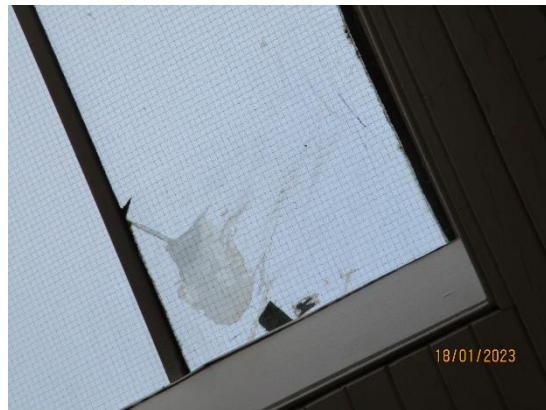
22. Georgian wired glass

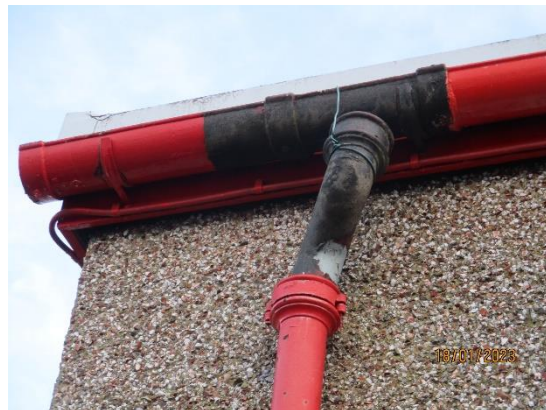
28. Half round cast iron to perimeter

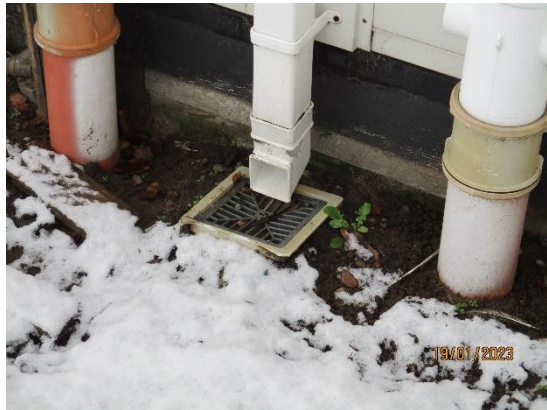
34. UPVC downpipes

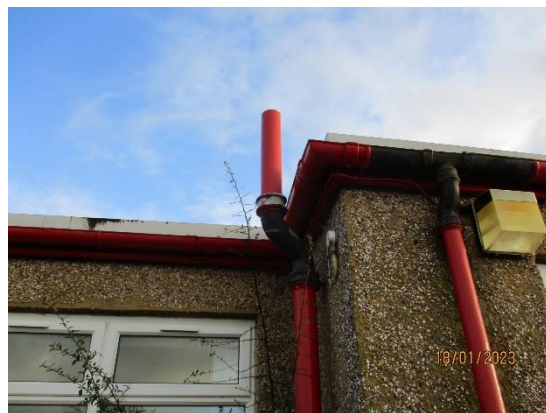
35. Cast iron soil vent pipes

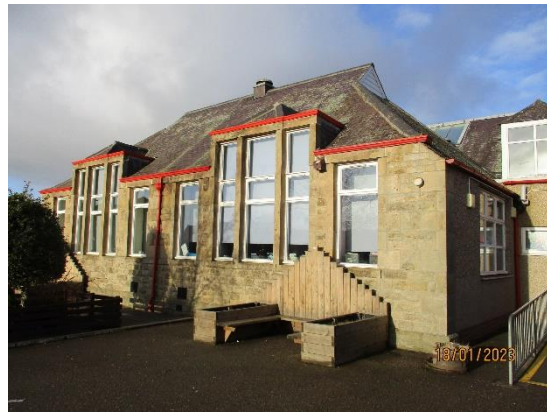
38. Natural stone external walls

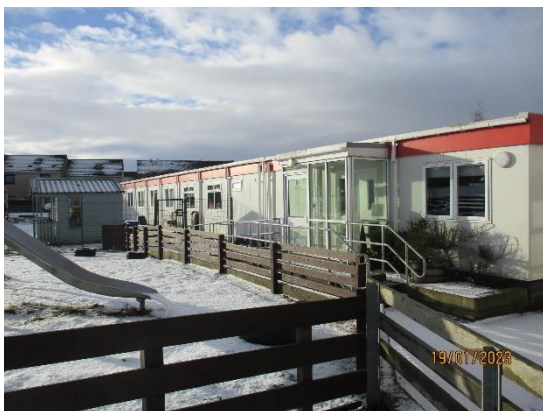
41. Composite panels to ASN building

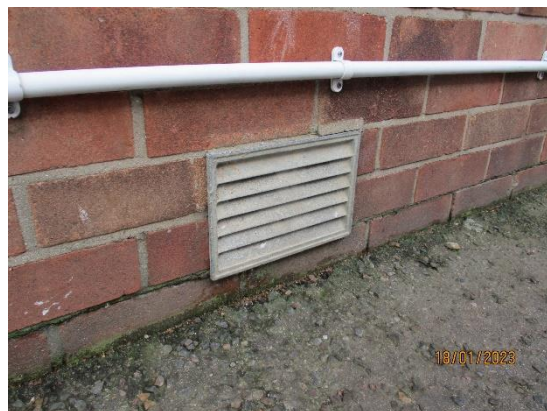
42. Ventilation below timber floors

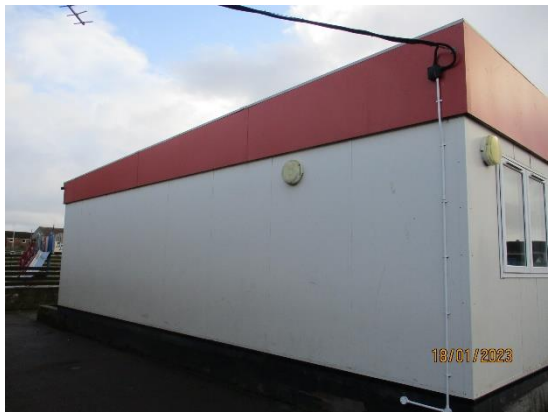
52. Composite panels to ASN building

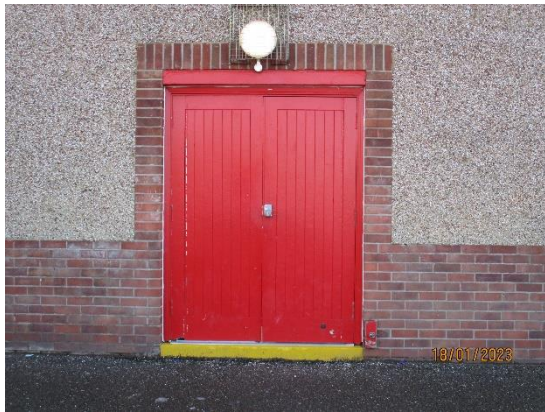
55. Timber doors

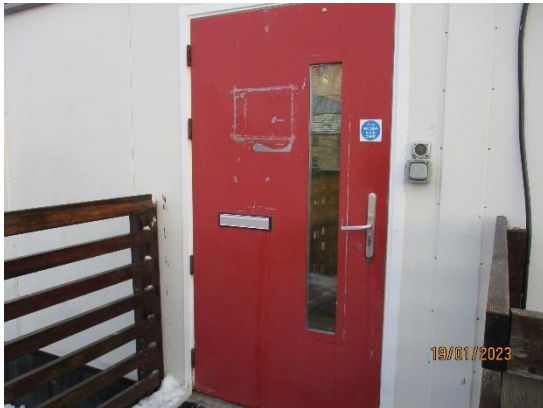
57. Steel single doors

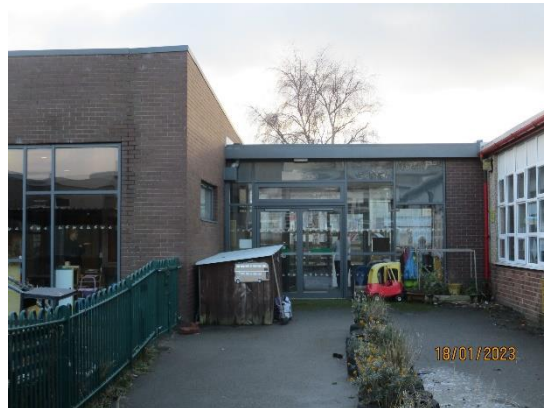
58. Powder coated aluminium doors

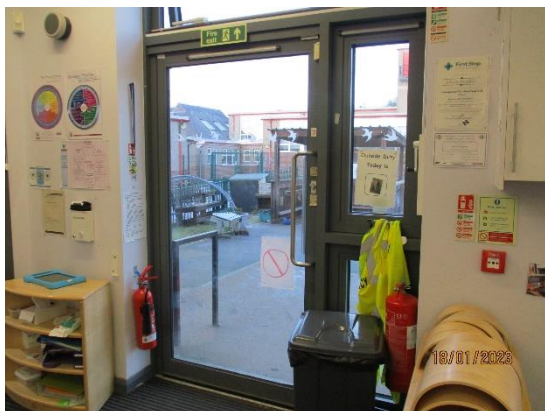
60. Powder coated patio doors

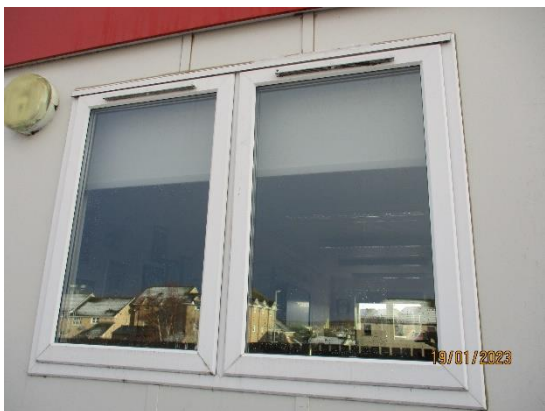
64. UPVC windows to ASN building

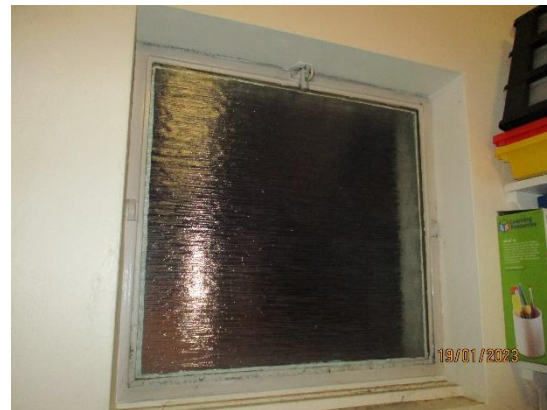
69. Steel centre pivot window

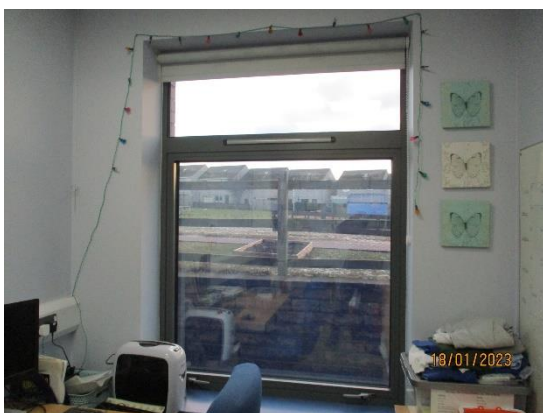
70. Aluminium windows to New Nursery

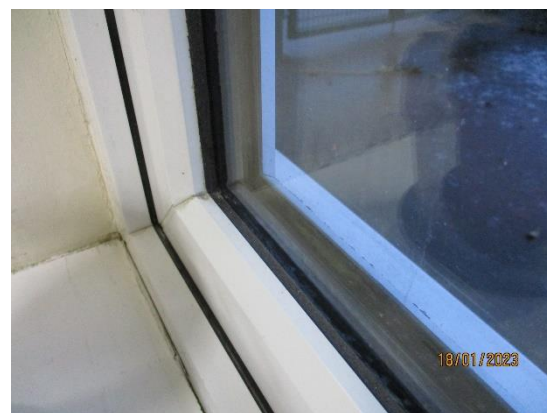
71. Double glazing

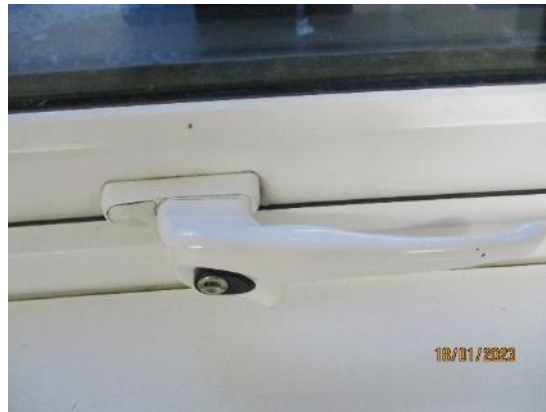
73. Lockable lever handles

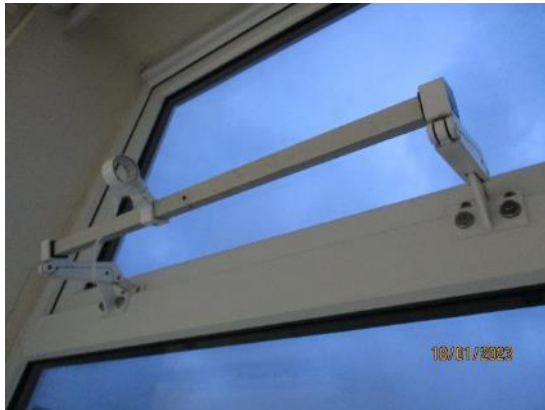
74. Cantilever top hung window ironmongery

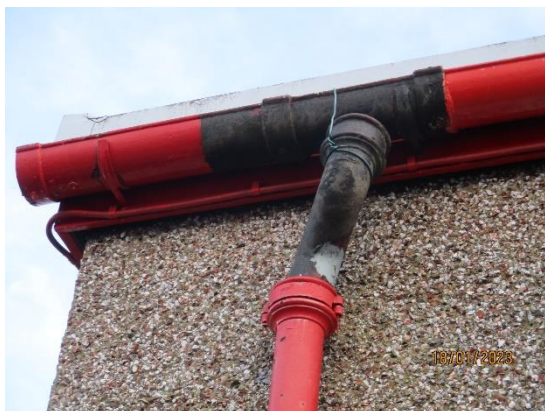
76. Rainwater goods

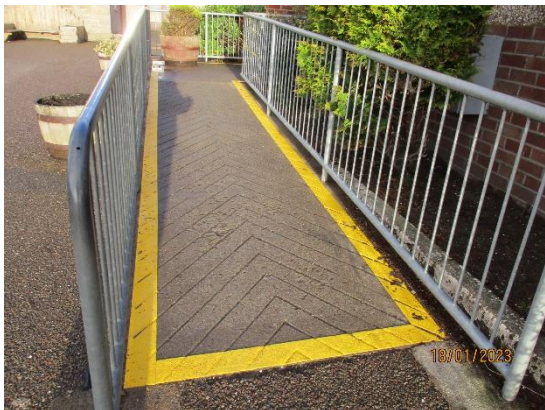
80. Concrete ramps

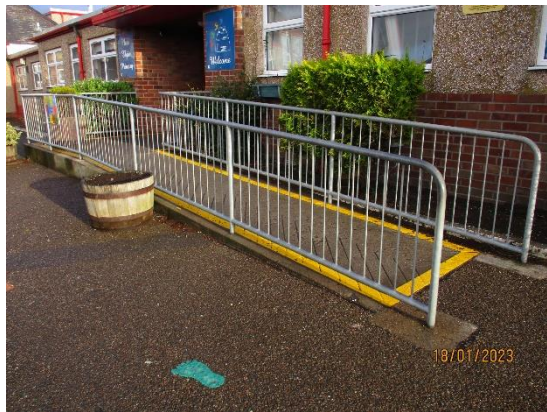
87. Galvanised guard rail

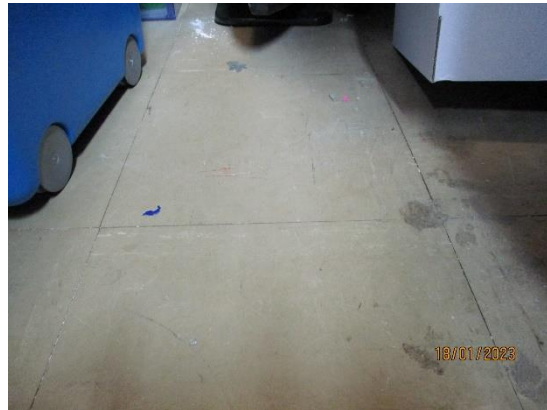
89. Vinyl tiles

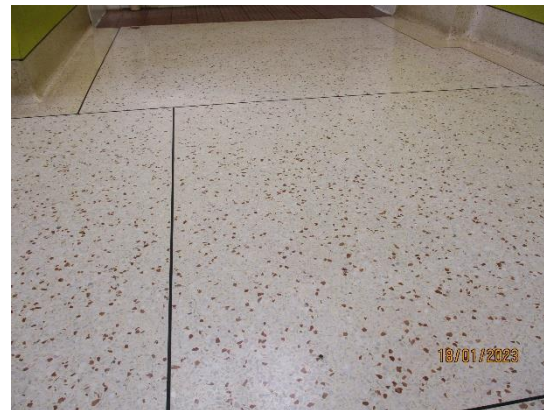
95. Terrazzo flooring

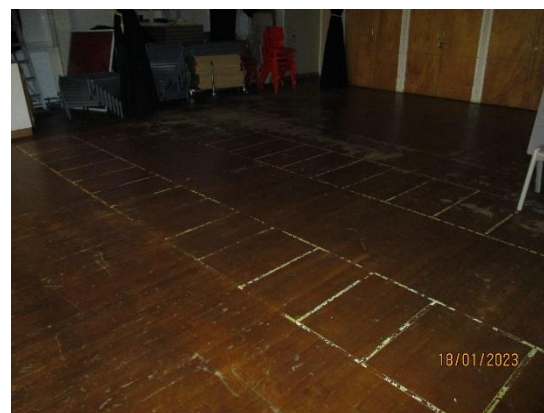
97. Timber boarding (Stage)

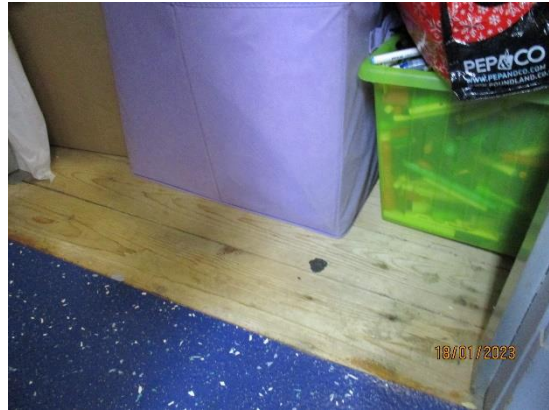
99. Timber boarding to cupboards

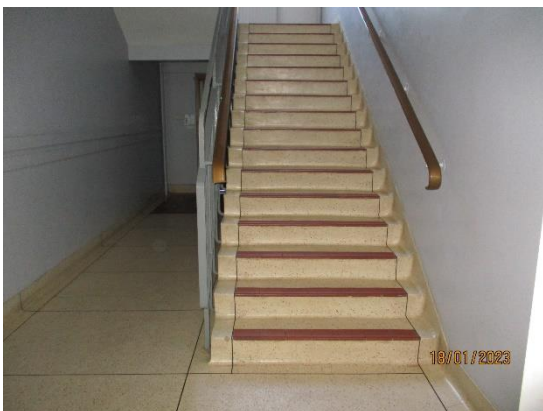
102. Concrete stairs

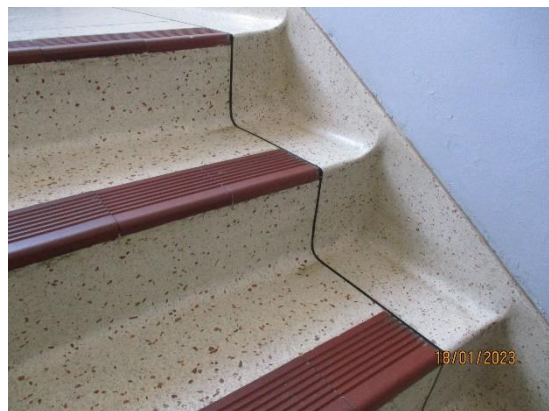
103. Terrazzo treads and risers

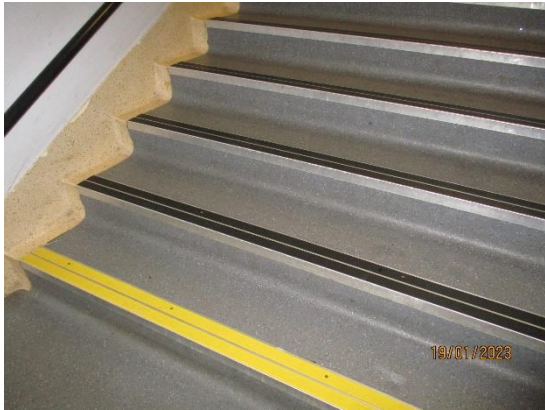
104. Vinyl treads and risers

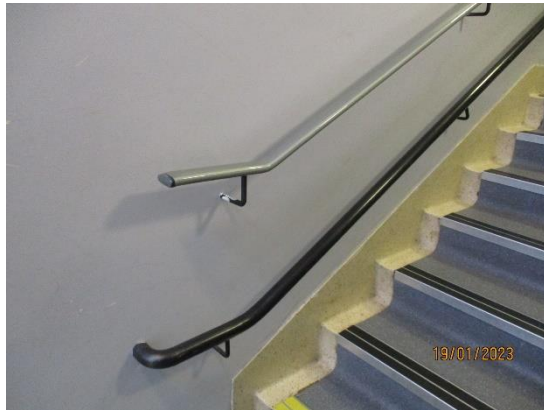
107. Tubular metal handrails

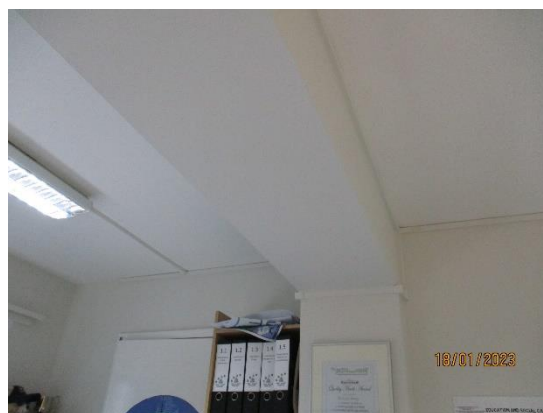
113. Plaster/plasterboard ceilings

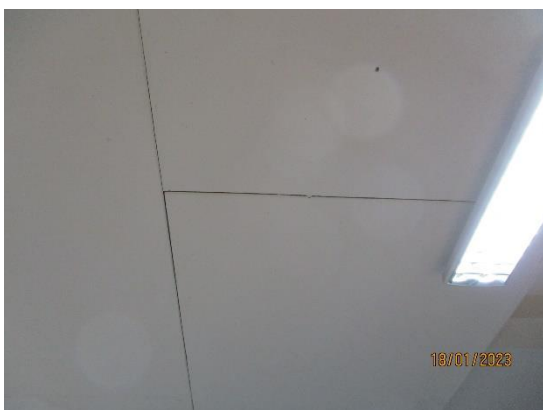
119. Fibre tiles

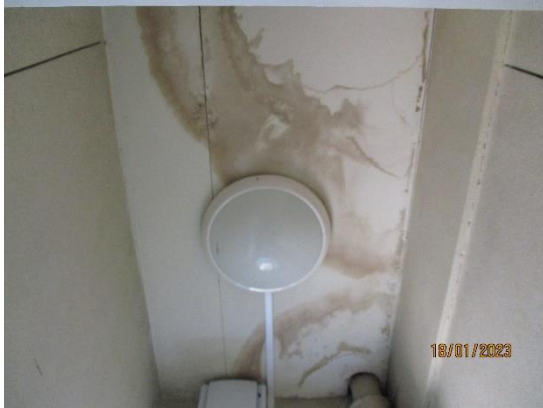
121. Watermarked fibre tiles

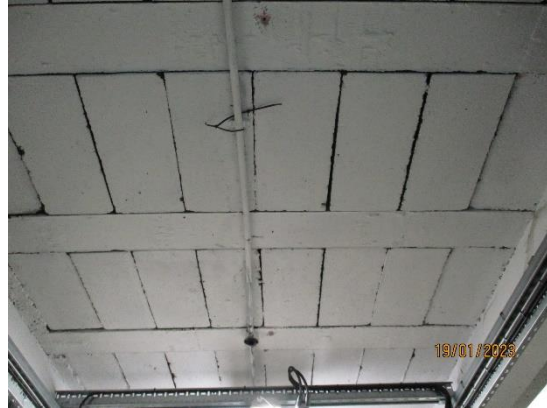
122. Beam & block ceilings

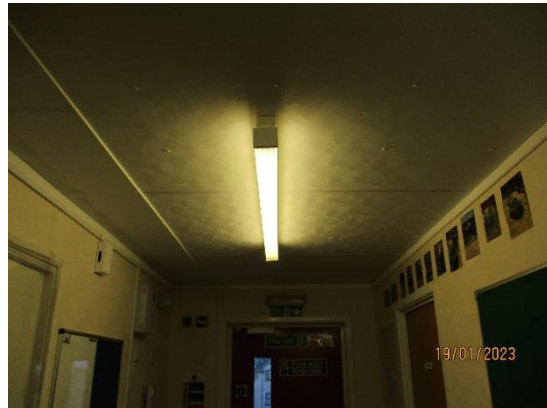
124. Composite panel ceilings (ASN)

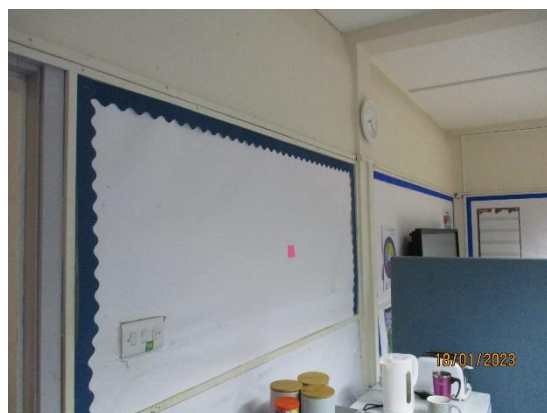
126. Plastered walls

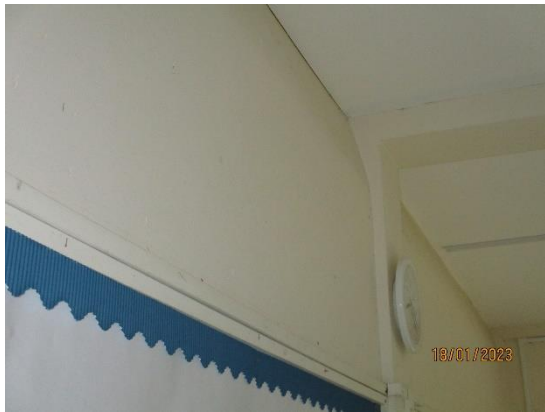
127. Plastered walls with curved top

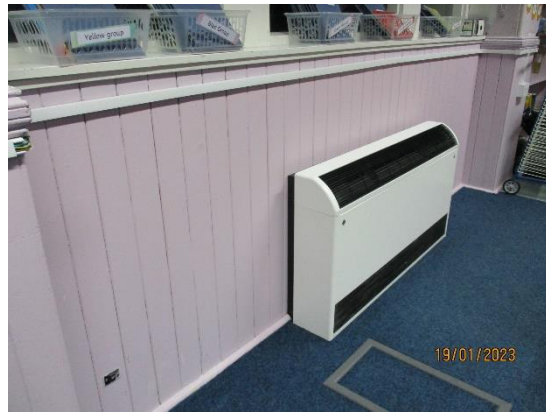
134. Timber linings

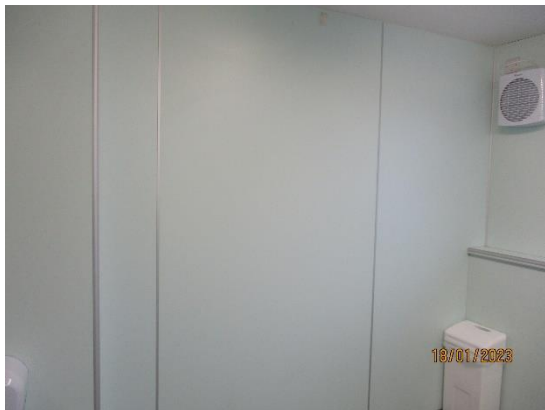
135. Wetwall

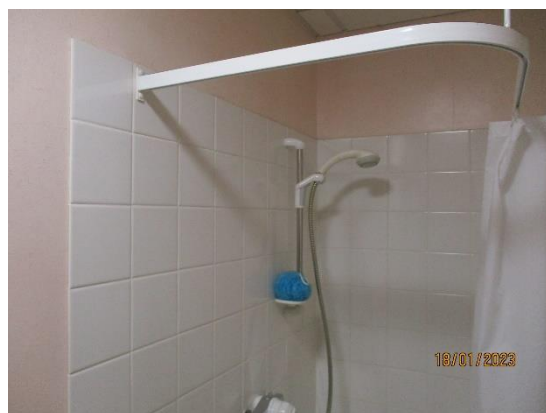
138. Ceramic tiles

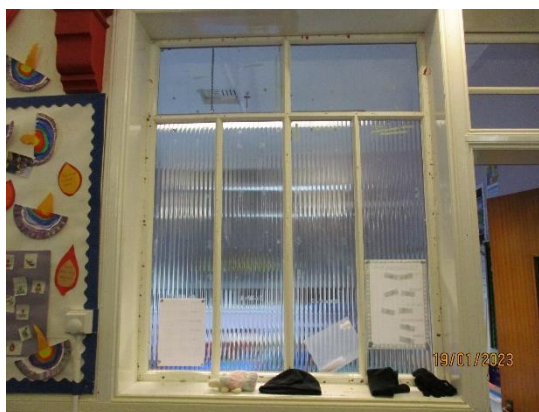
140. Borrowed lights

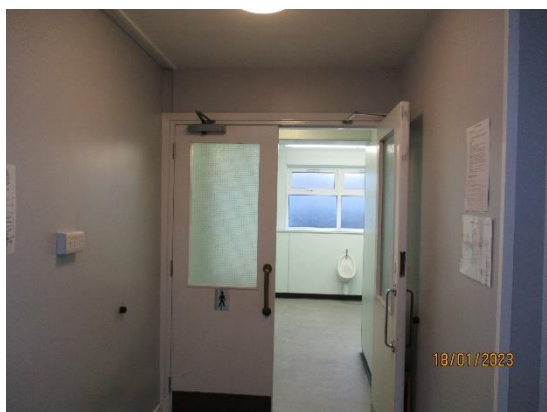
145. Timber double doors

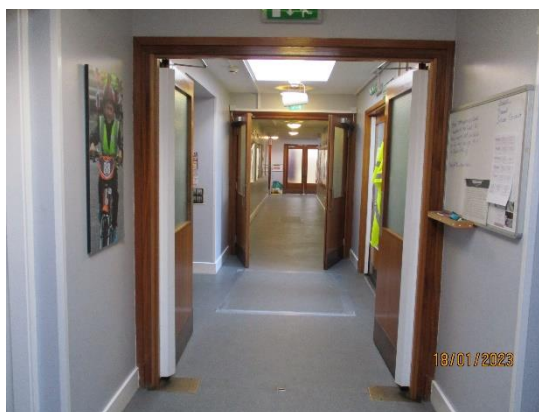
146. Corridor doors

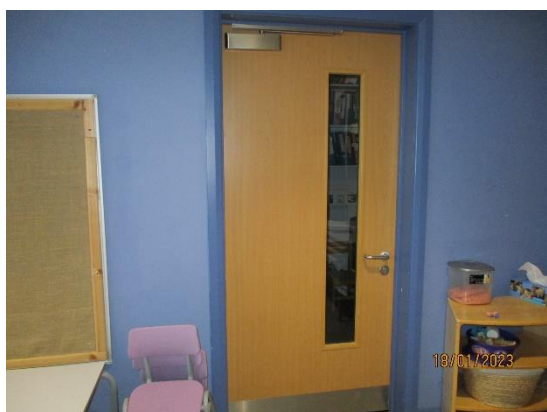
147. Veneered doors

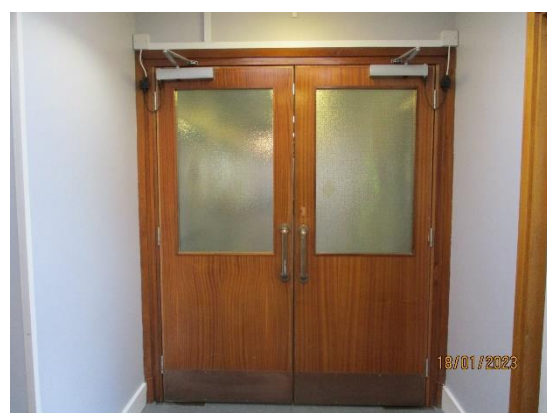
149. Georgian wired glass

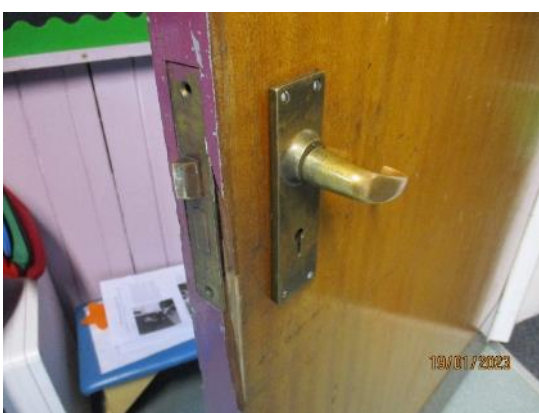
150. Brass ironmongery

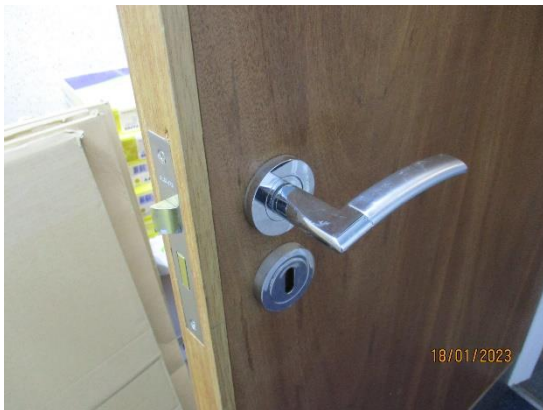
153. Chrome ironmongery

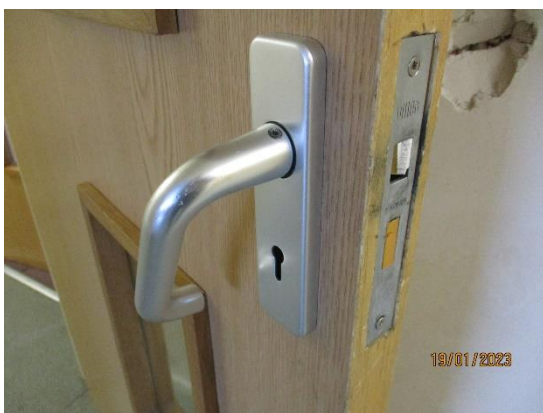
155. Aluminium ironmongery

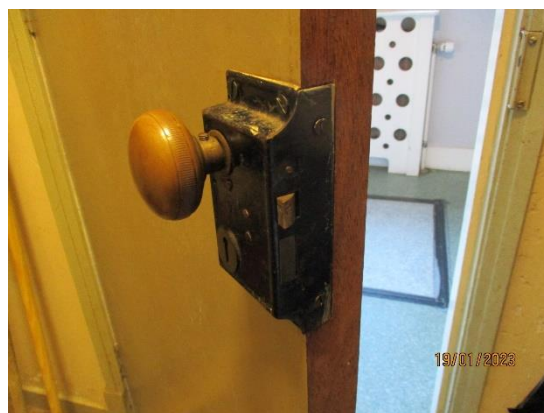
156. Metal rim locks

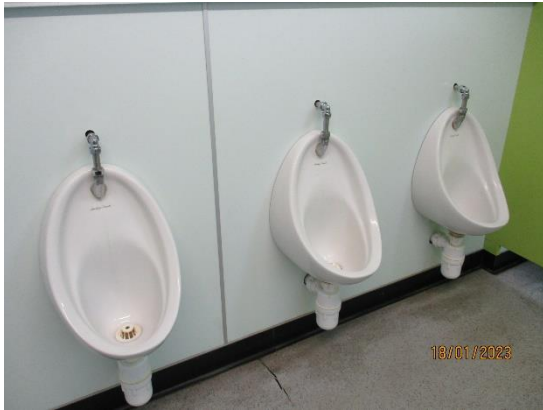
157. Urinals

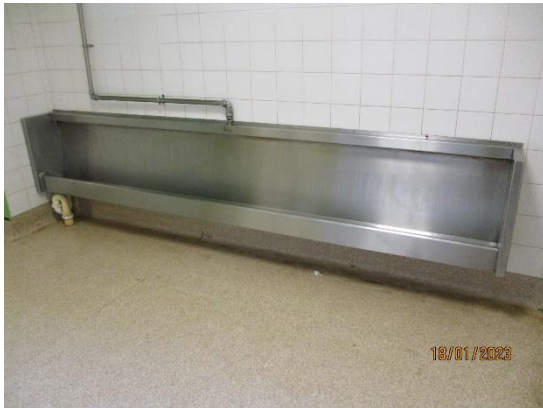
159. Stainless steel urinal troughs

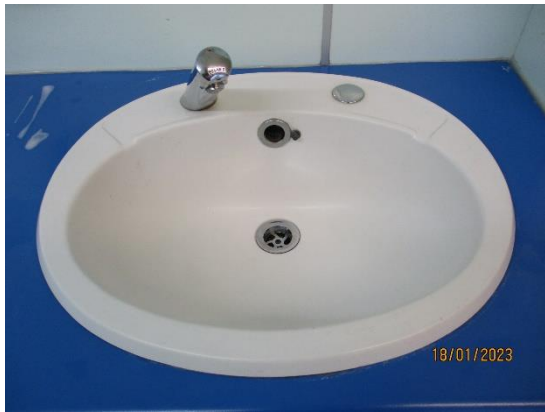
163. PVC vanity basin

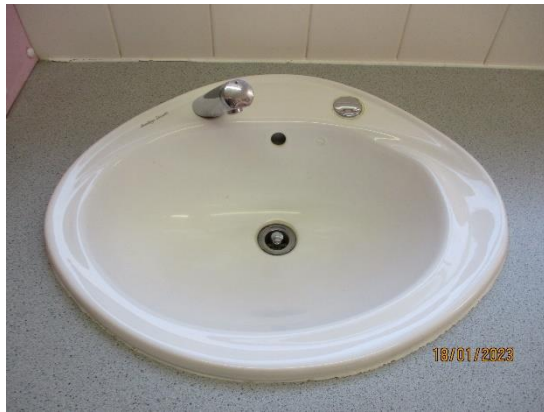
164. China vanity basin

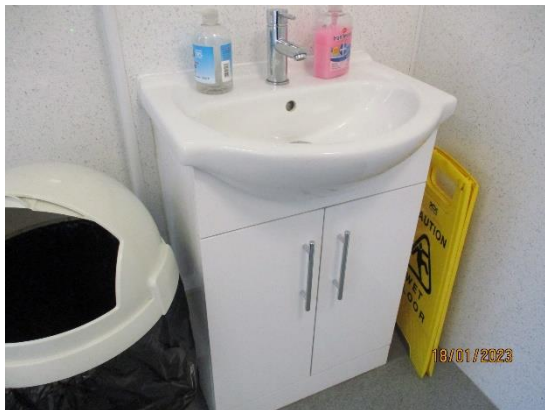
165. Vanity basin

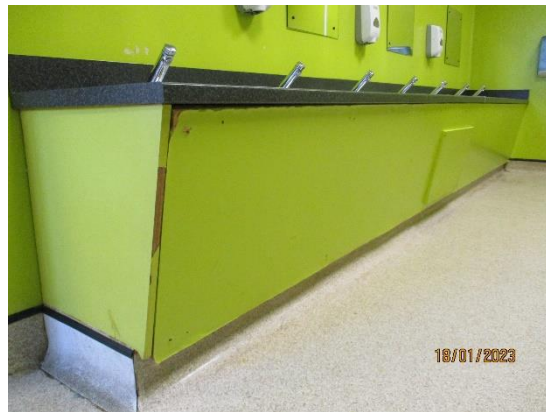
177. Damaged vanity units

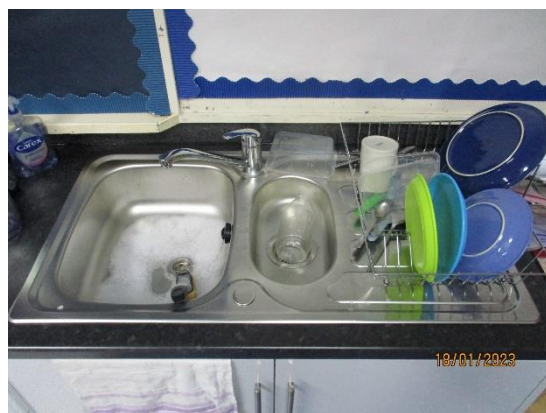
179. Commercial kitchen

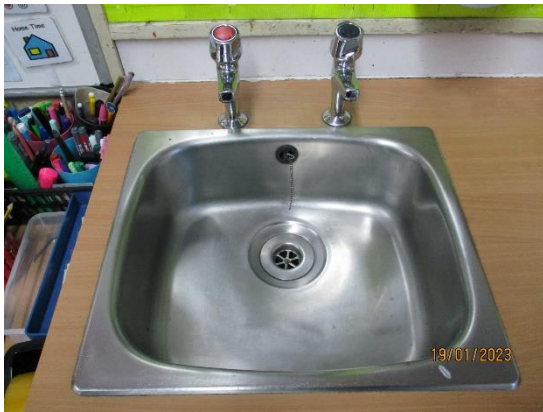
180. Stainless steel kitchen sinks

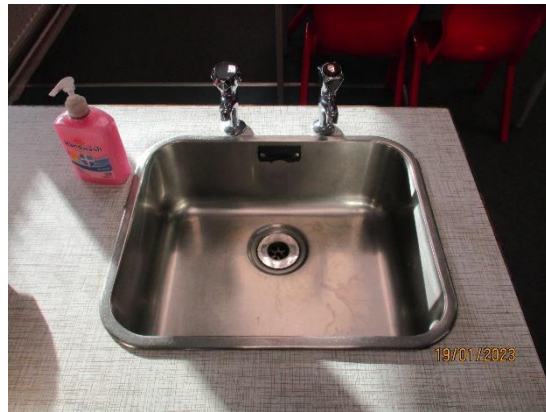
181. Stainless steel inset sinks

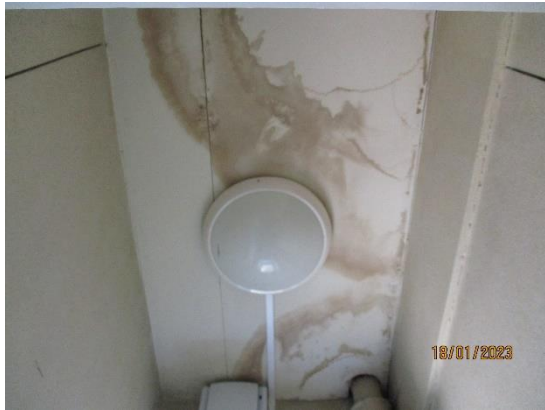
186. Timber linings to ceilings

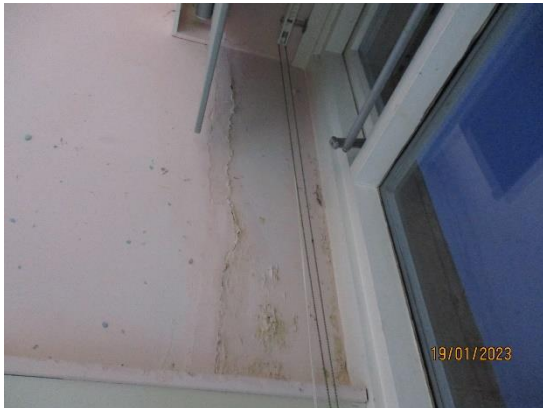
188. Paint peeling from plastered walls

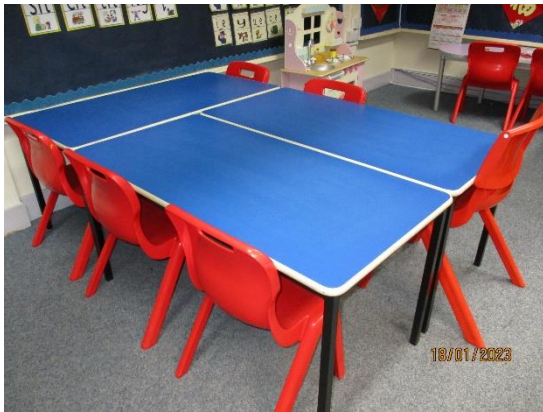
191. Paint chipped and peeling on joinery items

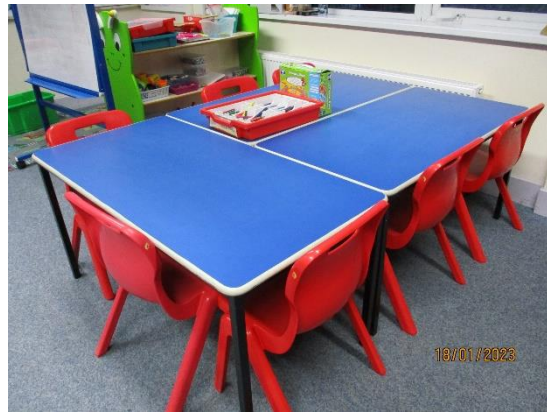
192. Classroom tables and chairs

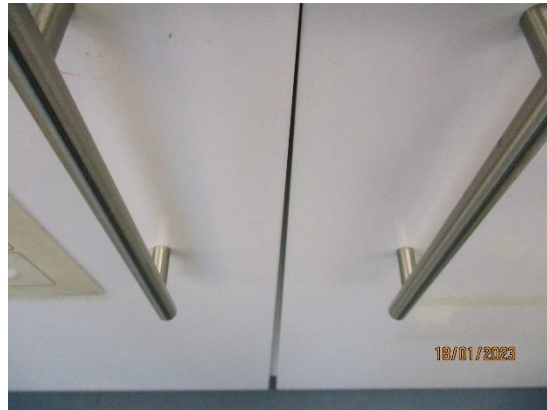
194. Sink base units

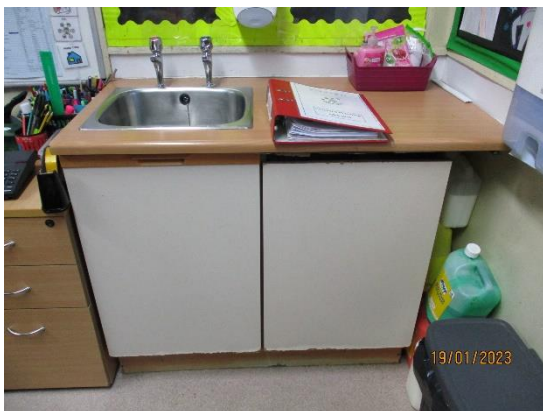
195. Misaligned doors

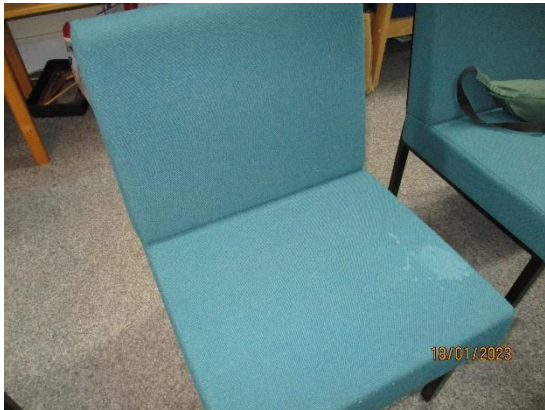
199. Staffroom furniture

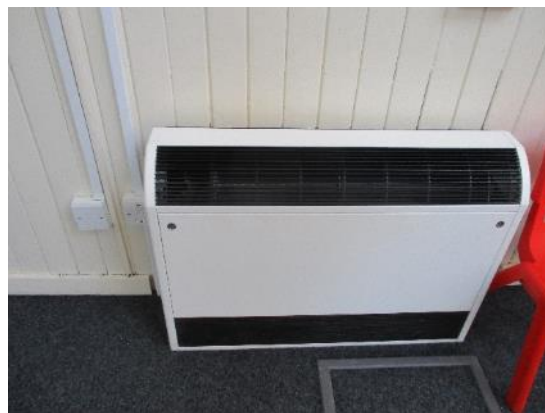
204. Pipework – heating system. 0/71

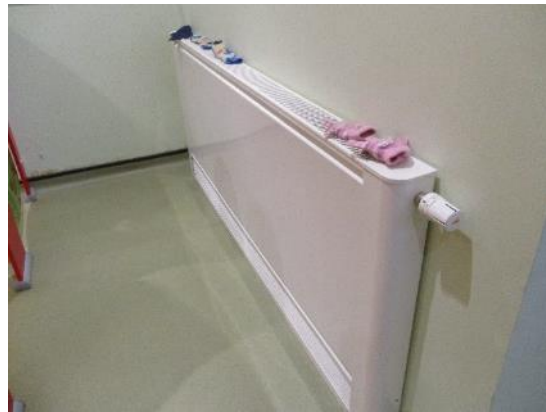
207. Radiator – main school 1/6 upgraded.

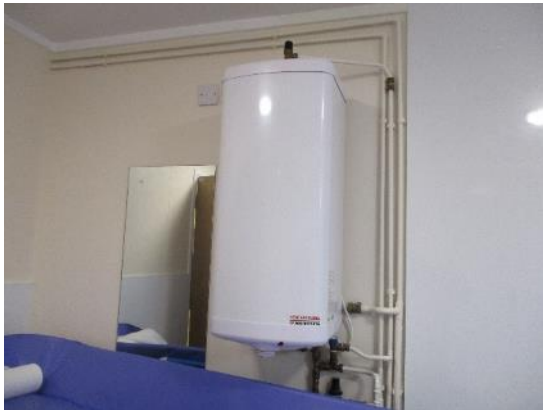
214. Hot water tank and pipework. Nursery GO2 utility.

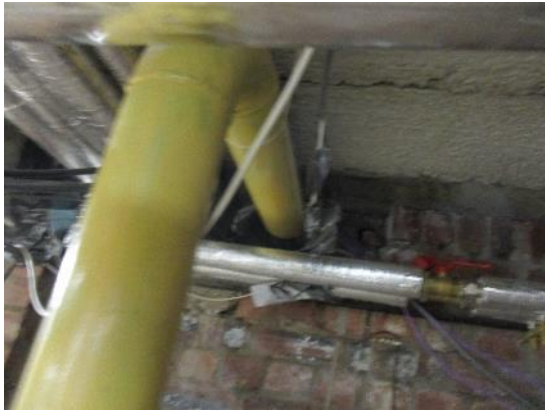
218. Pipework – existing hot and cold in main school.

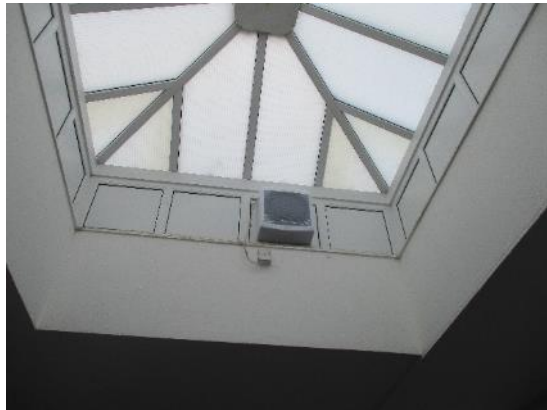
221. Extract fan 1/17 boys toilets main school

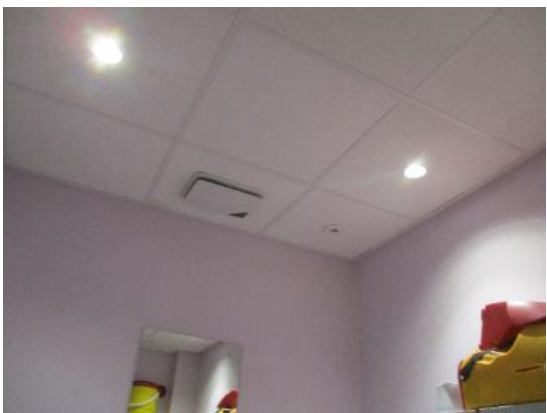
223. Extract fan ASN building typical 1-67 toilets

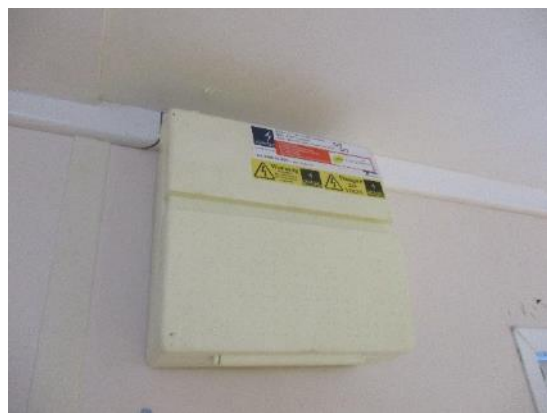
235. Distribution board – ASN building 1/79

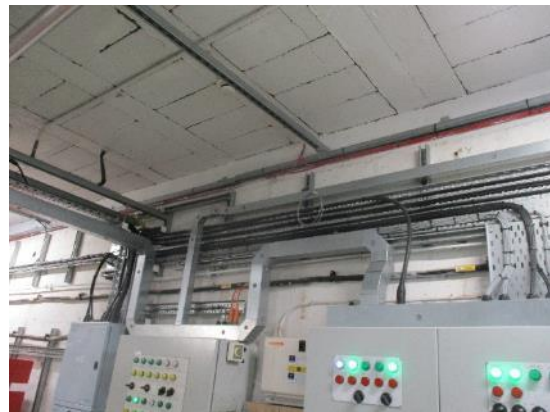
239. General wiring – ASN building ceiling space.

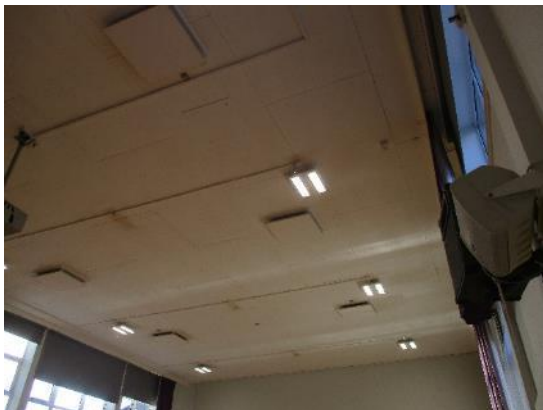
244. Lighting – main school classroom typical

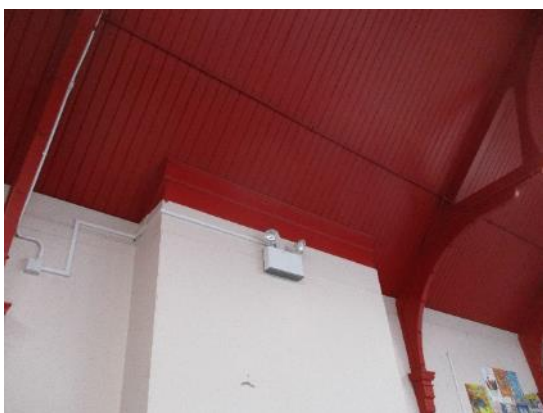
259. Emergency lighting main school hall

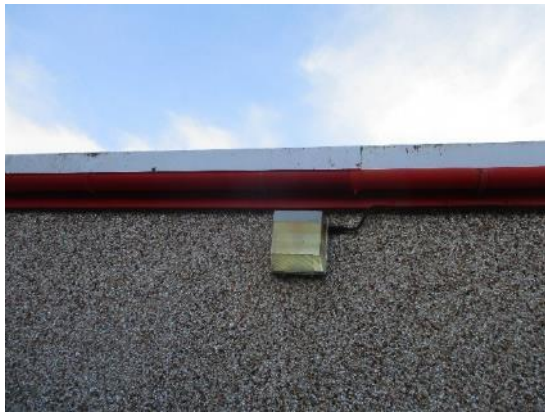
261. External lighting main school example

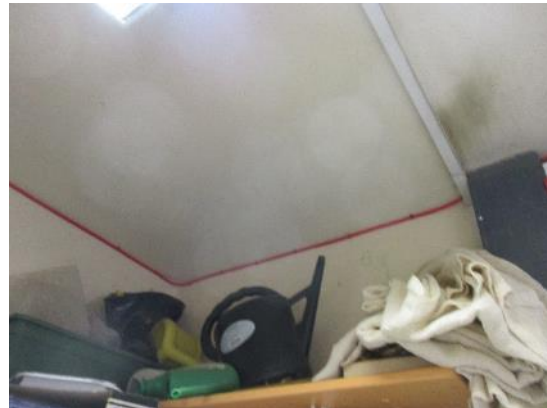
270. Fire alarm system wiring – typical.

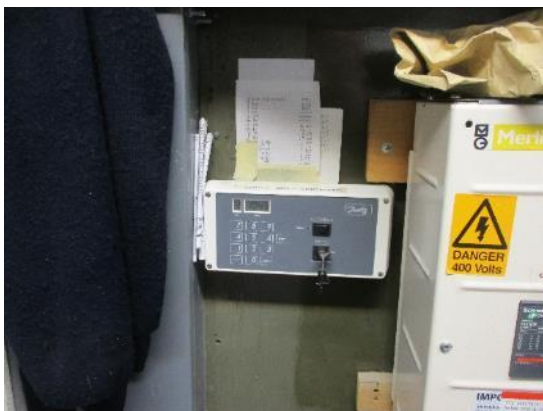
271. Period bell controller – main school

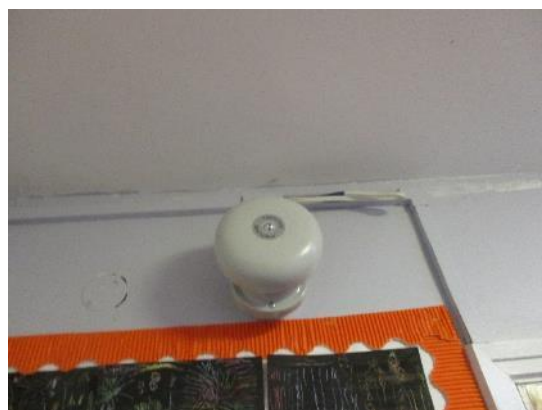
272. Period bell typical main school and nursery extension

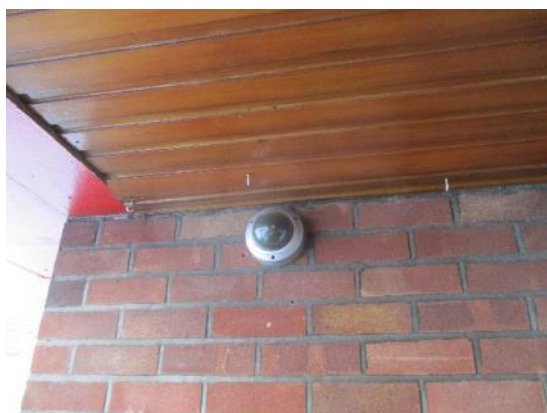
283. CCTV external camera main school entrance.

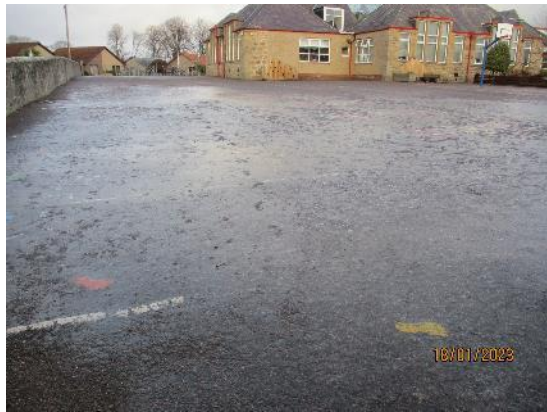
292. Tarmacadam playground

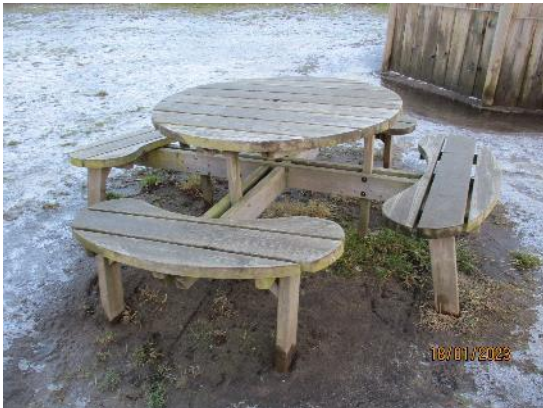
293. Playground furniture

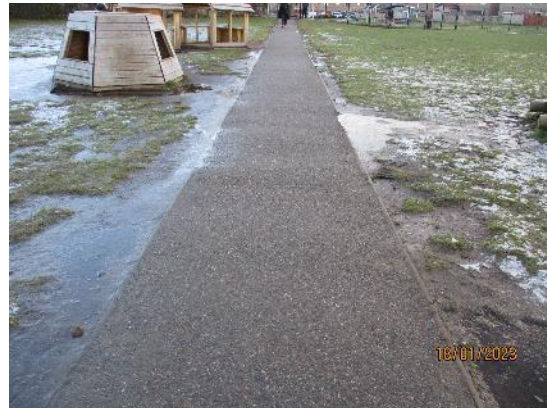
294. Tarmacadam footpaths

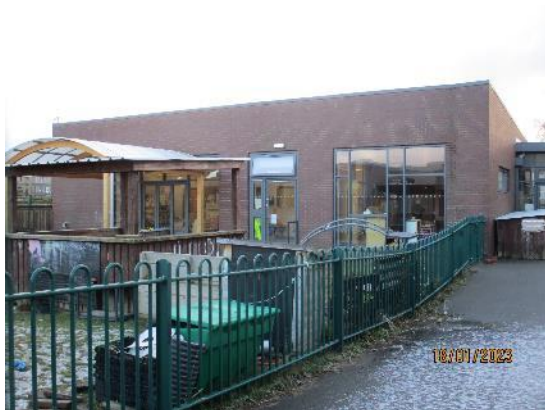
299. Metal bar fencing

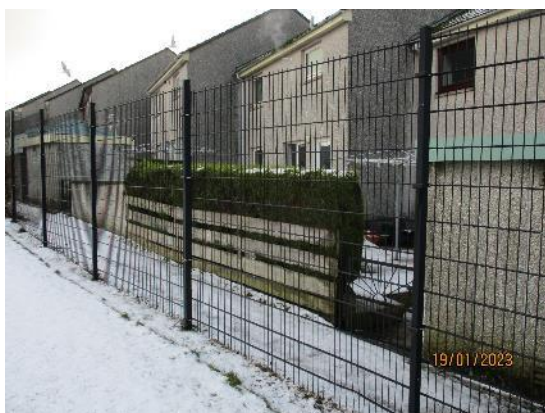
301. High security mesh to playing field

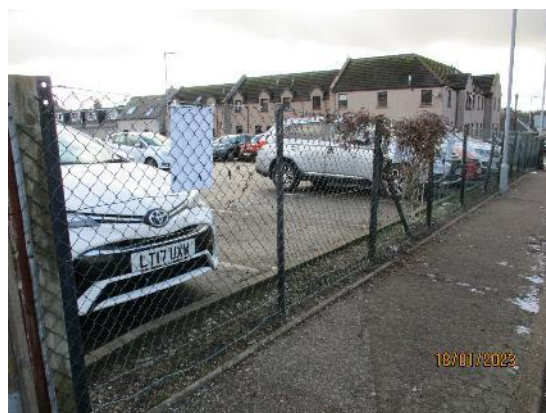
302. Metal chain link fencing

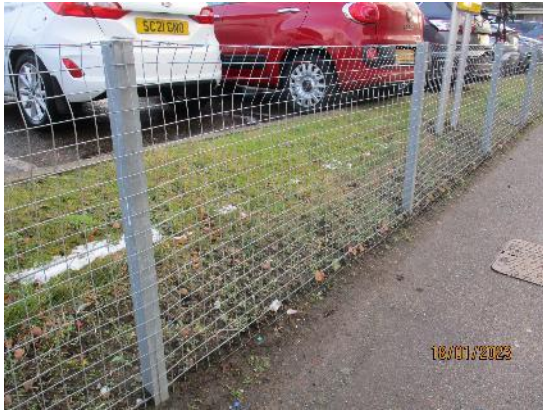
303. Galvanised fencing

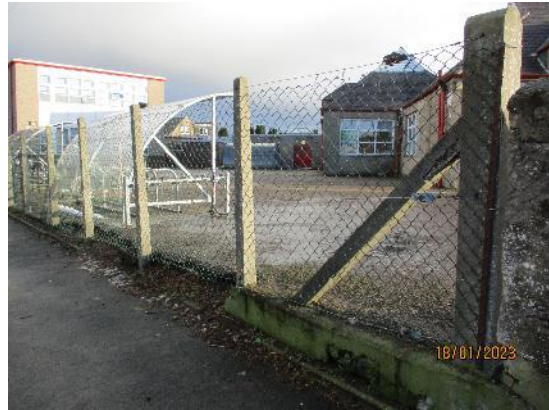
304. Concrete post and chain link

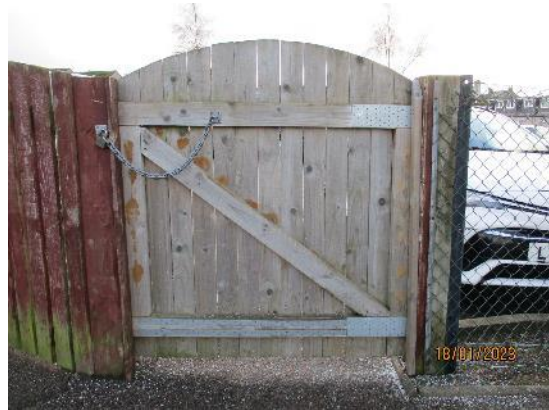
306. Timber boarded gate

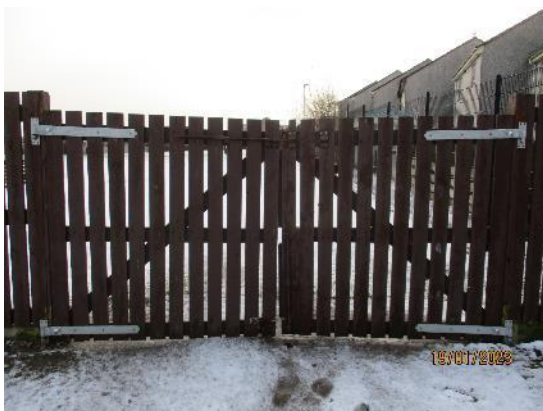
307. Timber double gates to playing field

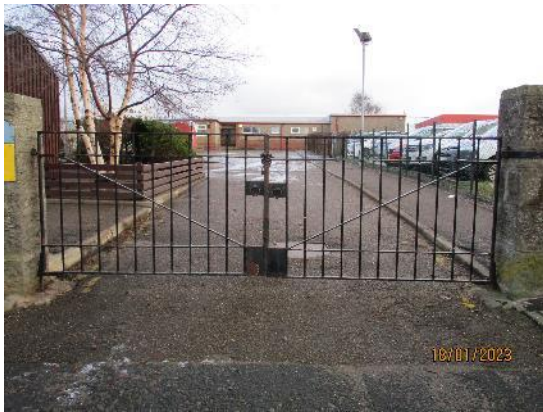
309. Vehicle metal bar gates

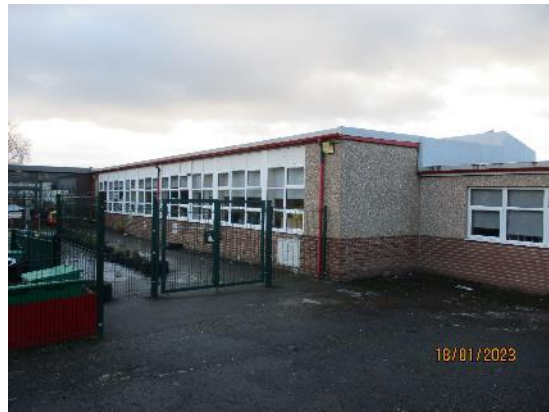
310. Metal framed security gates

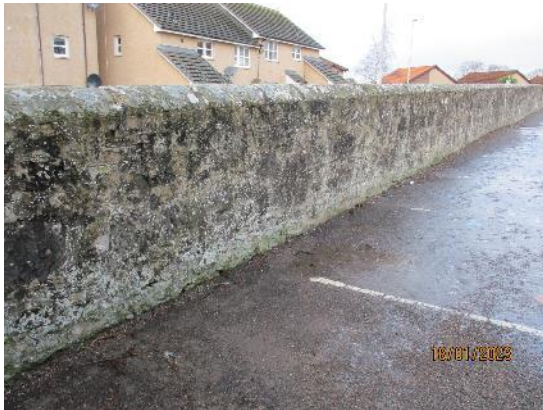
311. Natural stone walls

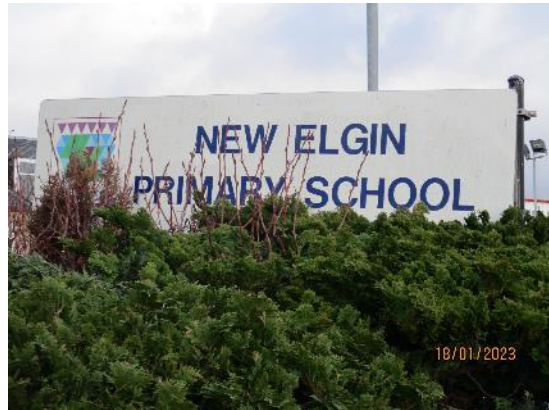
312. School signage

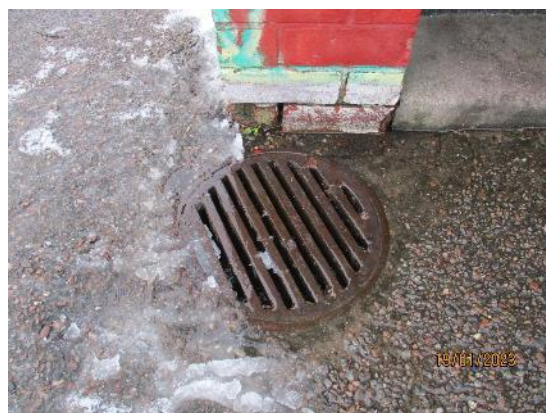
313. Playground drainage

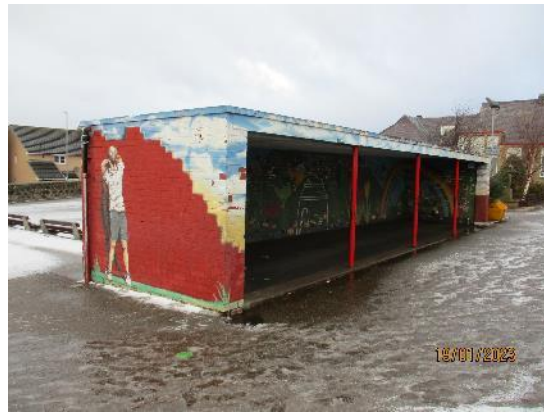
- Paving slab footpaths cracked and broken.
- Playground drainage is blocked.
- Playground shelter requires concrete and brickwork repairs.

316. Playground shelter

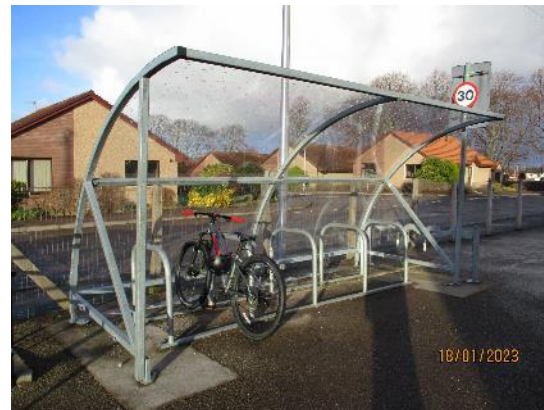
318. Galvanised framed bike shelters

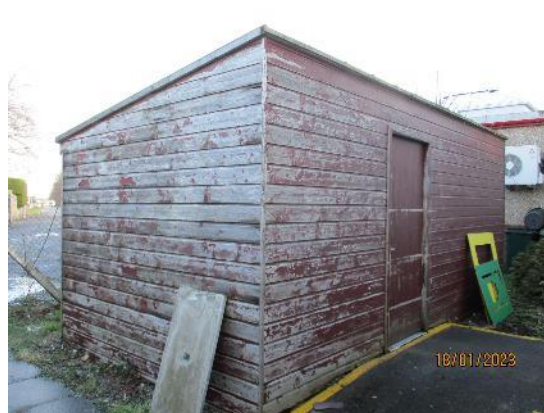
320. Timber sheds
