# **Summary Building Condition Survey Report**

**Mosstowie Primary School**  
**Miltonbrae, Milntonduff, Elgin IV30 8TY**

**3<sup>rd</sup> April 2023**

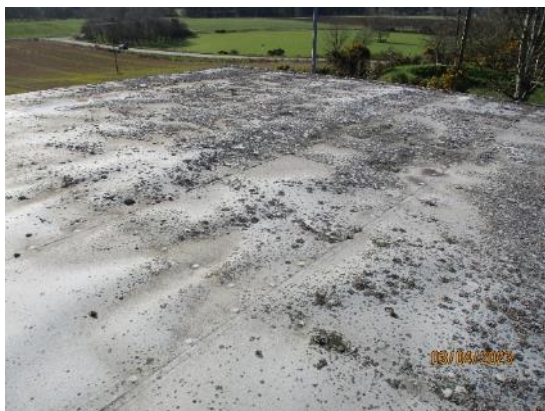
12. Extensive surface lichen and moss

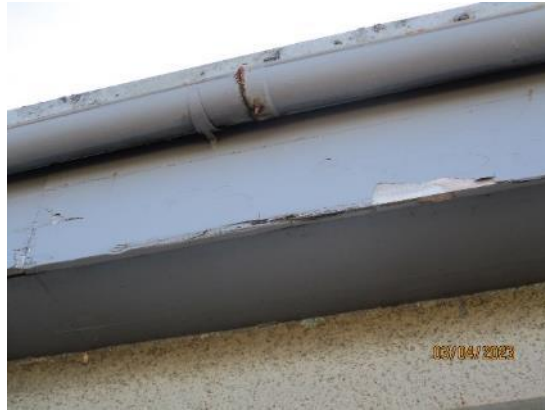
21. Cast iron ogee gutter in poor condition

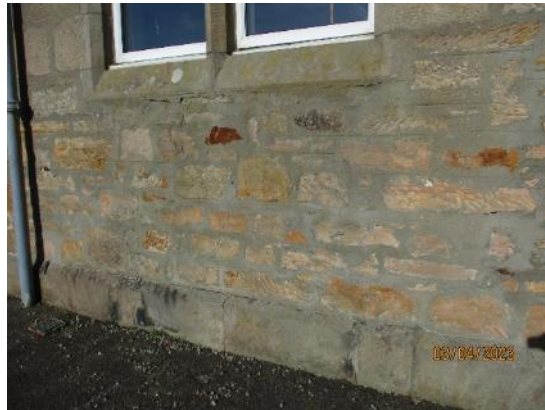
33. Natural stone finish

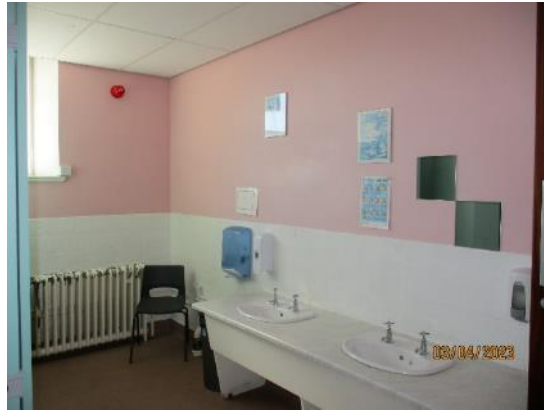
72. Plastered walls

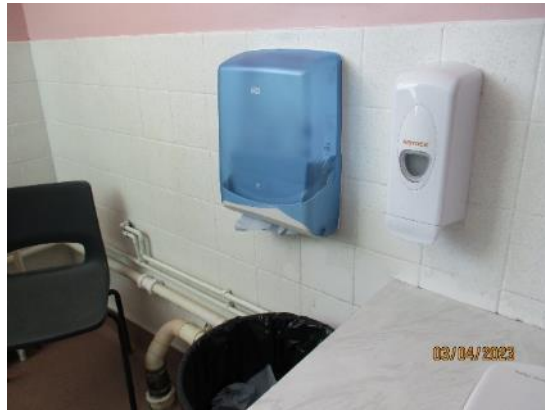
80. Ceramic tile in pupil toilets

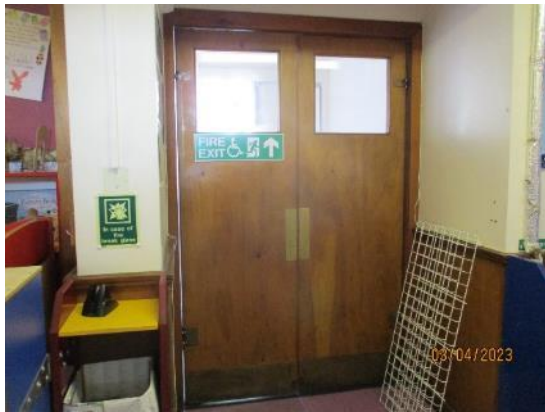
83. Timber double doors to fire escape

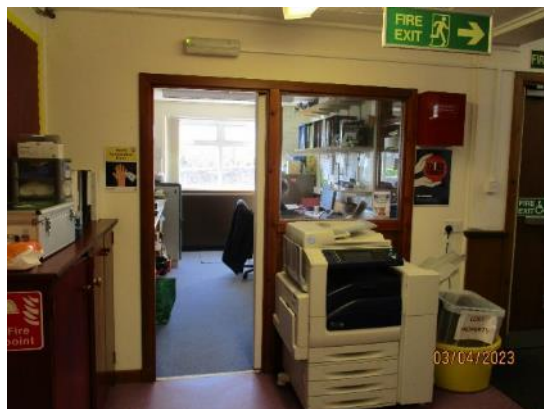
86. Timber screen to Reception

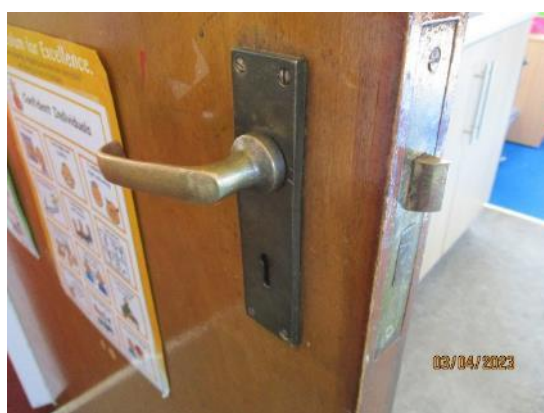
88. Brass lever handles

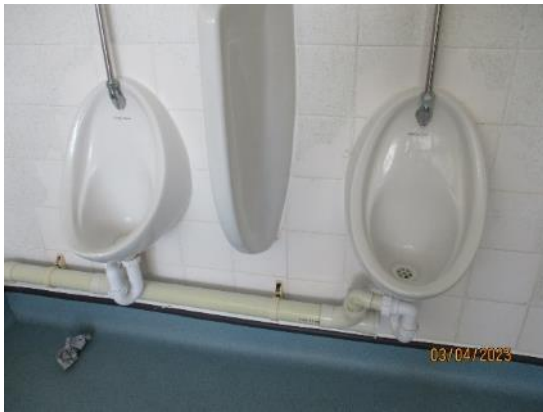
89. Individual china urinals

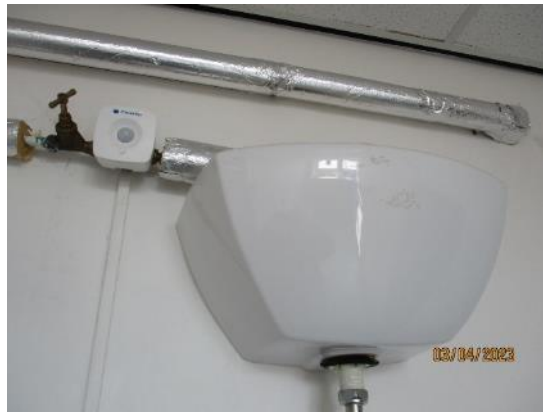
90. China cistern

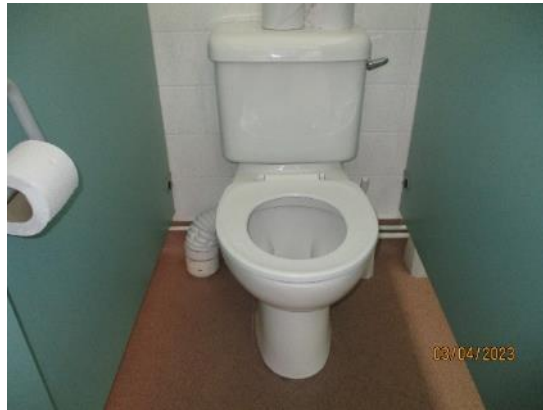
92. Pupil WC's

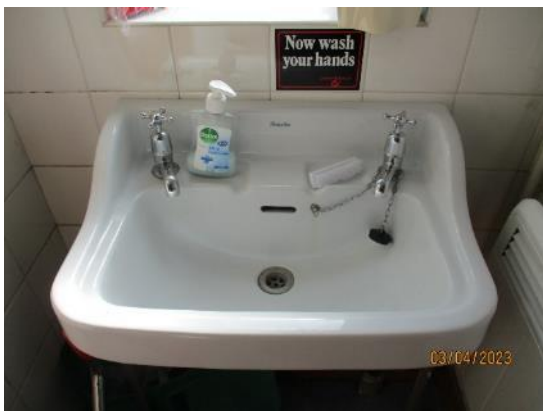
93. Wall hung wash hand basins

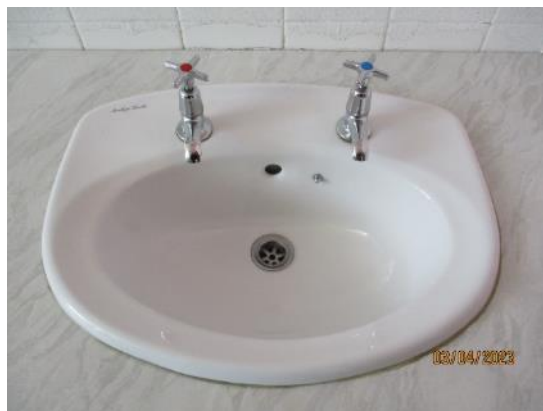
94. Vanity china basins

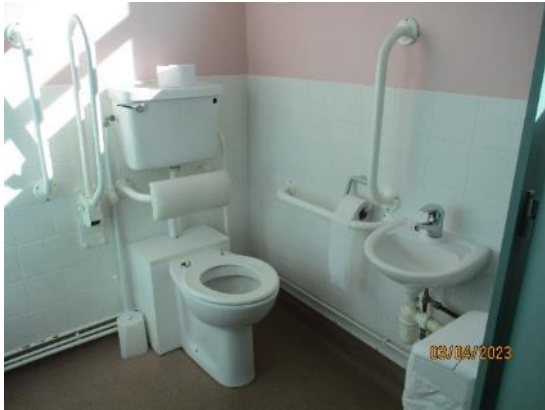
95. Accessible toilets

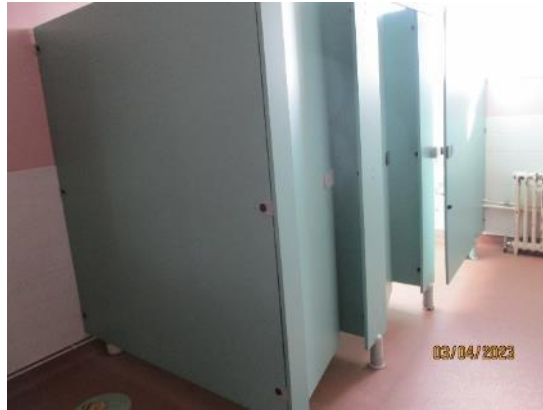
96. Composite cubicle partitions

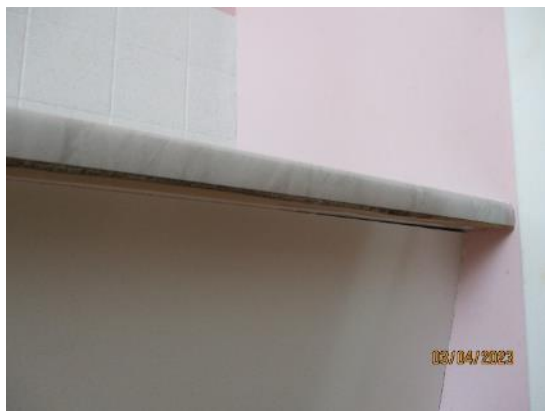
99. Laminating worktop

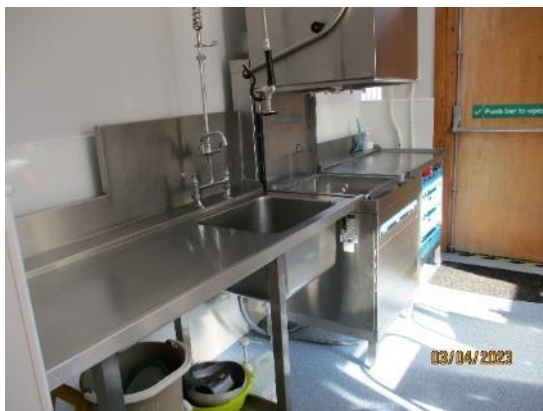
100. Commercial kitchen

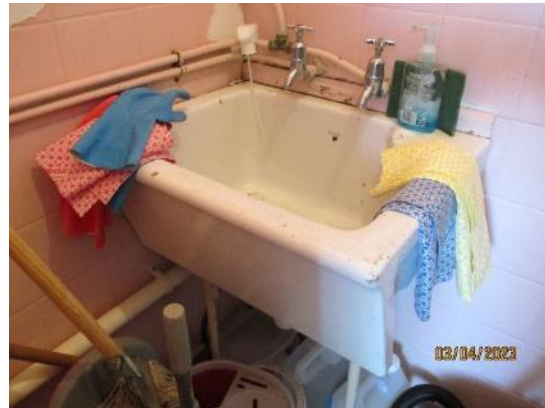
104. Cleaners butler sink

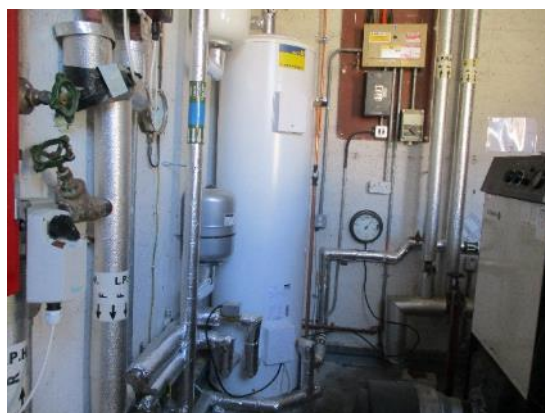
123. Hot water calorifier – boiler house 0/14

Domestic hot water is also generated by the oil fired boilers and is stored in a recently installed unvented, stainless steel calorifier. Hot water is distributed around the building via a pumped copper circuit. Hot water pipework is only insulated in parts.

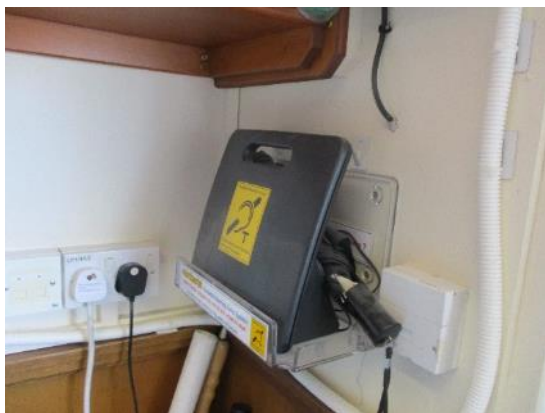
153. Portable hearing loop. Office 1/8

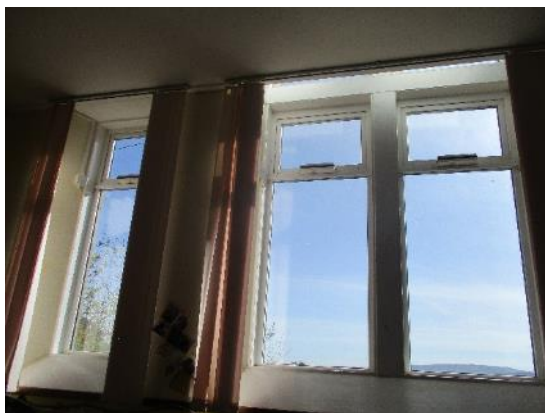
158. Electric window operators classroom 1/4

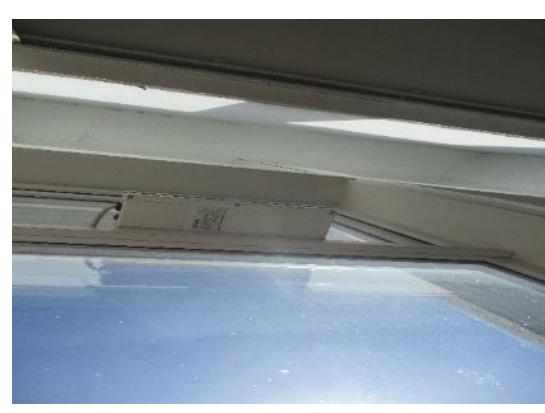
159. Electric window operators classroom 1/4

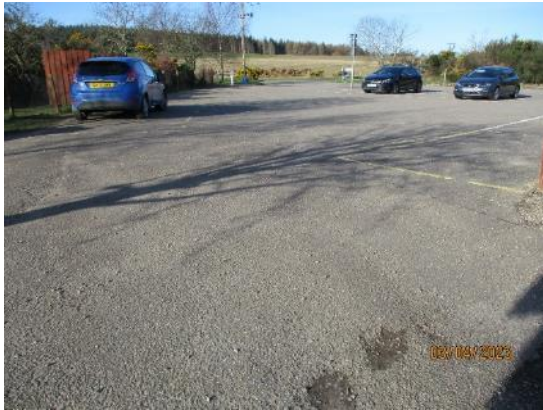
160. Tarmacadam car park

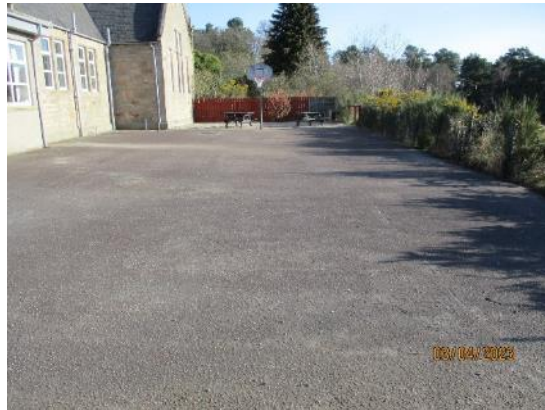
163. Tarmacadam east playground

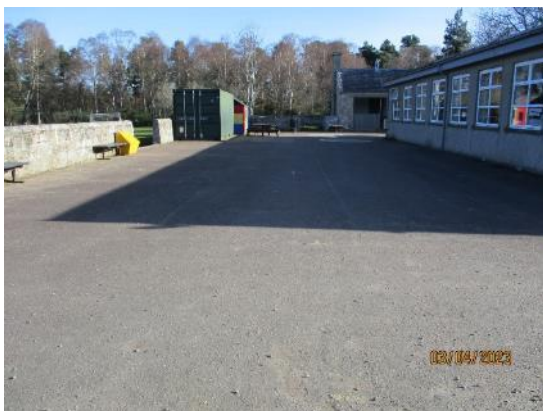
164. Tarmacadam west playground

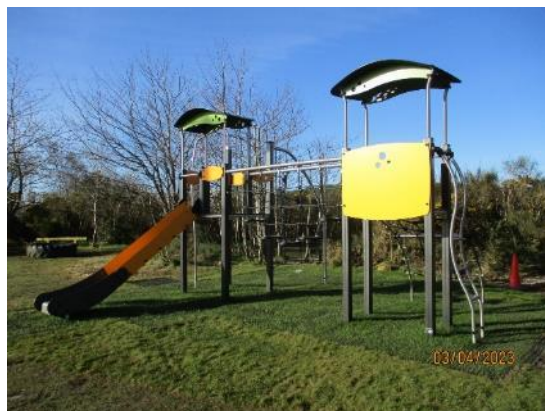
165. Playground equipment

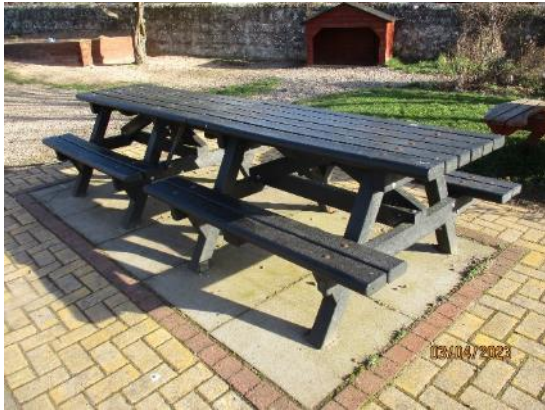
166. Recycled tables and benches

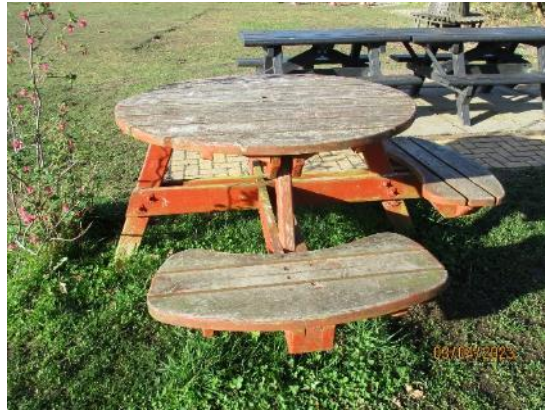
167. Timber tables and benches

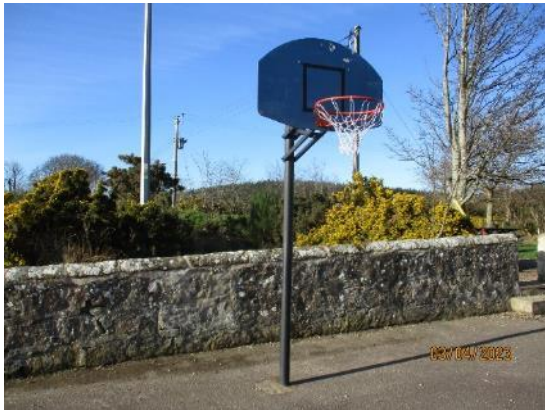
168. Basketball hoops

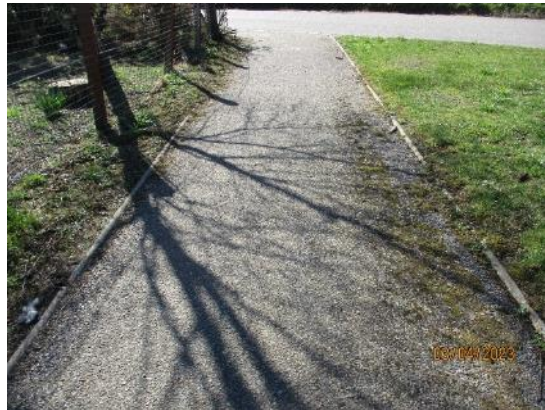
169. Tarmacadam footpath

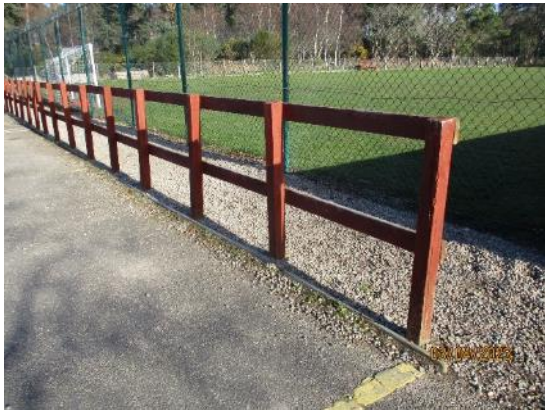
174. Timber post and rail fence

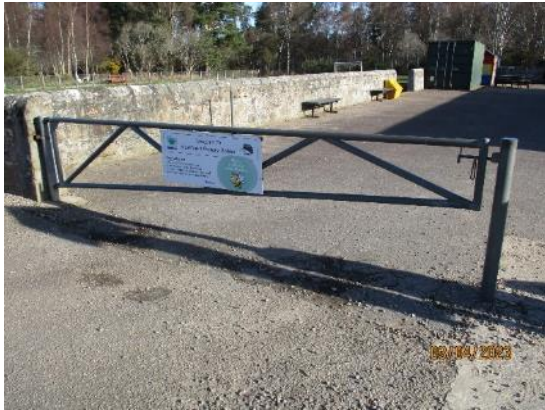
178. Galvanised tubular vehicle gate

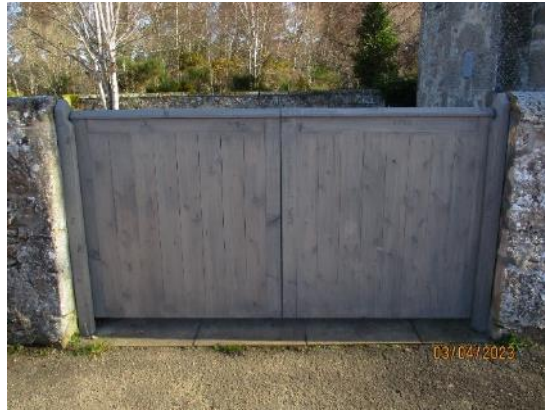
179. Timber double gate to the garden

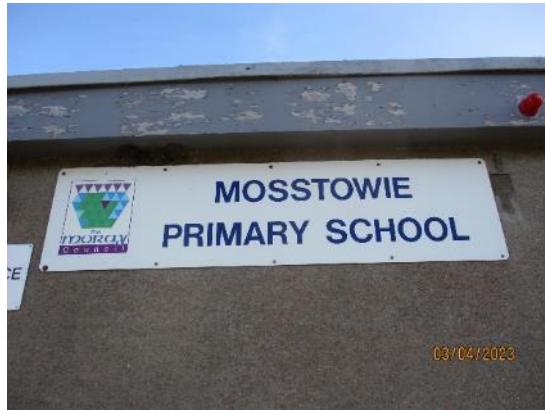
181. School signage

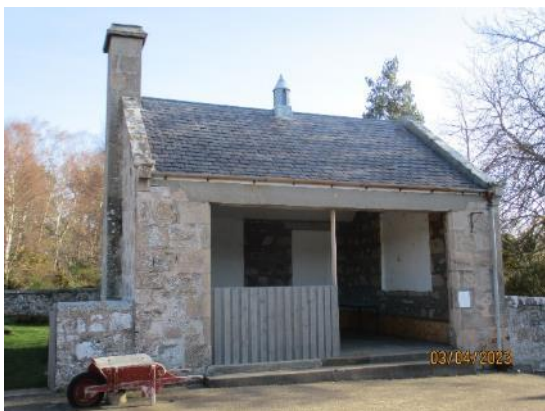
182. External shelter

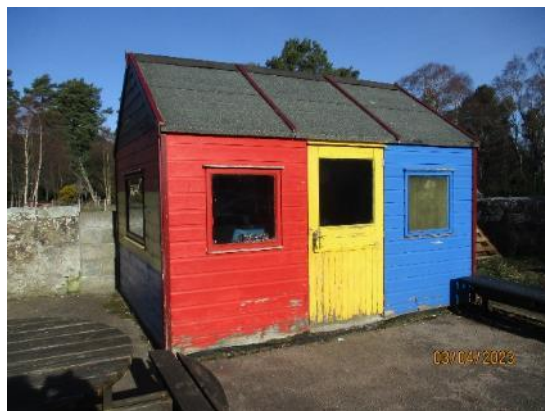
183. Timber shed

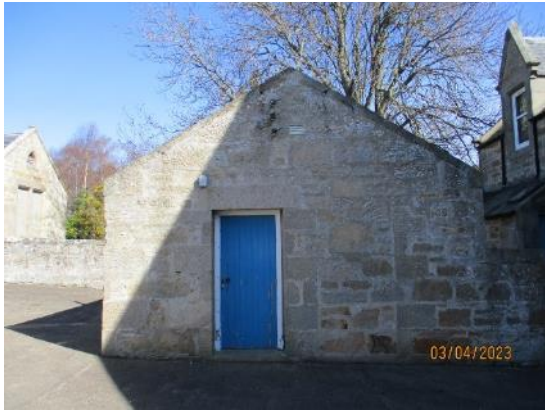
184. External store

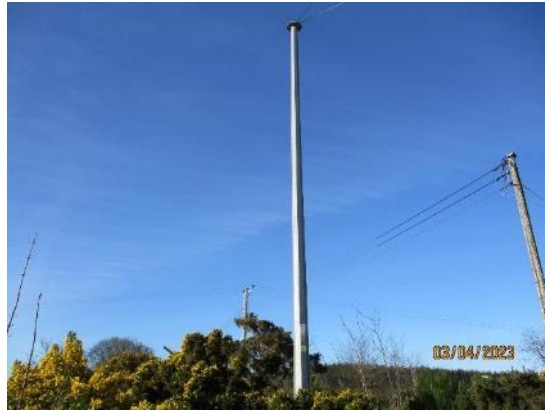
185. Aluminium utility pole

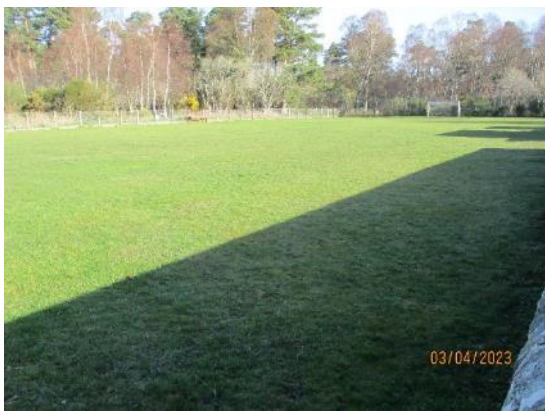
188. Grass sports field

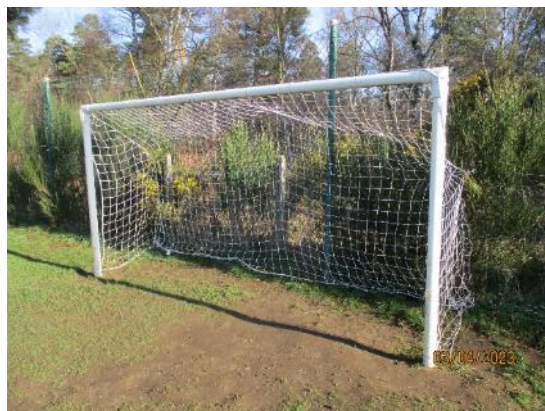
189. Football goal posts
