# **Summary Building Condition Survey Report**

**Greenwards Primary School**

**Edgar Road, Elgin IV30 6UQ**

**28<sup>th</sup> & 29<sup>th</sup> November 2022**

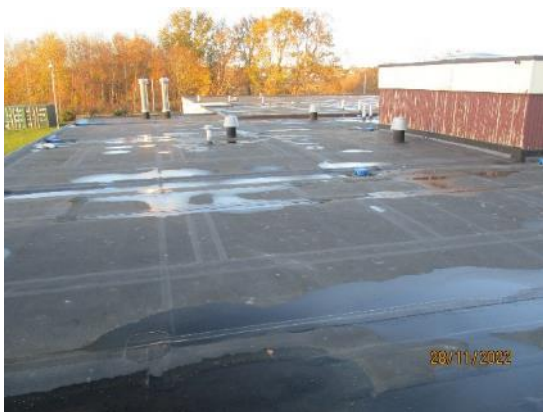
3. Single ply membrane (Alwitra)

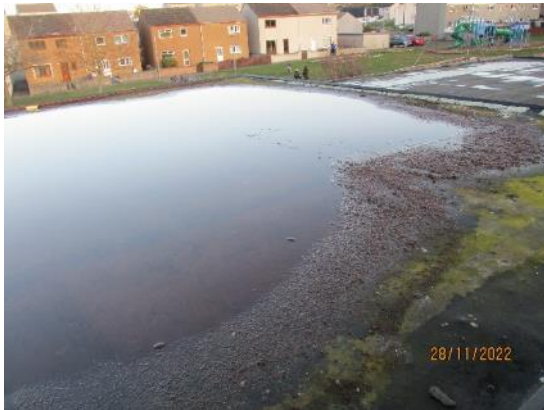
9. Significant ponding

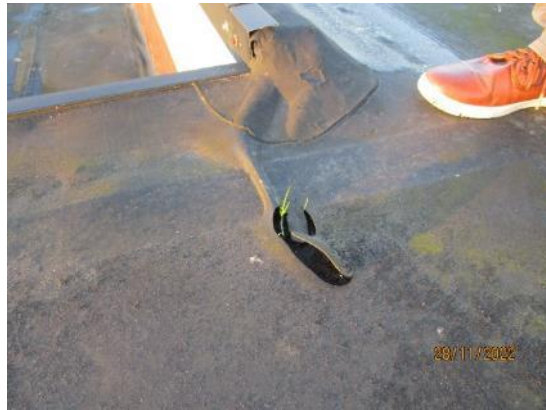
10. Tears and punctures

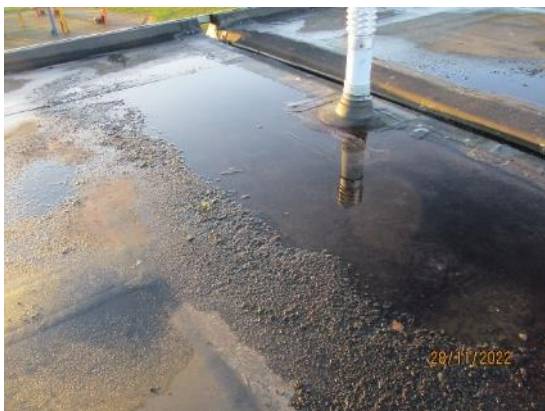
11. Cleaning required

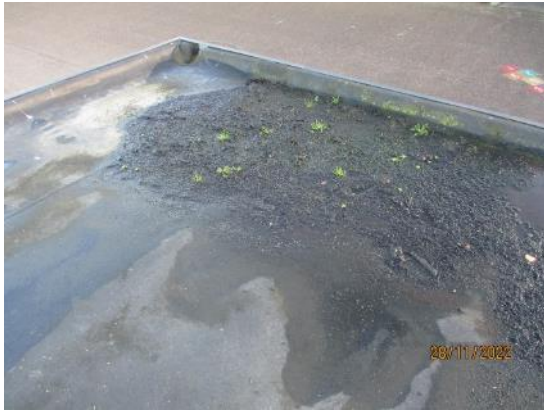
13. Surface silt and debris

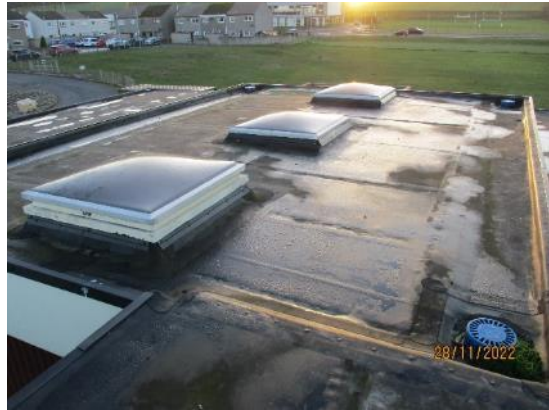
14. GRP domes

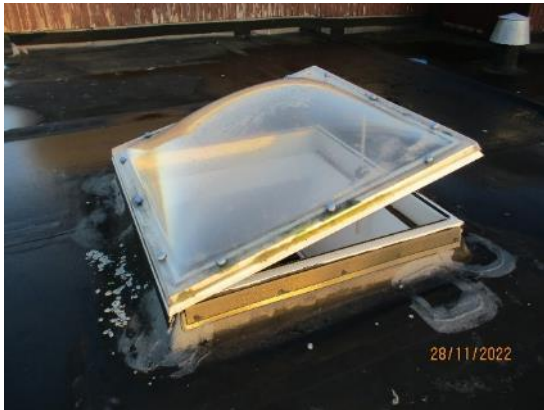
15. Some electrically operated

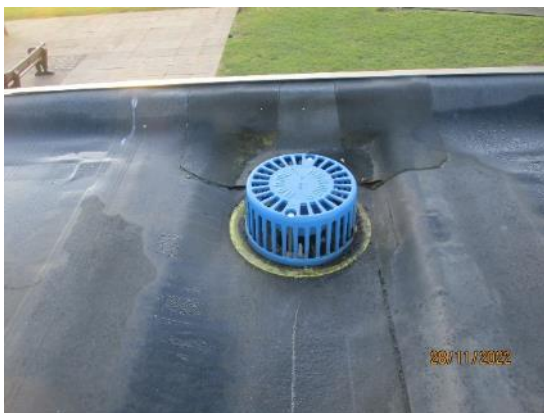
23. Flat roof outlets

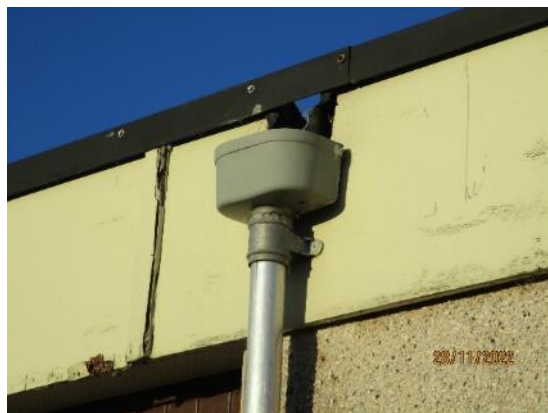
24. Hopper heads and downpipes

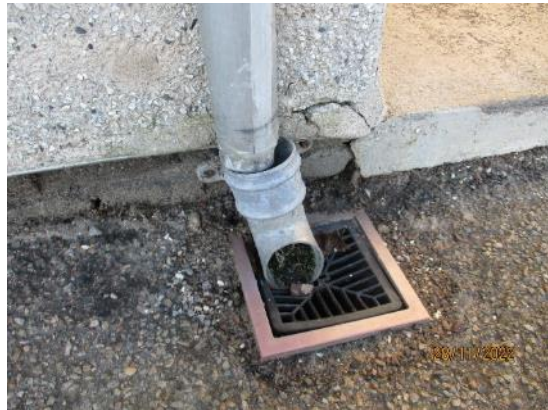
28. Displaced downpipe

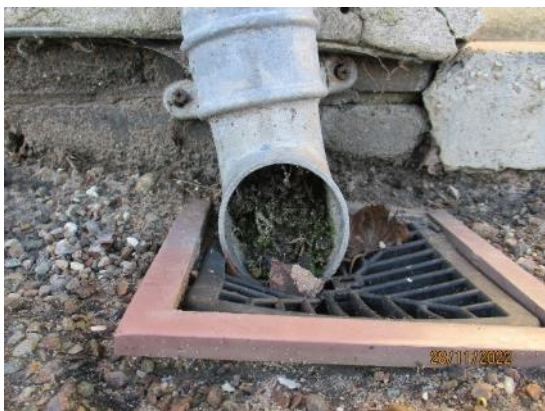
29. Blocked downpipe

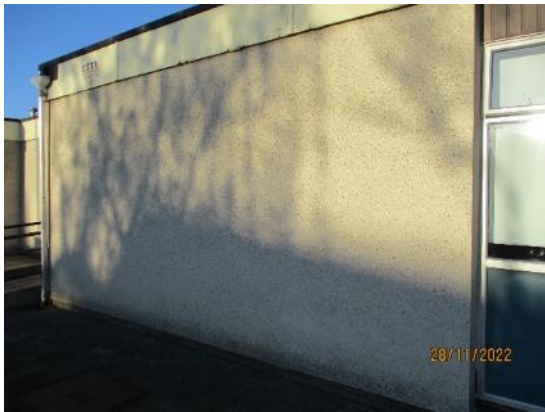
30. Dry dash roughcast

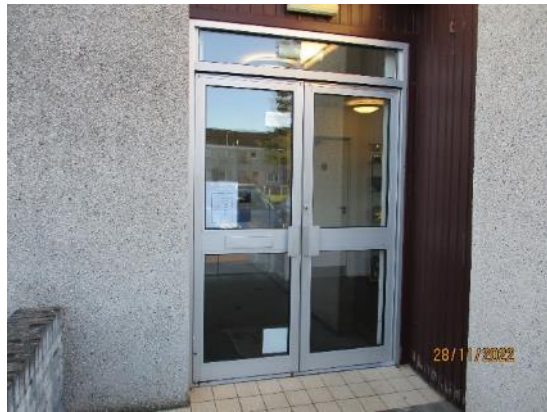
31. Aluminium entrance door

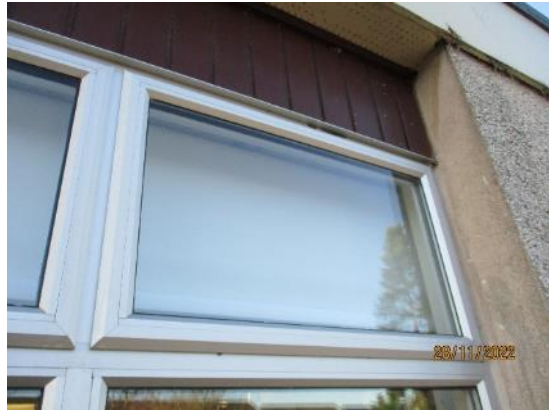
43. Opening hopper head windows

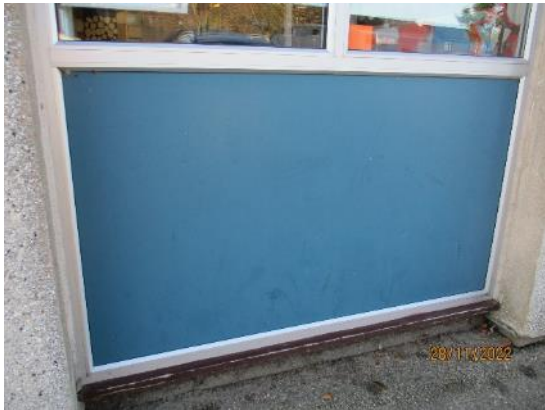
44. Metal panels below

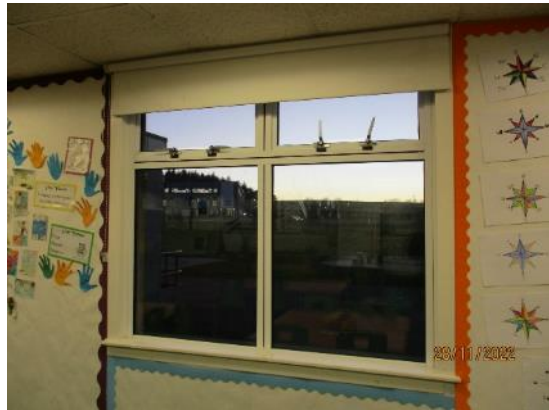
45. Windows internally

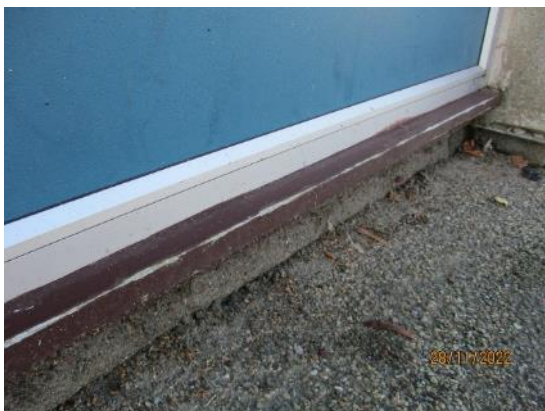
46. Timber sills

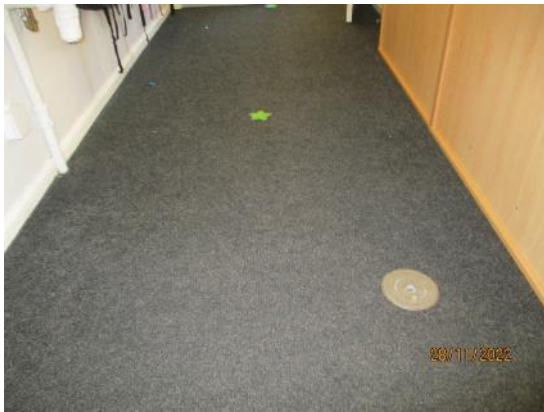
64. Carpet – soiled and stained

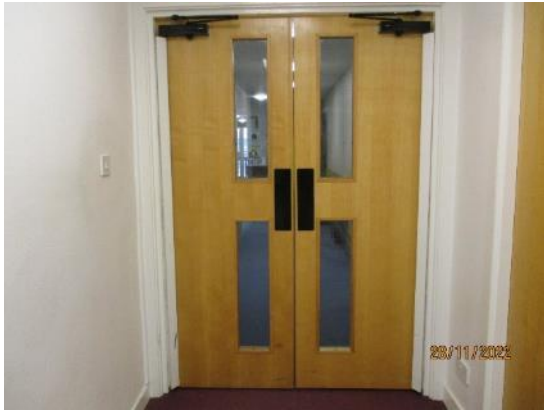
93. Veneered timber double doors

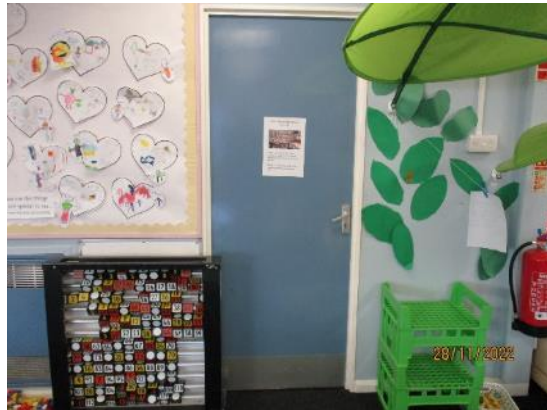
96. Timber doors (Stores etc.)

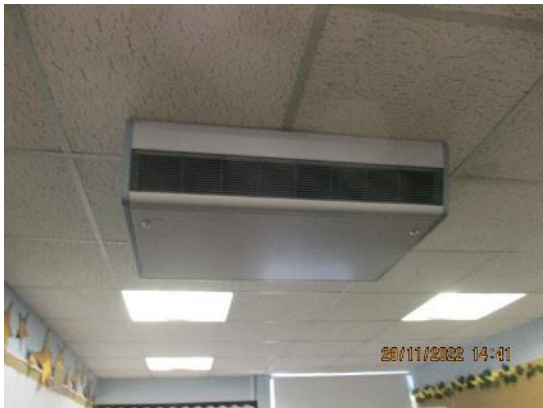
139. Fan convector heater SEN zone typical.

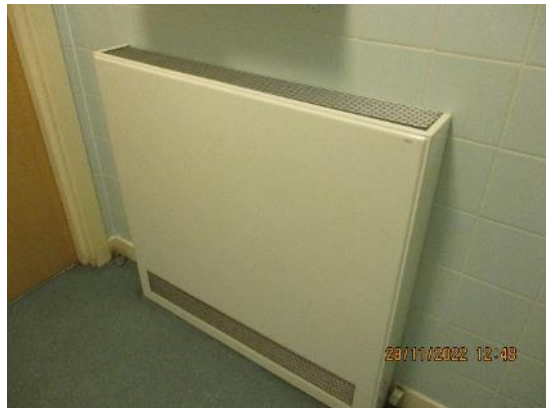
140. Radiator – LST type SEN zone typical.

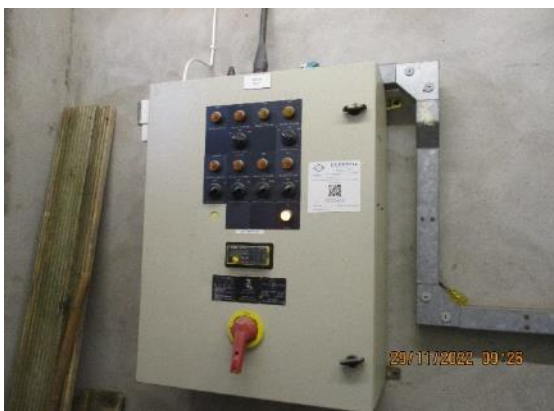
141. Heating control panel SEN zone 1/54

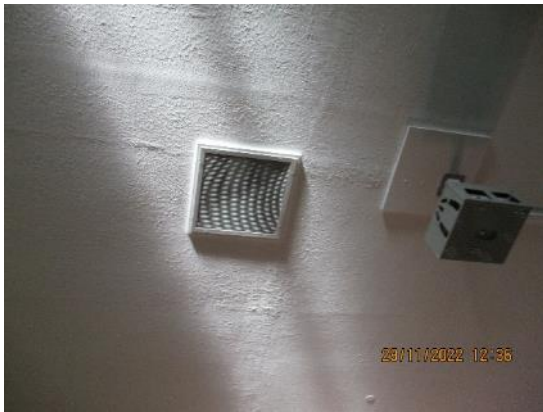
161. Extract /supply fan. Games hall main school.

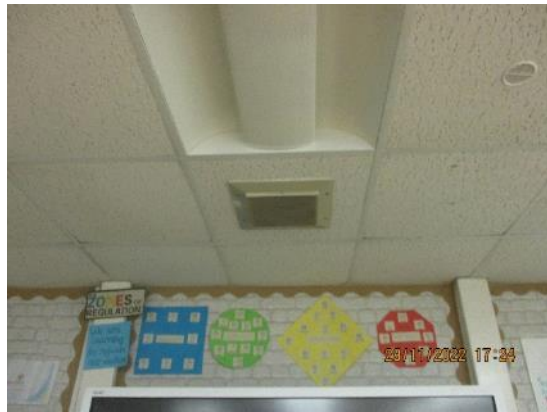
162. Extract fan – classroom main school typical.

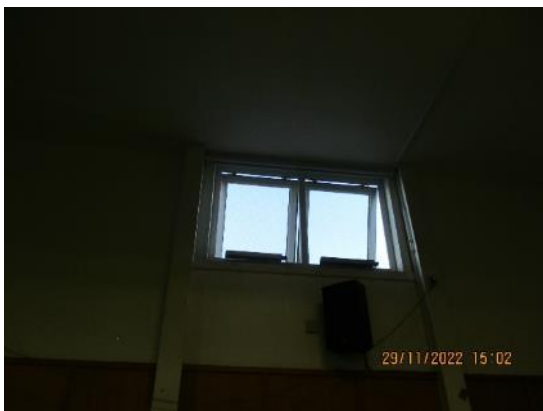
165. Electric operated windows. Games hall.

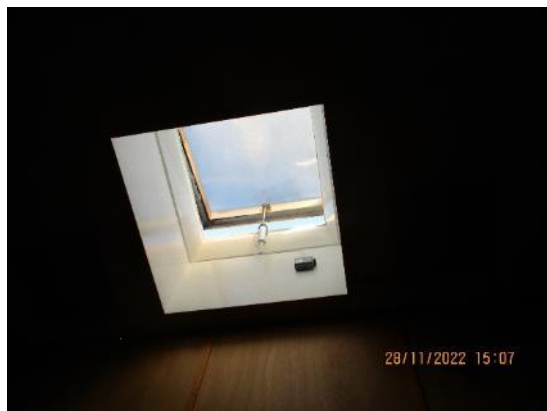
166. Electric motor operated roof lights. Typical.

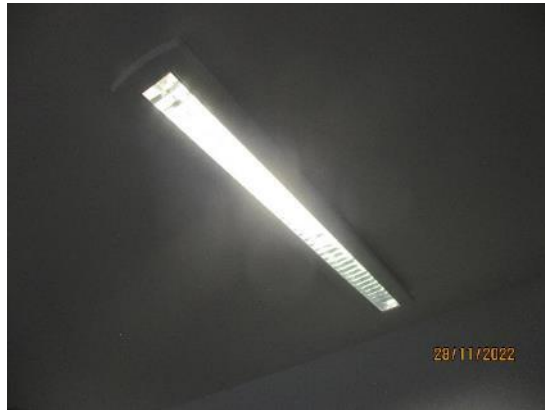
181. Emergency lighting central battery – extension 1/41

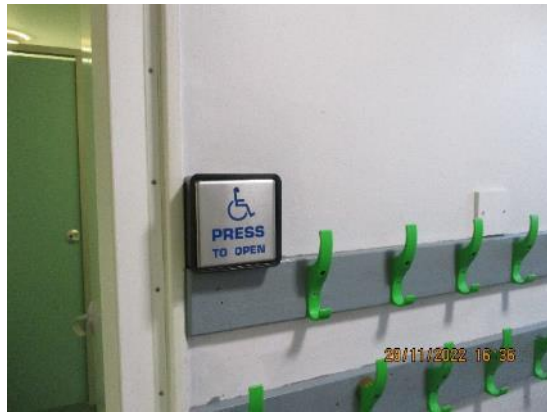
191. Automatic electric operated doors. 1/36a

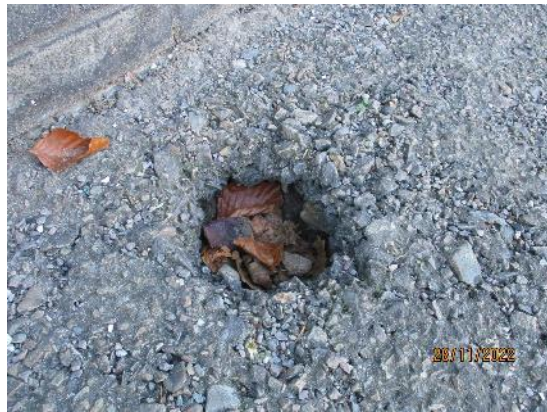
203. Tarmacadam car park

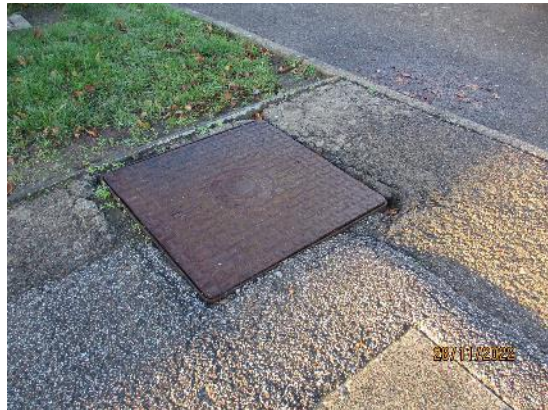
211. Tarmacadam footpaths

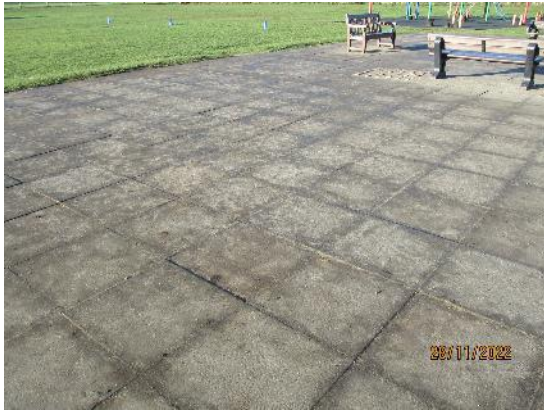
215. Paving slab play area

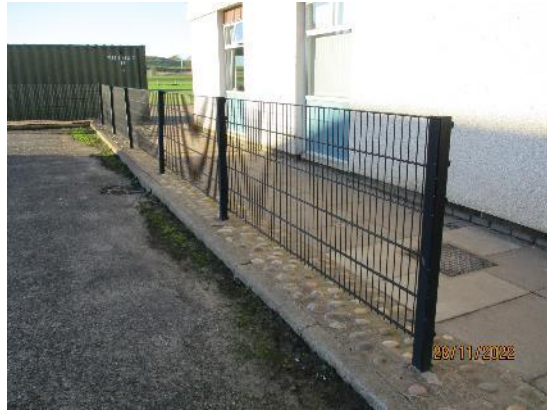
222. Metal security fencing

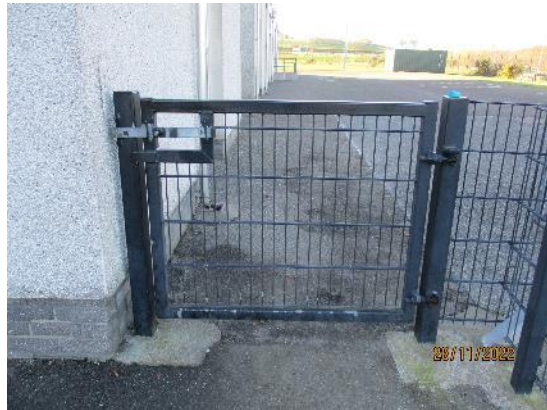
224. Metal mesh gates

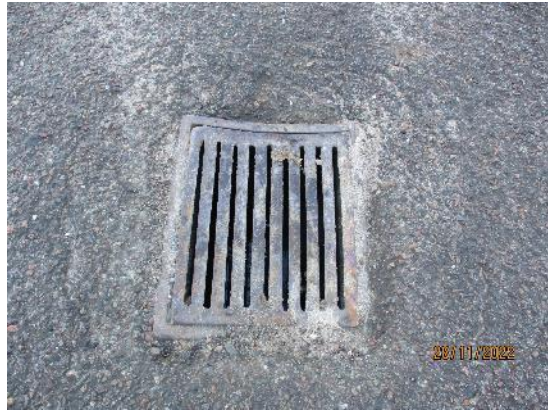
234. Playground drainage

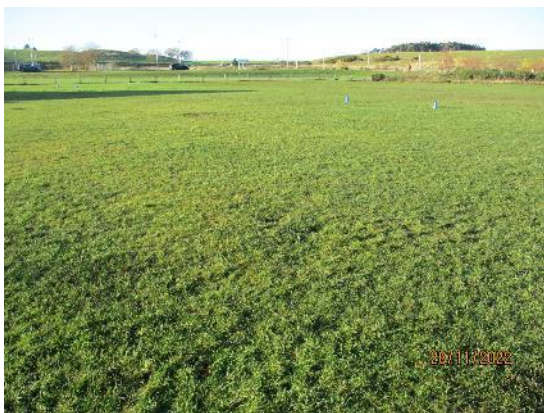
236. Sports field grass
