# **Summary Building Condition Survey Report**

**St Thomas Primary School  
Chapel Street Keith AB55 5AL**

**10<sup>th</sup> January 2024**

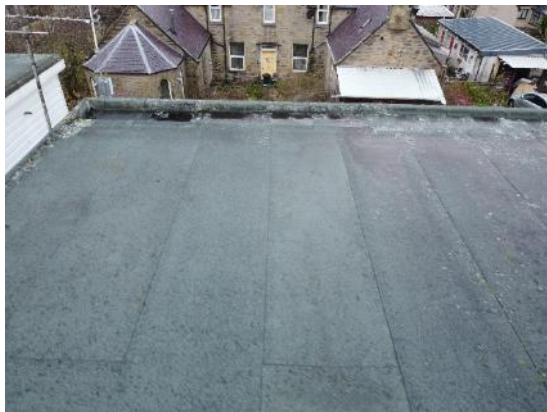
3. Games Hall roof

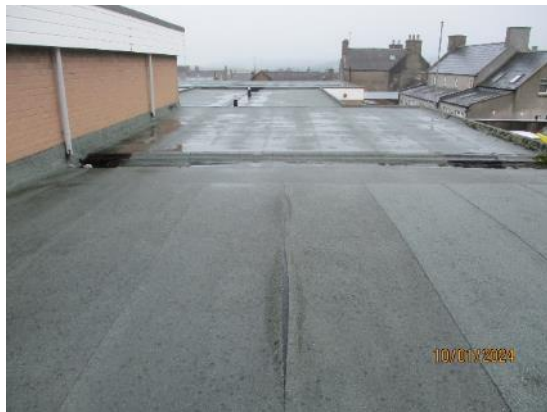
4. Felt roofing - general

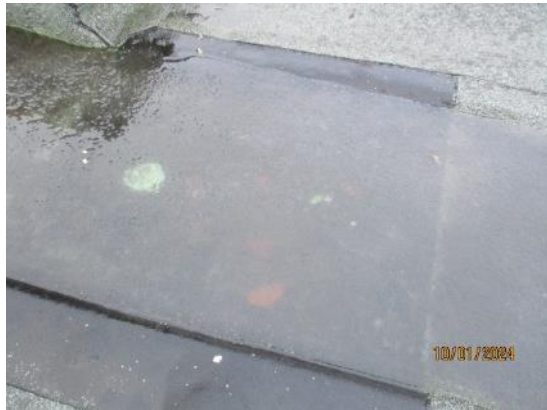
22. Frozen/blocked downpipes

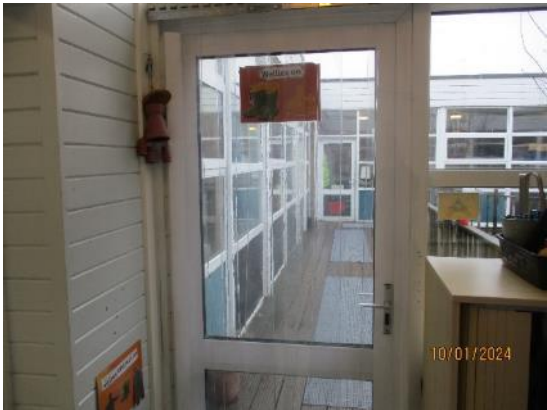
39. Powder coated doors to the Courtyard

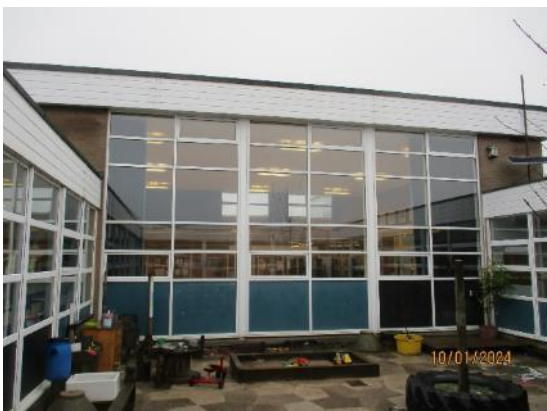
41. Powder coated glazed screen to the Games Hall

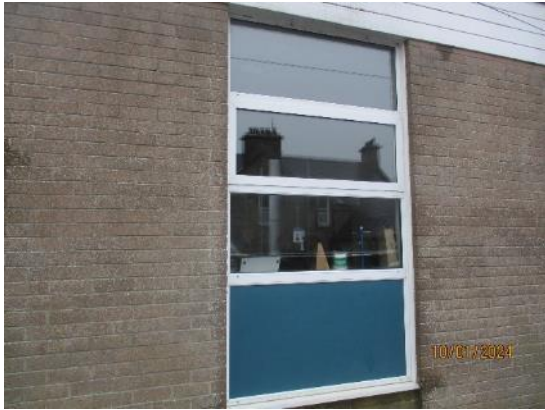
43. Powder coated (small) windows

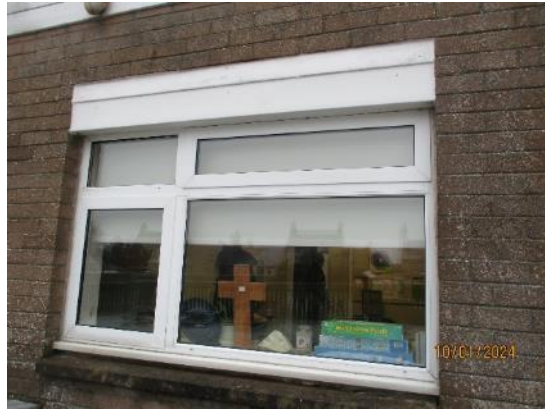
44. Medium size windows

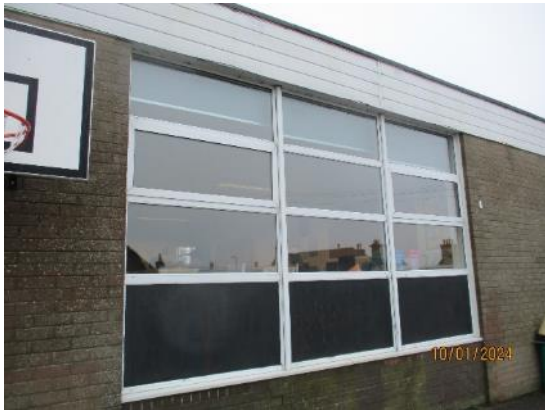
45. Large windows

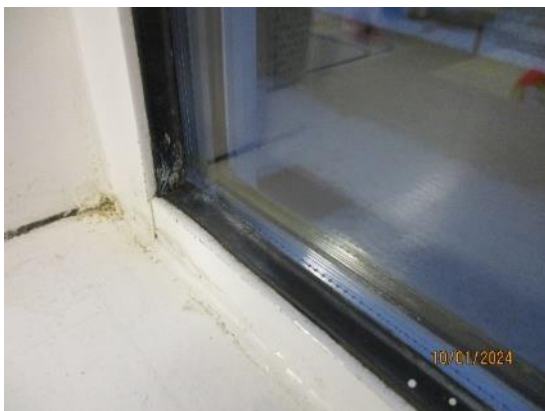
47. Double glazed units

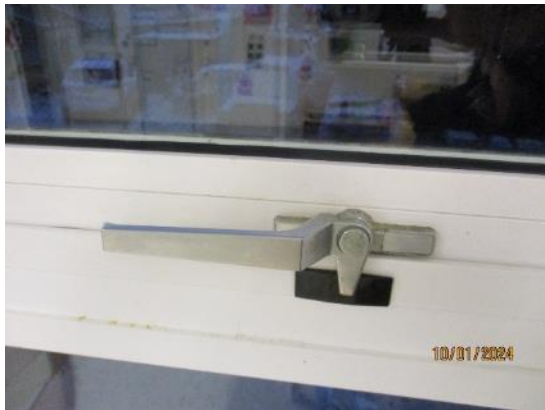
49. Typical window lever handles

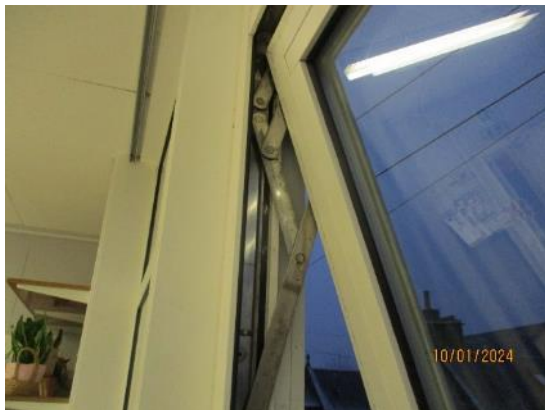
50. Missing keepers

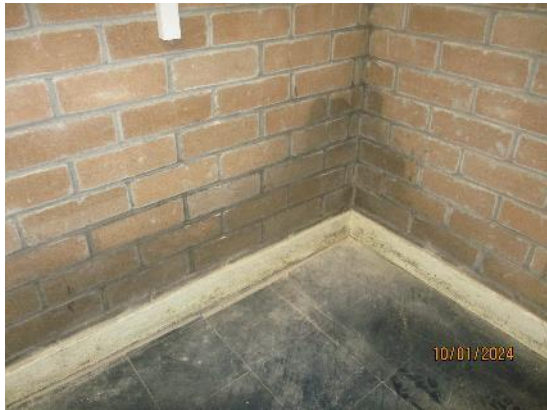
92. Condensation mould growth (not damp)

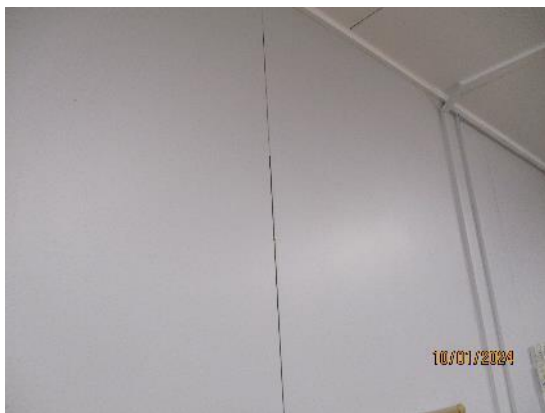
95. Plasterboard with no taping & filling

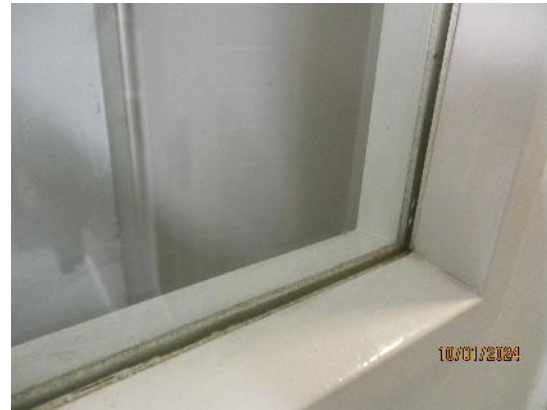
111. Clear glazing to doors

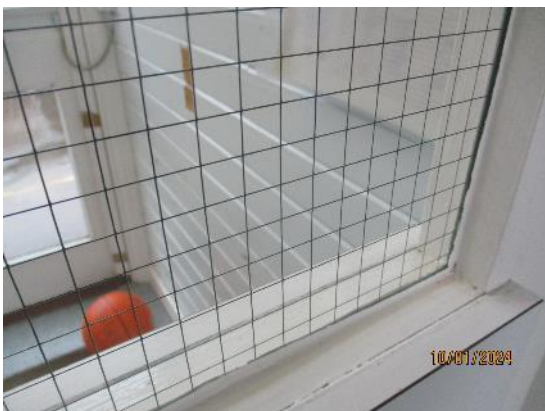
112. Georgian wired glass to doors

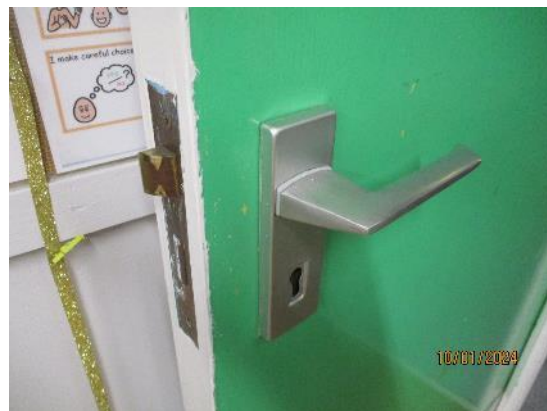
113. Aluminium lever handles to internal doors

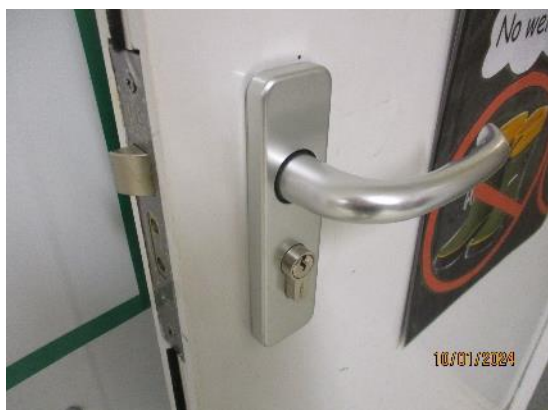
114. Aluminium lever handles

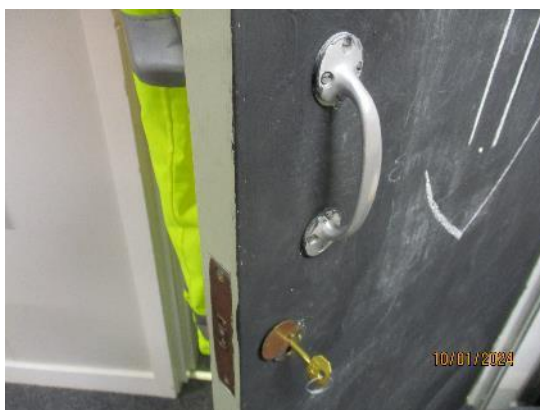
115. Aluminium pull handles

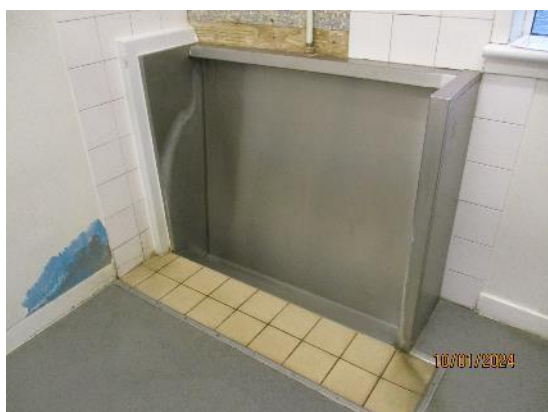
116. Stainless steel floor standing urinal

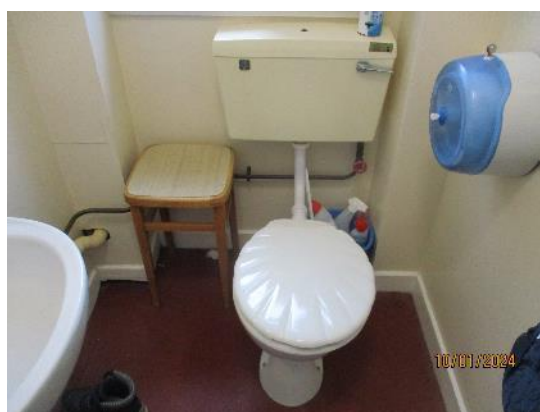
121. Staff W.C.

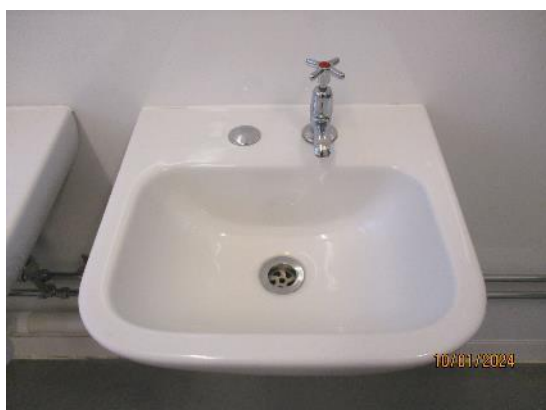
122. Boys wall hung basins

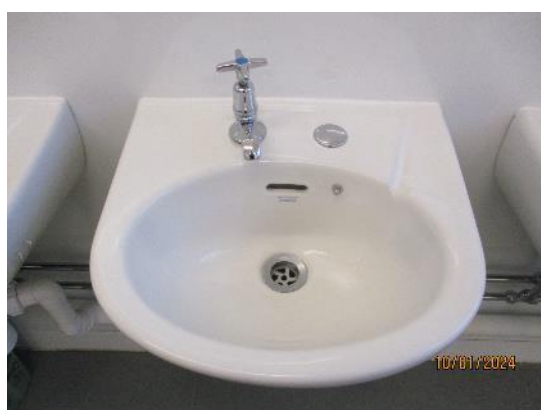
123. Girls wall hung basins

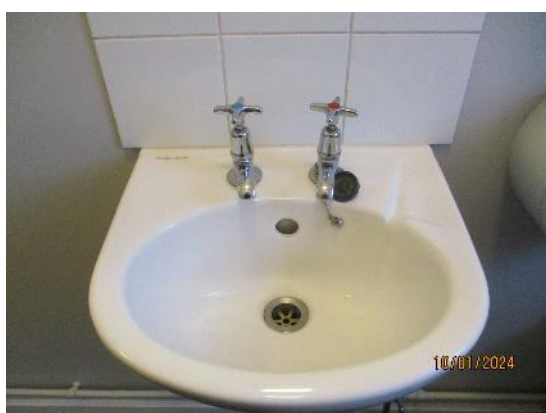
124. Staff wall hung basin

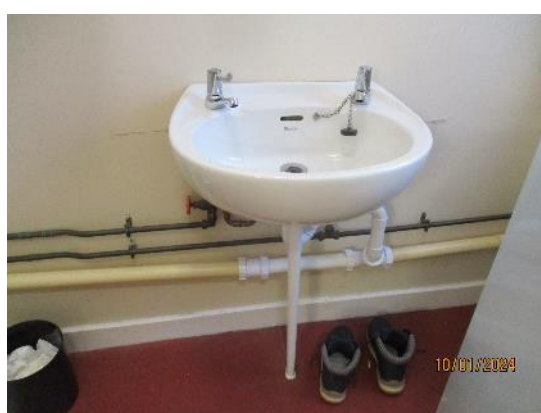
125. Wall hung basin with single leg

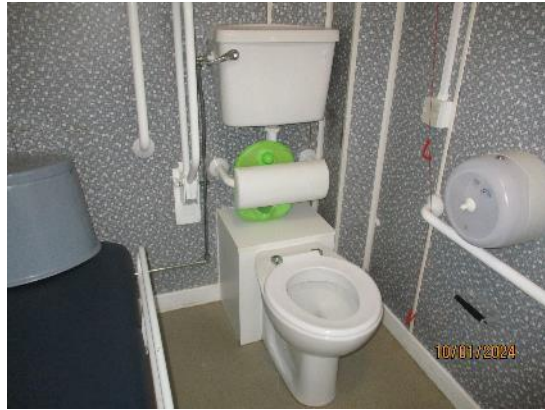
127. Accessible toilet

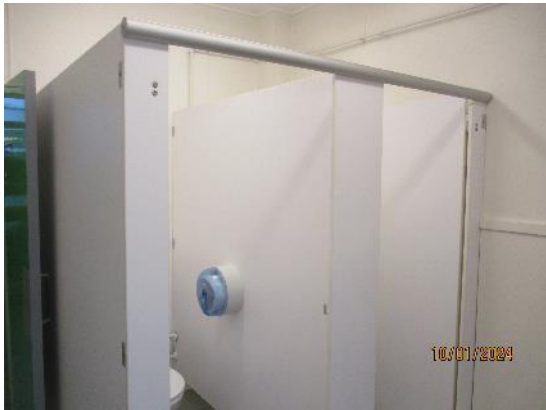
128. Composite cubicles

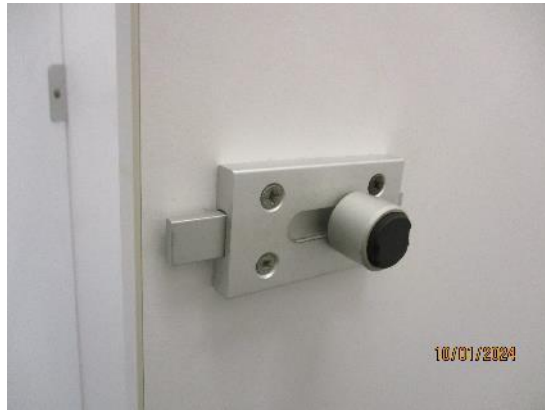
129. Ironmongery

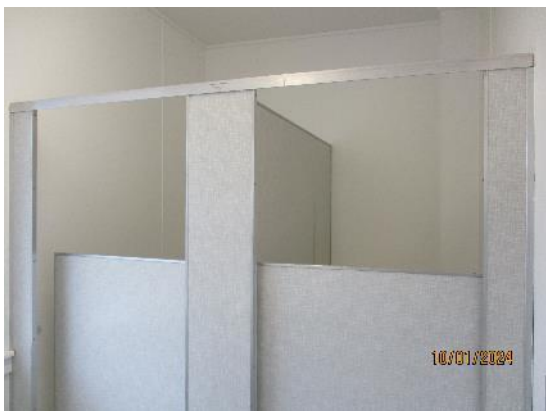
129. Dated composite cubicles – Nursery

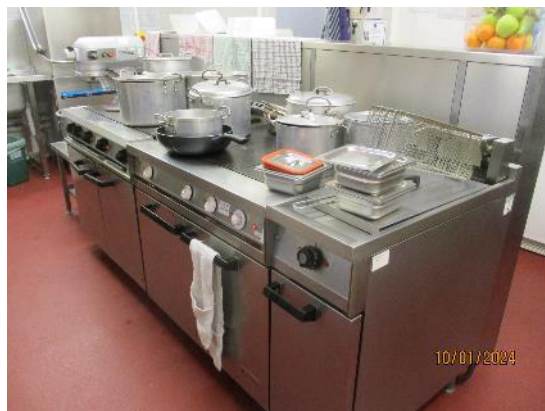
130. Commercial kitchen

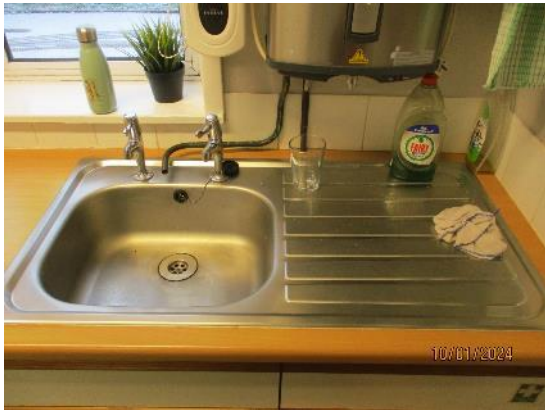
133. Stainless steel kitchen sinks

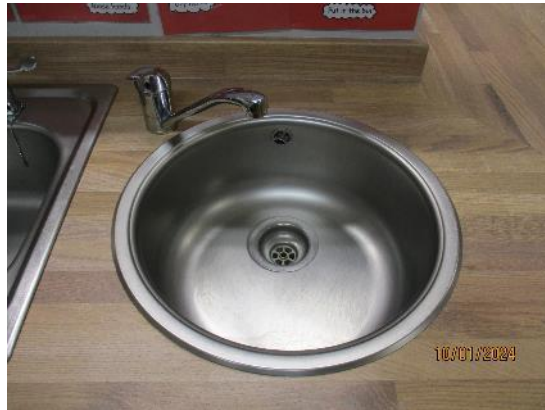
134. Stainless steel inset sinks

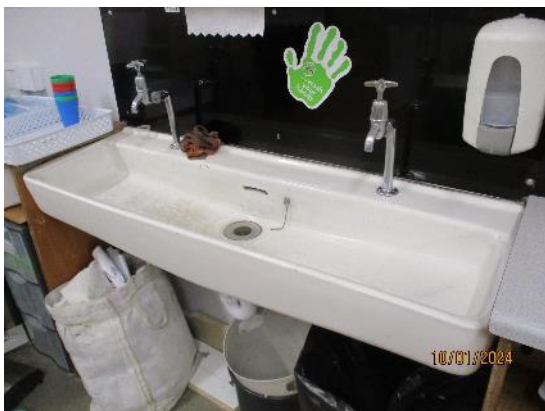
- Mineral felt roofs are life expired with several significant defects.
- Rainwater is ponding around the tank house.
- Gratings are missing from most of the rainwater downpipes.
- External brick walls have significant cracking.
- Cracking to and around concrete lintels.
- Window hinge mechanisms are failing and not sealing windows.
- Some windows have blown double glazed units.
- Ceramic wall tiles are broken and missing.
- The concrete floor has a sag in the corner of the Games Hall Store.
- Carpets are worn and soiled.
- Sheet vinyl has open joints.
- Vinyl tiles are cracked and broken.
- Classroom china trough sinks are worn, crazed with surface damaged.

135. China trough sinks - Classrooms

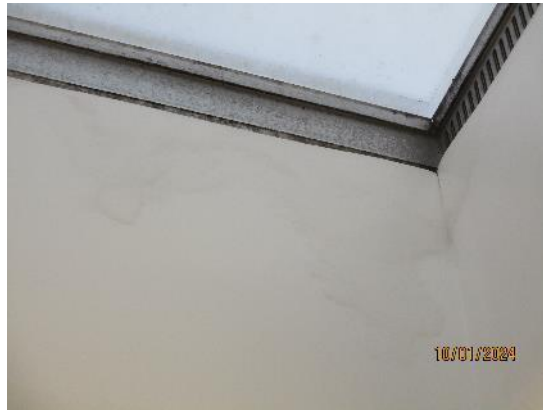
139. Watermarked walls

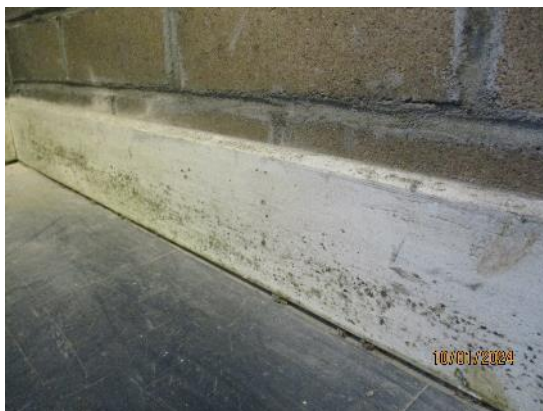
141. Mould marked skirting boards

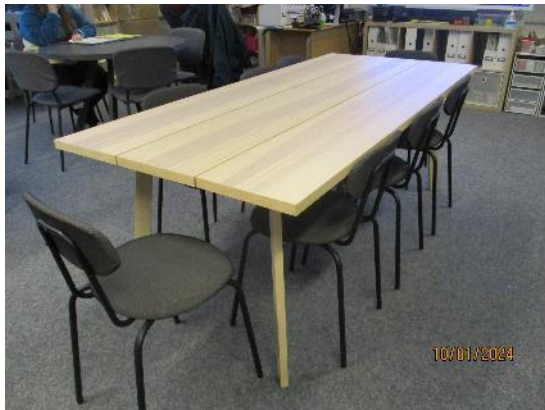
142. Classroom tables and chairs

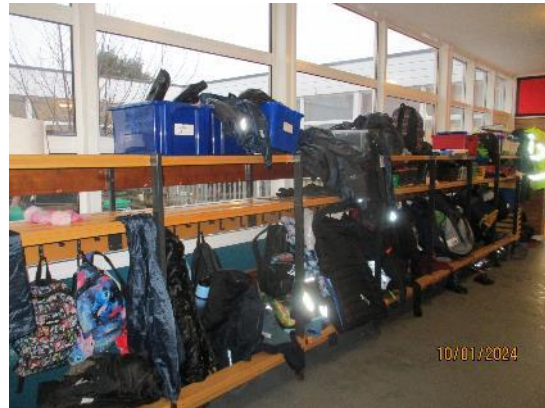
145. Coat hook racks

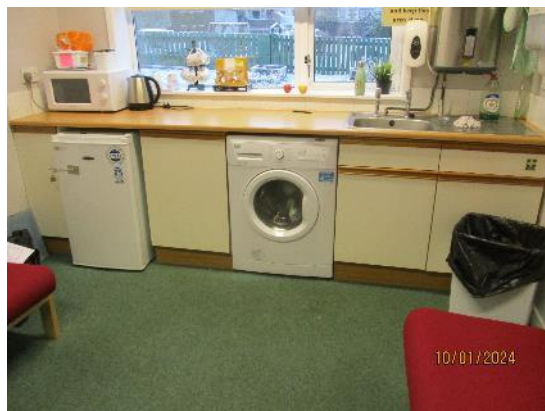
147. Kitchen units – staff room

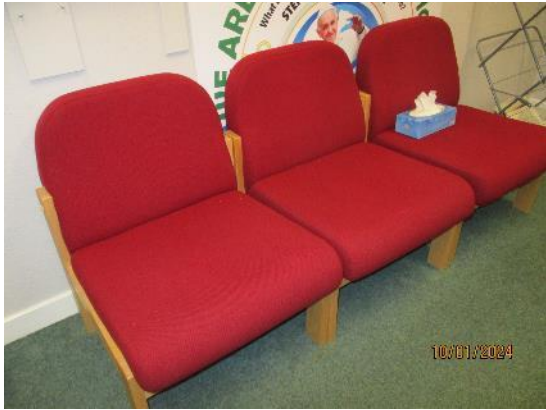
148. Staff room furniture

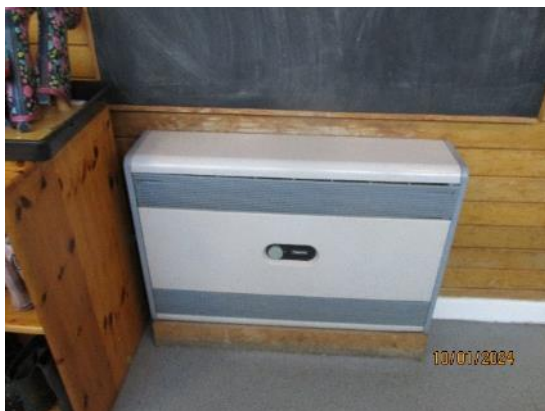
153. Cooperad convector heater – corridor.

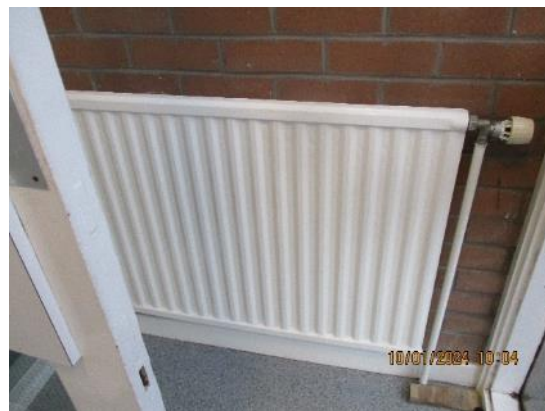
154. Steel panel radiator

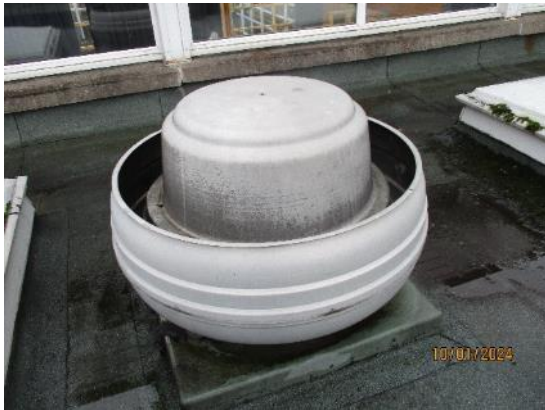
163. Extract fan – kitchen appliances.

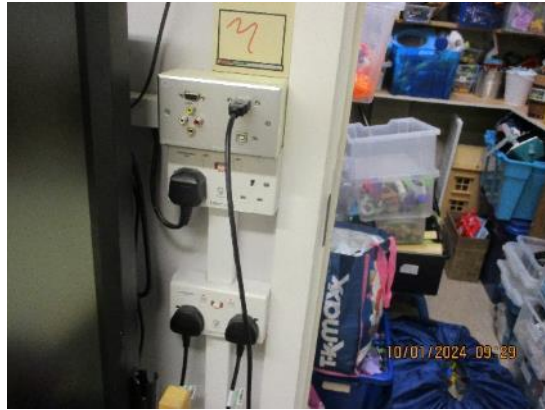
168. Sockets – typical. Nursery class

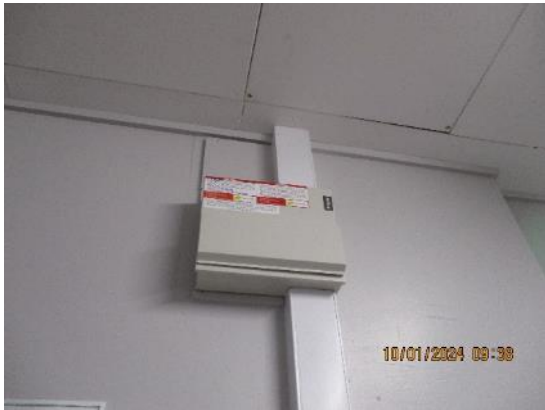
169. Consumer unit – new nursery office.

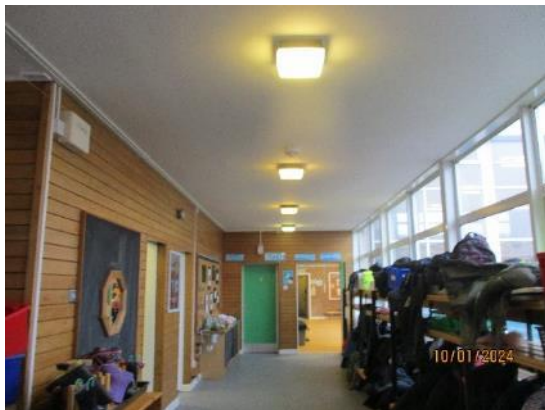
175. Lighting – corridor 1/9

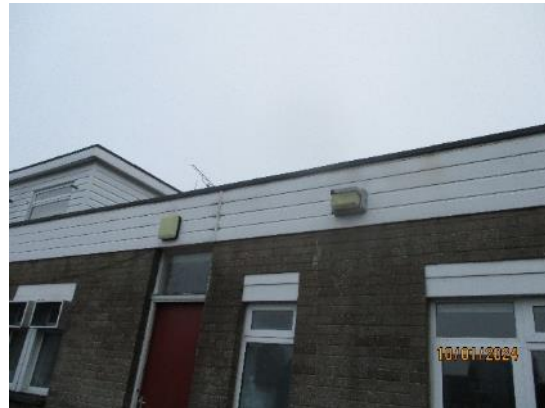
182. External lighting.

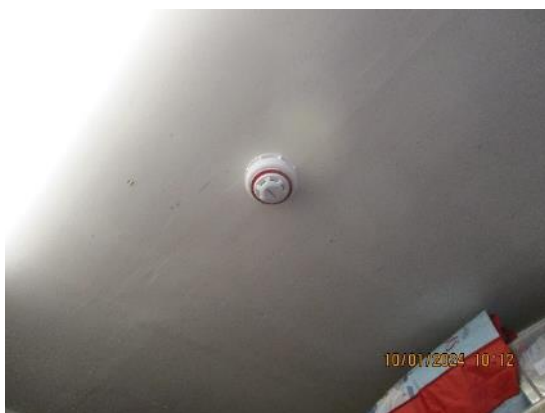
183. Smoke detection head. Typical.

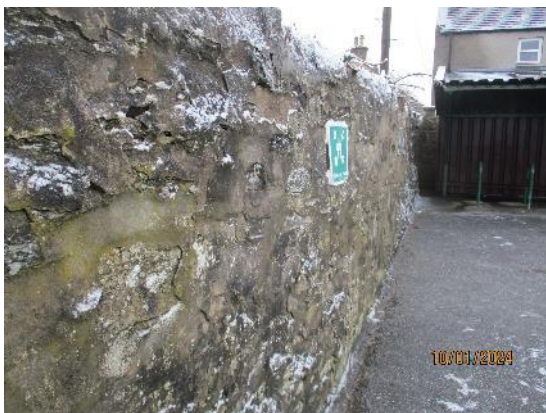
225. Stone wall - leaning

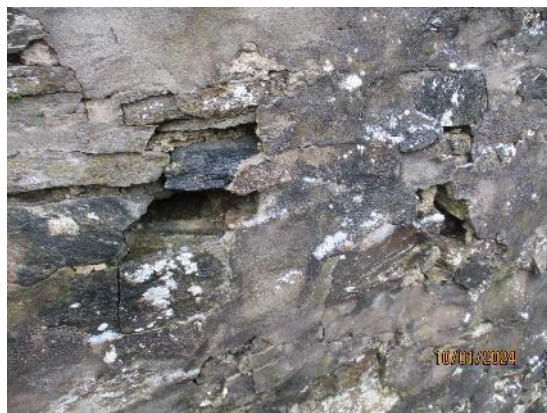
226. Repointing required

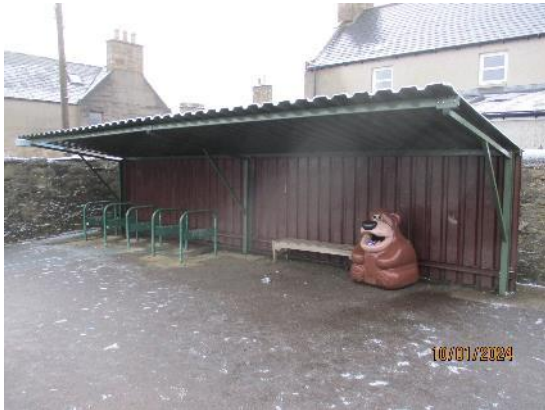
235. Steel framed pupil shelter

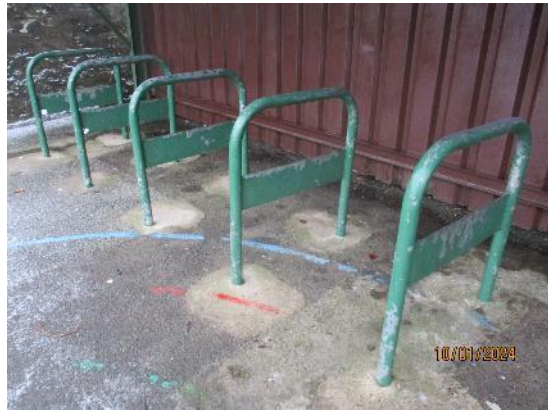
236. Metal cycle hoops

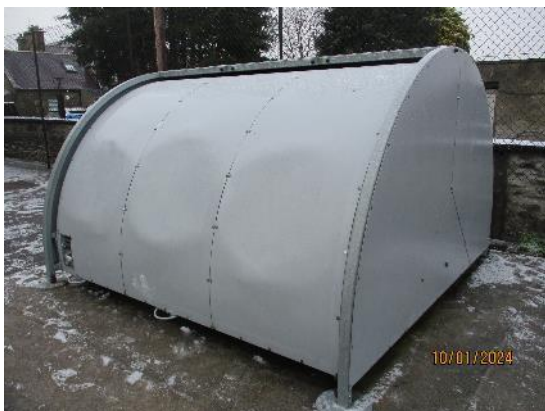
237. Metal store

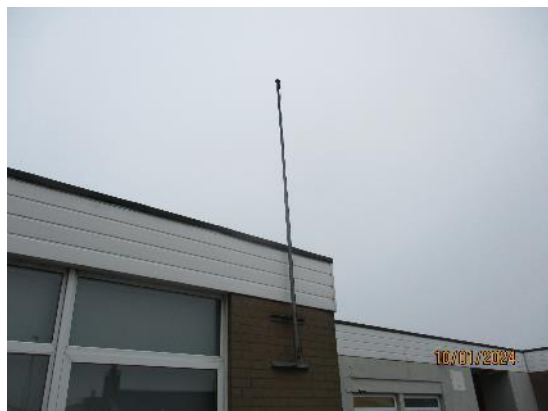
238. Metal flag pole

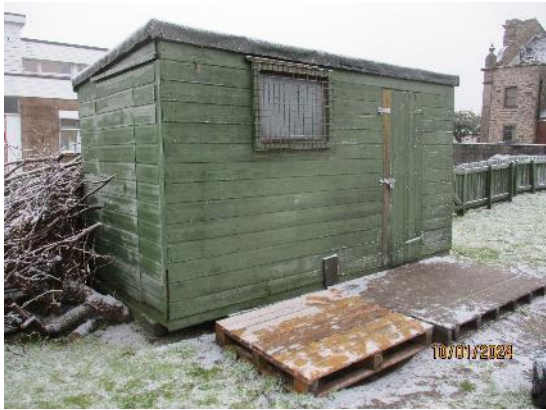
239. Timber sheds - Playground

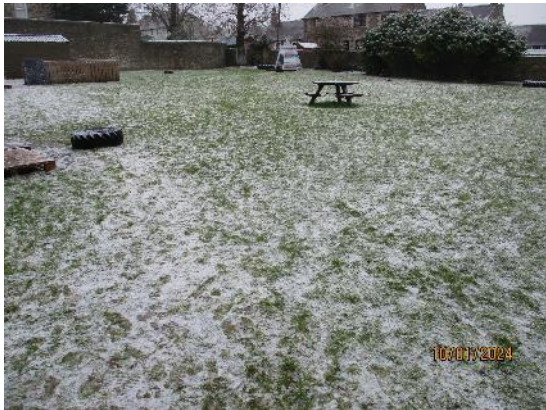
241. Grass sports field

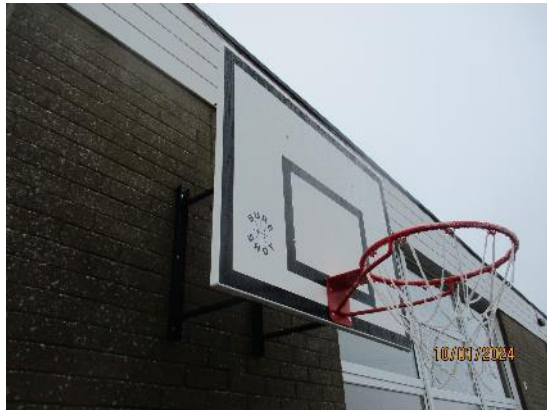
242. Single basketball hoop
