# **Summary Building Condition Survey Report**

**Botriphnie Primary School  
Drummuir, Keith AB55 5JF**

**28<sup>th</sup> August 2023**

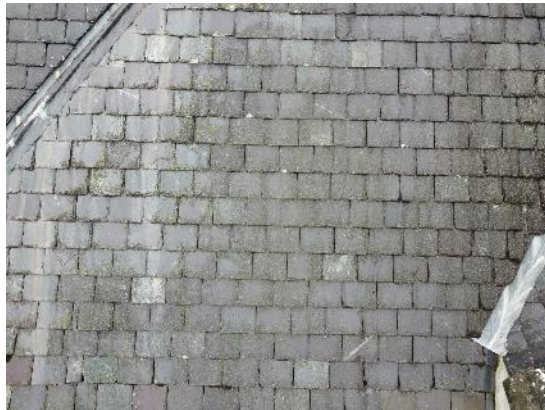
9. Typical slates

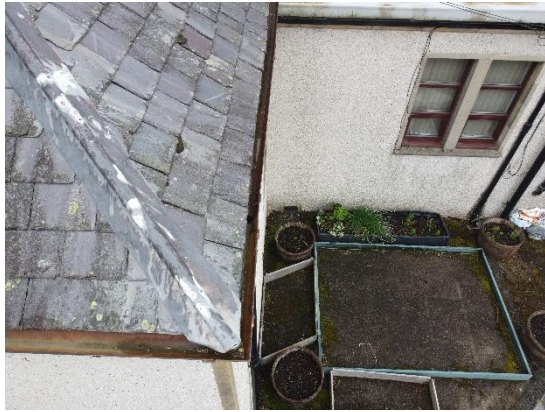
19. Cast iron 1/2 round gutters

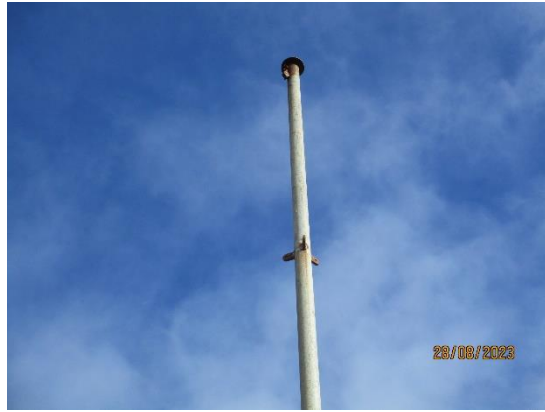
38. Metal pole flag pole

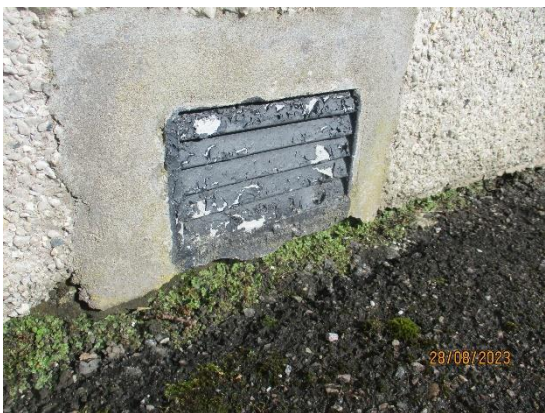
41. Ground level and underfloor ventilation

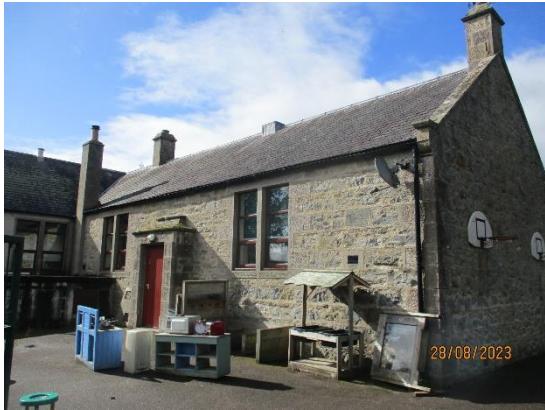
43. Natural stone to north wing

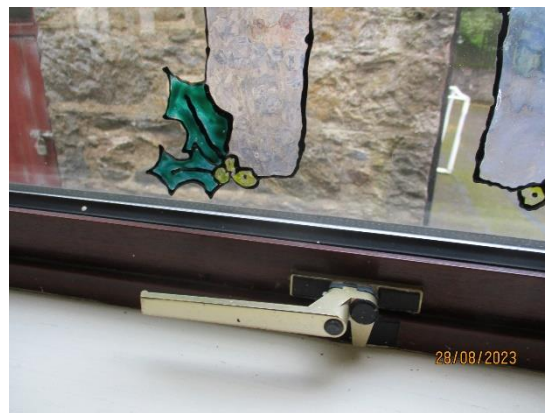
60. Typical lever handle

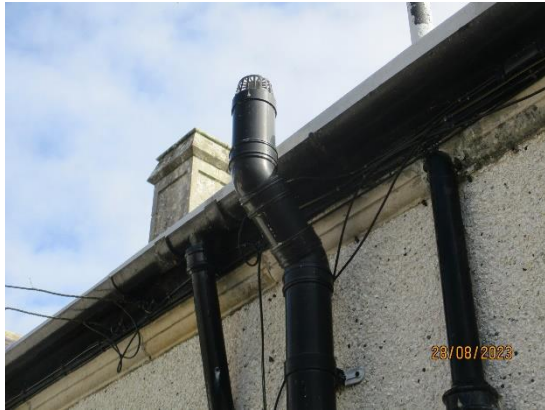
61. Timber fascia boards

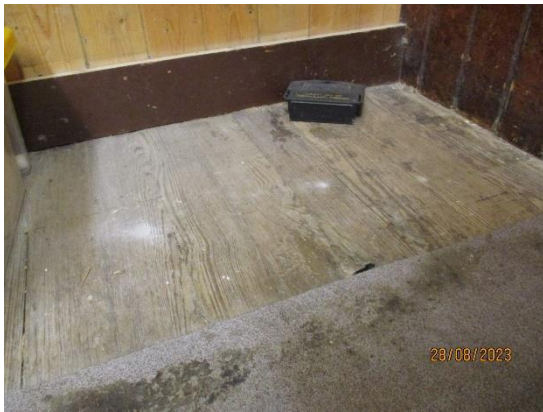
66. Suspended timber floors

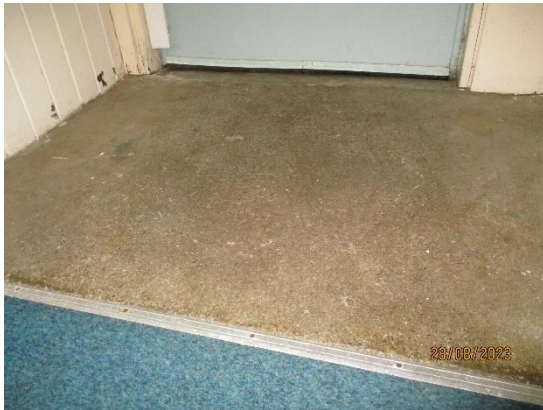
68. Concrete floors

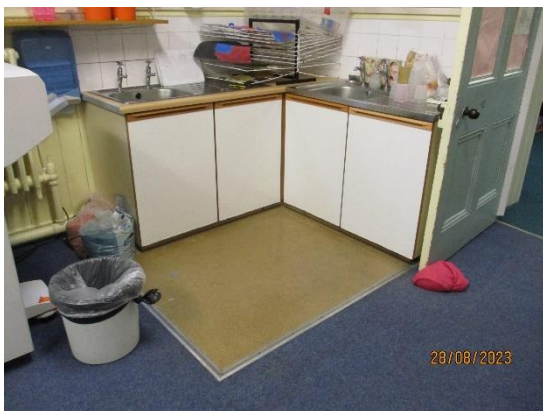
70. Sheet vinyl to wet areas

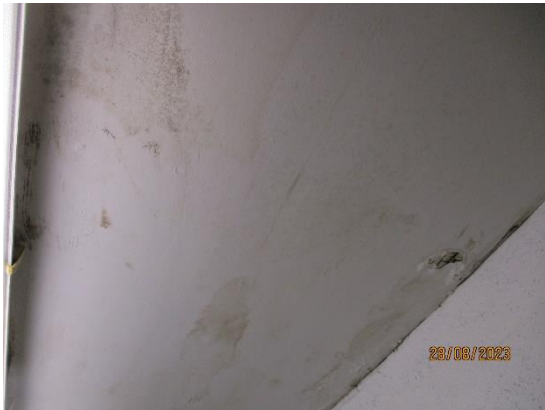
80. Plaster/plasterboard ceilings

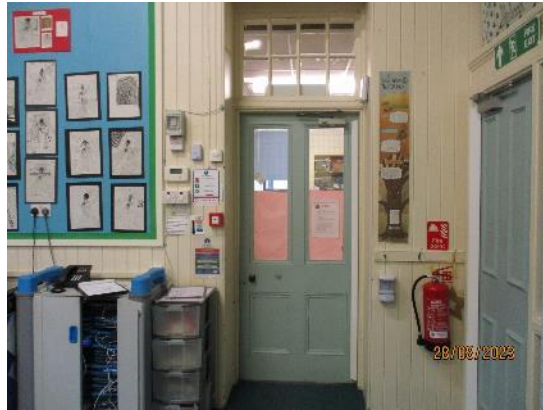
90. Timber panelled, part glazed doors

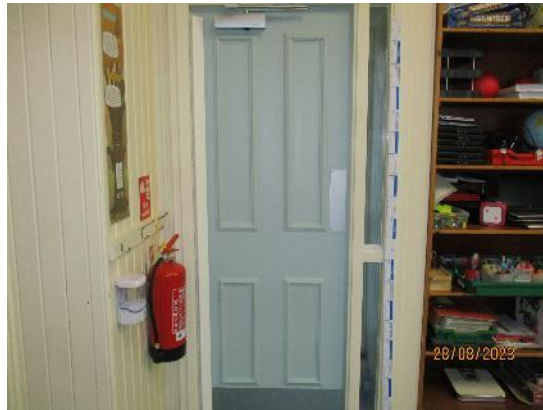
92. Timber panelled doors

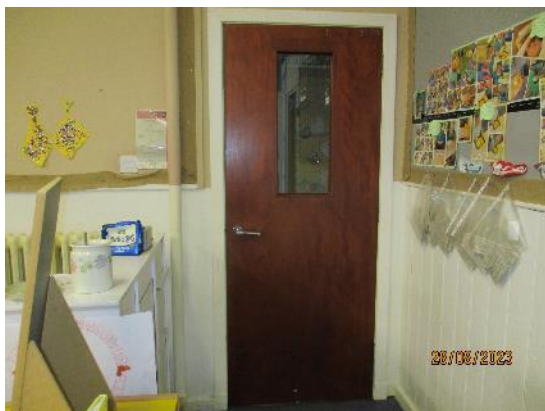
93. Timber hollow core doors

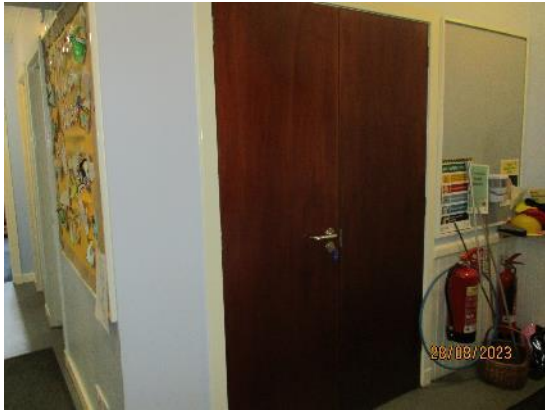
95. Timber hallow core double doors

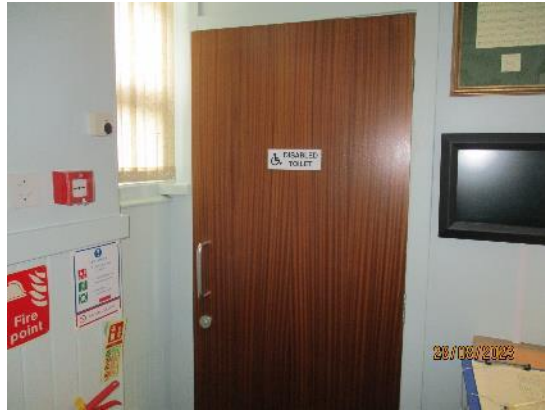
96. Timber veneered doors

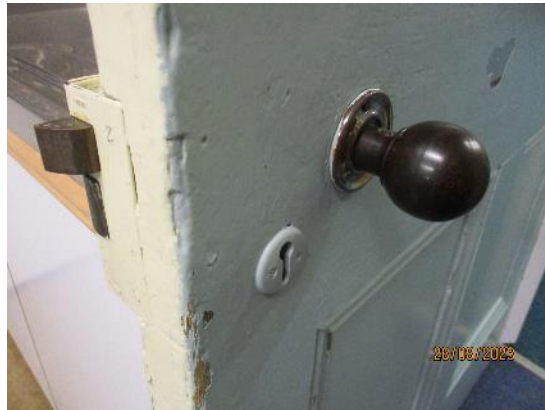
98. Bakelite and rim lock ironmongery

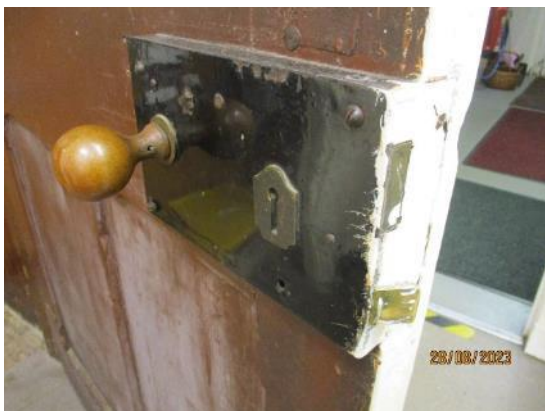
99. Brass and rim lock ironmongery

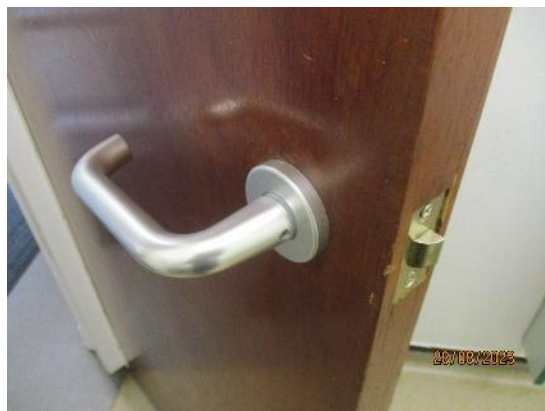
100. Aluminium lever handles

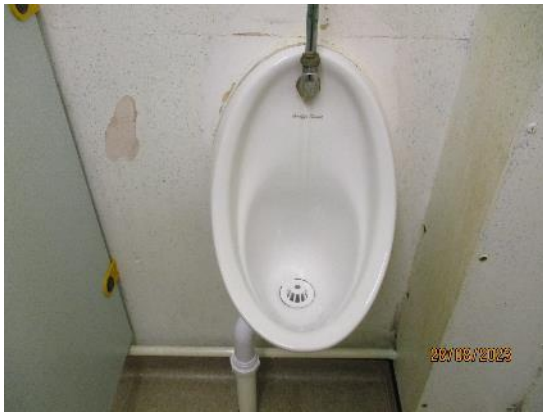
101. Vitreous china single urinal

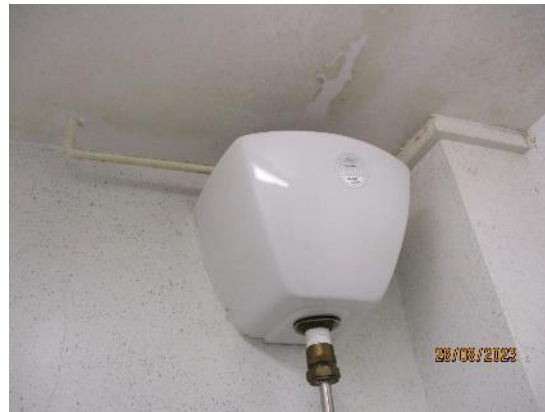
102. China urinal cistern

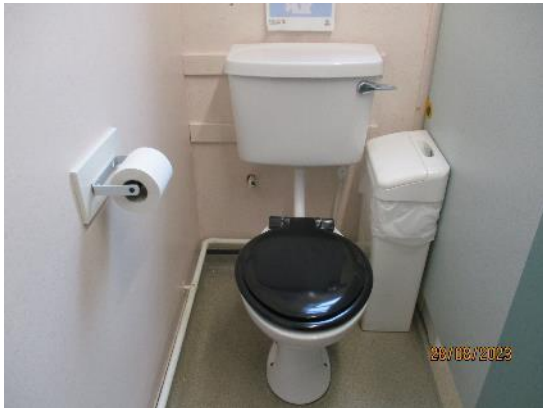
103. Typical W.C.

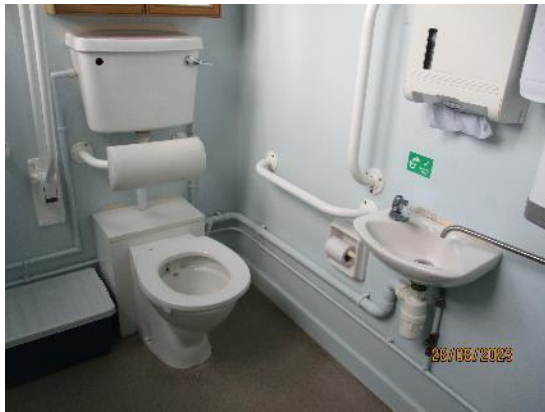
107. Accessible toilet

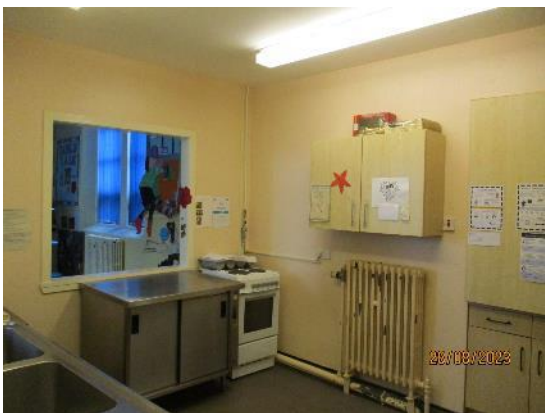
111. Commercial kitchen

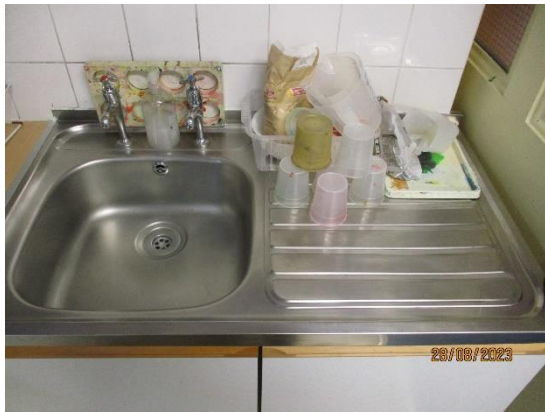
113. Typical, dated stainless steel sinktops

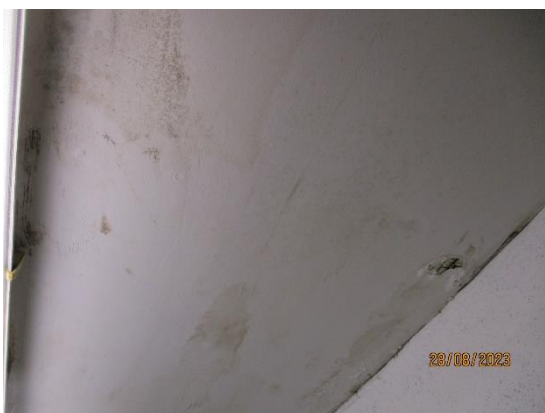
116. Plaster/plasterboard ceilings

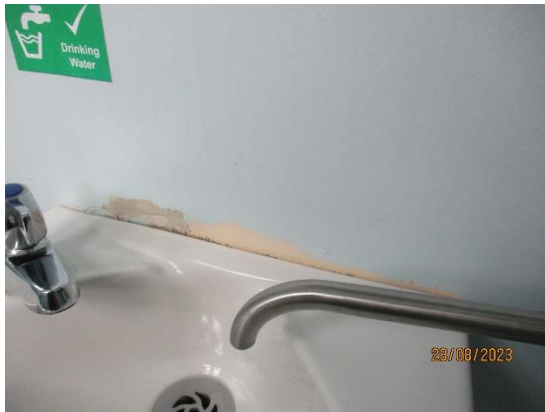
118. Plaster/plasterboard walls

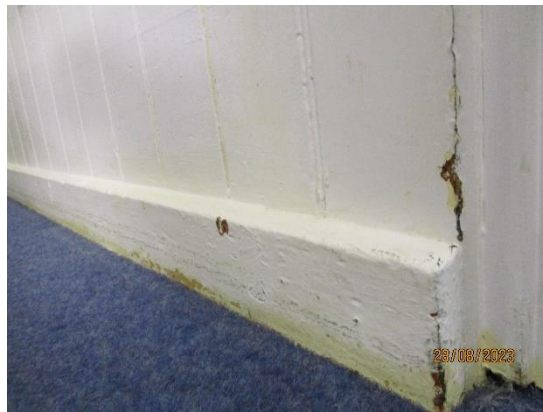
121. Timber joinery items

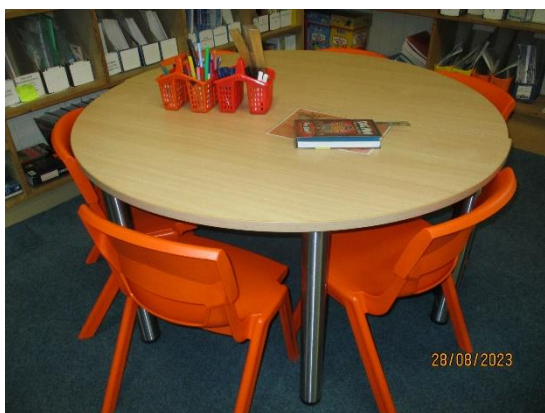
122. Classroom tables & chairs

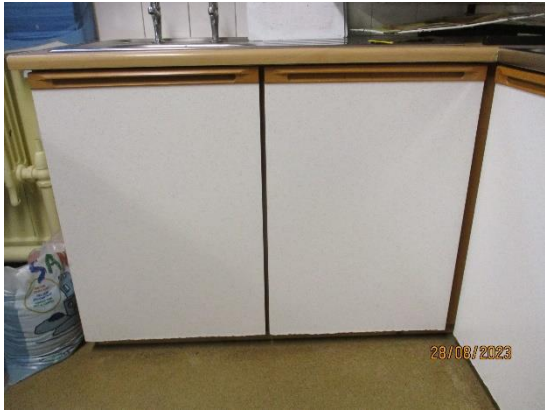
124. Sink base units

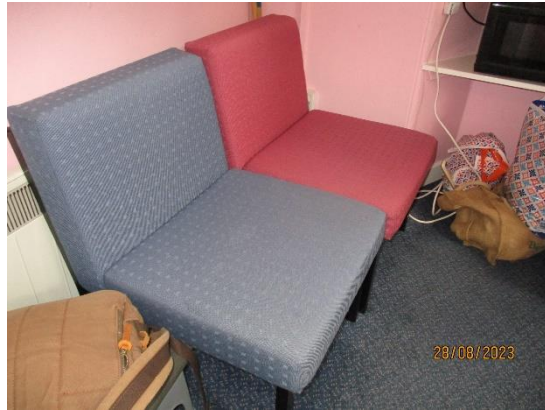
125. Staff room furniture

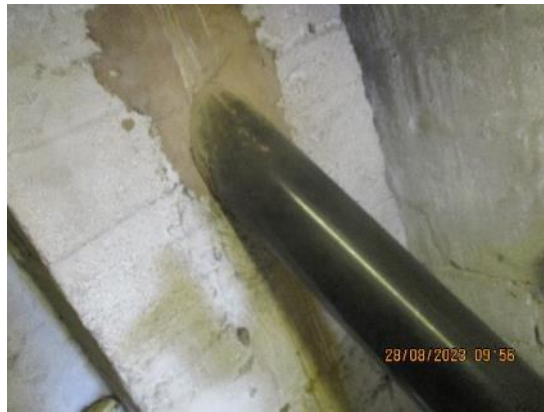
128. Boiler flue from appliance to brick chimney 0/14.

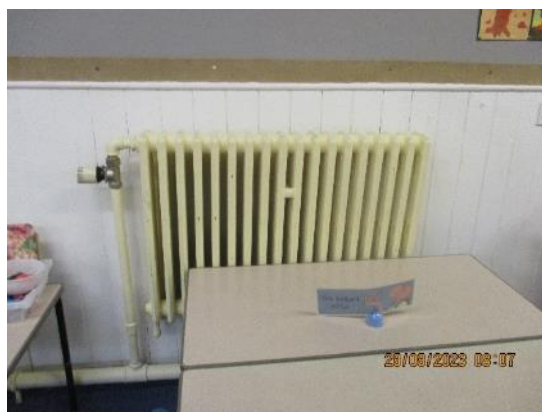
134. Radiator classroom 1/5.

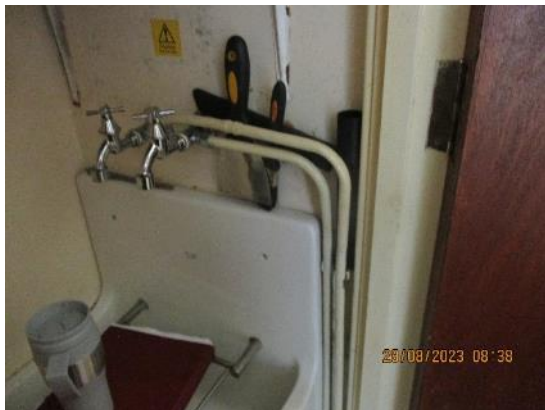
141. Pipework – hot water distribution 1/20.

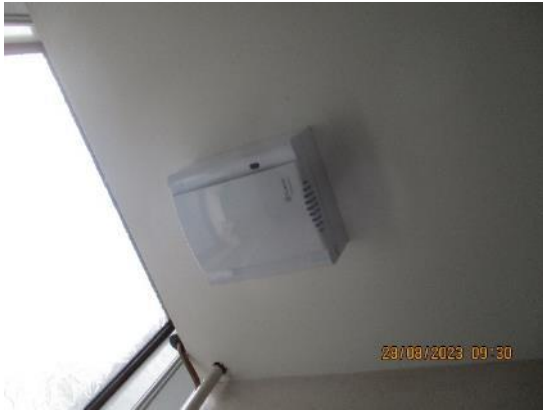
145. Extract fan girls toilet 1/9.

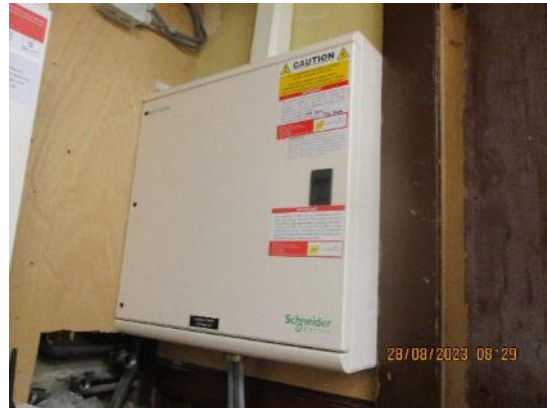
148. DB – kitchen Tariff. Cupboard 1/19.

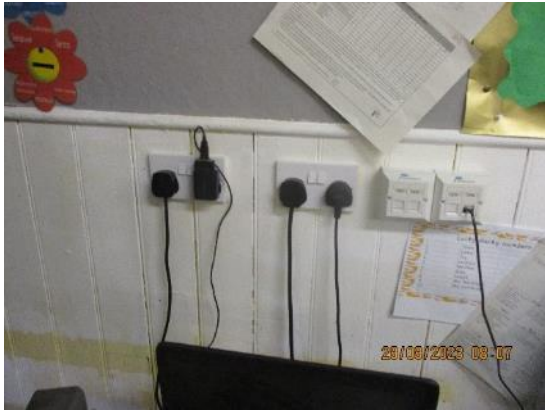
151. Sockets – class 1/5.

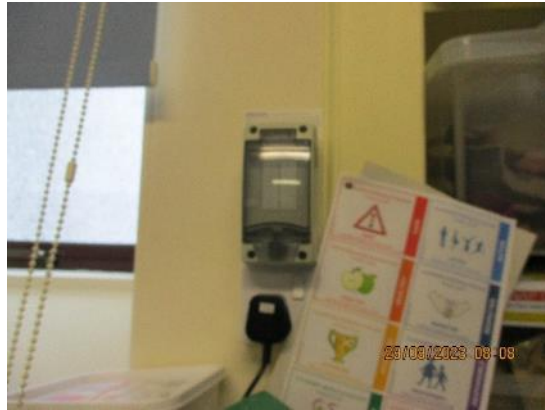
152. Class sockets RCD unit. Class 1/5.

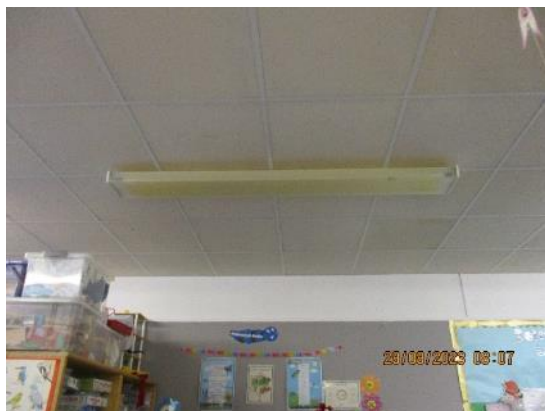
155. Lighting – class 1/5.

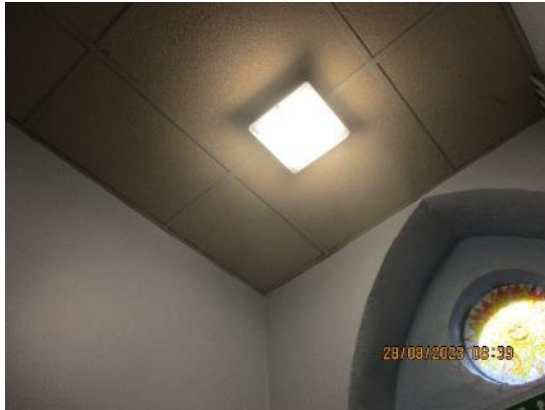
157. Lighting corridor 1/7.

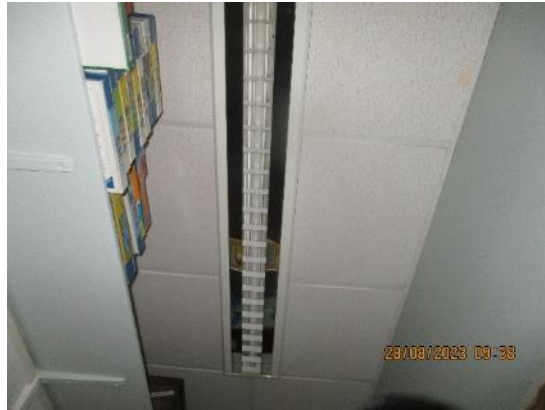
158. Lighting corridor 1/4.

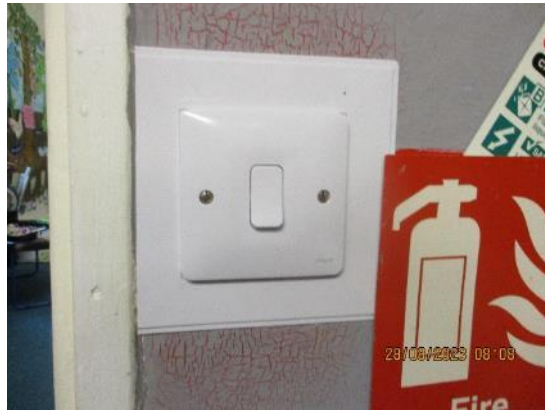
160. Light switch class 1/5 typical.

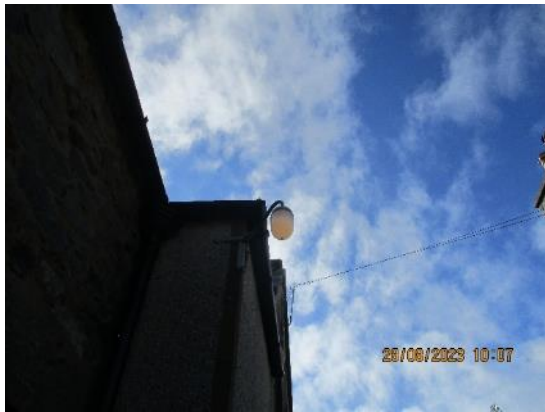
163. External lighting west wall.

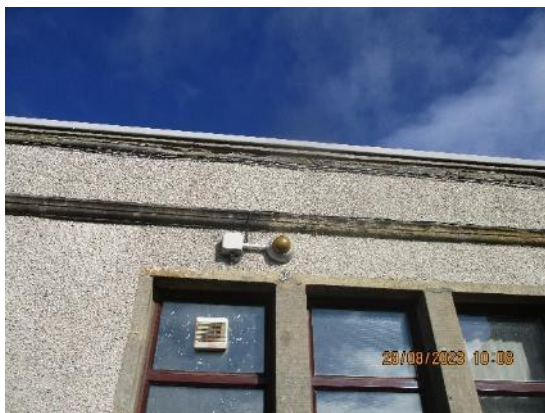
One CCTV camera is installed at the front main entrance door, with monitor and desktop processing unit located in the reception office. This is currently defective and site staff report it has not been operational for a number of years.

167. CCTV camera. Main entrance door.

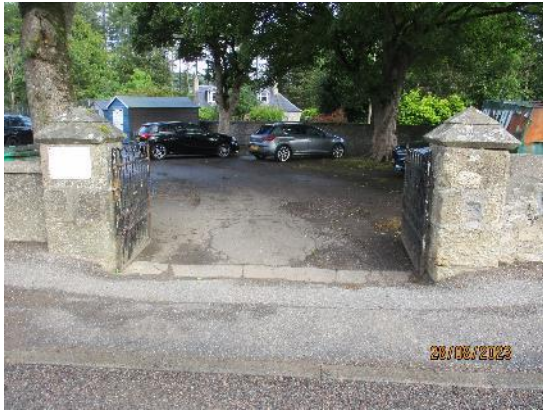
169. Car park entrance

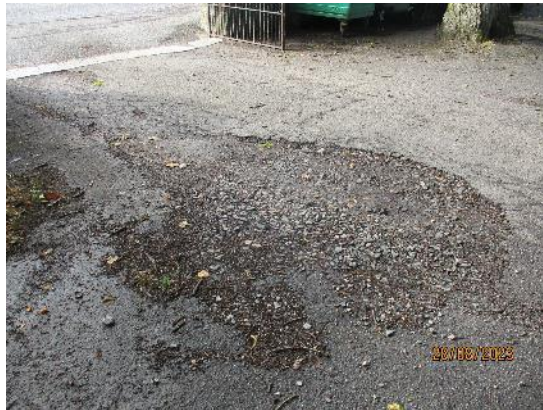
- Tarmacadam car park pot holed with surface erosion.
- Tarmacadam playground has damaged and cracked surface.
- Personnel and vehicle metal gates are in poor condition and life expired.
- Stone perimeter walls require repointing.

171. Eroded surface

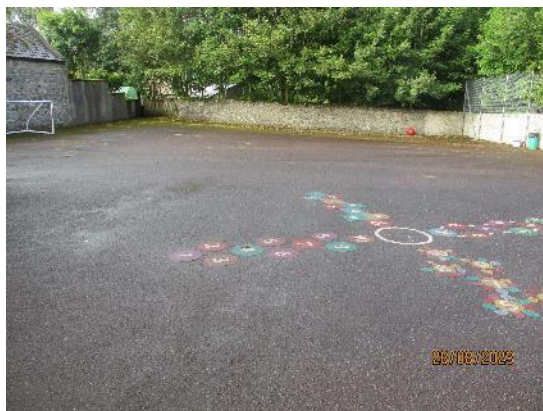
173. Tarmac playground

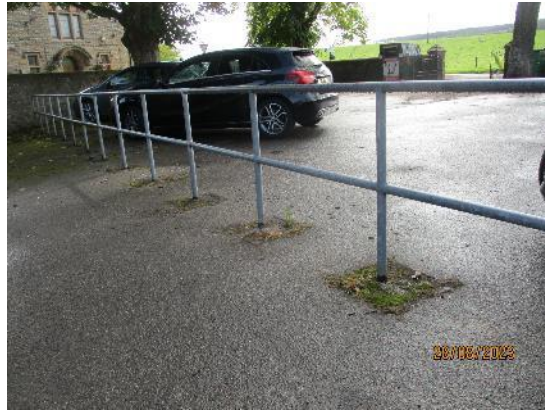
176. Galvanised tubular rail separation

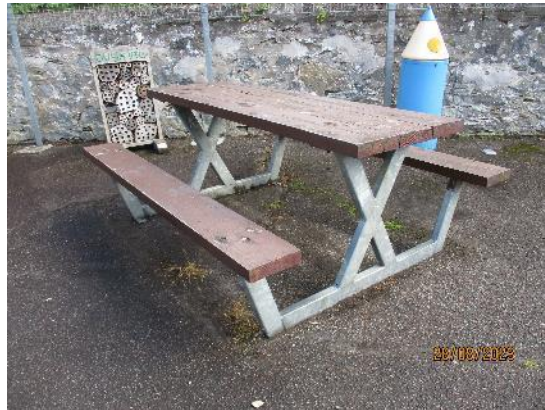
178. Tables and benches

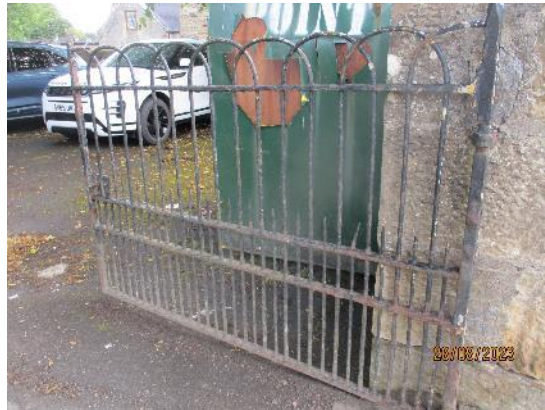
184. Metal hoop vehicle gate

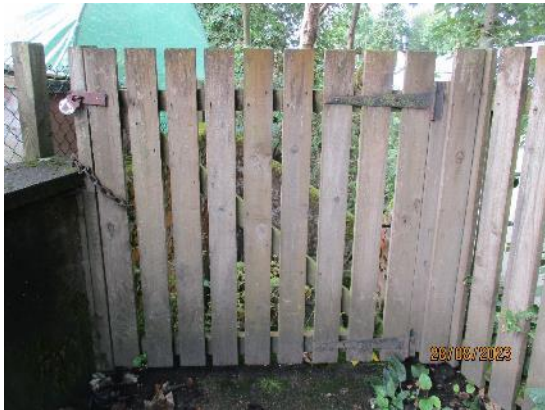
189. Timber boarded gate

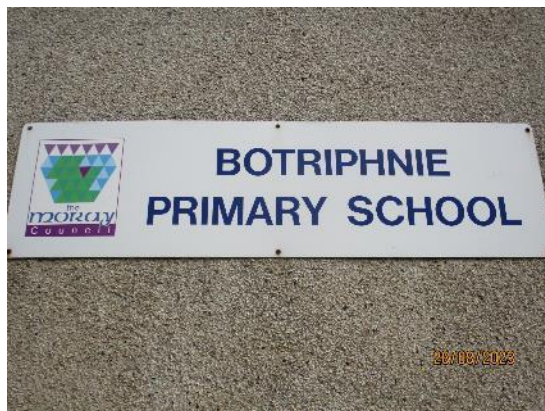
198. School signage

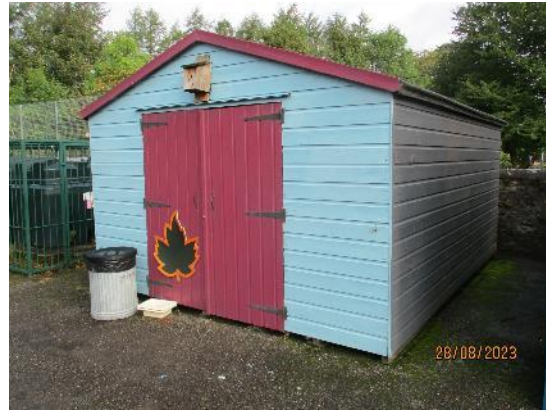
200. Timber sheds

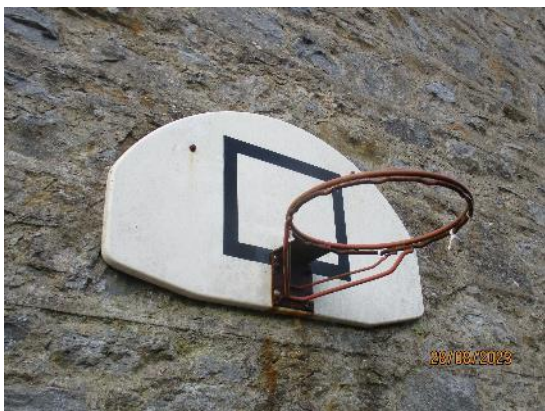
203. Basketball hoops

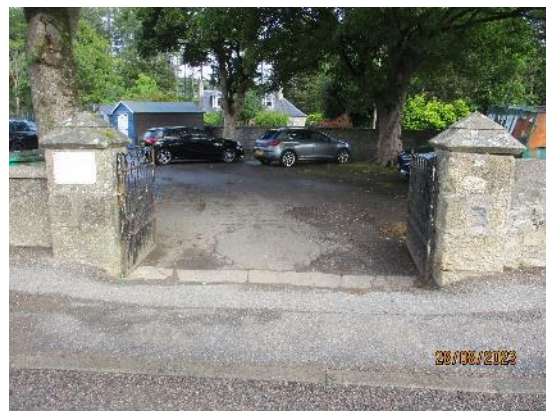
204. Mature trees within car park area
