# **Summary Building Condition Survey Report**

**Keith Grammar School and Leisure Centre  
School Road, Keith AB55 5GS**

**9<sup>th</sup> to 12<sup>th</sup> October 2023 and 22<sup>nd</sup> to 25<sup>th</sup> January 2024**

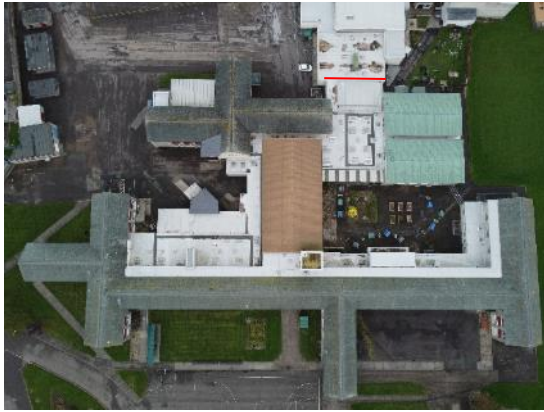
1. Grammer school overview

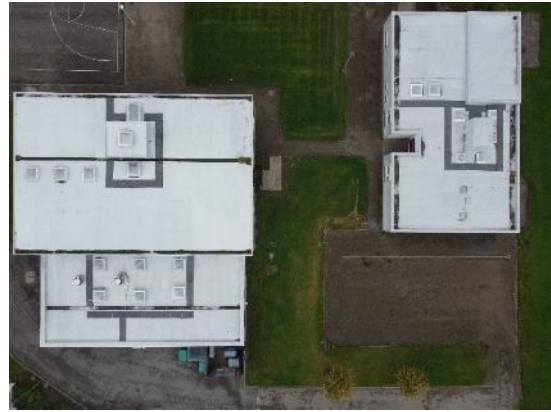
2. Blocks K and M overview

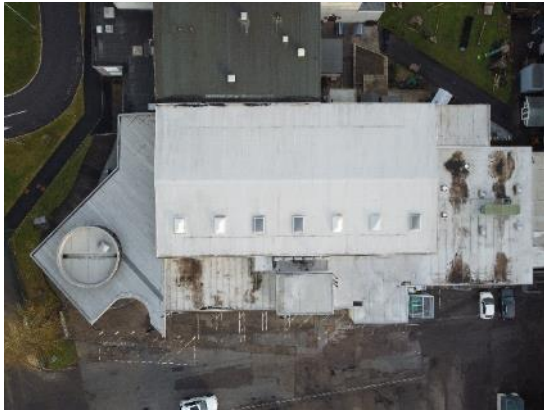
3. Swimming Pool overview

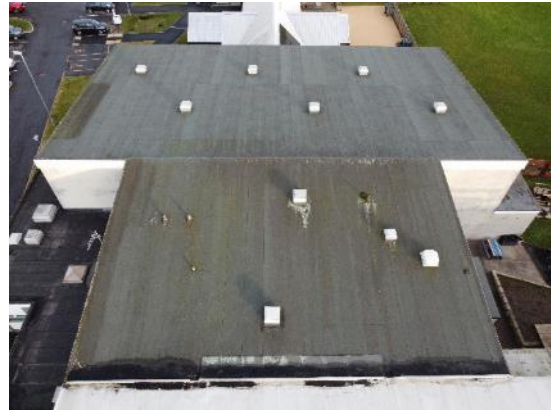
4. Games hall overview

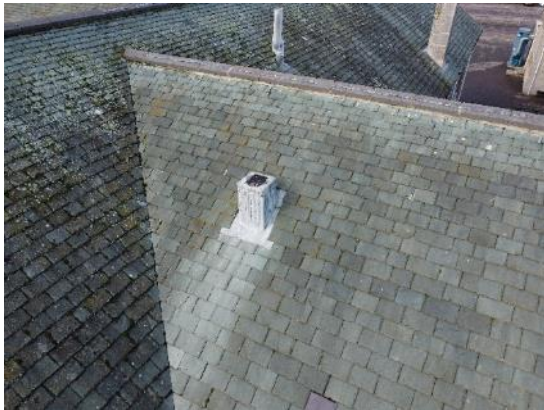
9. Slated pitched roofs

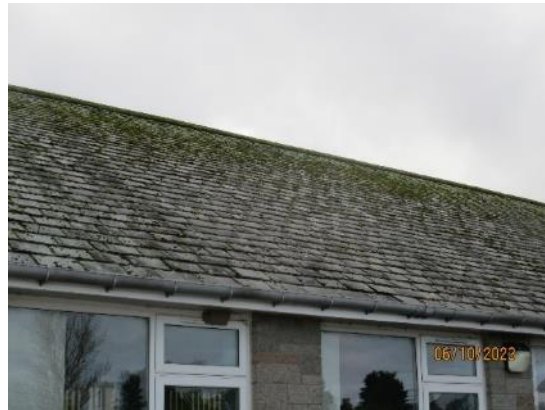
10. Moss coverage

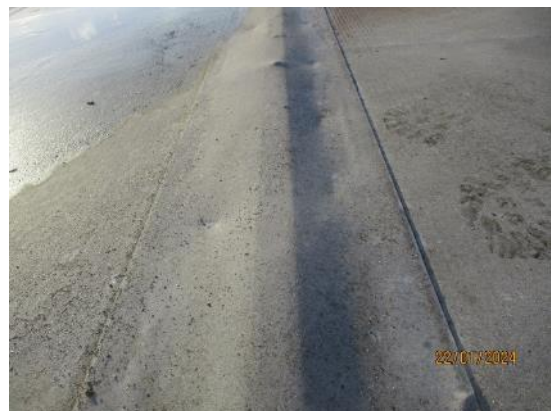
24. Raised fixings

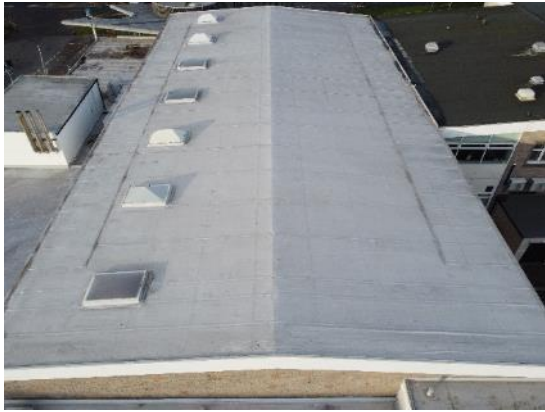
25. Single ply to Swimming Pool

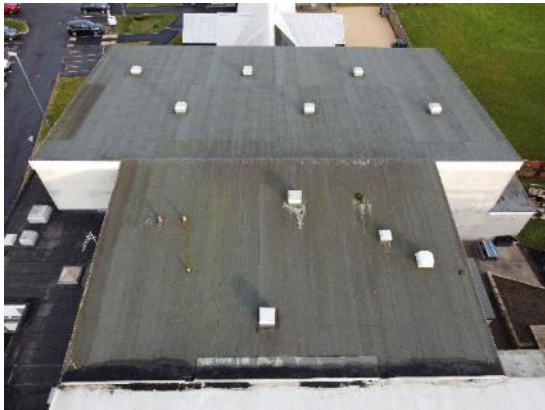
27. Mineral felt to Games Halls

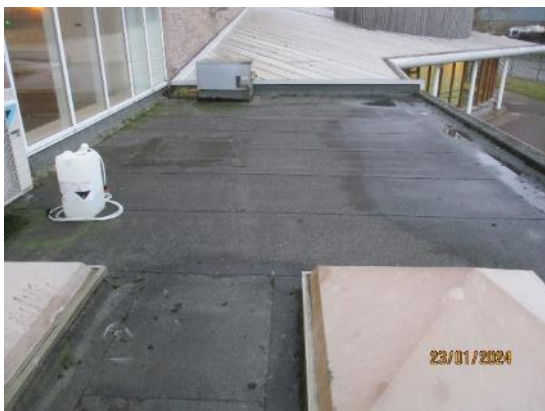
29. Mineral felt above Admin

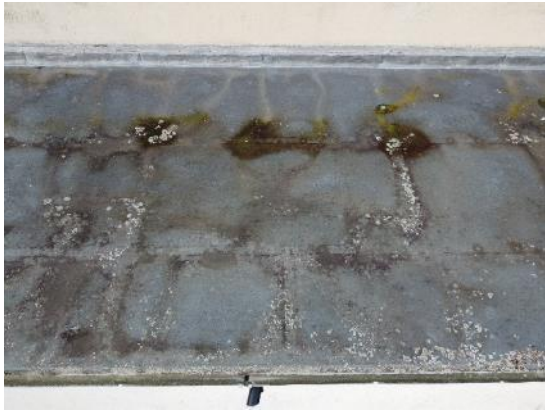
31. GRP bubbling and blistering

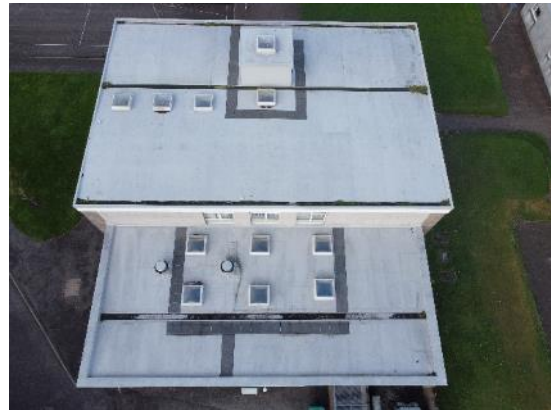
34. SPM to Block K

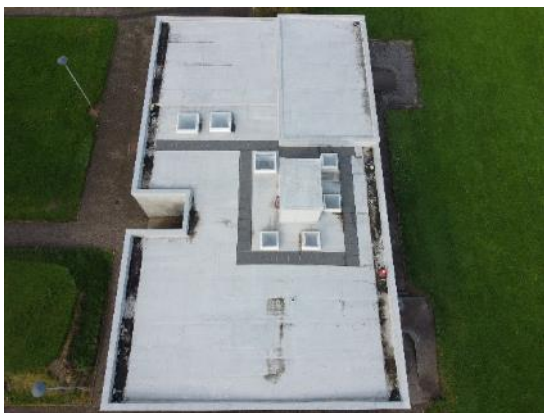
35. SPM to Block M

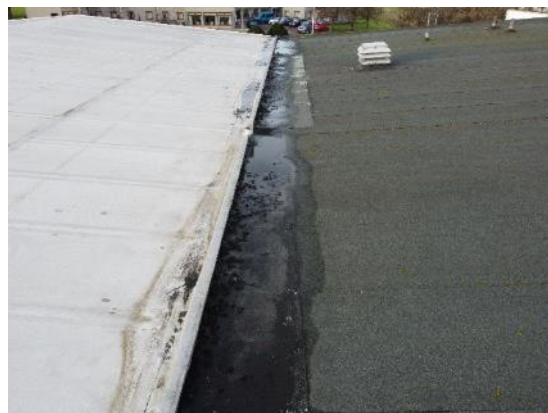
36. Cleaning required above Games Halls

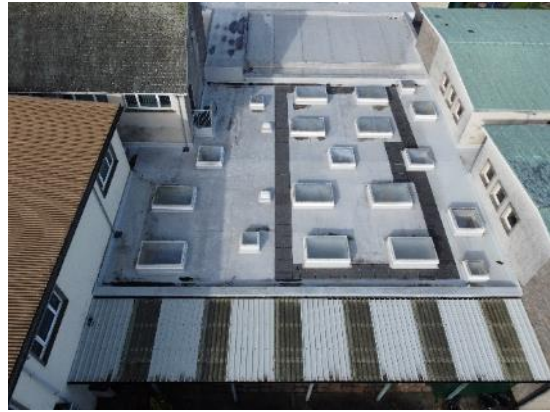
38. Various GRP rooflights to School

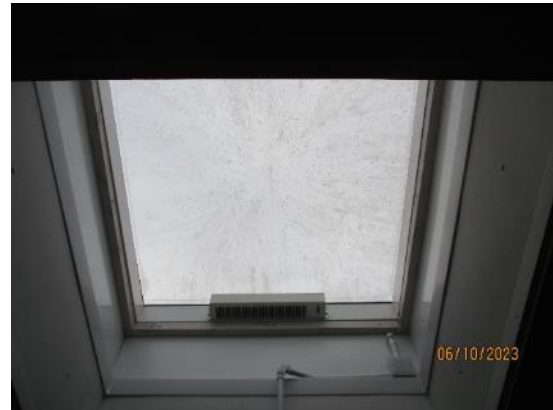
40. Internal view

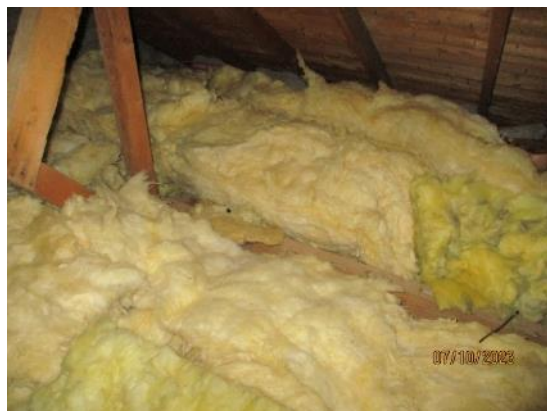
48. Mineral fibre insulation - School

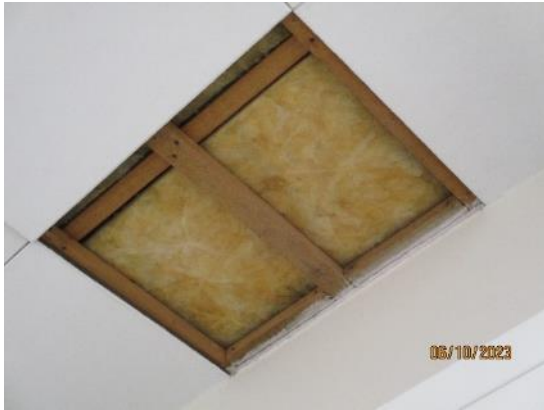
49. Mineral fibre insulation to flat roofs - School

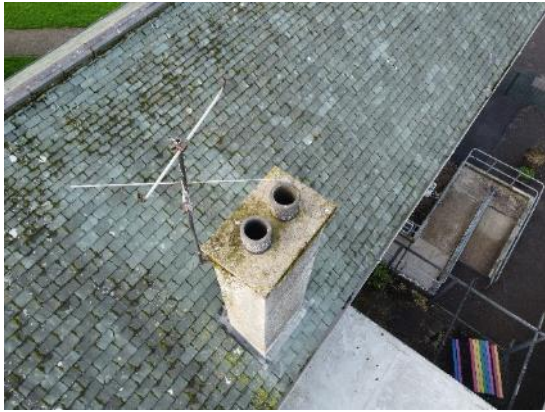
73. Clay pots are open

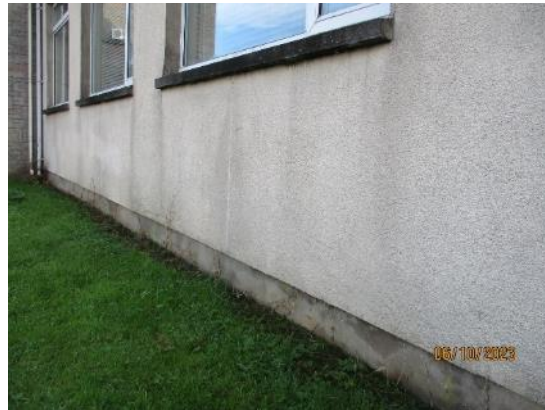
76. Roughcast walls

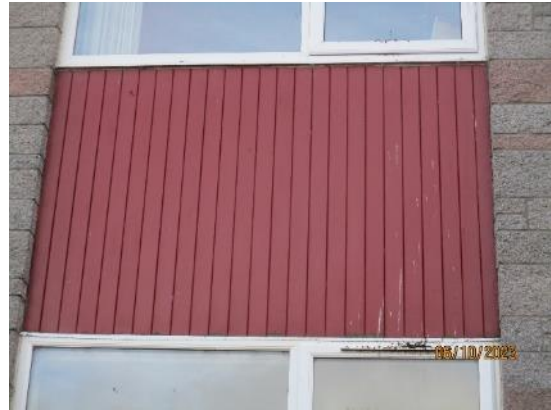
80. Timber linings

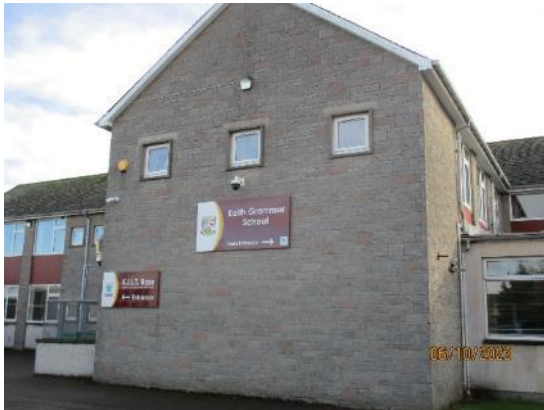
81. Granite stone walls

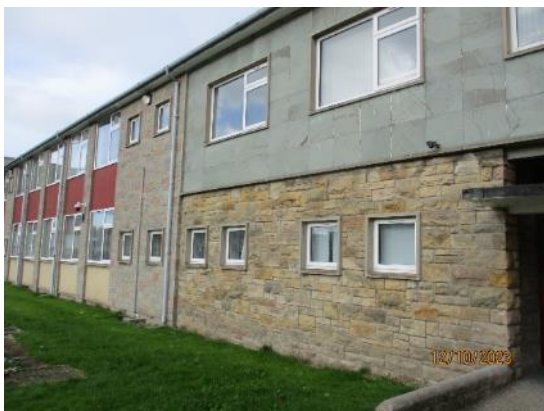
83. Sandstone walls at pupil entrance

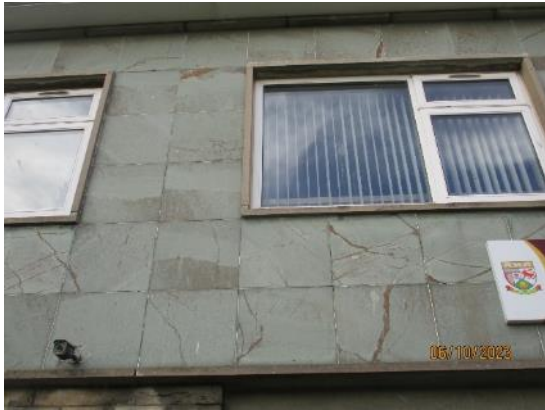
85. Slate tiles above pupil entrance

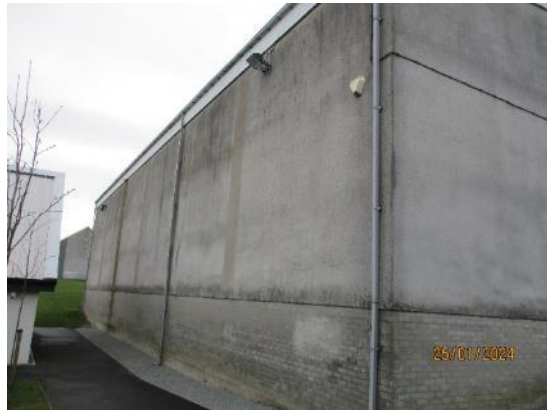
87. Roughcast walls to Games Hall

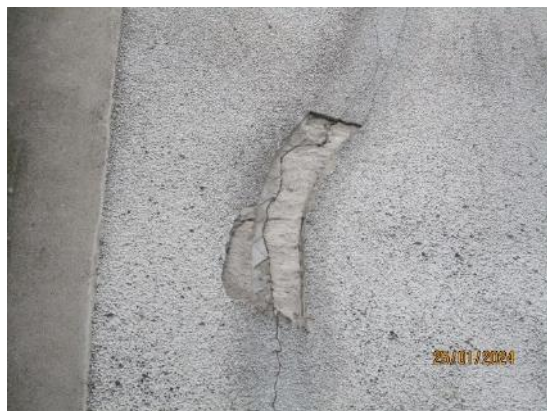
89. Cracks in roughcast

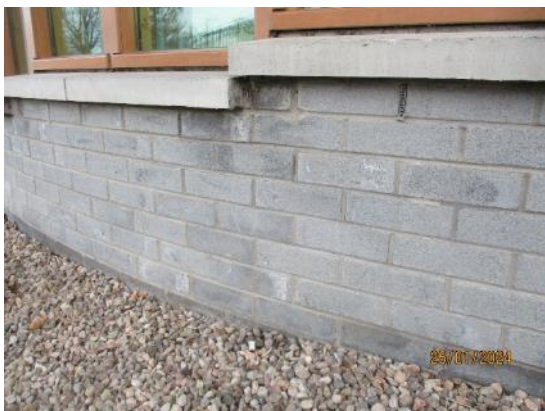
94. Fyfe stone walls to Pool and Admin

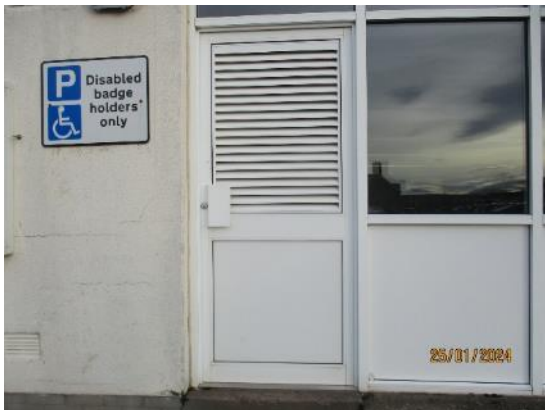
98. PVC fully glazed doors

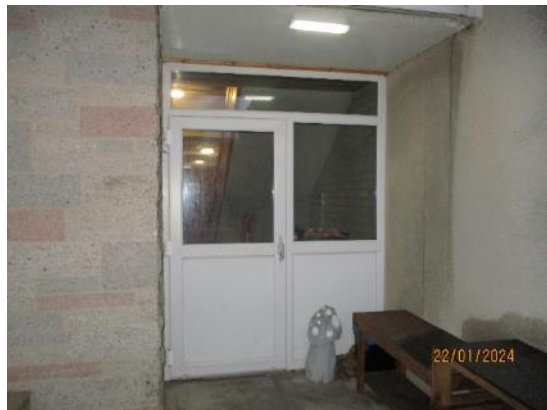
99. Powder coated doors

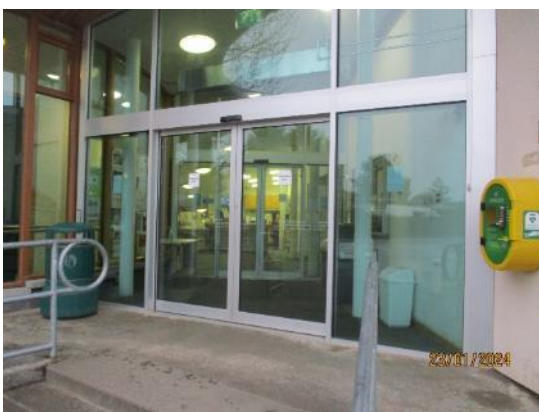
103. PVC electric doors - School

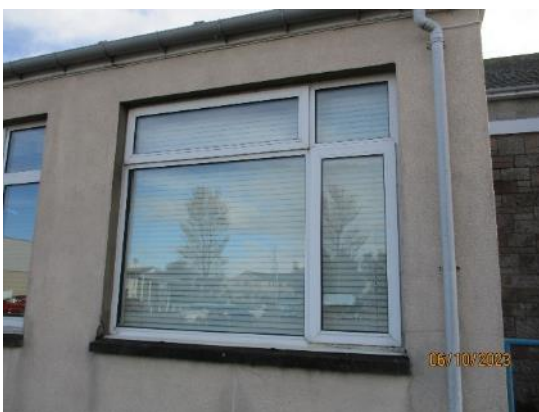
109. PVC small windows - School

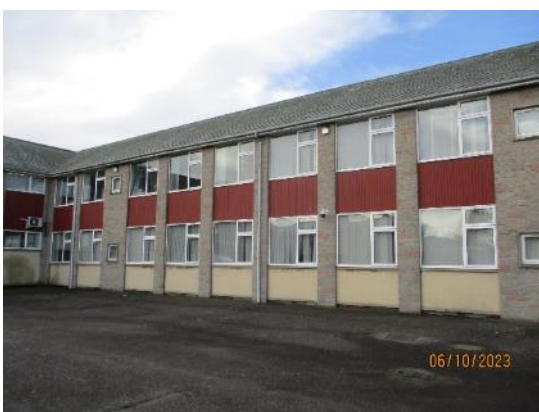
111. PVC windows internally

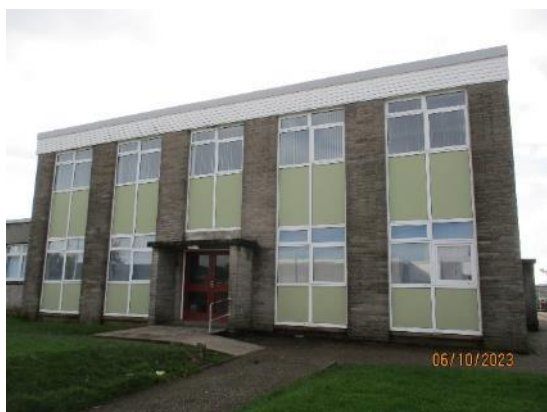
114. Powder coated windows – Block K

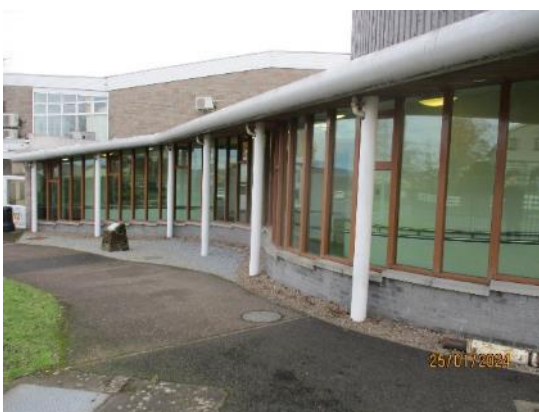
117. Timber curved screen – Leisure Centre

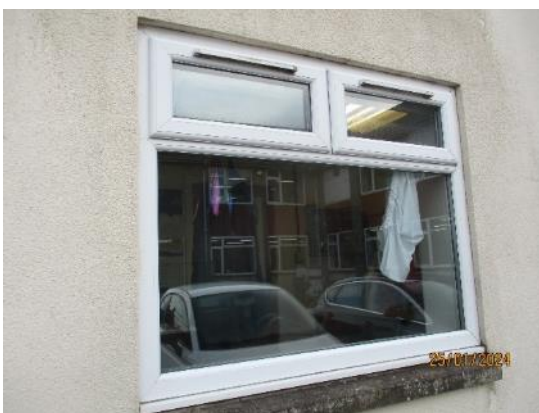
119. Powder coated large windows

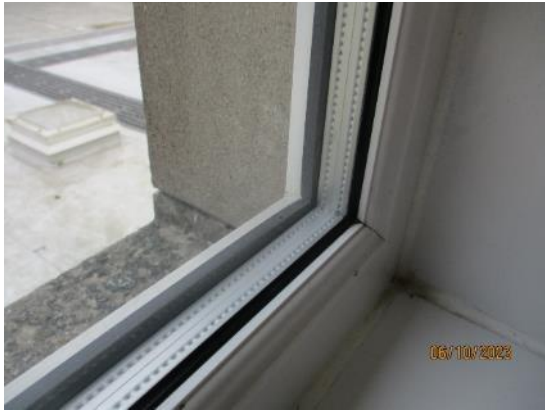
120. PVC medium windows – Leisure Centre

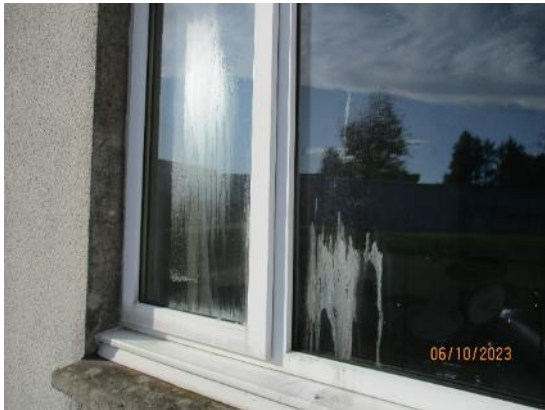
122. Blown double glazed units – Block M

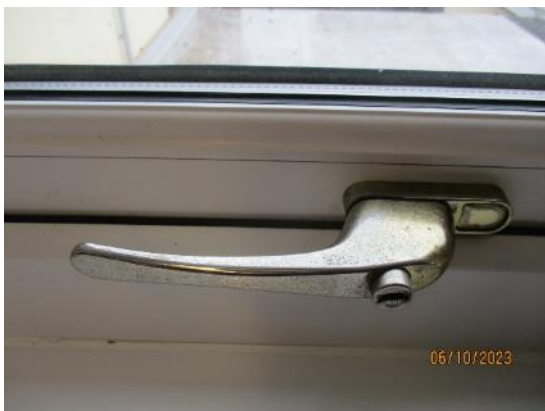
124. Lockable lever handles

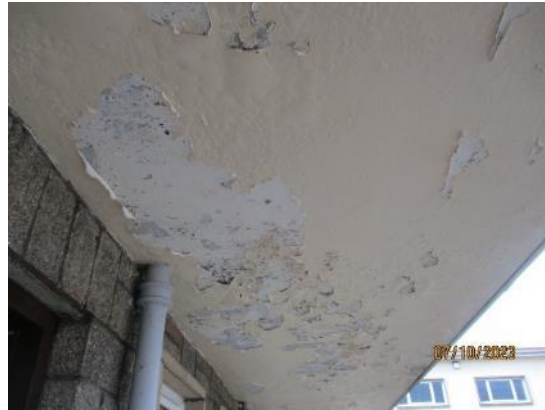
125. Canopy soffits

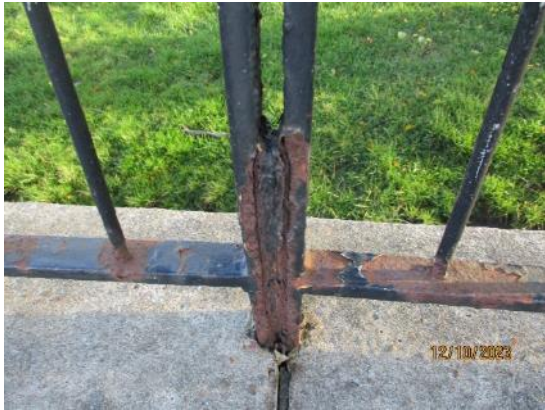
131. Metal fencing

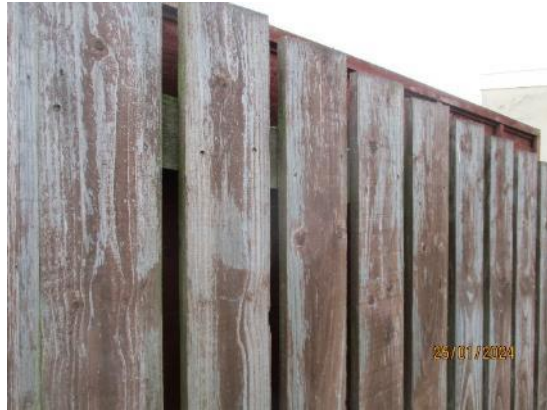
132. Timber fencing

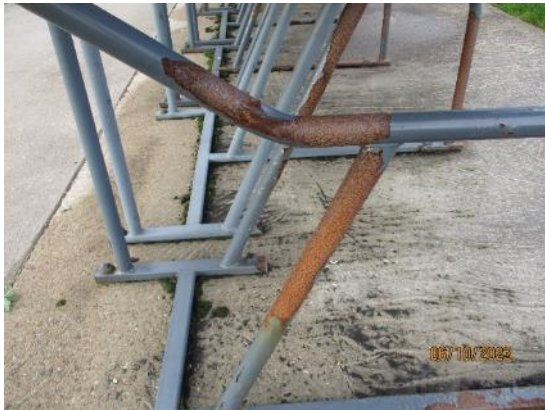
133. Cycle hood frames

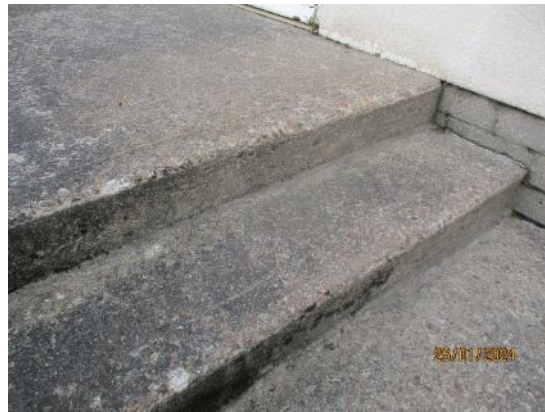
138. Concrete steps to Leisure Centre staff room

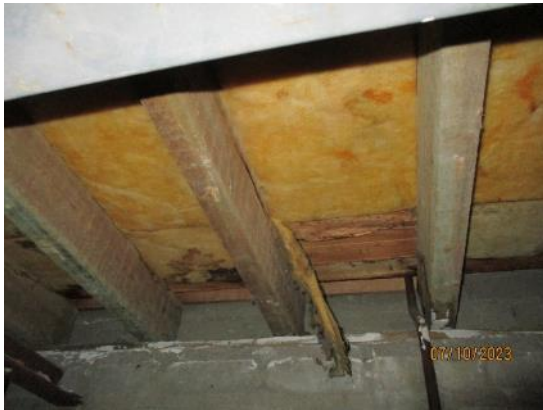
145. Timber suspended first floor - School

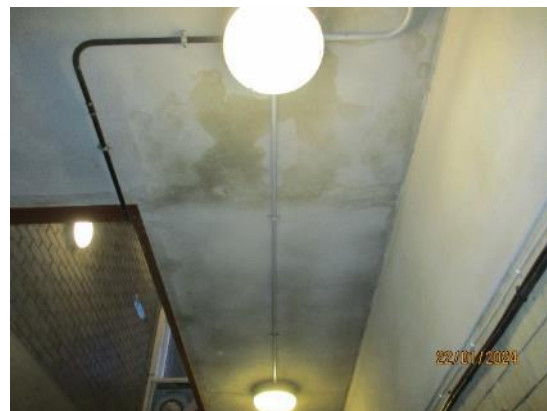
148. Suspended concrete first floor – Leisure Centre

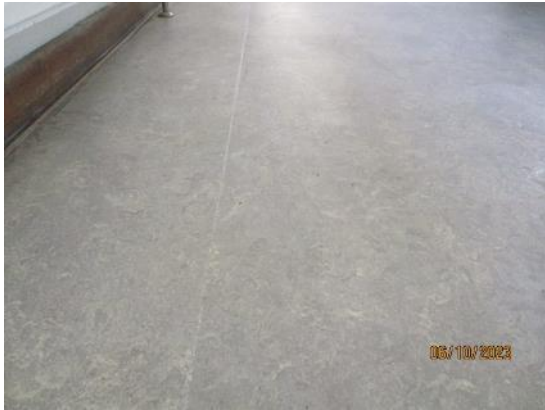
149. Sheet vinyl/lino - School

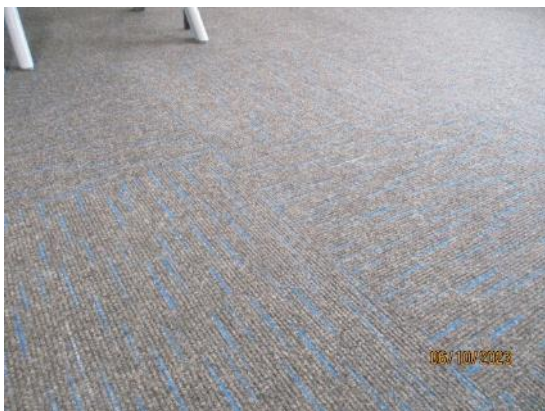
153. Carpet floor finish - School

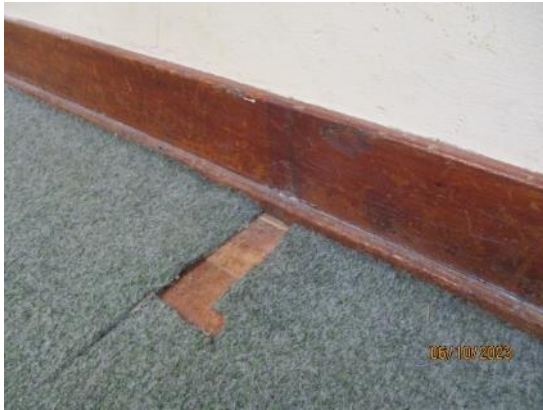
155. Isolated damage

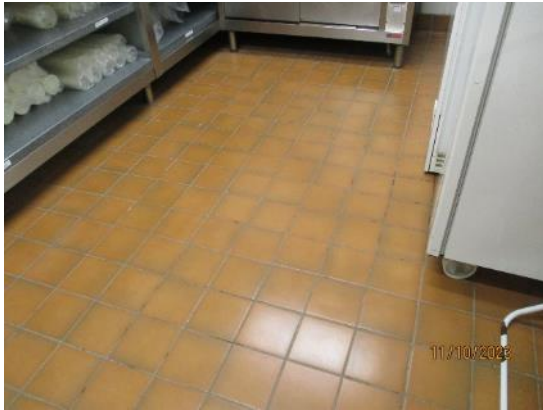
161. Ceramic tile - Kitchen

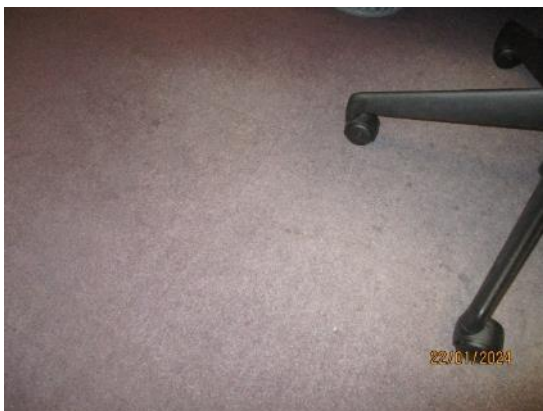
164. Carpet floor finish – Leisure Centre

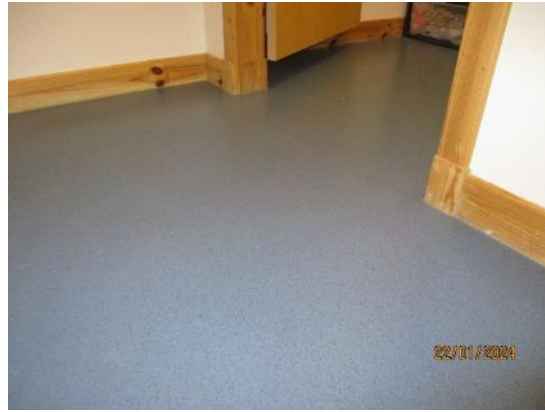
167. Sheet vinyl – Leisure Centre

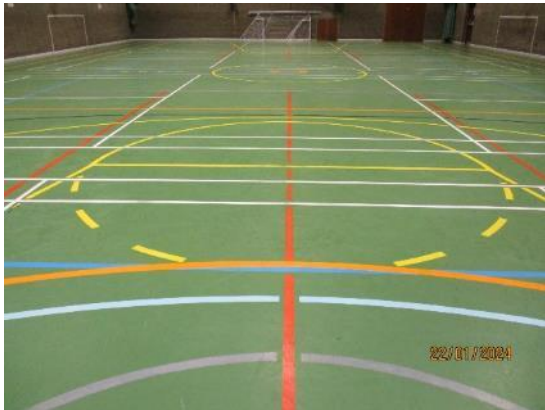
168. Sheet vinyl – Games Hall

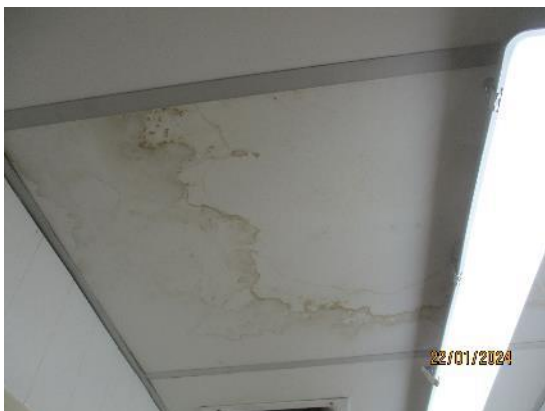
210. Watermarked suspended ceilings

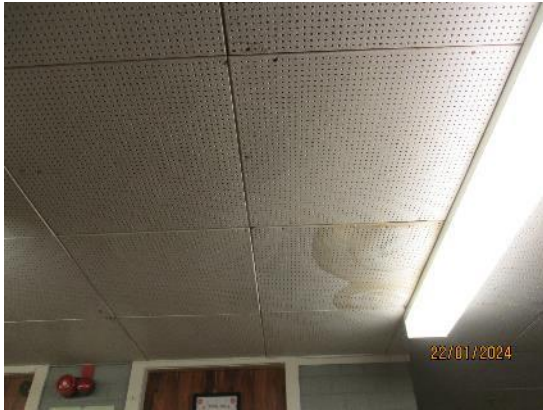
212. Watermarked fibre tiles – Leisure Centre

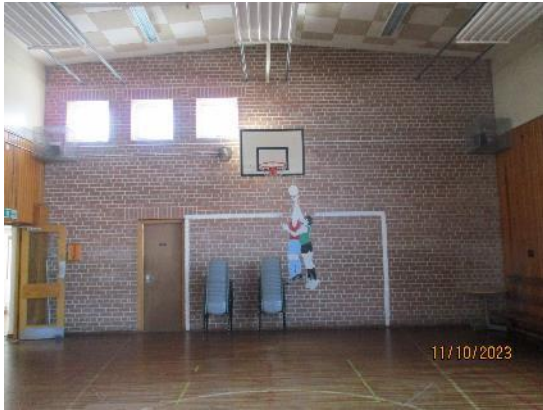
217. Brick external walls

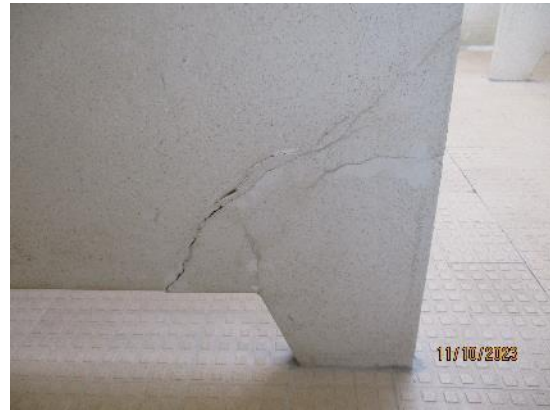
220. Cracking at the feet

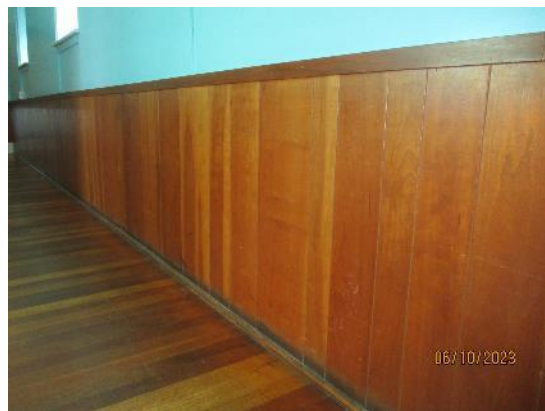
228. Impact damage

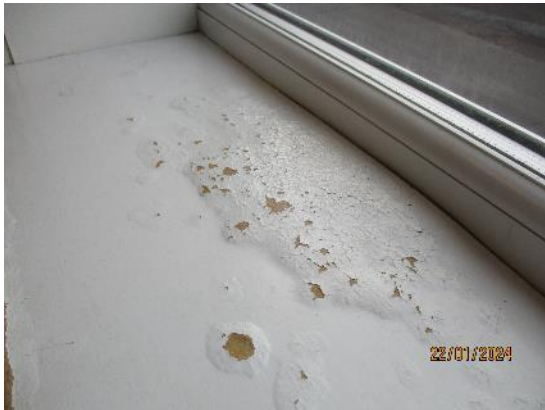
249. Blistered, laminating window sills

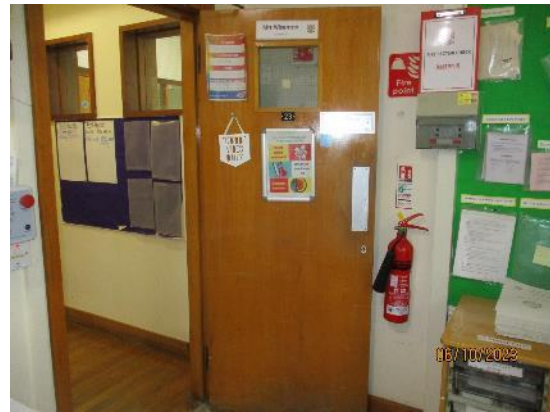
260. Damaged hollow core doors

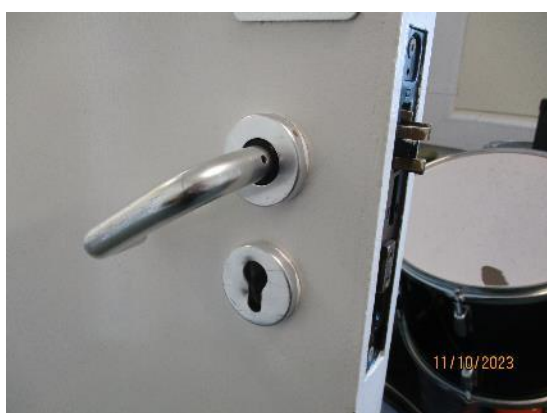
276. Chromed, faulty lever handles

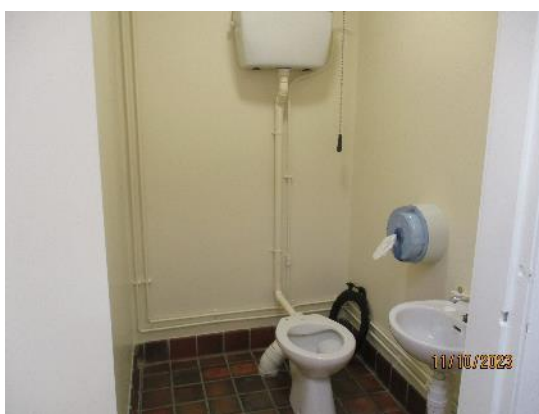
283. Dated/loose WC's

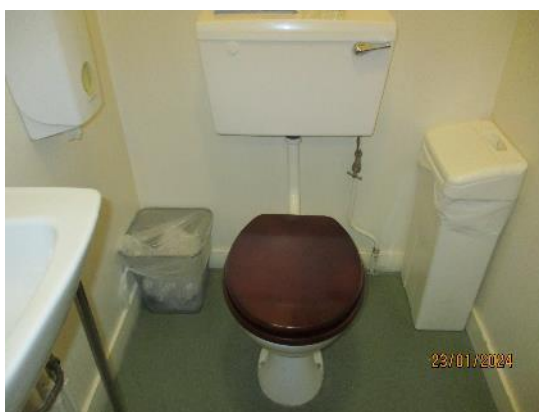
286. Dated WC's

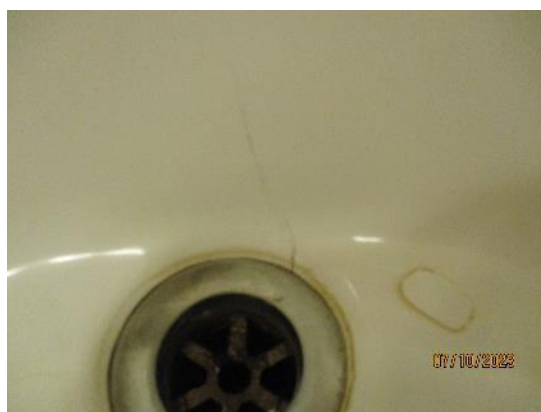
292. Cracked basin

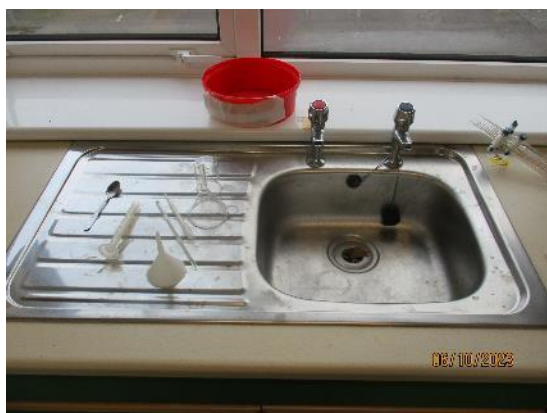
305. Stainless steel sinks - School

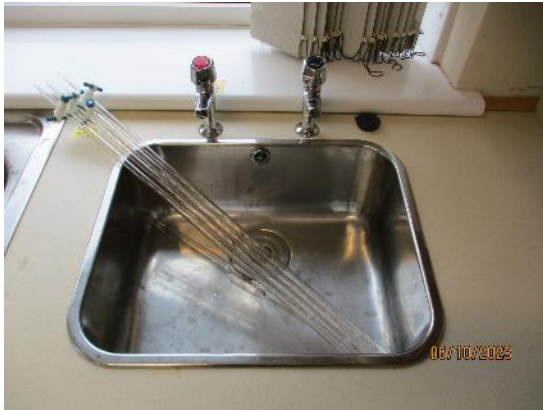
307. Stainless steel inset sinks

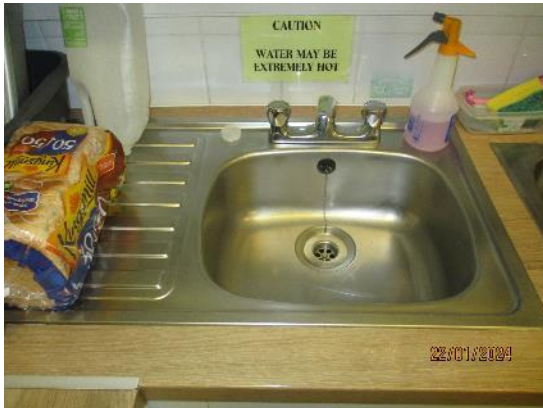
309. Stainless steel sinks – Leisure Centre

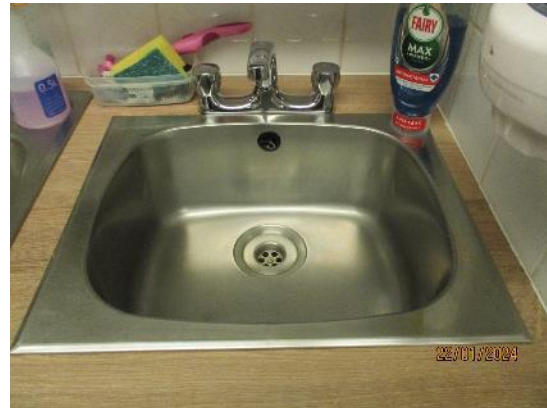
310. Stainless steel inset sinks

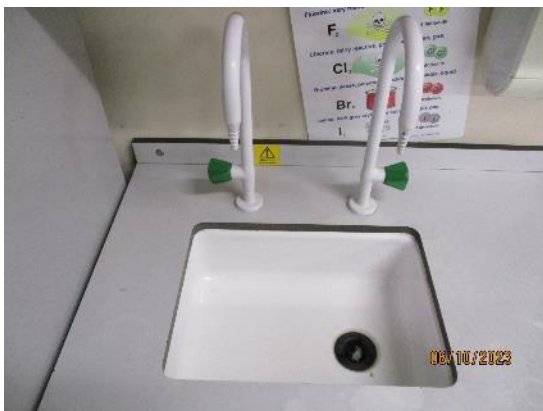
311. China inset sinks - Science

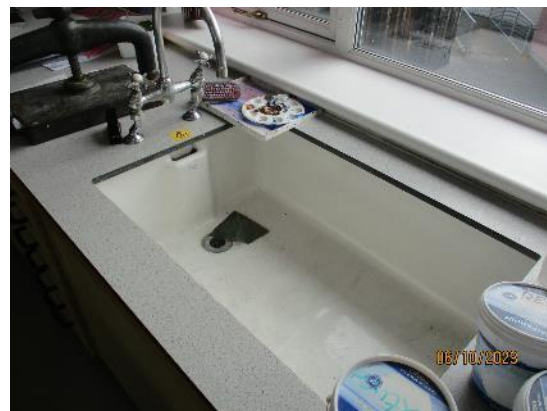
312. Large china inset sinks

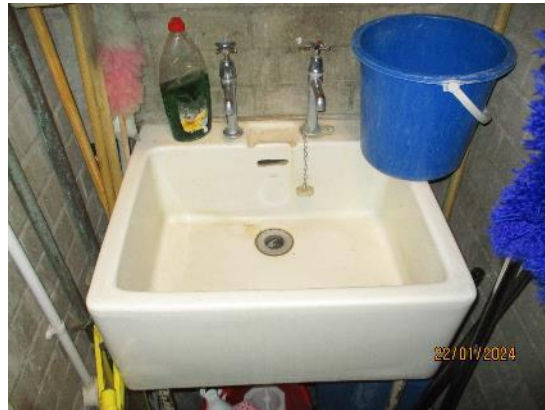
316.

315. Surface crazed and cracked

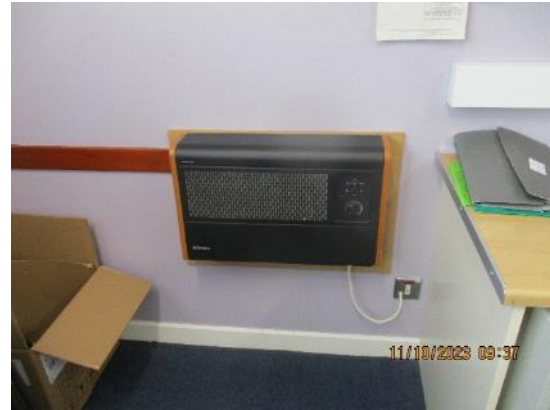
357. Electric fan convector K Block typical.

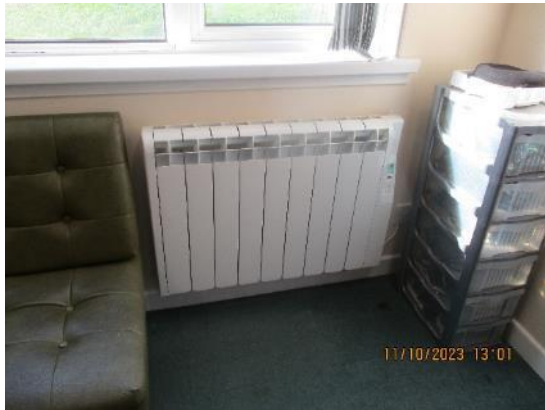
358. Rointe electric panel convector – M Block typical.

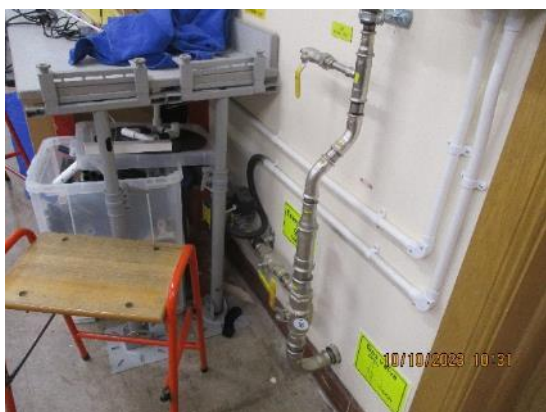
380. Gas pipework technology dept classroom.

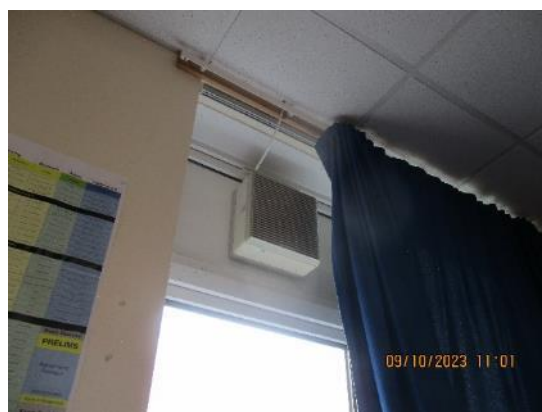
383. Extract fan class 1-86 main school.

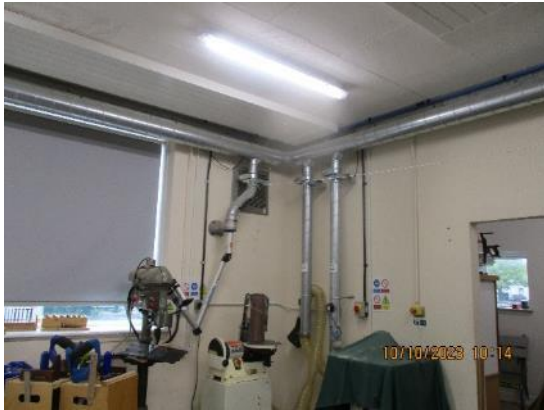
386. LEV system – Technology dept.

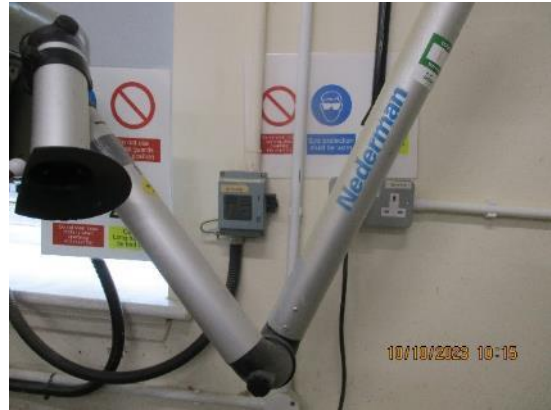
387. LEV extractor hood technology dept.

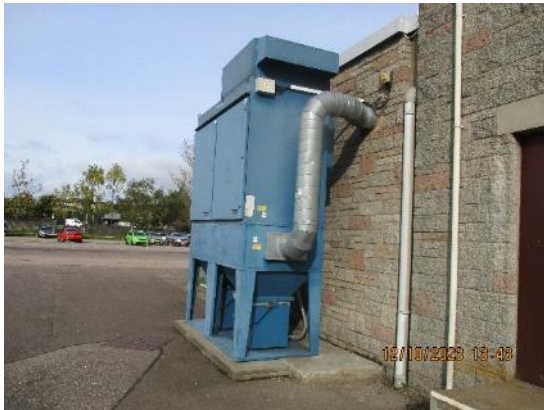
388. LEV collection unit and fan – Technology dept.

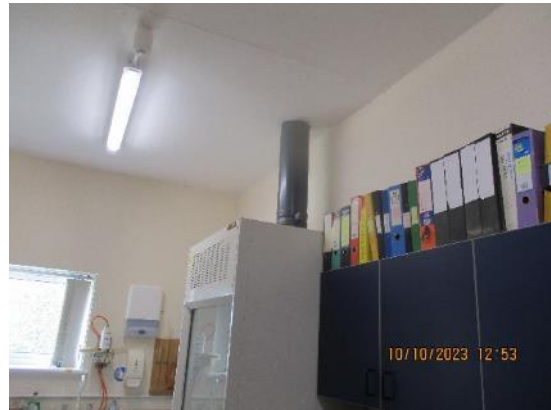
389. LEV – Fume cupboard science dept.

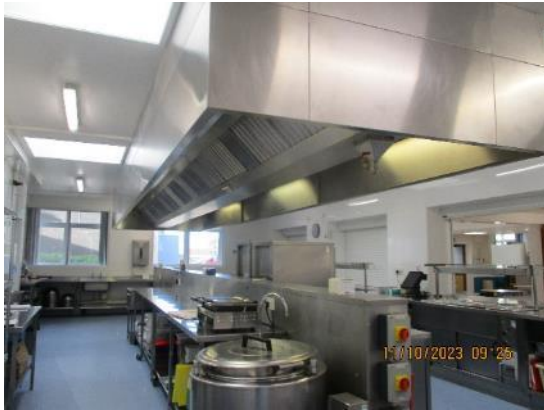
392. Kitchen extract canopy – K Block.

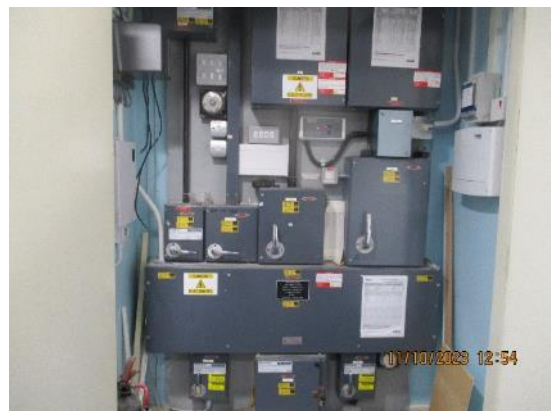
397. Switchgear and busbar – Music block.

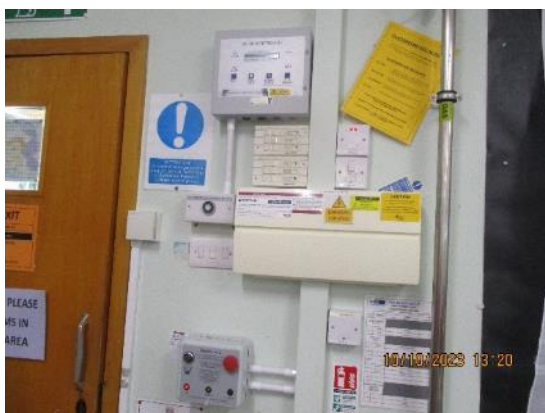
402. Consumer unit science class main school typical.

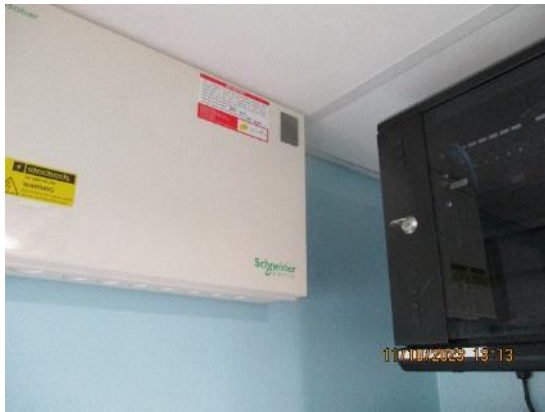
404. Consumer unit – Music block

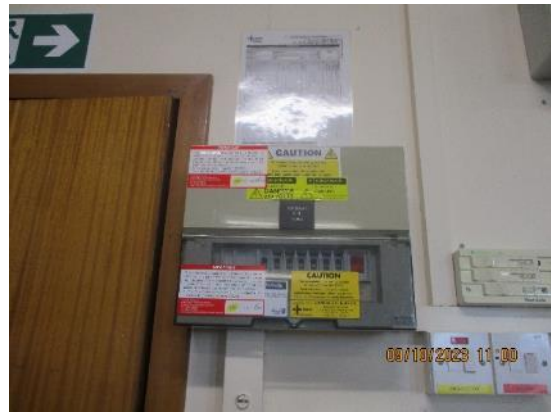
405. Consumer unit class 1-86 main school.

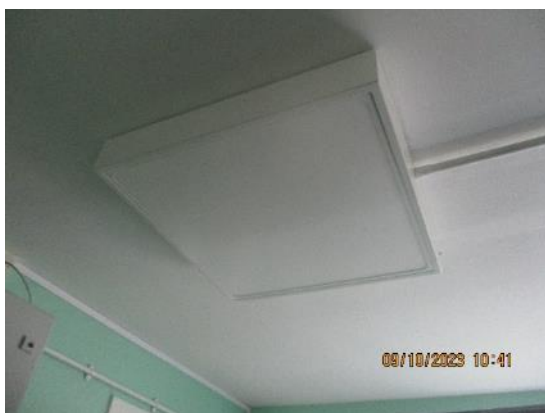
408. Lighting 1/77 maths base main school.

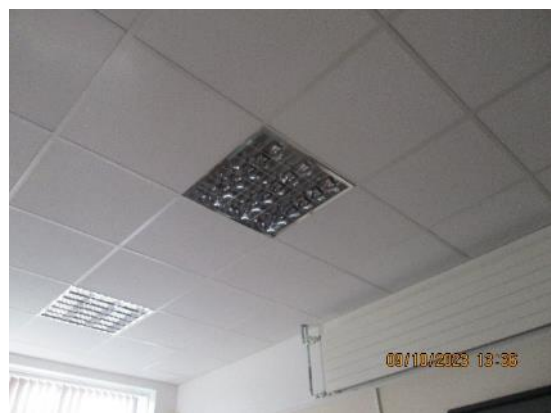
409. Lighting – main school ASN dept.

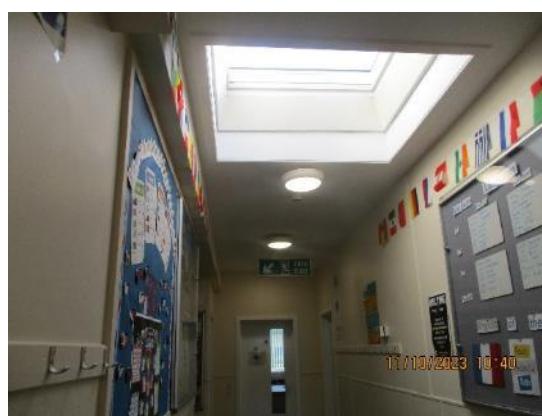
415. Lighting – K Block upstairs corridor.

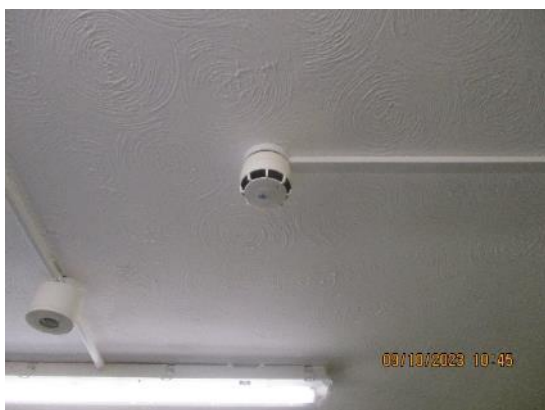
426. Smoke head typical main school.

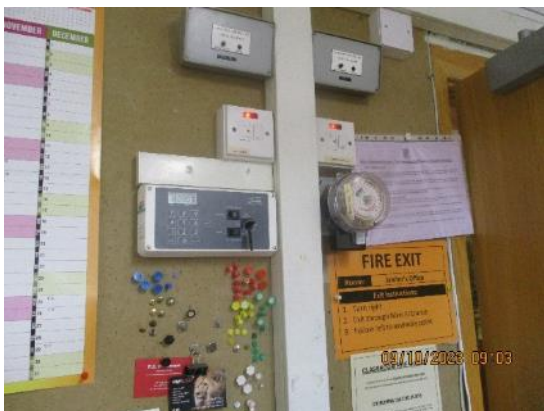
432. Period bell timeclock – janitors 1/70

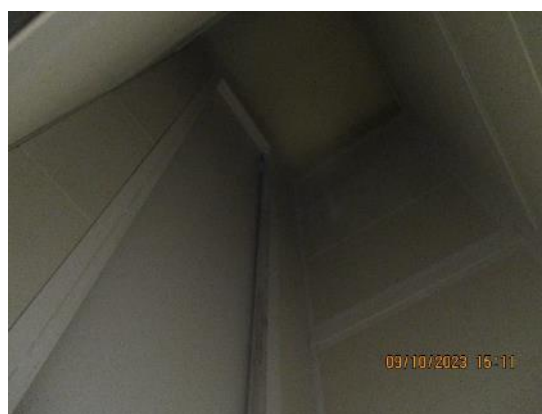
435. Lift shaft from ground floor. 1/116

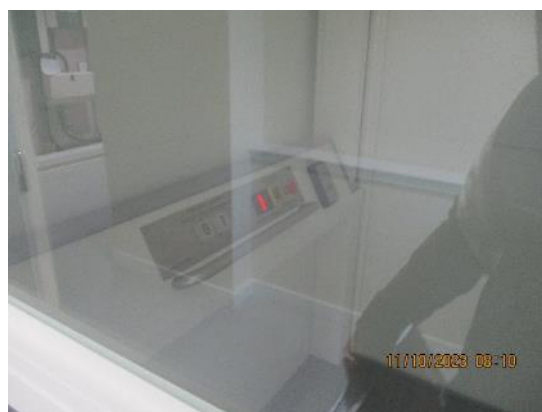
437. Lift 2 – upstairs view.

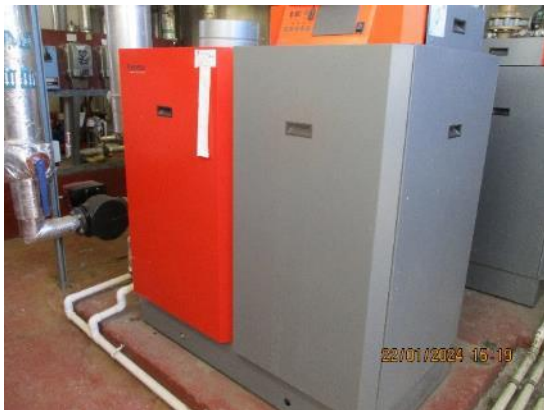
446. Natural gas condensing boiler

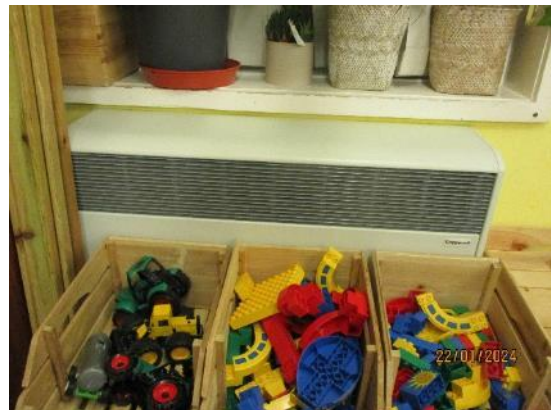
449. Convector heater – playgroup room

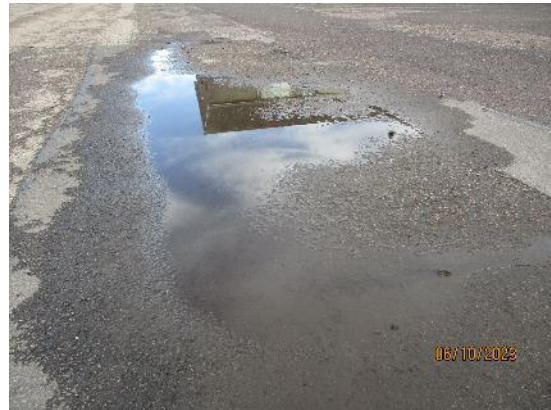
509. Surface ponding

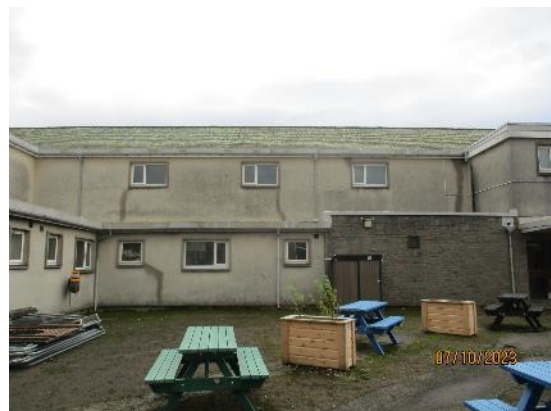
511. Tarmac central courtyard

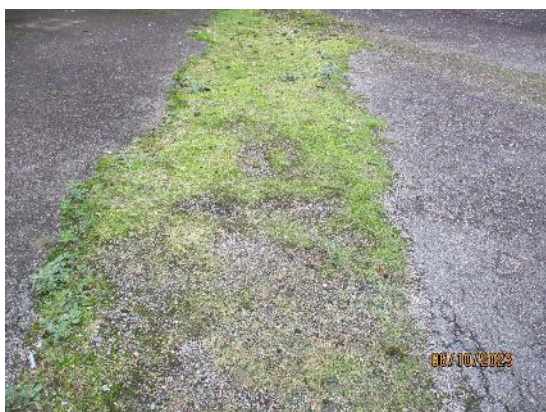
512. Extensive moss growth

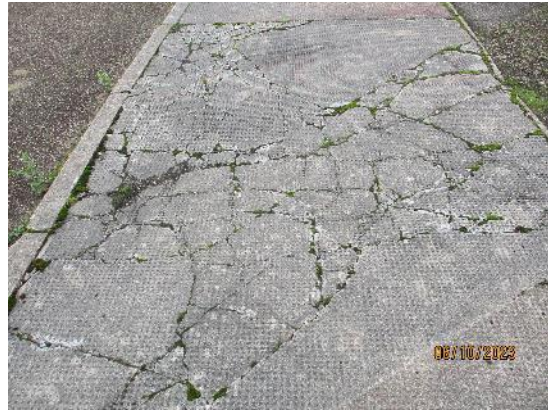
519.

518. Cracked concrete footpaths

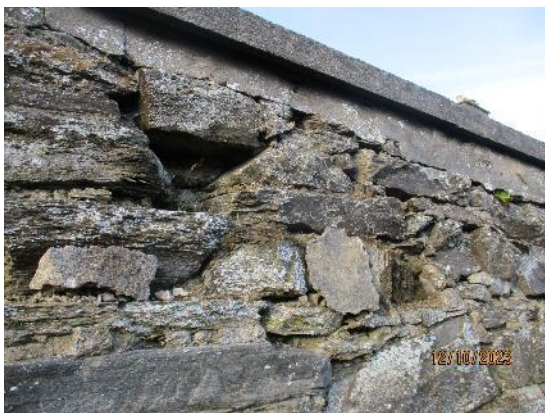
540.

539. Loose stones and repointing required

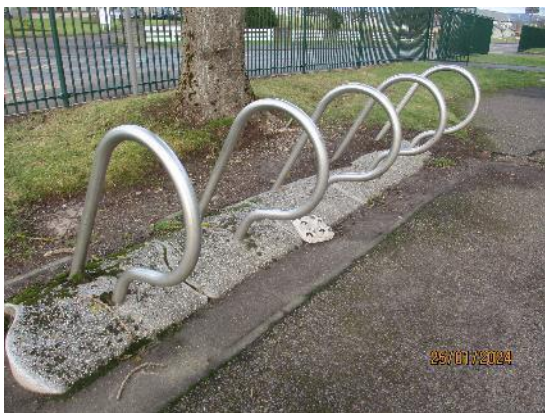
558. Stainless steel cycle hoops – Leisure Centre

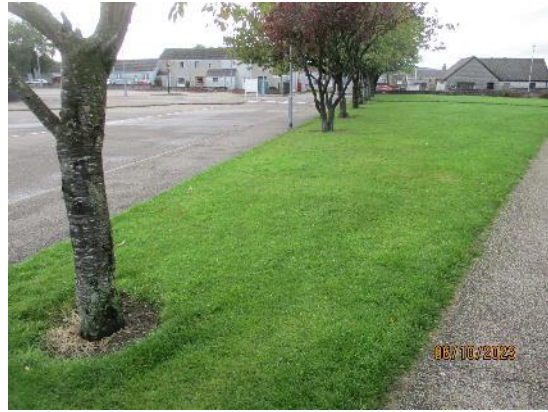
561. Landscaping – grass and trees
