# **Summary Building Condition Survey Report**

**Keith Grammar School and Leisure Centre  
School Road, Keith AB55 5GS**

**9<sup>th</sup> to 12<sup>th</sup> October 2023 and 22<sup>nd</sup> to 25<sup>th</sup> January 2024**

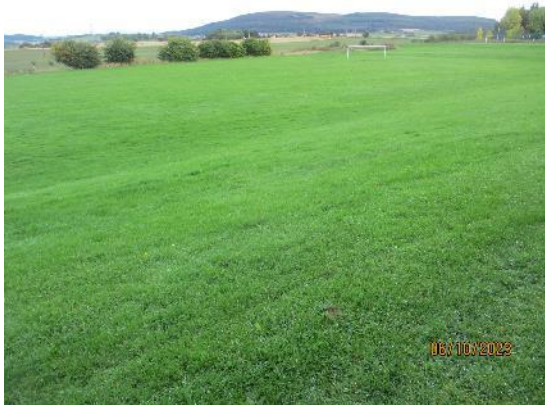
562. Grass sports field

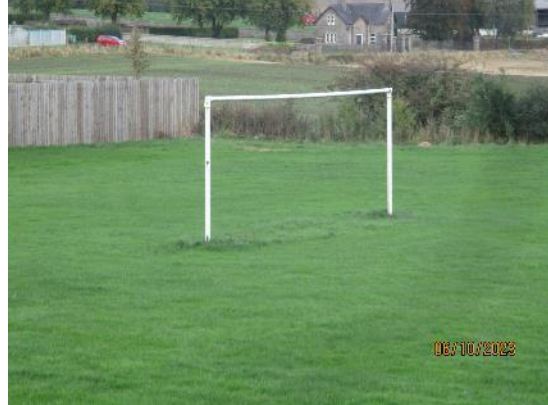
563. Metal goal posts
