# **Summary Building Condition Survey Report**

**Rothiemay Primary School  
Main Street, Rothiemay AB54 7LT**

**25<sup>th</sup> September 2023**

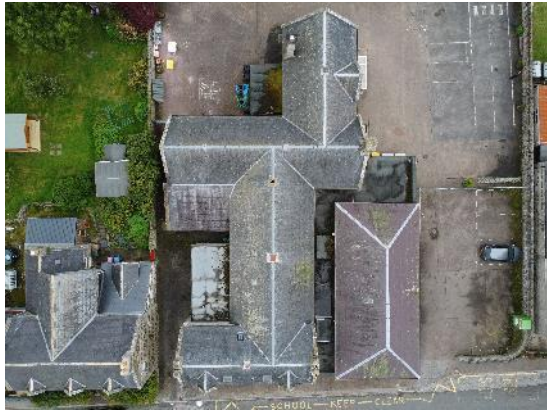
3. Overview of all roofs

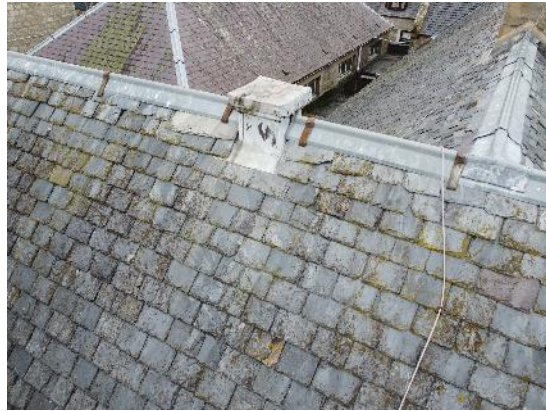
4. Isolated slipped slates

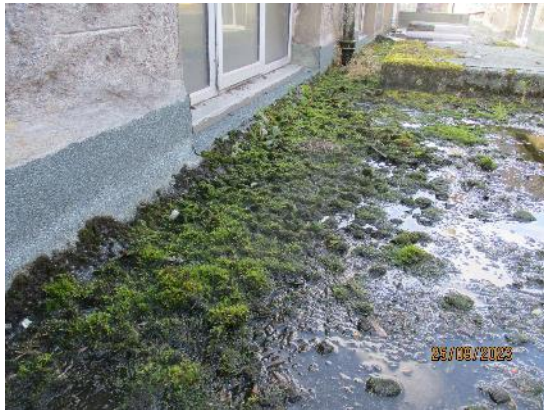
10. Extensive moss growth trapping water

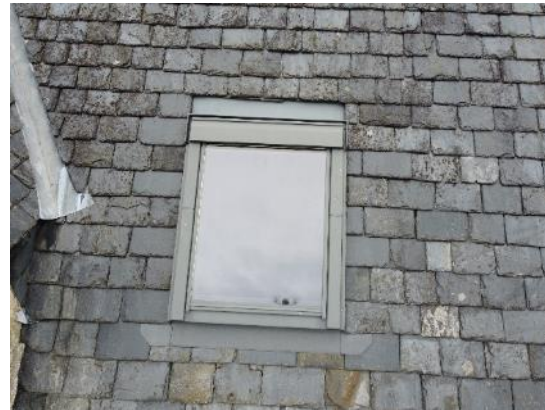
16. Velux window

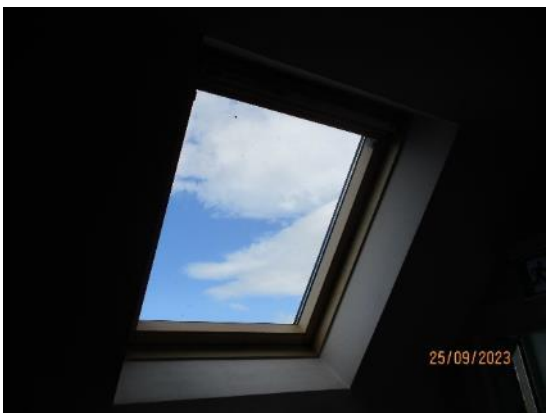
17. Internal view

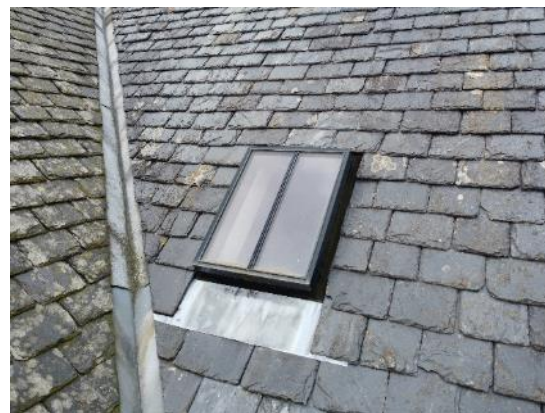
18. Metal skylight

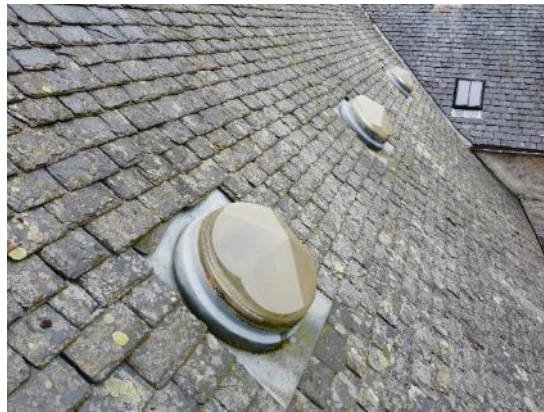
20. Sunpipes to Games Hall

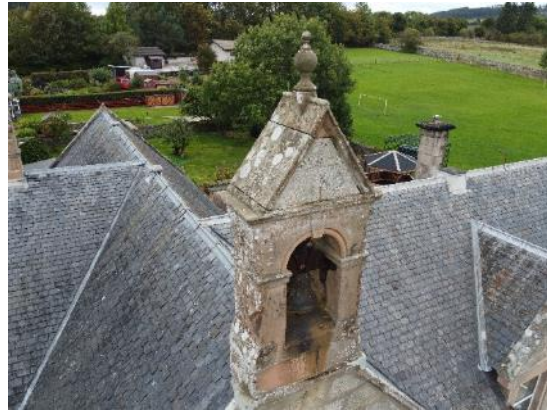
38. Stone bell tower

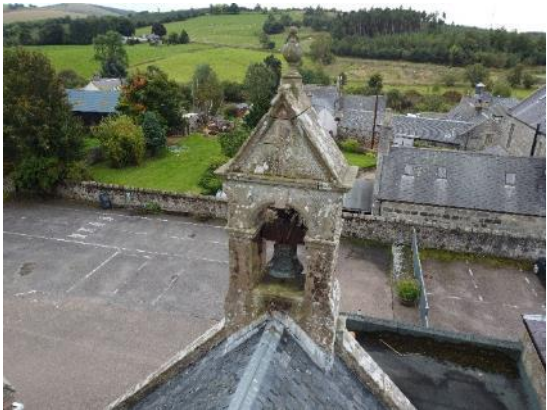
39. Rear of bell tower

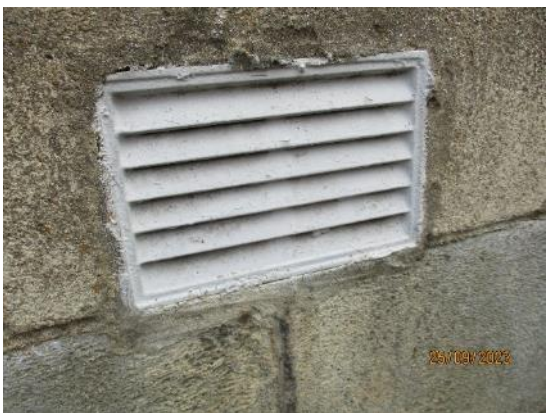
41. Underfloor ventilation

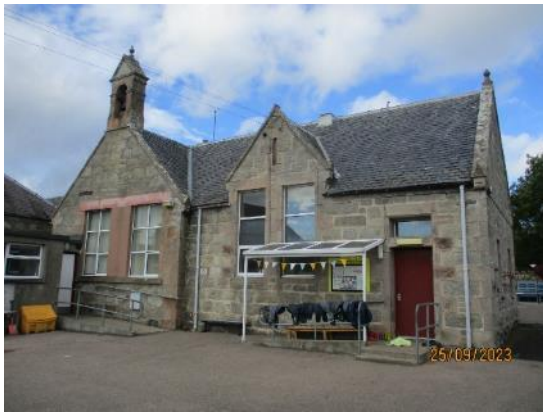
43. Stone walls

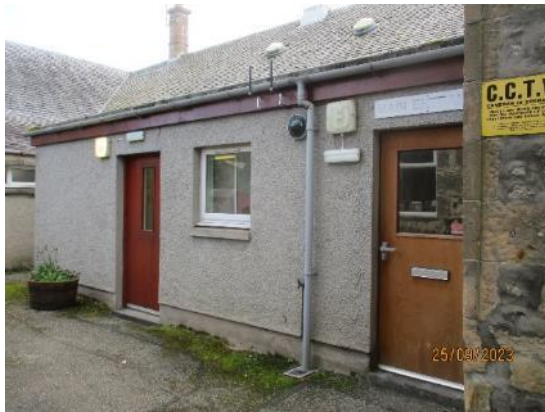
49. Roughcast walls

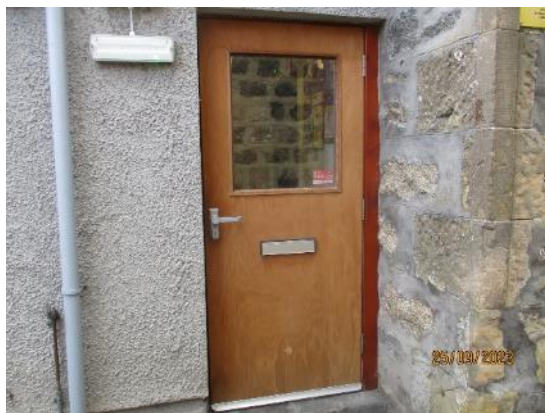
54. Timber external doors

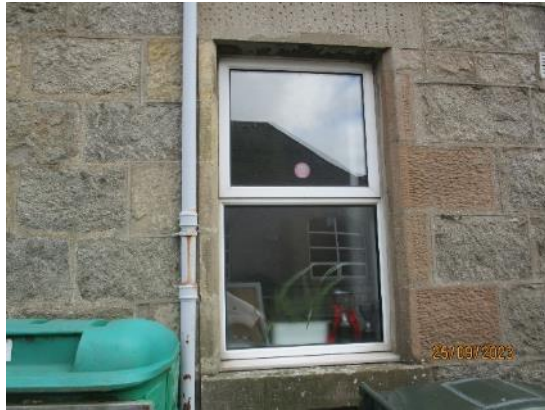
56. Standard UPVC window

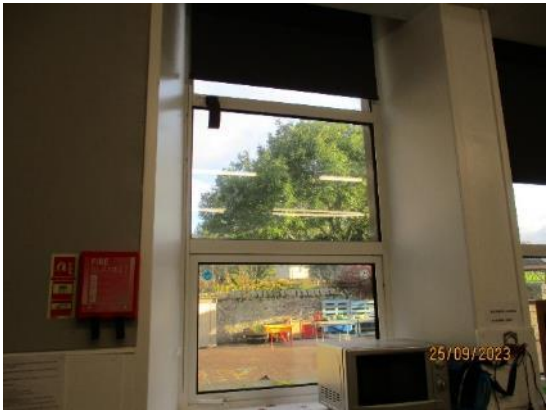
57. Internal view

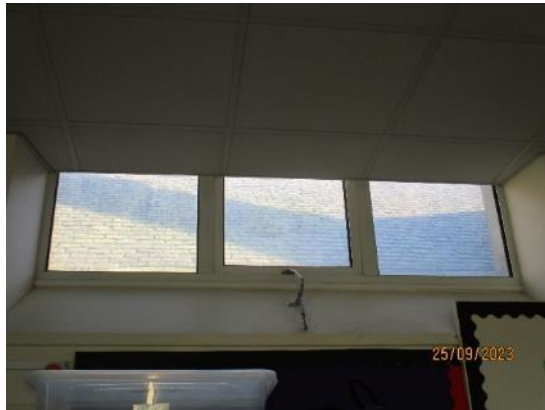
58. High level UPVC windows

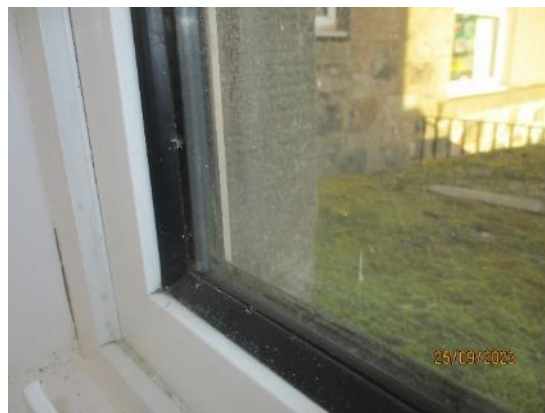
60. Double glazing

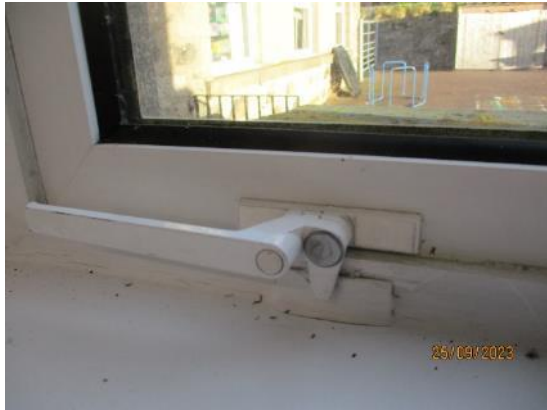
61. Lever handles

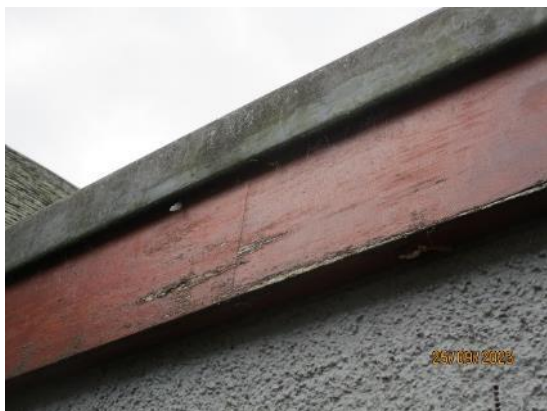
65. Timber fascia boards

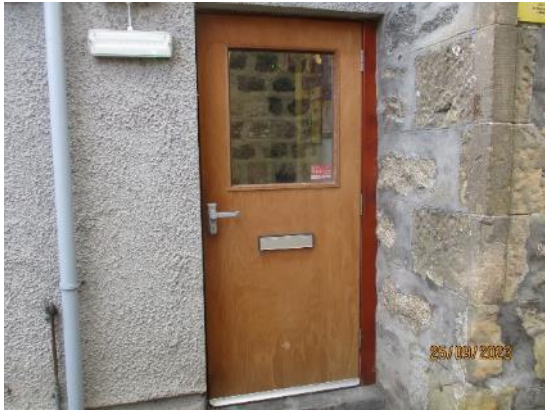
67. Timber doors

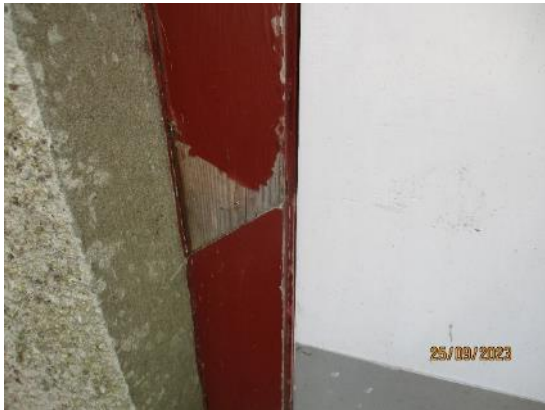
69. Door frames

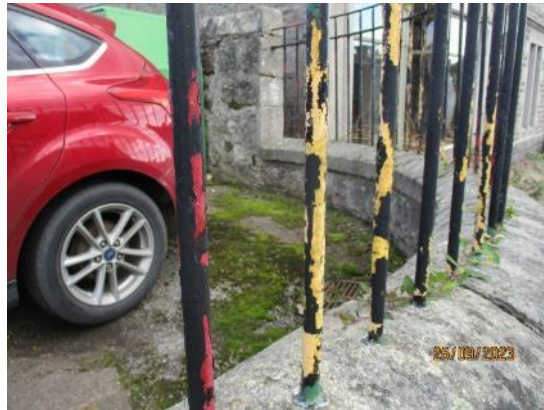
70. Metal railings

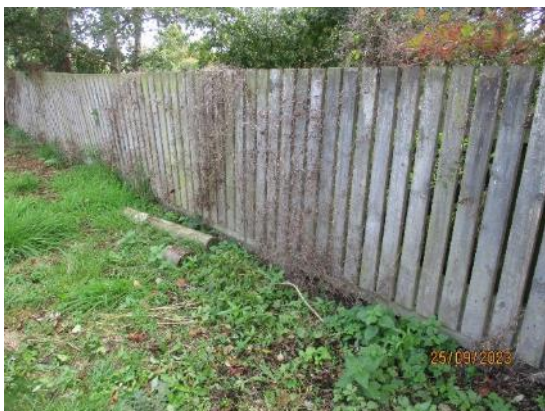
71. Timber fences and gates

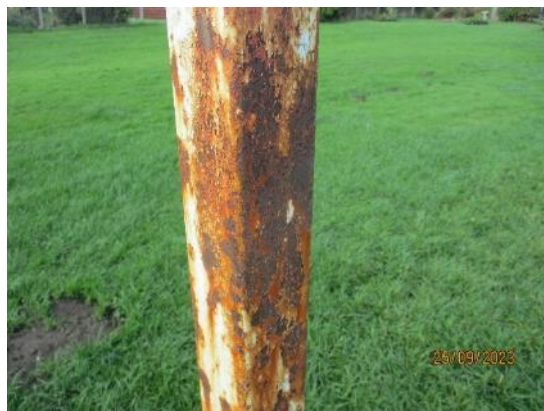
72. Metal goal posts

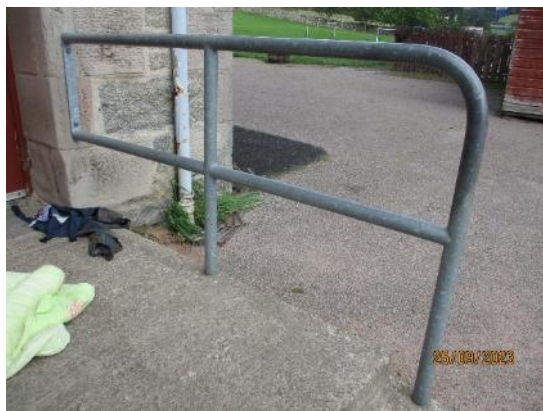
77. Galvanised tubular guard rails

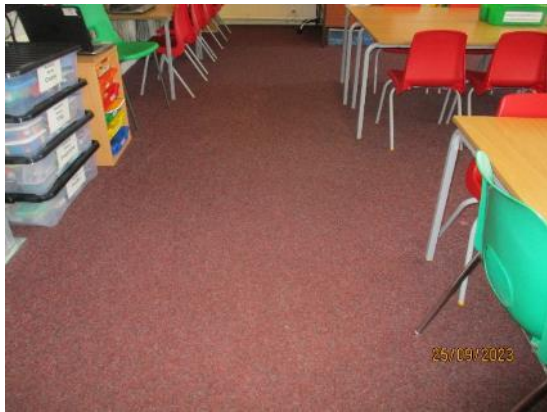
79. Classroom carpet

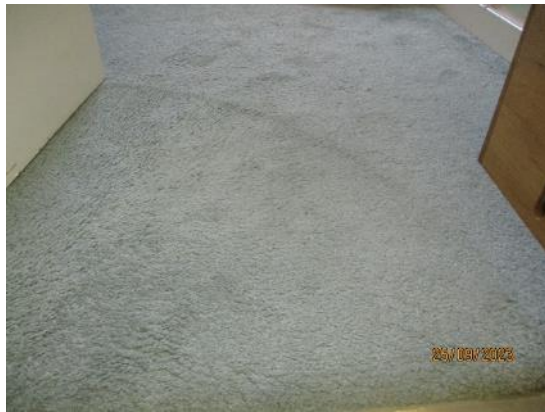
80. Nurture room carpet

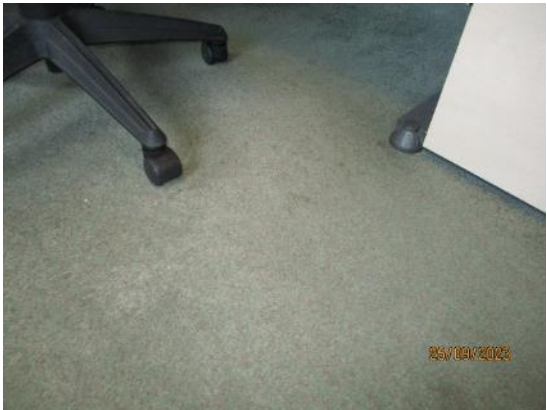
81. Reception carpet

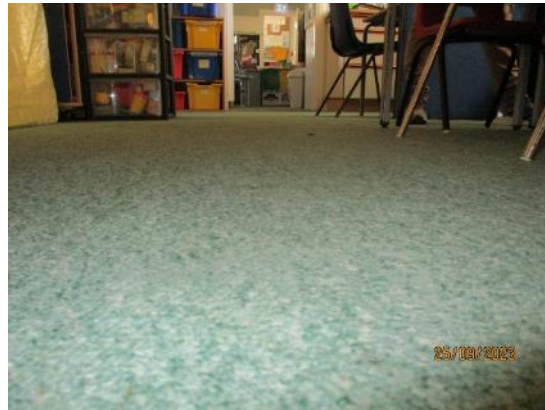
82. Library uneven carpet

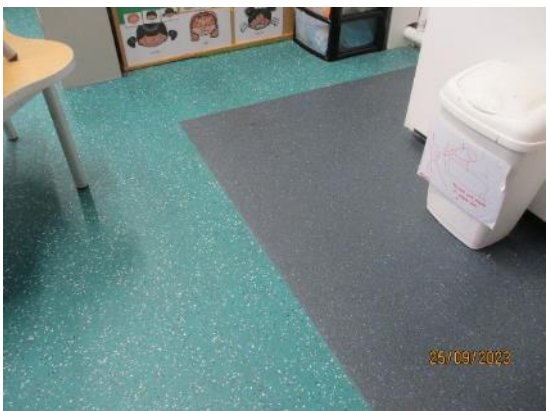
83. Sheet vinyl

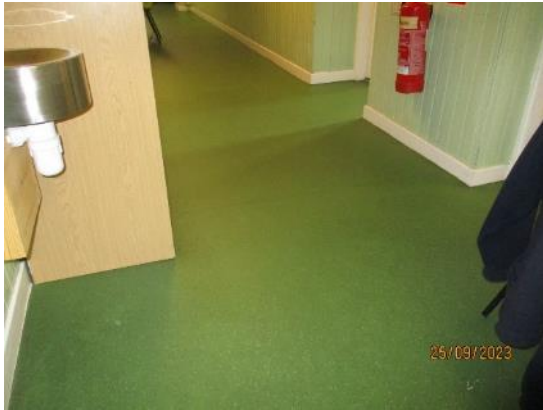
85. Sheet vinyl to corridors

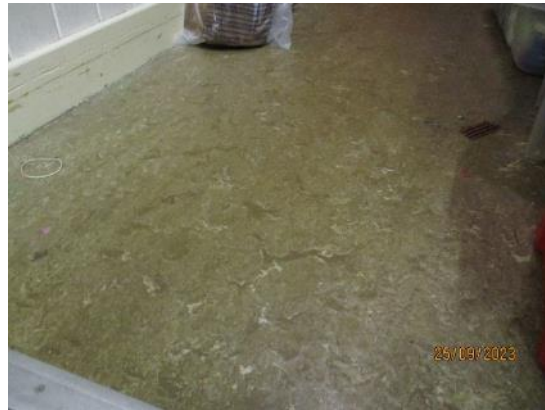
88. Linoleum in store 1/9

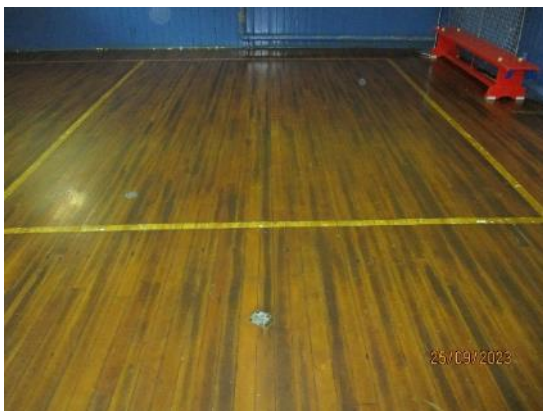
89. Timber boards in Games Hall

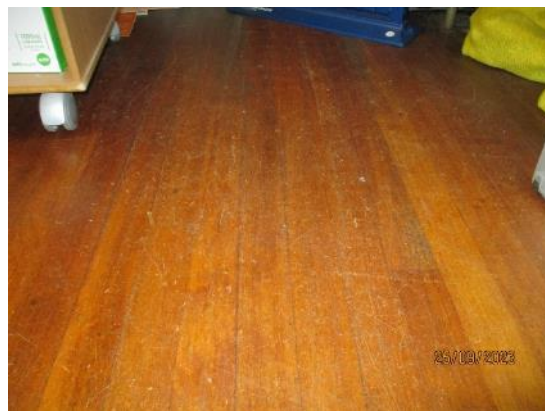
90. Timber boards in Resources room

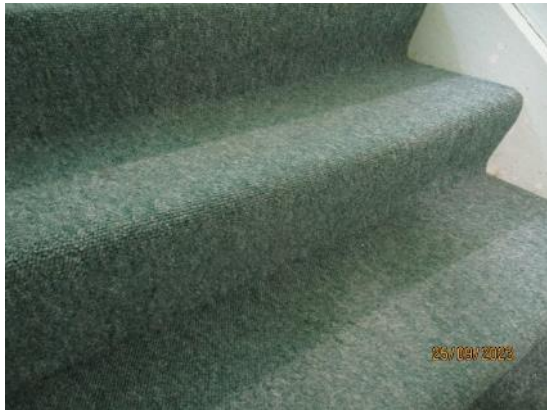
93. Carpet treads and risers

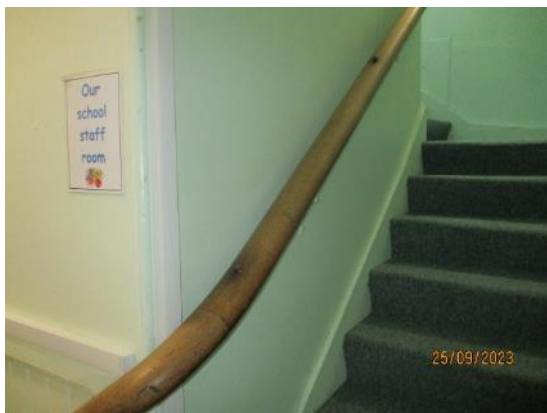
95. Timber handrail

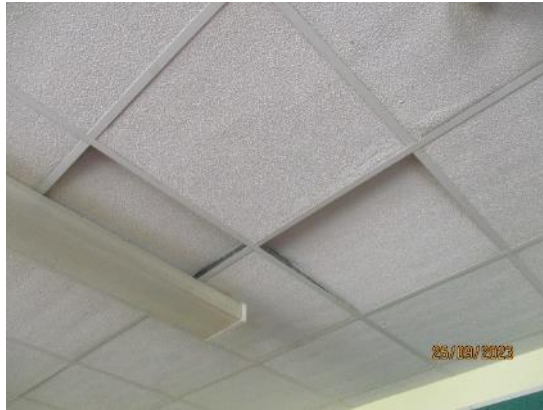
97. Disturbed tiles

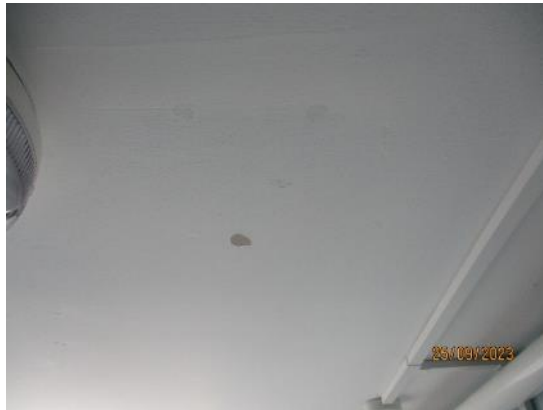
99. Plasterboard ceilings

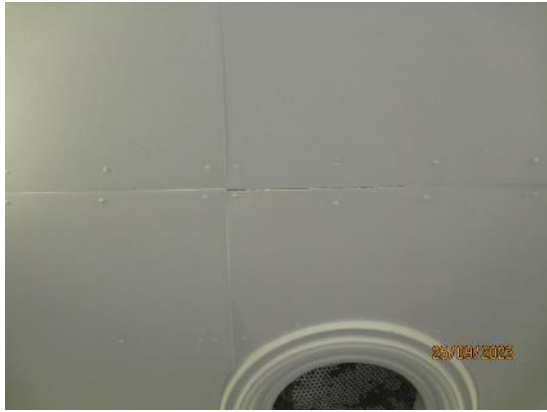
102. Board material to Games Hall ceiling

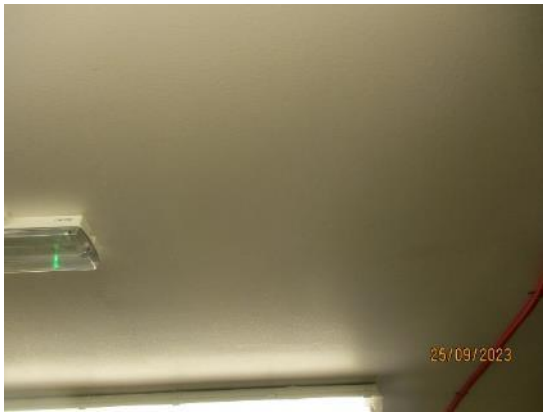
108. Plastered ceilings below flat roofs

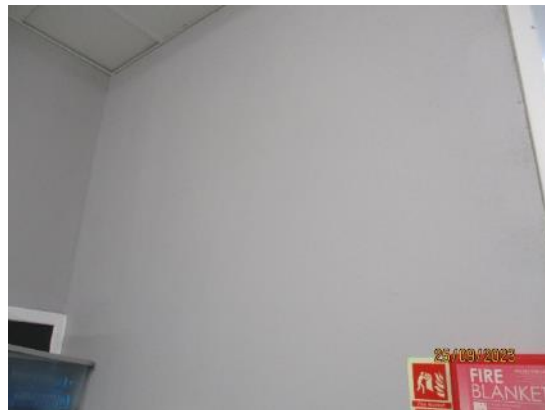
111. Lath & plaster

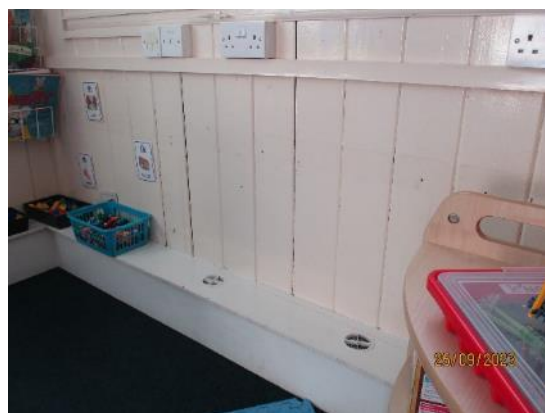
113. Timber linings at low level

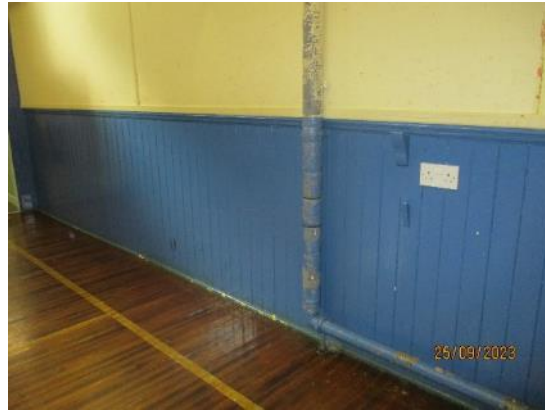
115. Timber linings in Games Hall

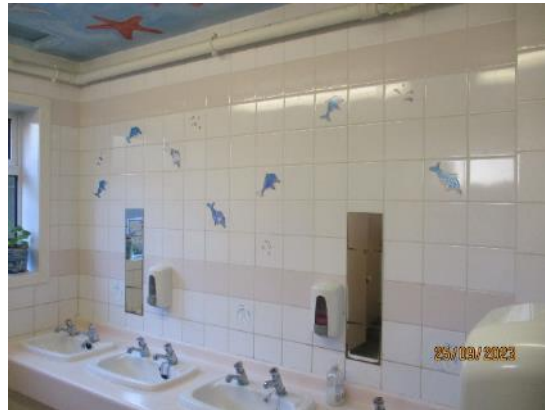
117. Ceramic tiles in pupil toilets

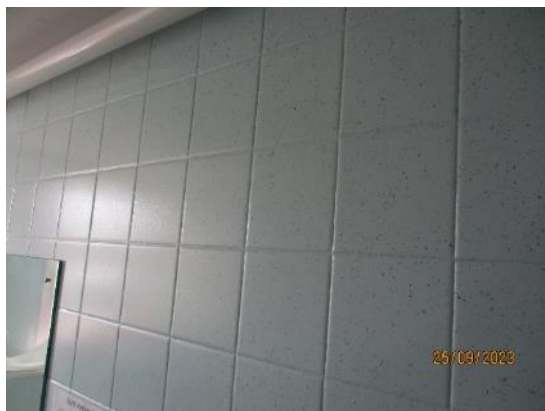
118. Painted ceramic tiles

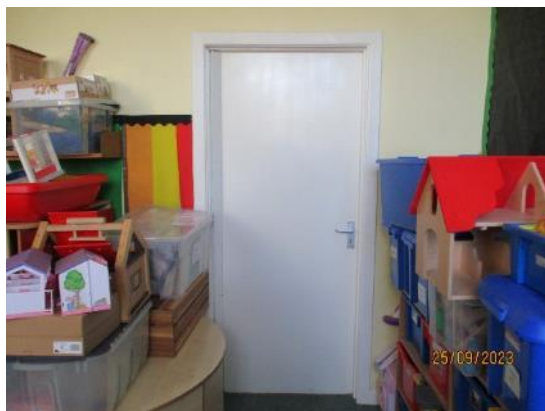
119. Timber hollow core doors

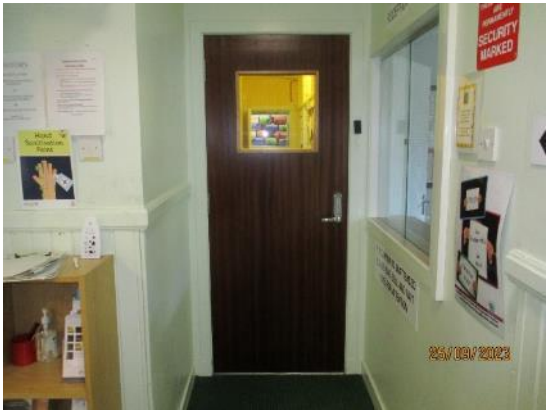
122. Timber veneered doors in corridors

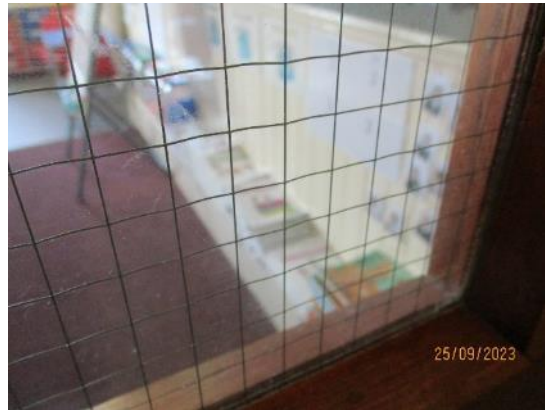
123. Georgian wired glass

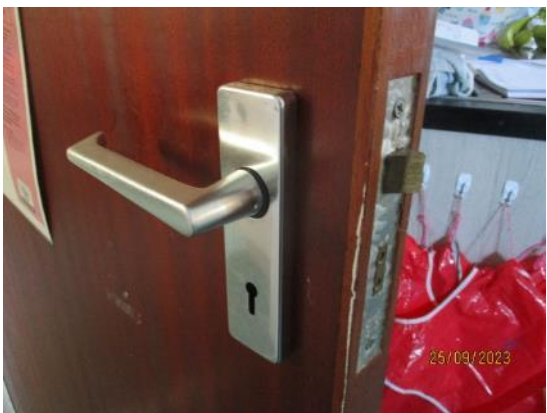
124. Aluminium lever handles

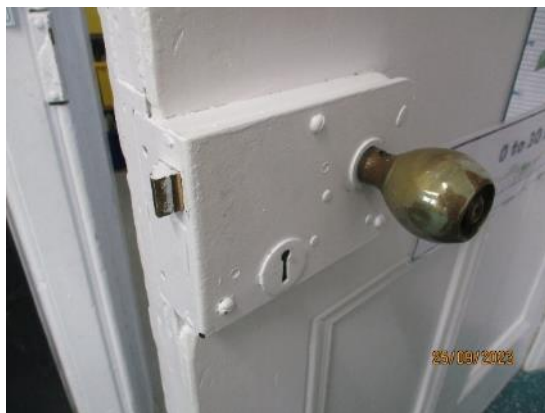
125. Brass knobs and rimlocks

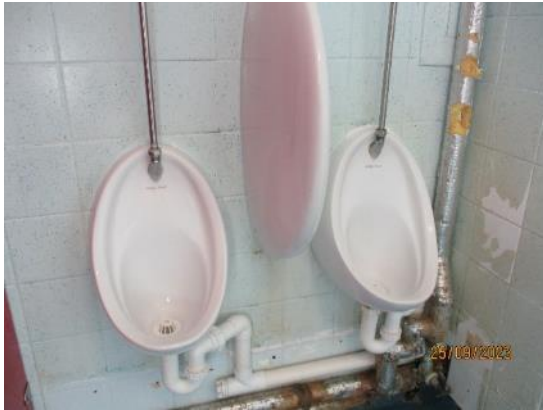
126. Single urinals

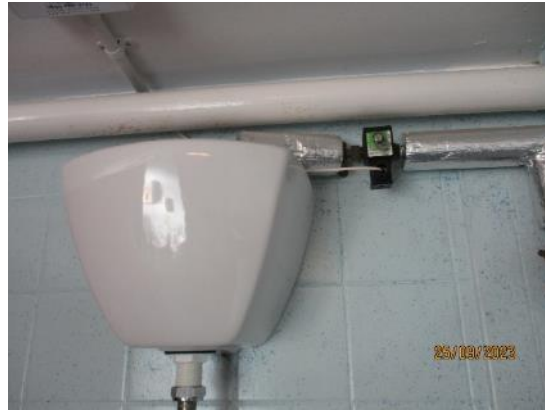
127. China cistern

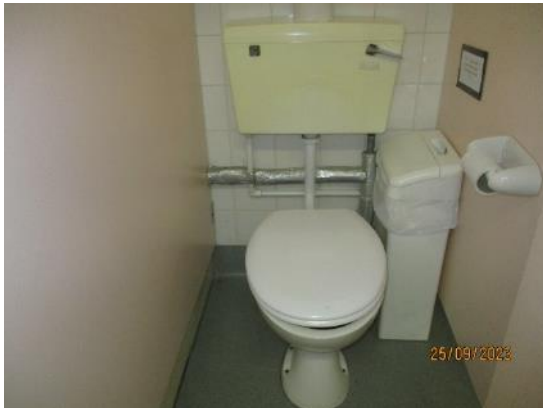
128. Typical W.C.

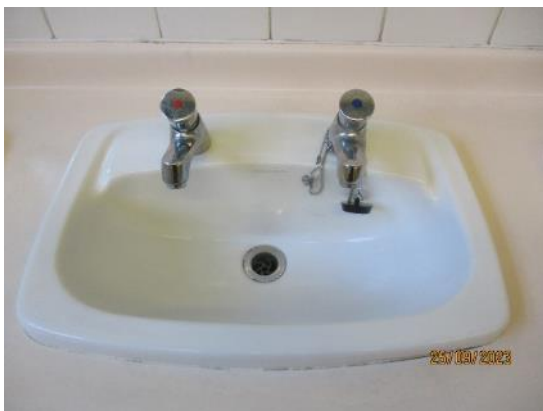
130. China vanity basin

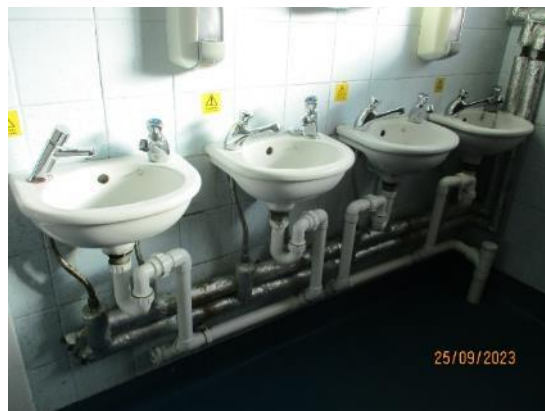
131. Wall hung china basins

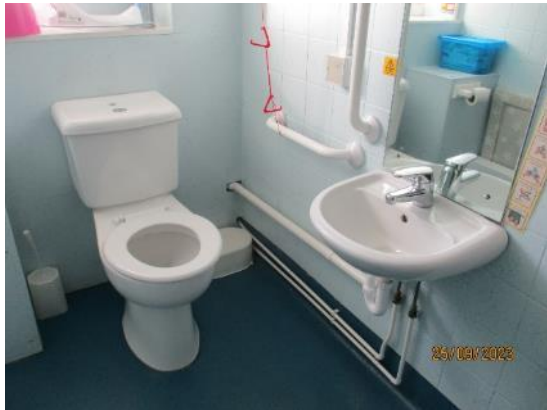
134. Accessible toilets

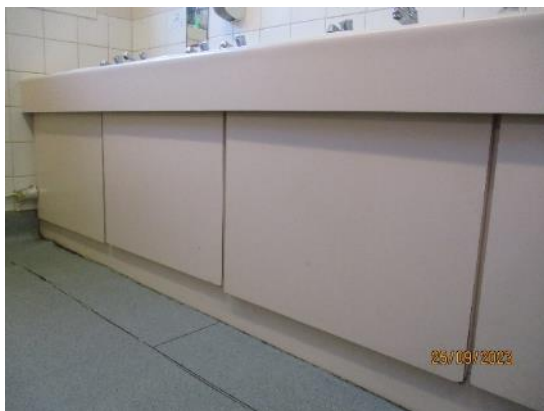
137. Composite panel vanity units

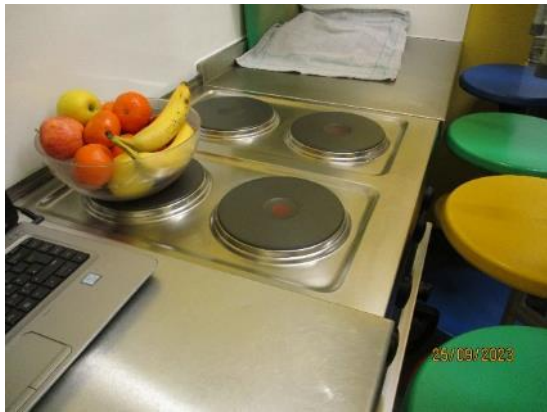
138. Commercial kitchen

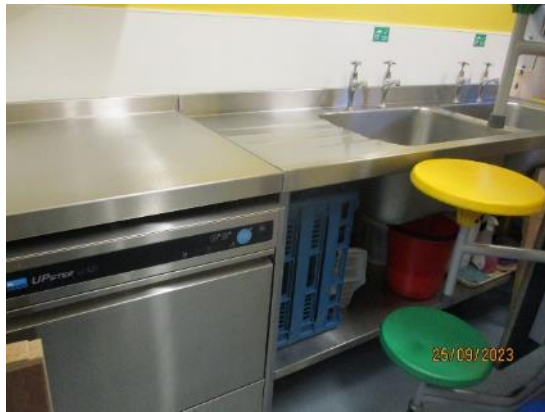
139.

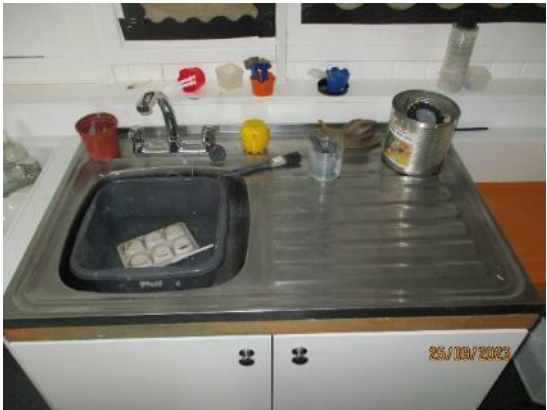
140. Stainless steel kitchen sinks

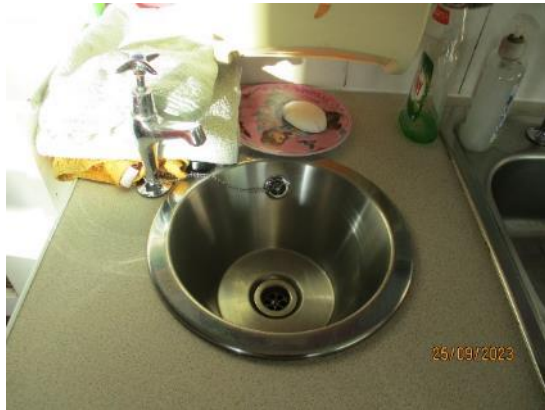
141. Stainless steel inset sink

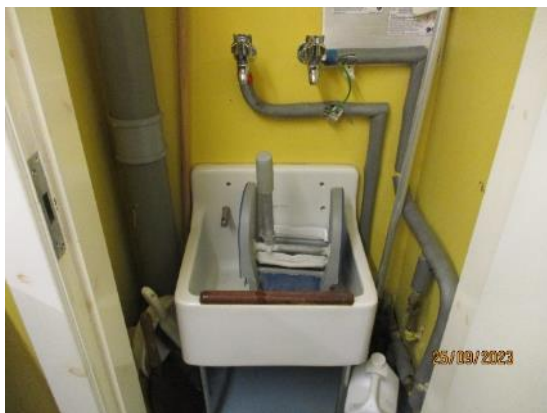
142. Cleaners Butler sink

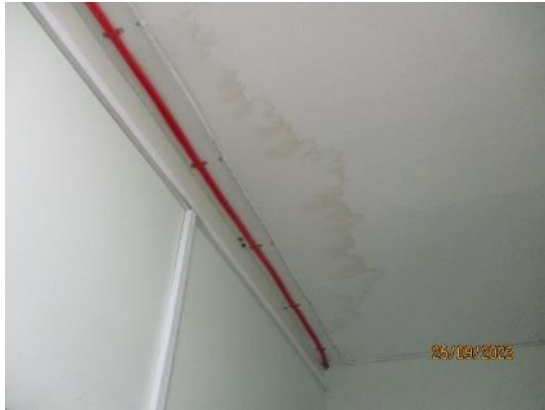
144. Ceilings

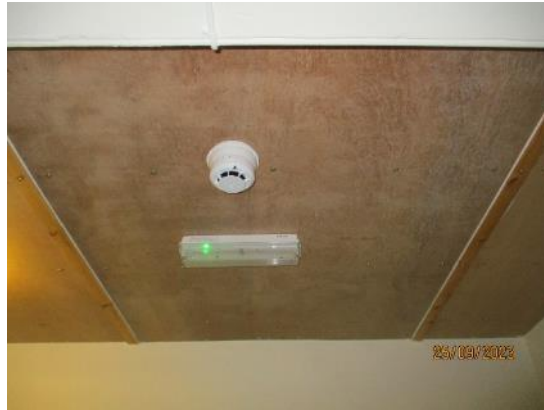
145. Patched ceilings

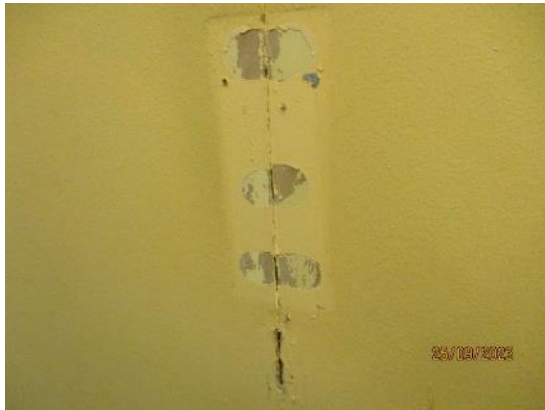
146. Plasterboard walls

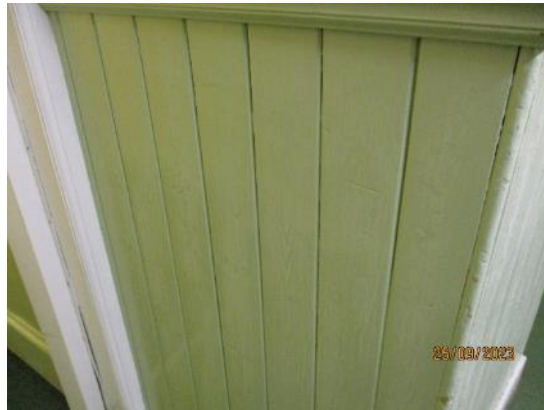
147. Timber linings

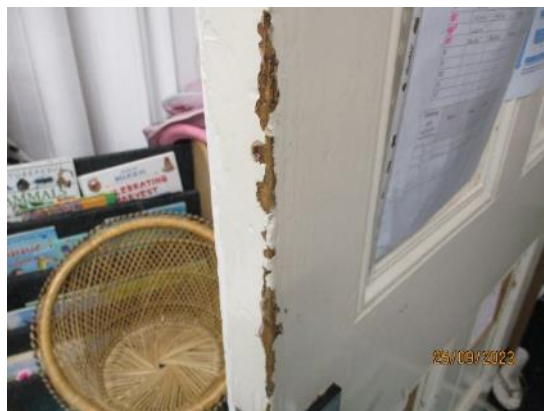
149. Timber doors

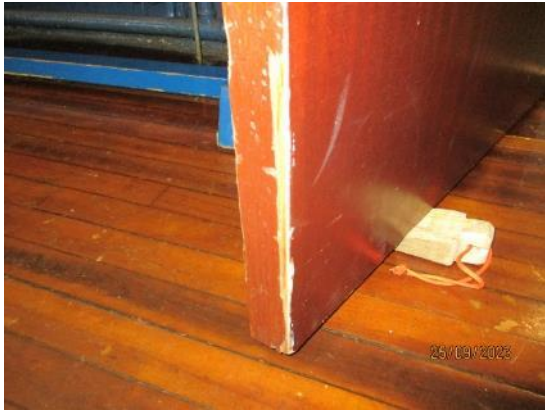
150. Timber doors

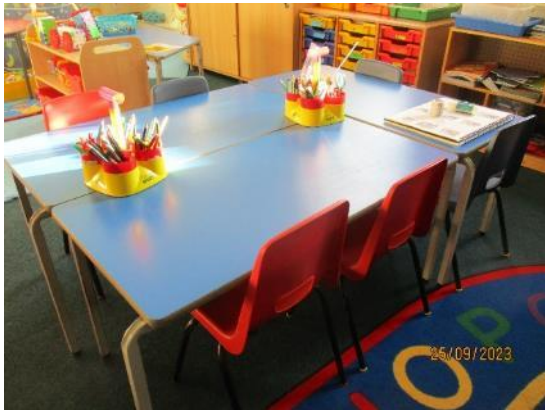
152. Classroom tables and chairs

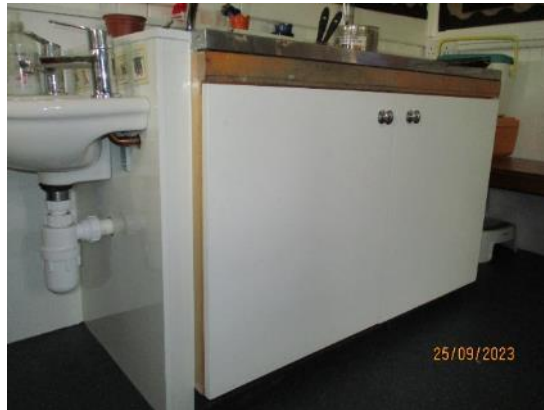
153. Sink base units

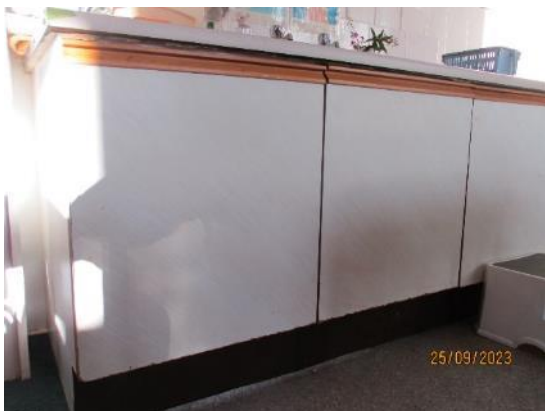
154.

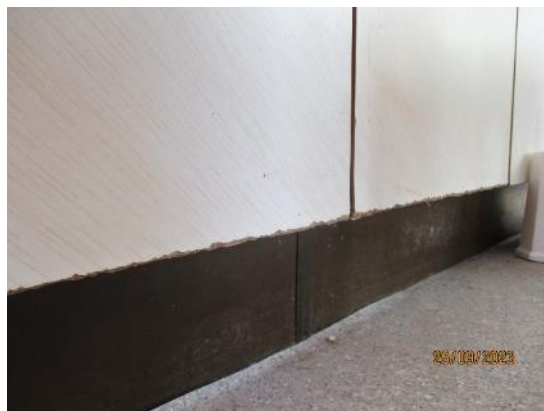
155. Chipped edges

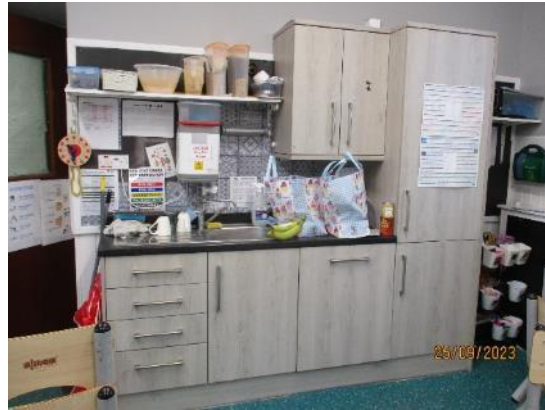
157. Newer units in Play Group

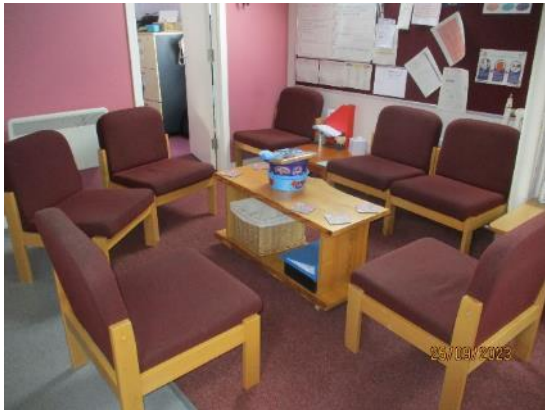
158. Staff room furniture

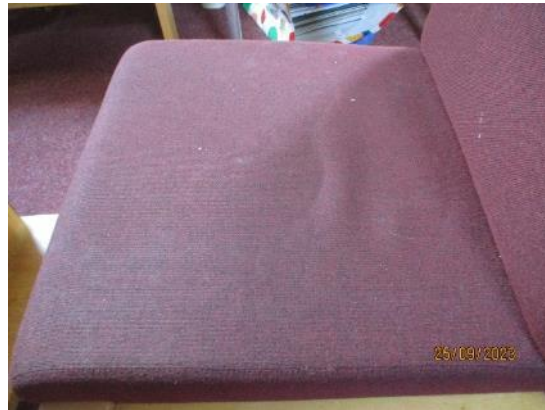
159. Sagging fabric

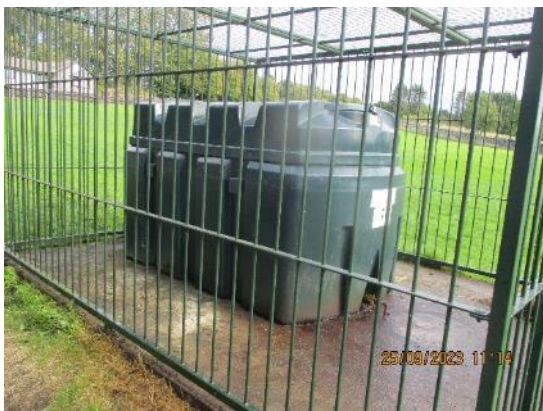
164. Oil storage and supply tank.

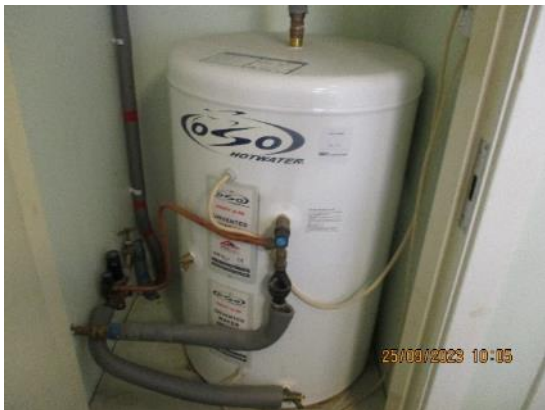
168. Hot water cylinder – kitchen supply.

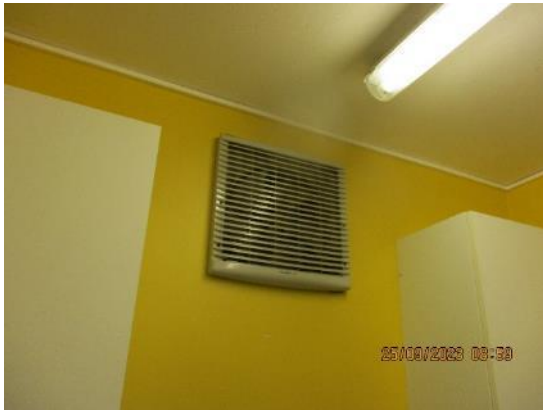
174. Extract fan – kitchen.

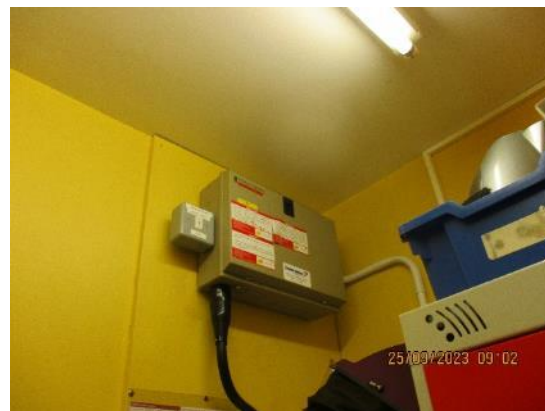
177. Distribution board – kitchen store.

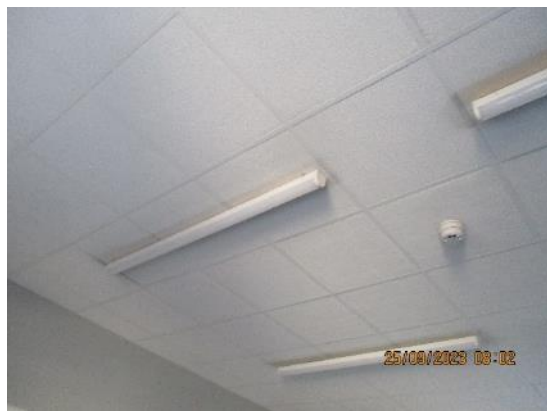
182. Lighting – staff room.

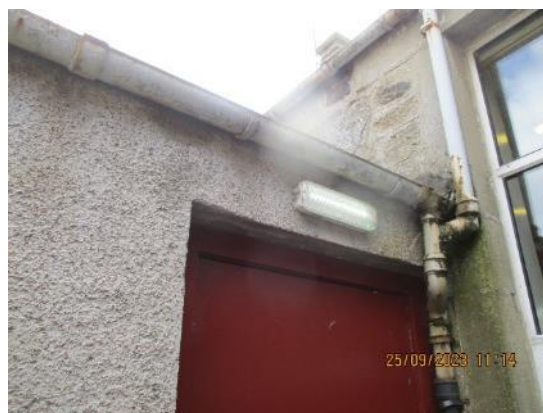
188. External lighting typical.

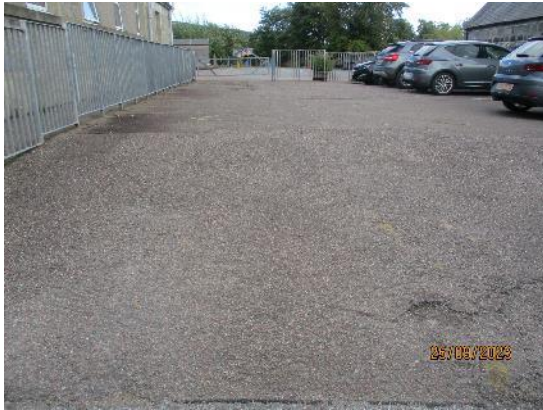
202. Tarmacadam car park

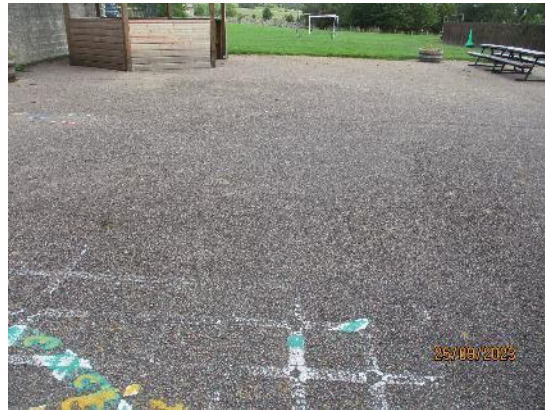
205. Tarmacadam playground

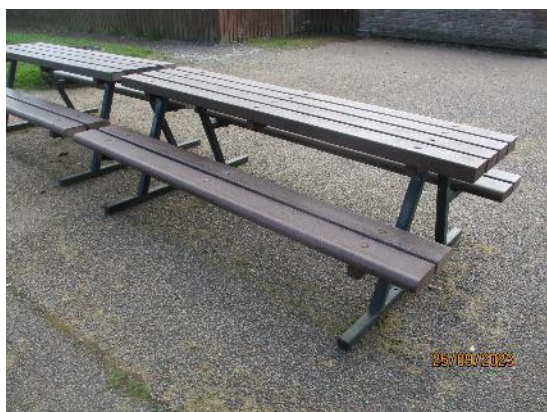
208. Recycled tables and benches

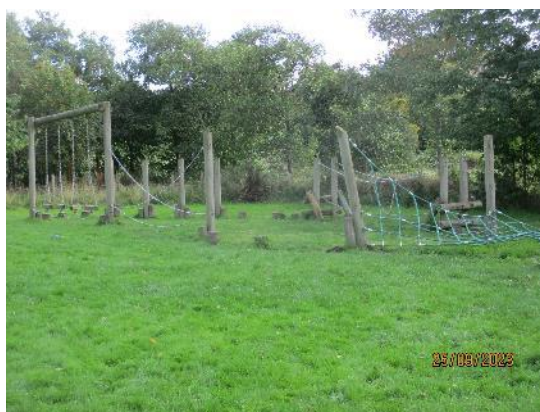
209. Playground equipment

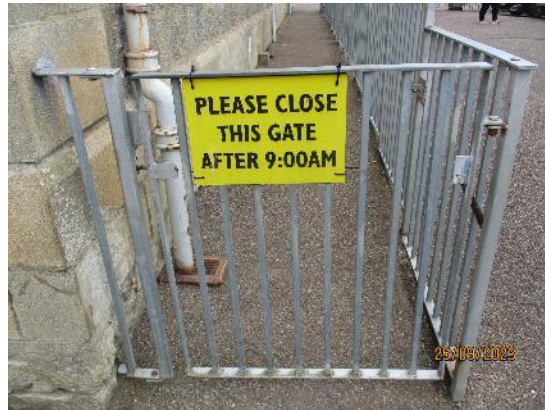
217. Galvanised bar gates

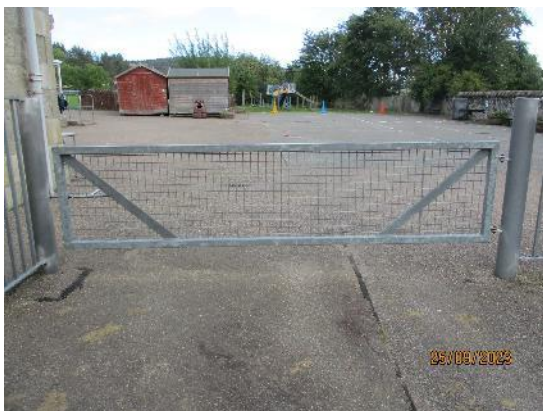
218. Galvanised mesh vehicle gate
