# **Summary Building Condition Survey Report**

**Newmill Primary School  
Middle Brae, Keith AB55 6US**

**11<sup>th</sup> September 2023**

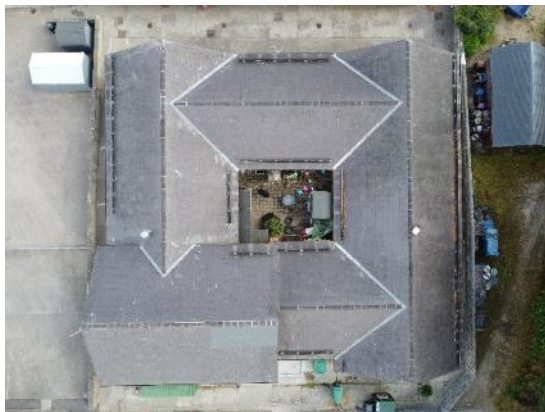
3. Overview of slated roofs

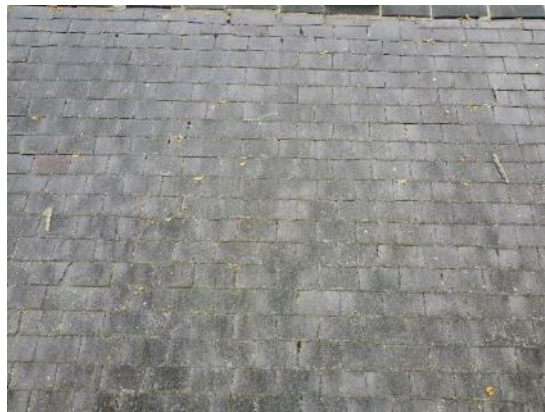
4. Typical slating

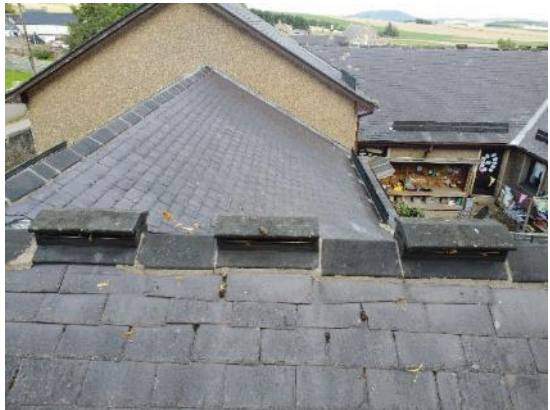
10. Ridge vents and slipped slates

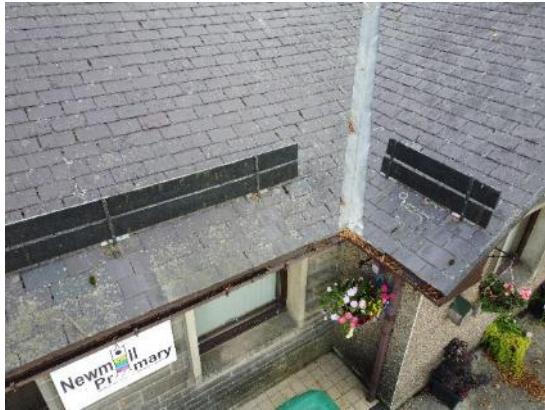
13. Timber snow boards

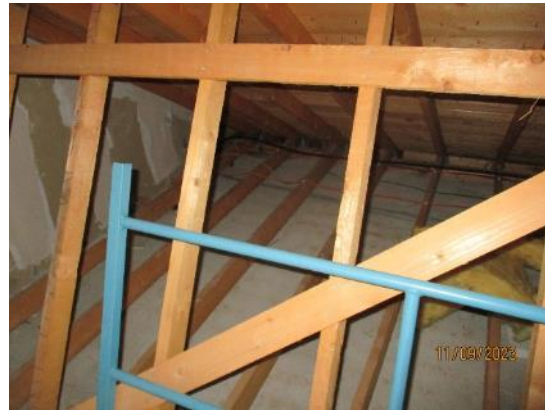
16. Missing insulation

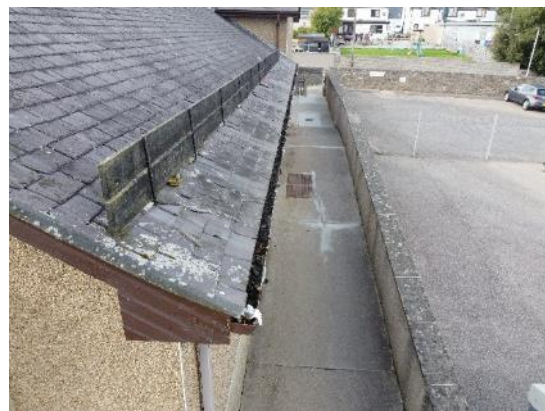
18. UPVC gutters

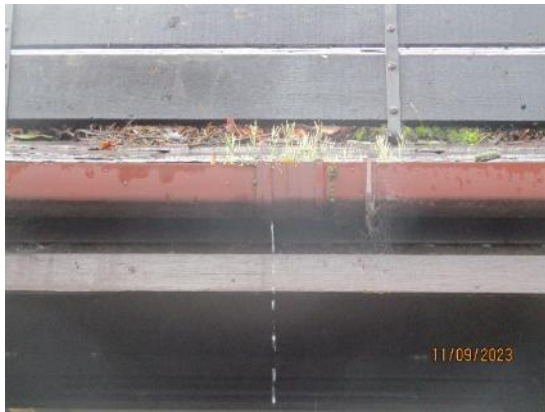
19. Blocked/leaking gutters

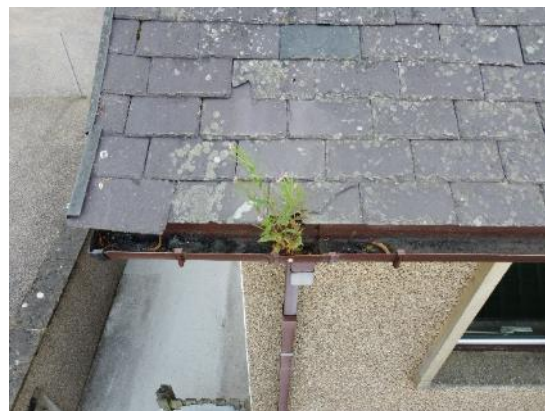
24. Blocked gutters

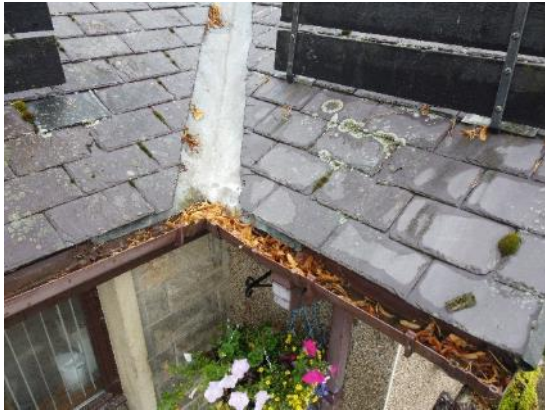
25. Blocked gutters

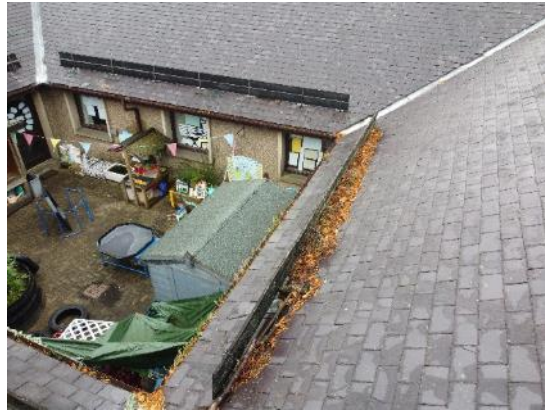
26. Leaf fall and debris trapped by snow boards

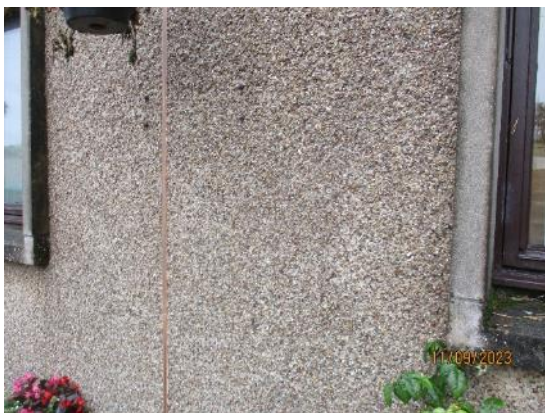
29. Roughcast finish to external walls

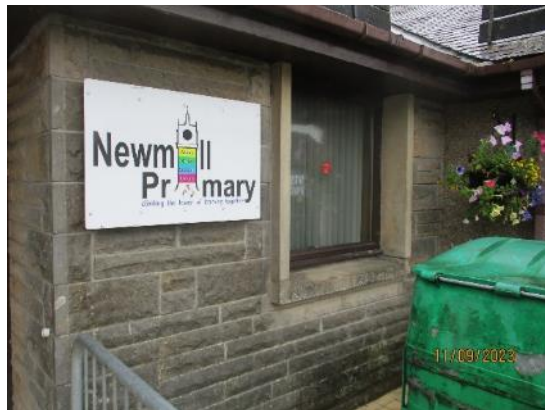
34. Sandstone feature panels

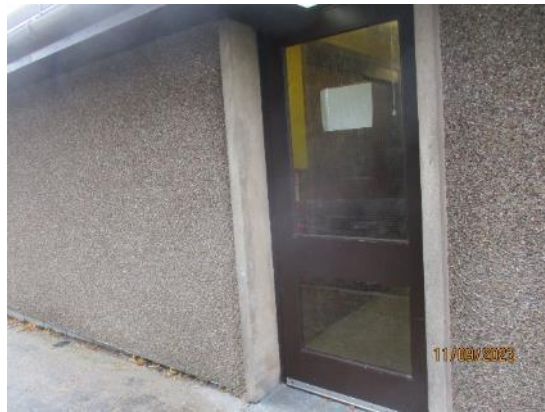
38. Timber glazed external doors

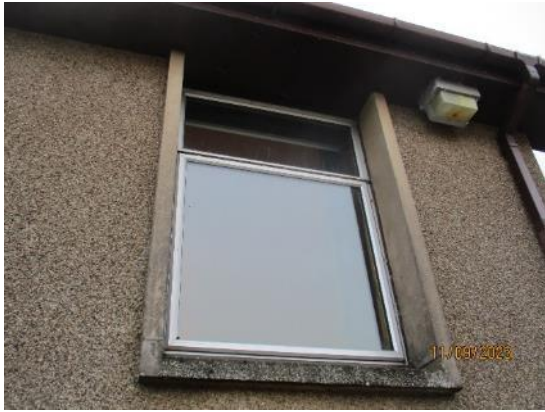
43. Aluminium windows to Games Hall

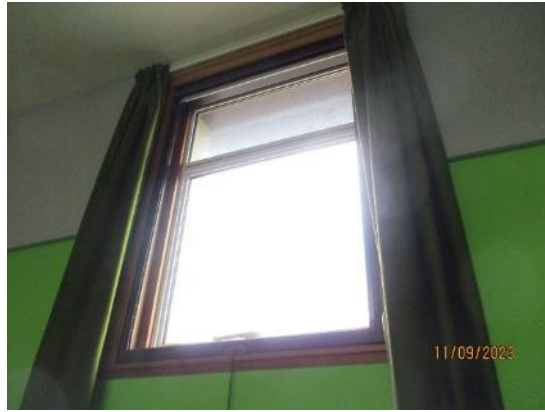
44. Internal view

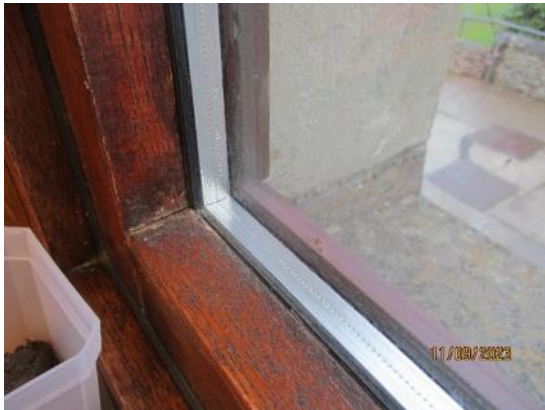
45. Double glazing

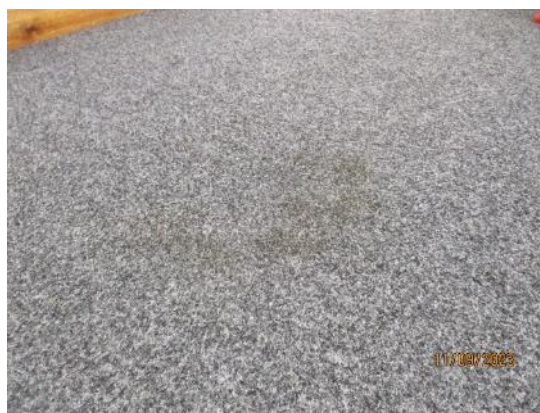
57. Soiled in isolated areas

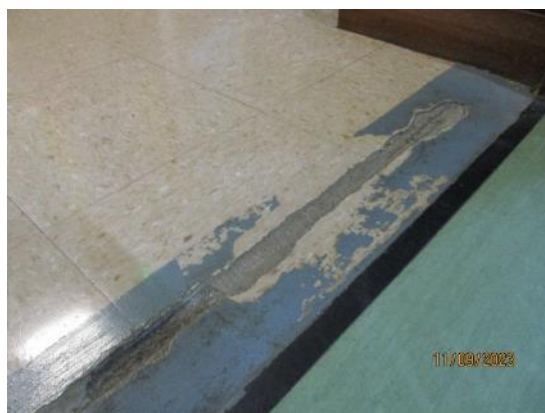
63.

62. Vinyl tiles cracked and breaking up

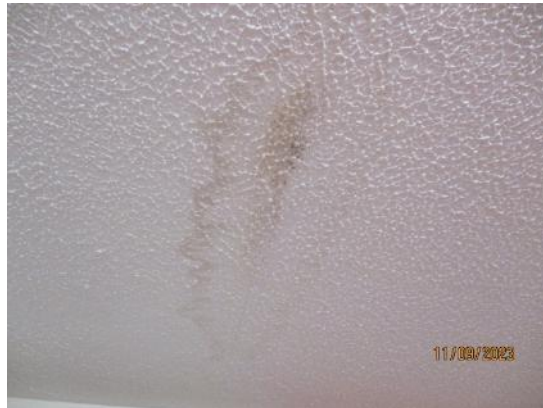
72. Watermarked plasterboard

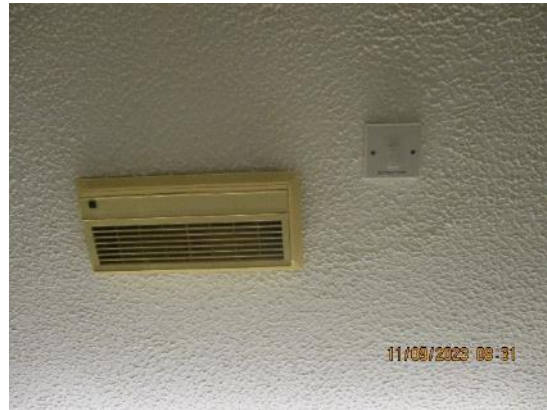
- The oil tank and oil supply pipework and controls are life expired and in poor condition.
- All electrical extract fans fitted in toilets are life expired and in poor condition.
- The school heating system controls and control panel are life expired and in poor condition.
- Heating pipework is only partly insulated.
- Hot water pipework is only partly insulated.
- Cold water pipework is only partly insulated.
- Electrical convector heaters installed are life expired and in poor condition.
- General wiring and wiring accessories are life expired.
- General lighting is life expired with exception of class 1/13.
- Building external lighting is life expired with exception of new LEDs.
- No intruder alarm system is installed.
- The CCTV system is basic and nearing the end of its useful life.
- The fire alarm system is manual type only and has no detectors incorporated.

127. Extract fan girls toilets 1-15.

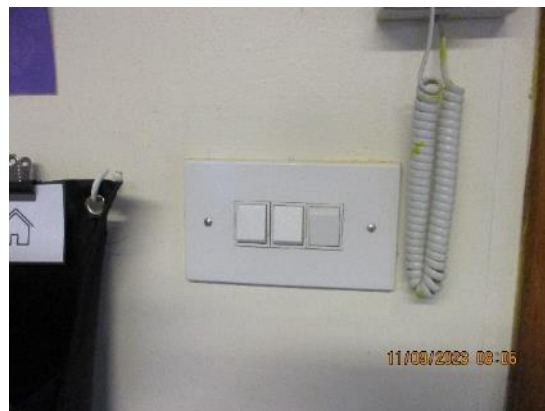
135. Flush fitted wiring accessories – light switch typical.

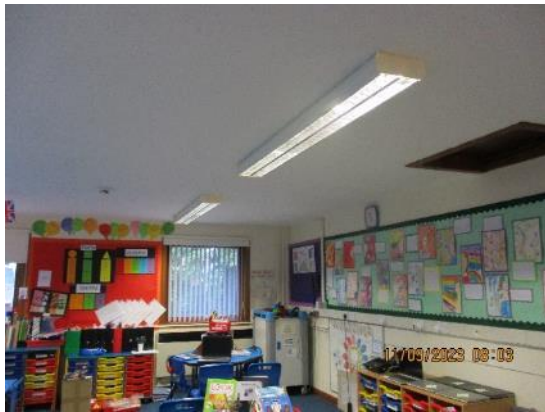
136. Lighting – classroom 1/12.

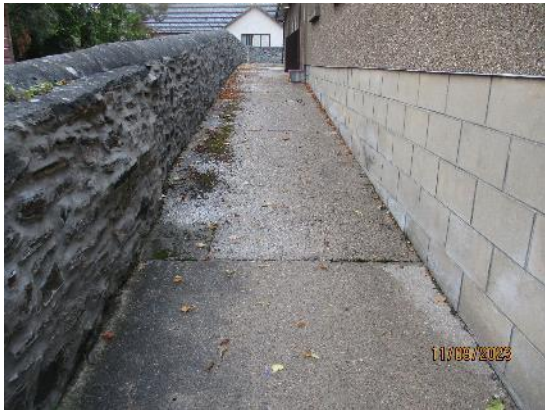
- Car park tarmacadam surface is eroded and potholed.
- Front concrete path is heavily eroded.
- Concrete ramps and footpaths are uneven/trip hazards.
- Concrete steps to the playing field are cracked and uneven.
- The metal frame of the chain link gate to the playground is corroded.
- Stone perimeter walls require repointing.
- The blockwork retaining wall to the car park requires roughcast repairs.

163. Raised edges and trip hazards

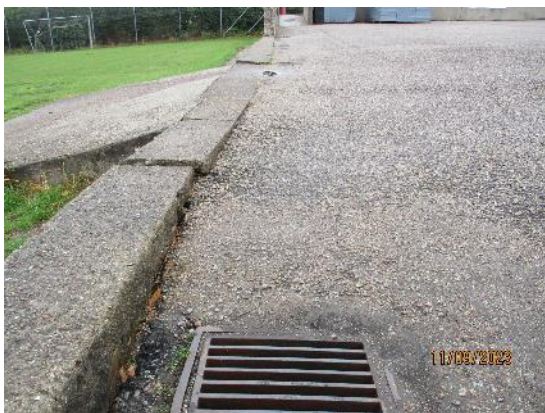
170. Concrete steps to sports field

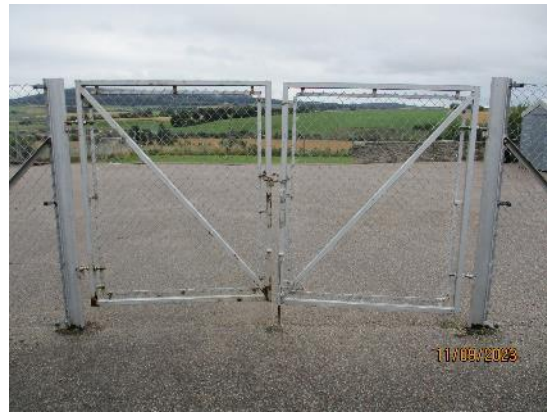
179. Metal framed chain link gates

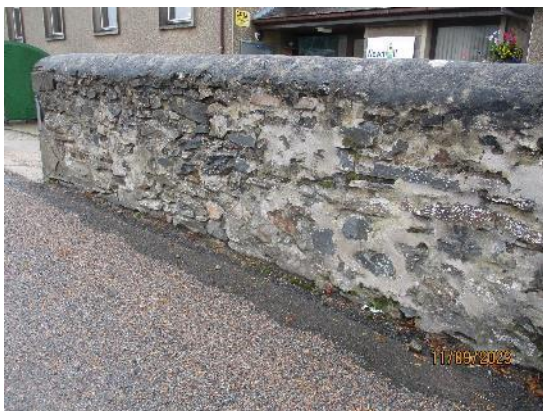
182. Natural stone perimeter wall

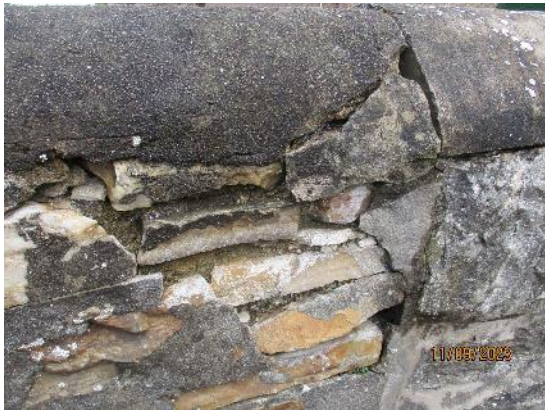
186.

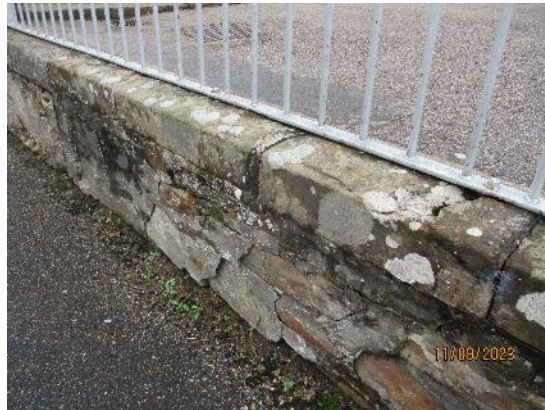
187. Low stone wall

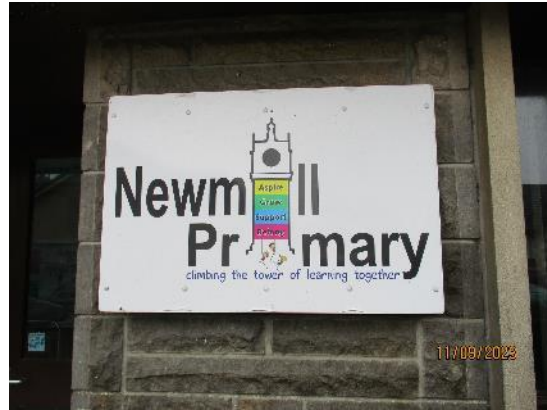
191. School signage

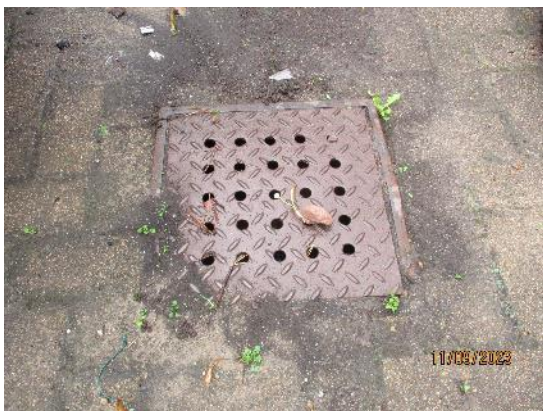
194. Courtyard gully cover

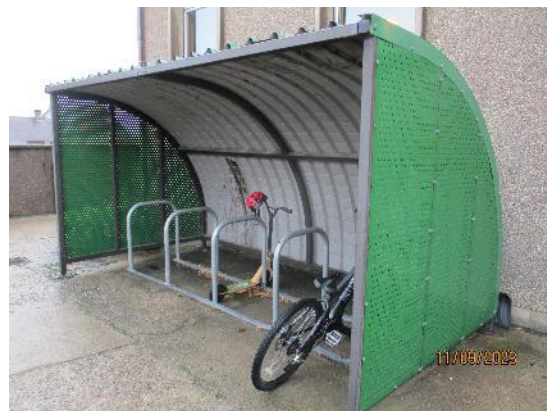
195. Bike shelter with cycle hoops

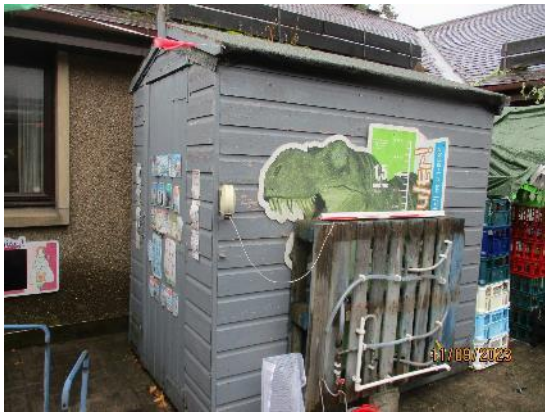
196. Timber sheds
