| PROJECT :<br>MORAY COUNCIL<br>HARBOUR INSPECTIONS | | | | |
| TITLE :<br>HOPEMAN HARBOUR - 2020<br>SURVEY AREA | | | | |

The Moray Council engaged Arch Henderson to undertake an inspection of Hopeman Harbour which was to include principle structural assets above and below the water line. Assets were to include sea walls, piers, jetties, quays, slipways and steps. At Hopeman these assets are constructed from masonry in the original parts of the harbour or from insitu concrete in areas where the harbour has historically been extended. No historic drawings of the structures are available and the assessment of defects is based on comparison with adjacent areas and archive photographs. Arch Henderson has no knowledge and has made no assessment into the load bearing capacities of the structures which would require further analysis.

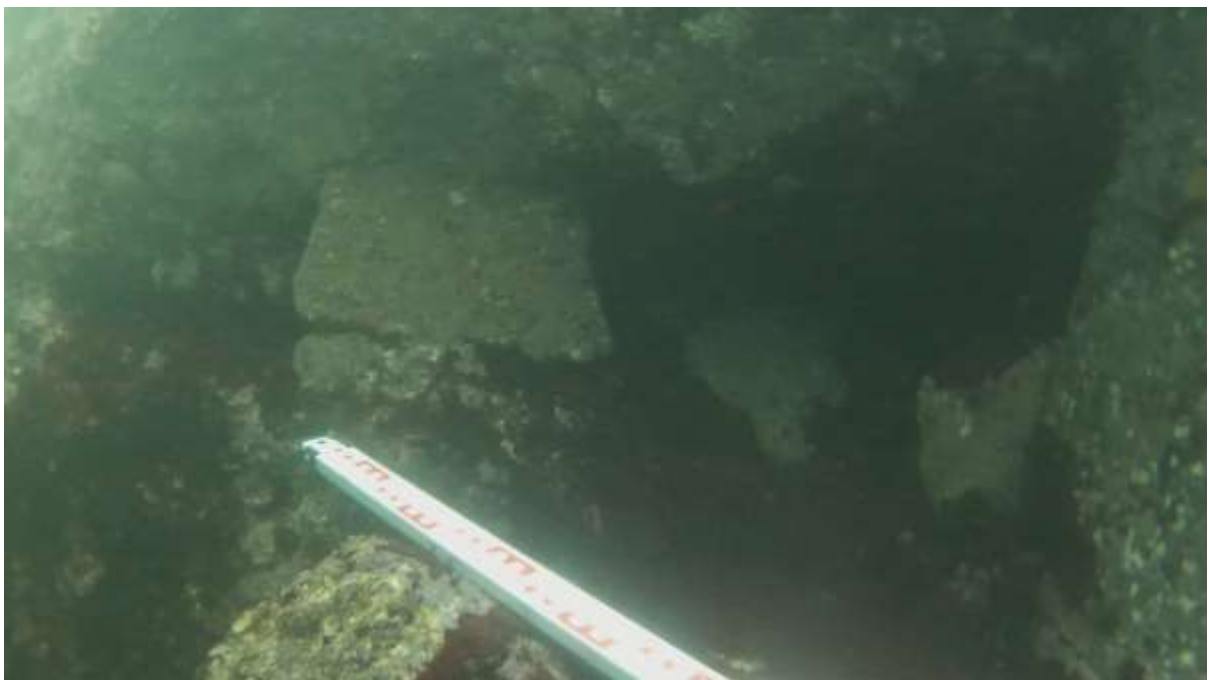
Defect 1

| Reference | Description | Easting | Northing |
|---|---|---|---|
| 1 | Abrasion to horizontal joint at mid height of wall on outer face - approximately 2m long x 1m high x 0.3m deep - further areas of shallower abrasion adjacent | 314401 | 870030 |

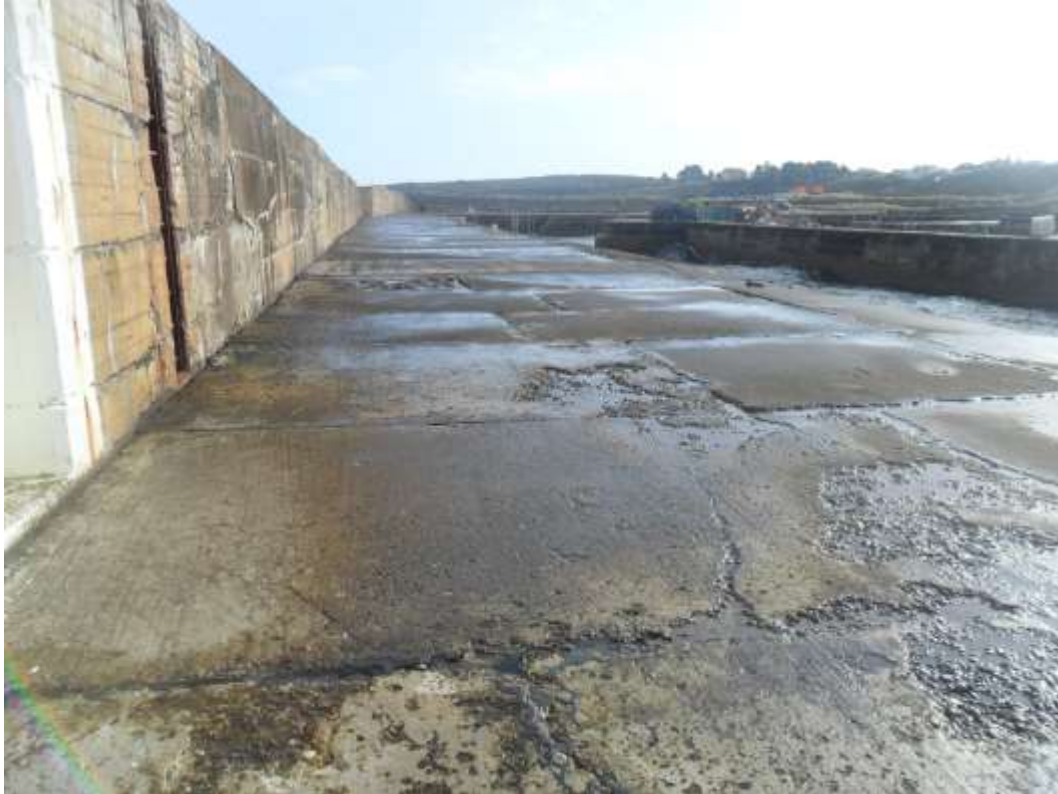
Defect 8

| Reference | Description | Easting | Northing |
|---|---|---|---|
| 8 | Spalling concrete along inside of parapet | 314430 | 870031 |

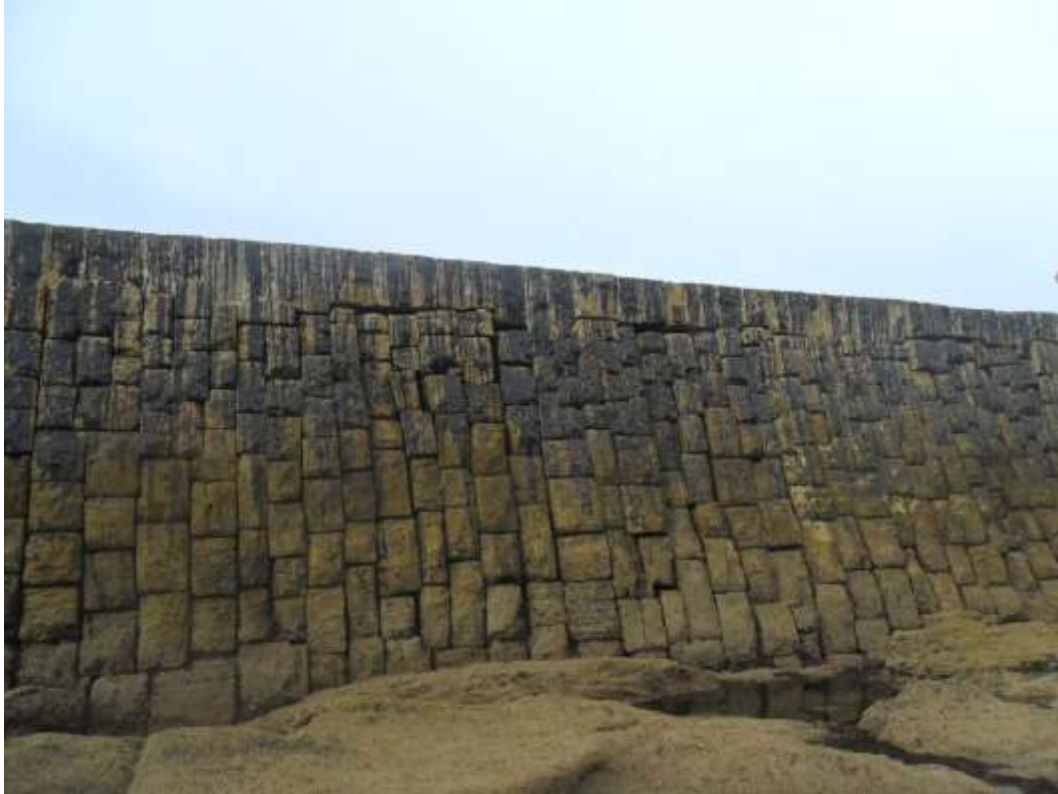
Defect 12

| Reference | Description | Easting | Northing |
|---|---|---|---|
| 12 | Missing block 0.6m deep adjacent berm | 314532 | 870027 |

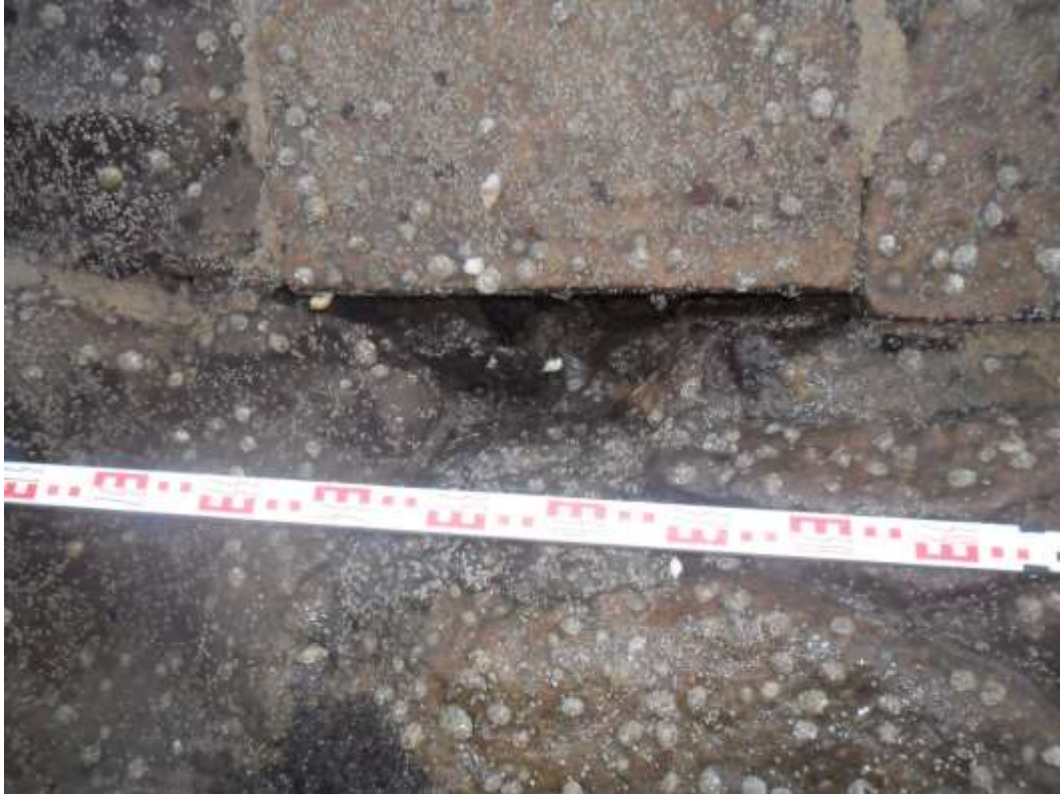
Defect 14

| Reference | Description | Easting | Northing |
|---|---|---|---|
| 14 | Missing blocks approx. 1m deep with 0.25m x 0.25m opening | 314561 | 869994 |

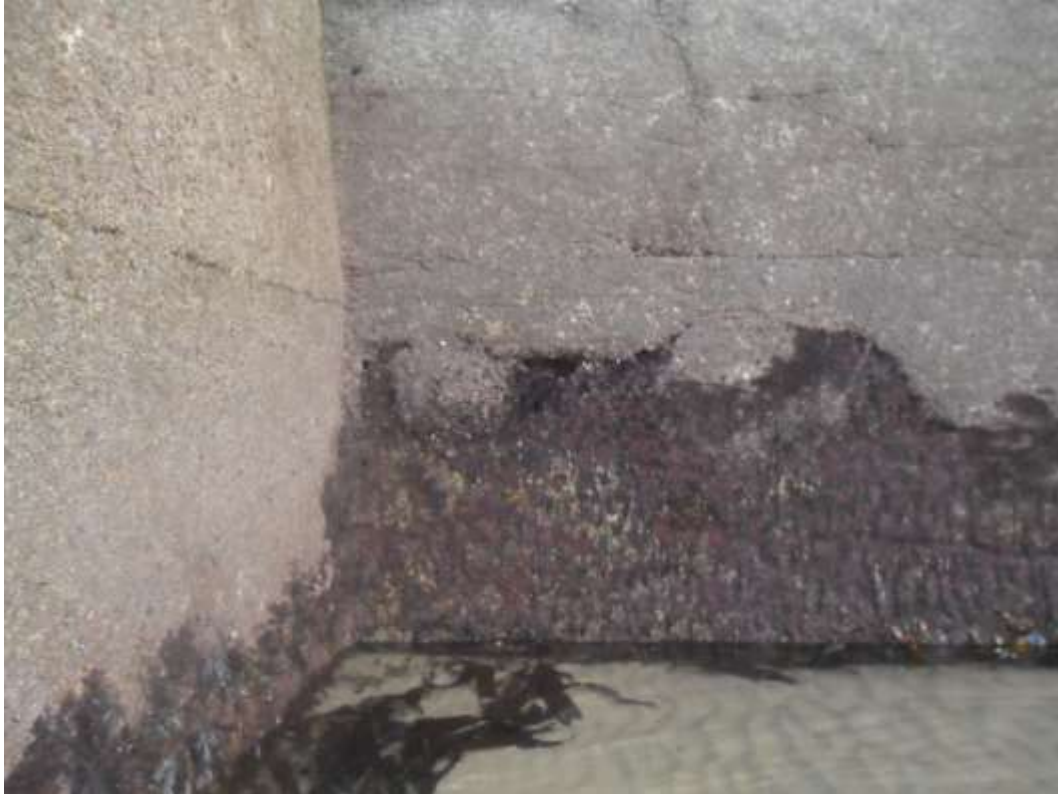
Defect 24

| Reference | Description | Easting | Northing |
|---|---|---|---|
| 24 | Cavity above concrete repair 2.5m long x 0.5m high x 0.2m deep | 314458 | 870002 |

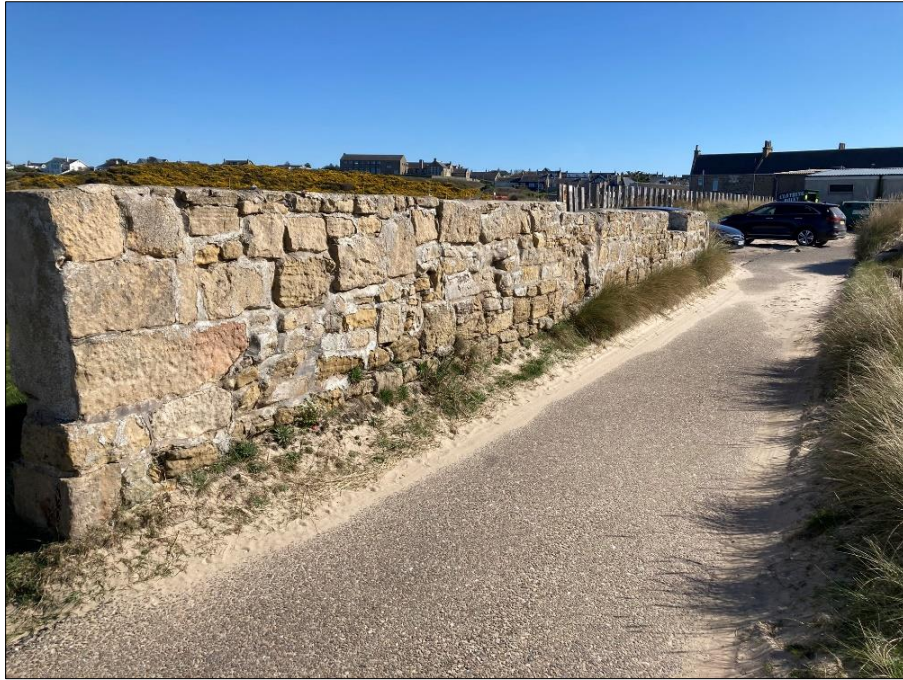
| Ref. | Element | Observation | Photo Reference | Comments |
|---|---|---|---|---|
| 01 | Masonry Wall. | Some joints open, mortar missing. | Photo 1<br>3876 | Wall in reasonable condition. |

Photo 1: Entrance to East Pier

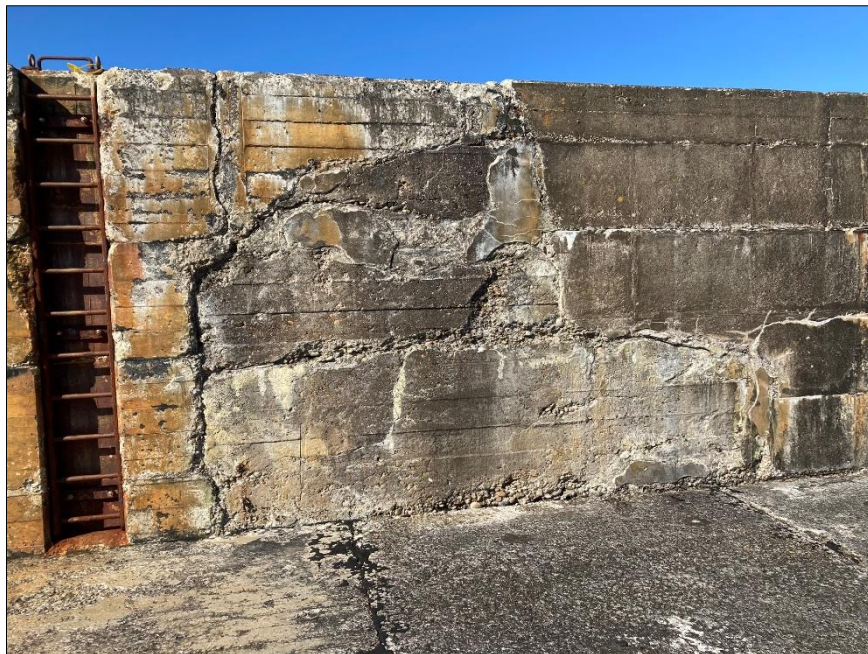
| Ref. | Element | Observation | Photo Reference | Comments |
|---|---|---|---|---|
| 07 | Inside Face Parapet Wall | Inside face badly abraded. Concrete from previous repairs has spalled. Vertical crack full height of parapet wall. | Photo 6<br>3924 | Likely to deteriorate further if no repairs carried out. |

Photo 6: North Pier inside face parapet wall.

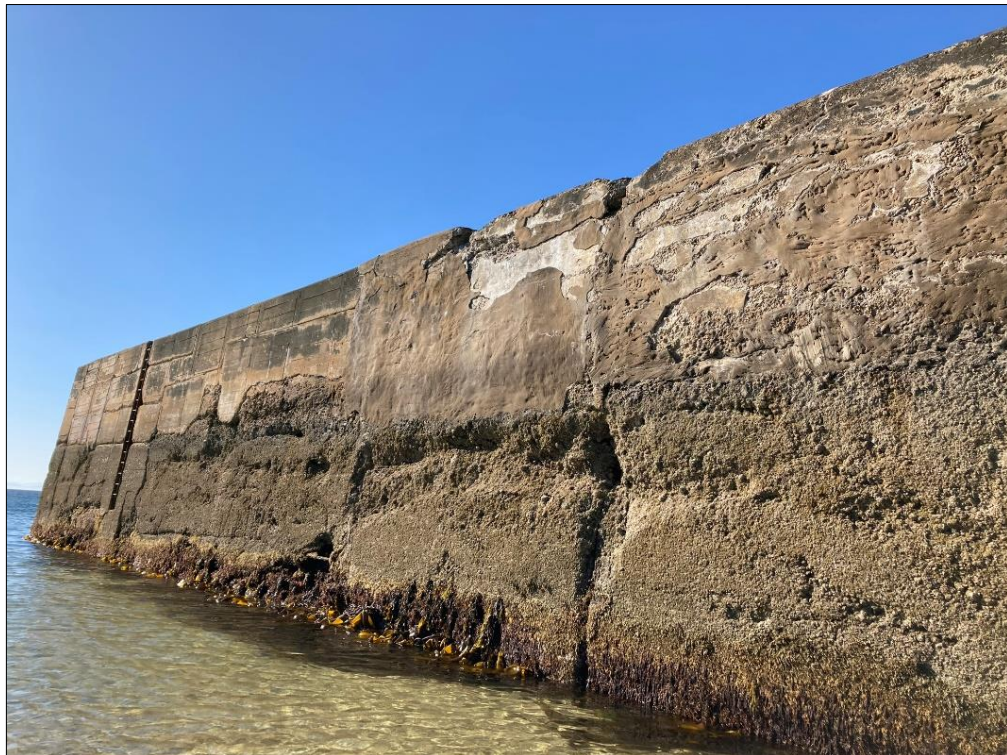
Photo 13: North Pier quay wall.

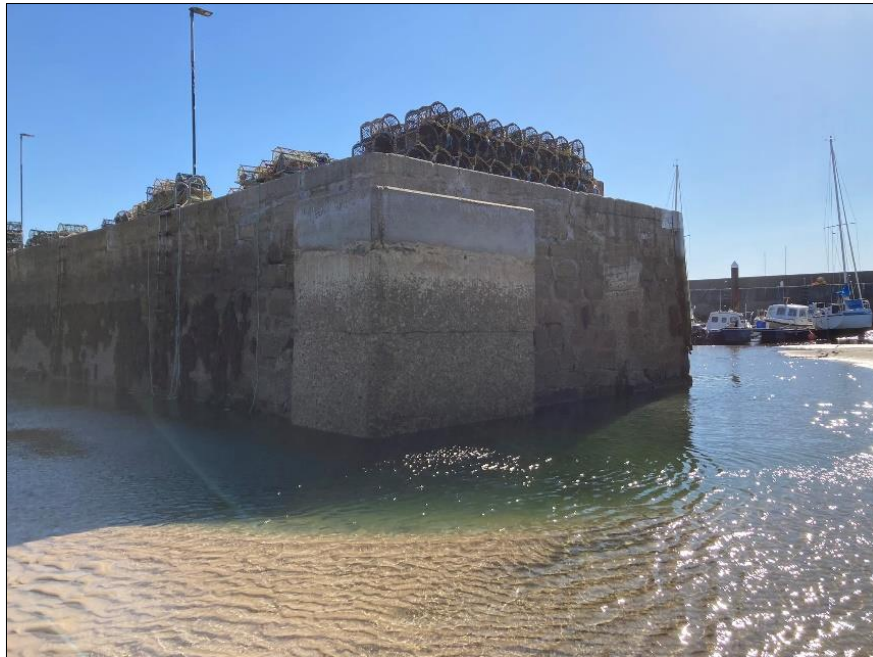
Photo 15: North Pier Quay Wall.

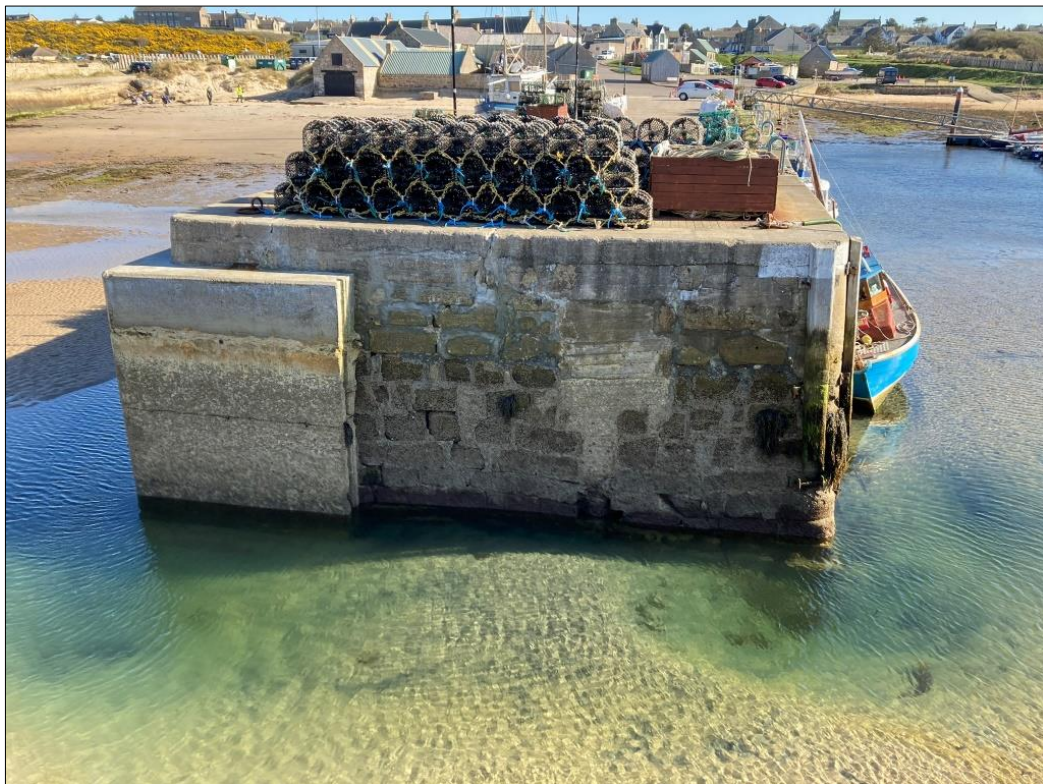
Photo 21 : Central Pier quay wall face outer basin.
