# **Summary Building Condition Survey Report**

**Crossroads Primary School**

**Grange, Keith AB55 6LX**

**26<sup>th</sup> October 2022**

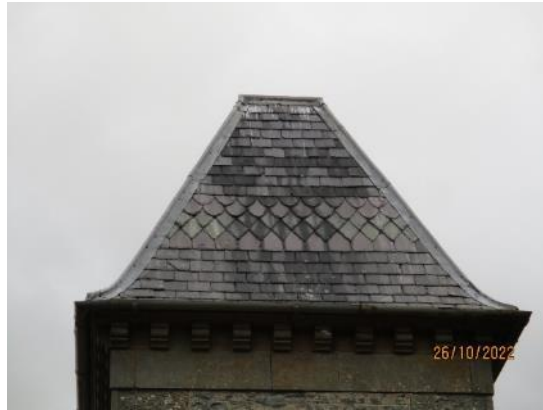
2. Decorative slate to bell tower

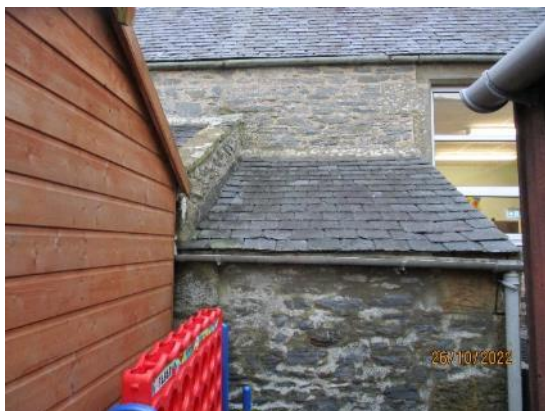
5. Lean-to slated roofs

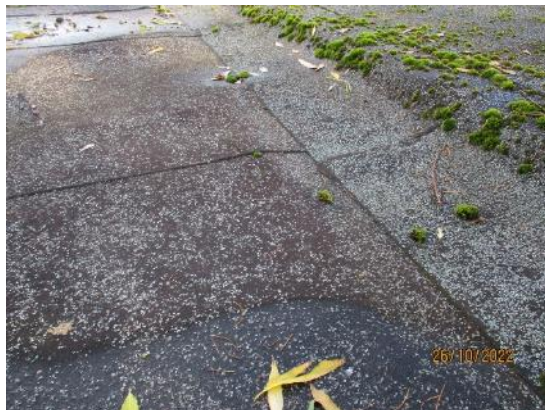
- Felt roof cracking and not draining to rainwater outlets.
- Half round and box gutters, blocked with vegetation.
- External timber cladding damaged with wet rot.
- Single leaf timber framed external walls.
- External timber doors damaged with wet rot.
- Minor damage to plasterboard walls.
- All floor finishes are worn.
- Internal decoration is overdue.

9. Felt has exceeded useful life

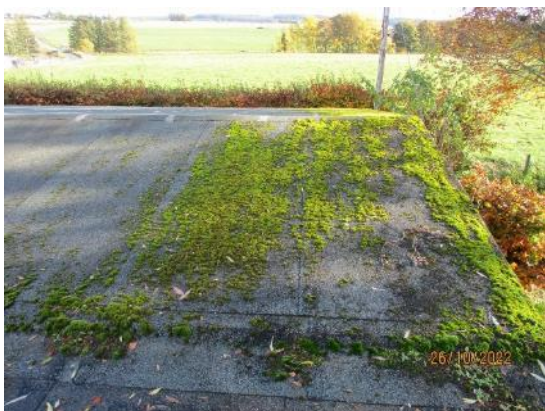
11. Surface moss to pitched felt roof

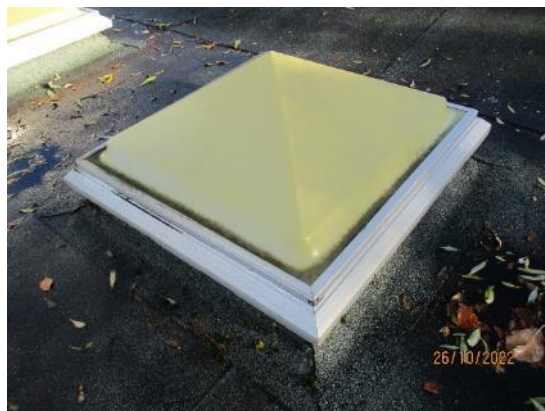
12. GRP domes to teaching block

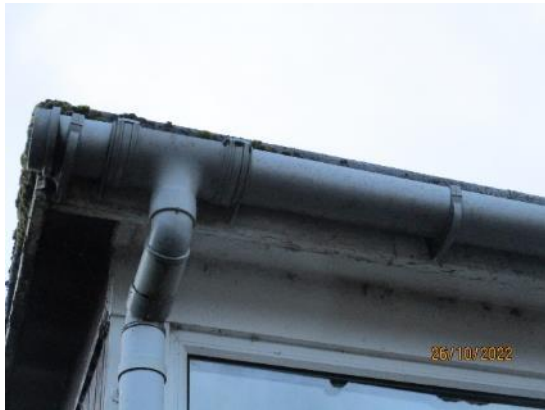
15. UPVC gutters to teaching block

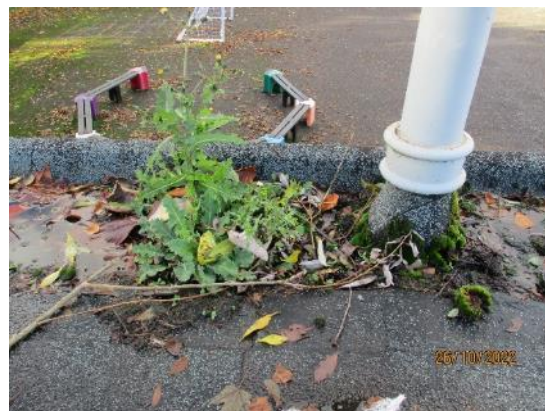
18. Vegetation in box gutters

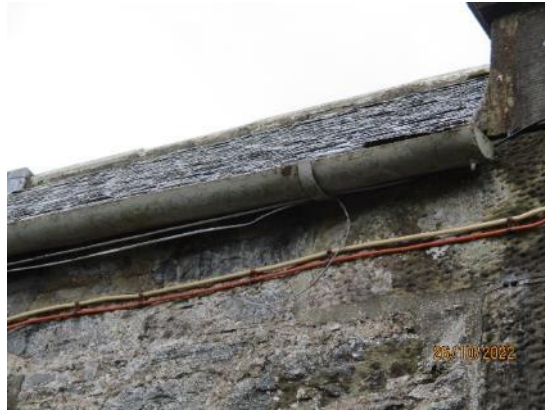
20. Cast iron gutters to old building

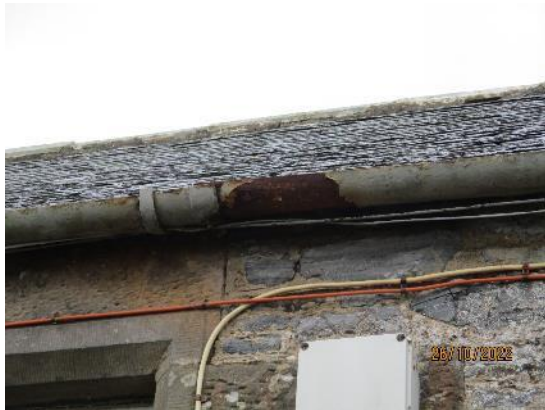
21. Surface corrosion

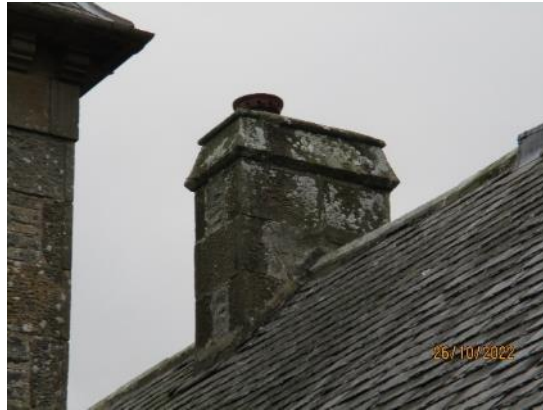
26. Stone chimney

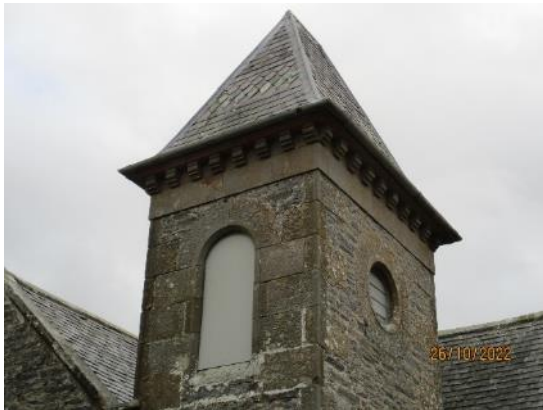
27. Stone bell tower

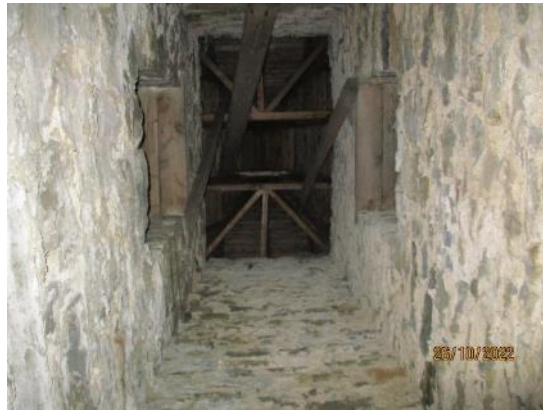
28. Internal structure

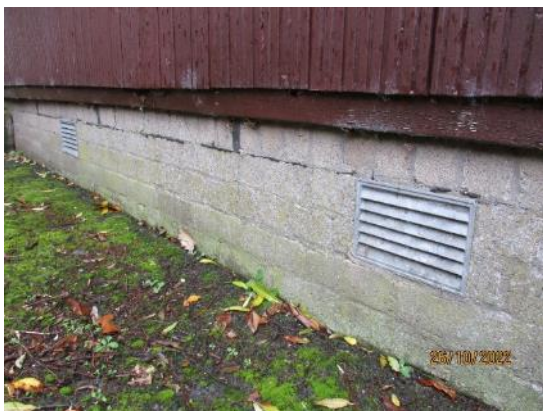
29. Ground level – Teaching block

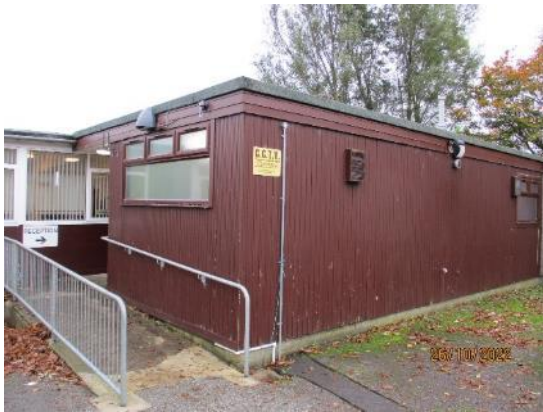
31. Timber cladding

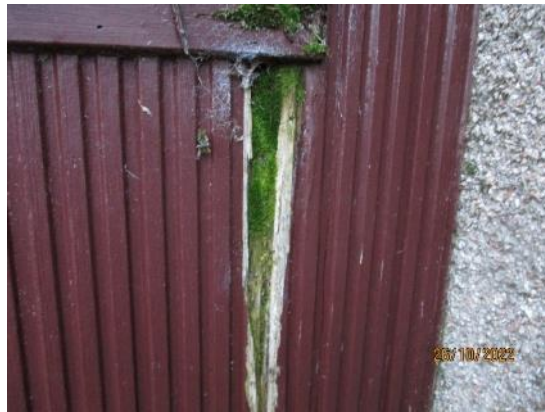
32. Timber decay

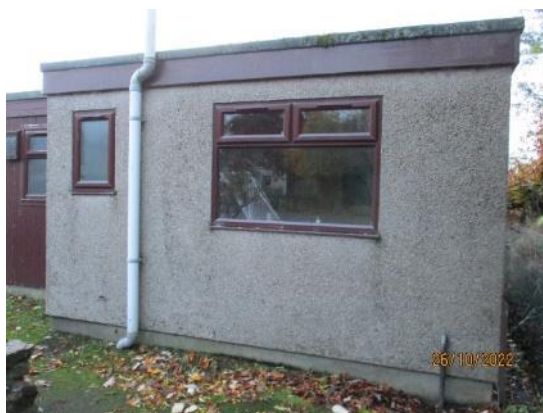
35. Roughcast walls

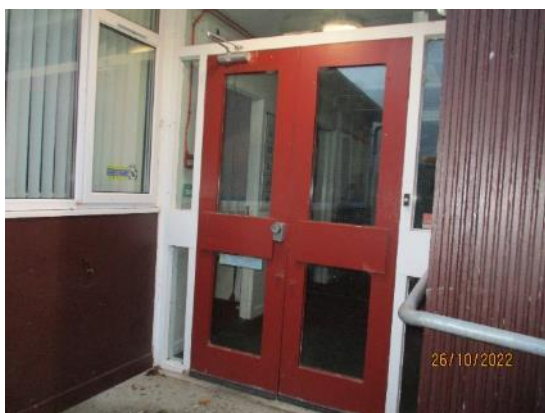
36. Timber entrance doors

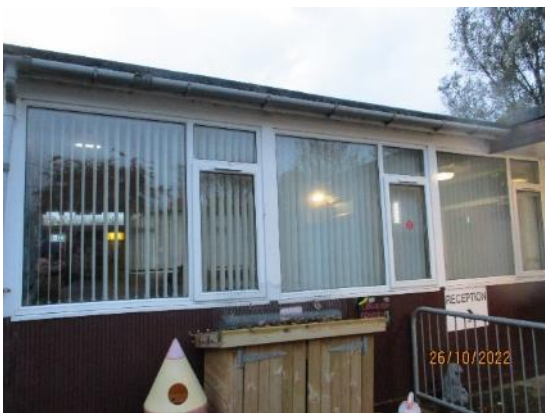
41. UPVC windows – Teaching block

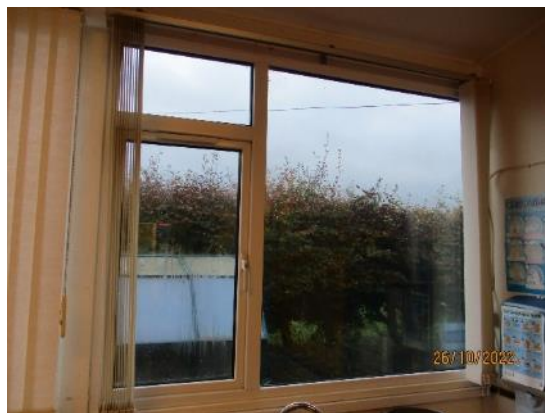
42. Windows internally - White

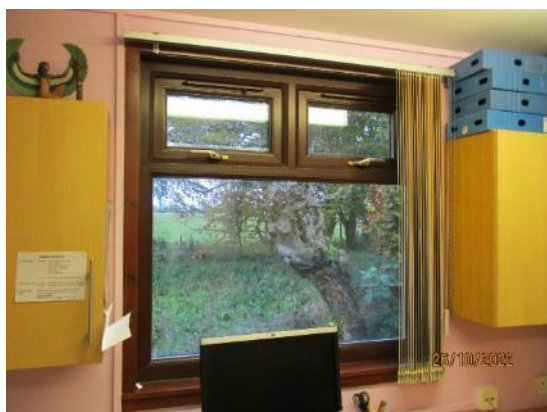
43. Windows internally - Brown

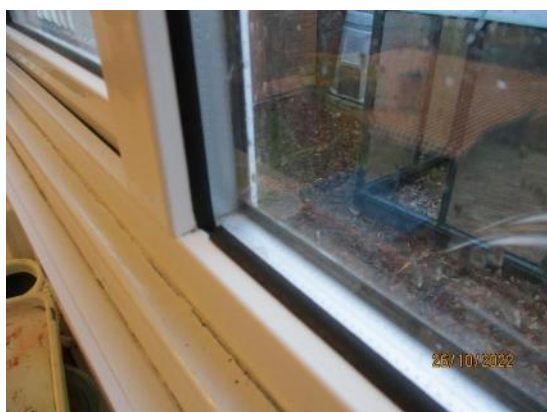
45. Double glazed windows

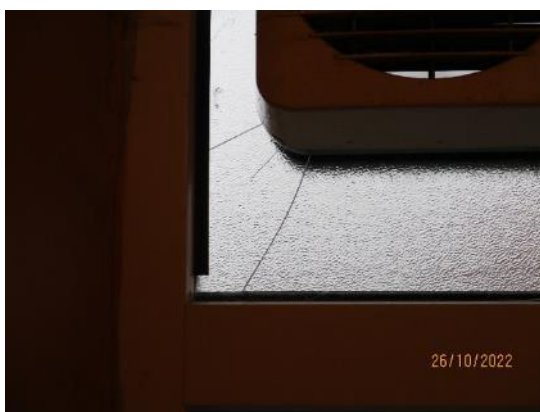
46. Broken glazing

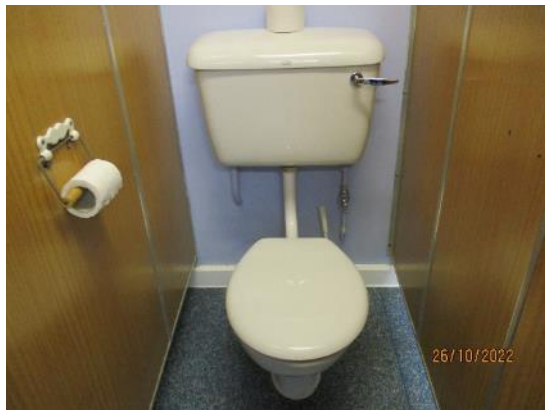
86. Pupil toilet, plastic cistern

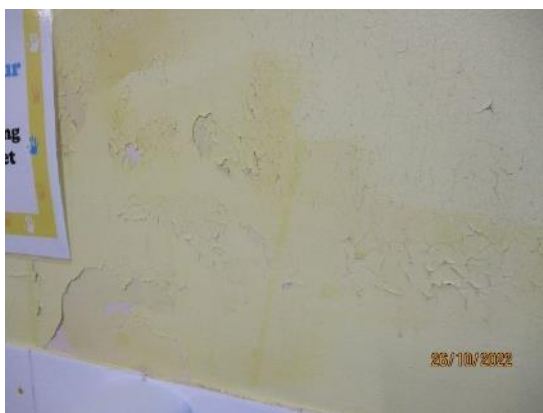
87. Flaking wall decoration

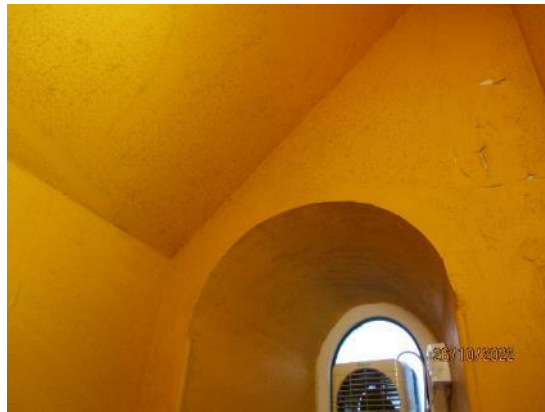
89. Peeling decoration

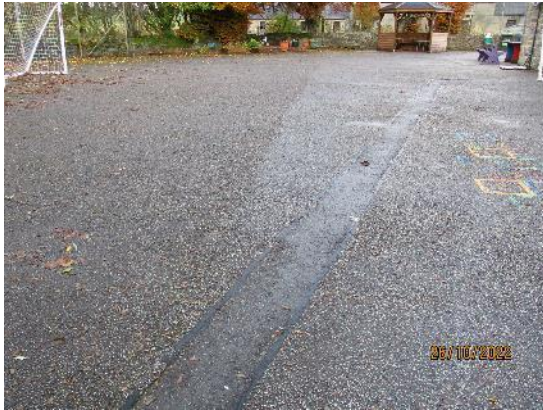
141. Tarmacadam playground

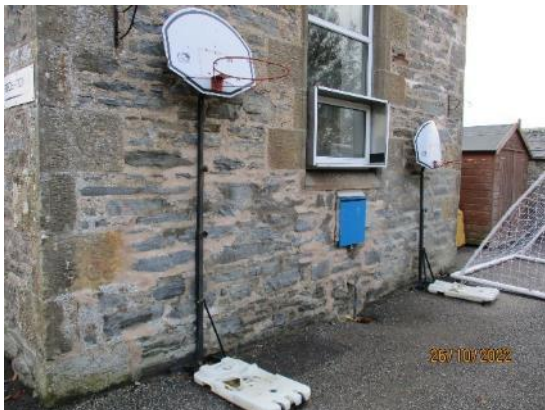
161. Basketball stands

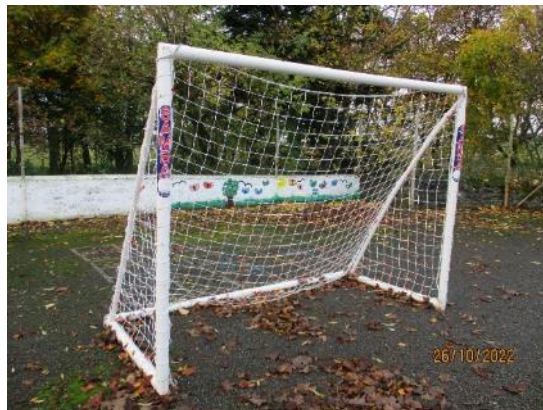
162. Goals with netting
